RESIDENTIAL REPORT
The Fairways of Brevard Association #1, Inc.
725 Port Malabar Blvd NE
Palm Bay, Florida 32905

Phase One Milestone Inspection

PHASE ONE MILESTONE INSPECTION

11/30/2023

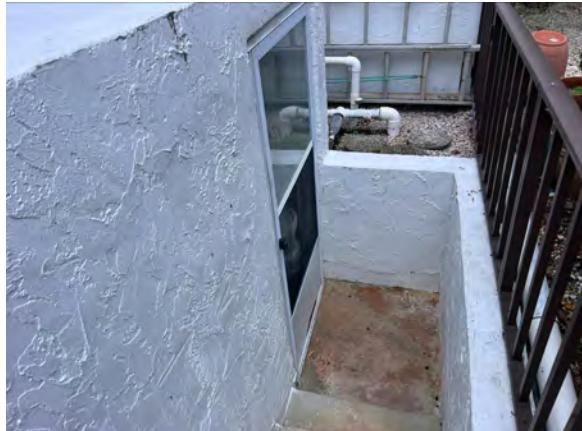
1.o.1

1. Handrail near pool equipment is loose and needs to be secured. 2. Handrail at balcony corner near Unit 200 is loose at the bottom and needs to be secured. 3. Handrails on 3 rd level near Units 301,308, and 309 needs to be sealed at bottom connecting point to concrete slab. 4. Minor cracking in stucco. Edge of concrete slab on 3 rd level elevated walkways. 5. Minor spalling at the edge of concrete slab. 3 rd level elevated walkway between Units 305-306. 6. Minor spalling at the edge of concrete slab. 2 nd level elevated walkway between Units 206-208. 7. Minor spalling in concrete slab near the bottom of the handrail near Unit 210. 8. Spalling on top of concrete slab of 2 nd level elevated walkway near Unit 201. 9. Minor cracking in concrete around door frame of Unit 205. 10. Minor spalling in concrete beam supporting first landing of stairs near Unit 100. 11. Minor spalling at bottom of stair riser near Unit 100. 12. Minor cracking in concrete and stucco. Bottom of exterior wall of garbage collection room. 13. Cracking in concrete and stucco of exterior wall of patio. Rear of Unit 109. 14. Holes in wood fascia at front and back right corners.

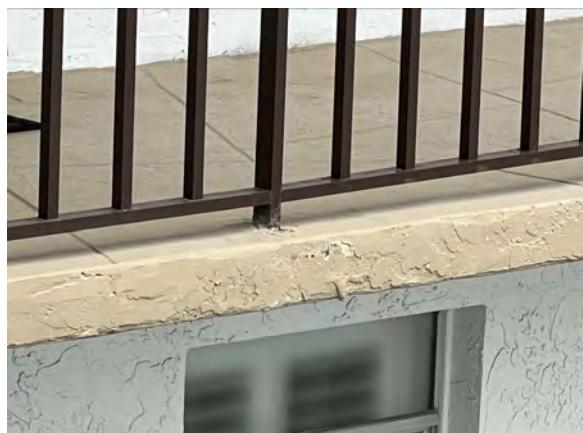
1.o.4

See repair items 1.o.4, 1.o.9, 1.o.12, 1.o.13.

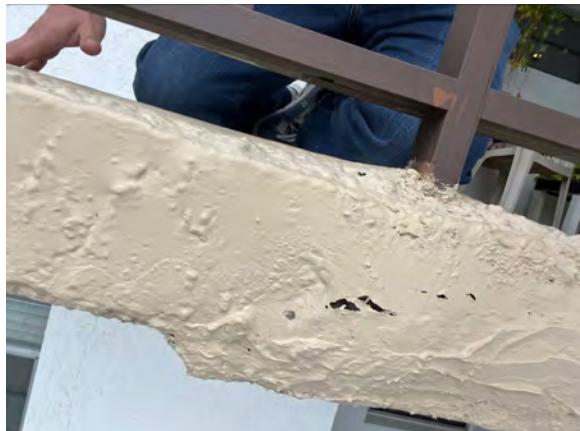
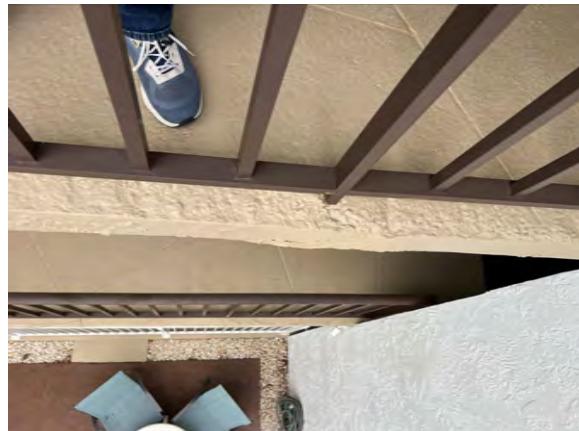
1.0.5

See repair items 1.o.5-1.o.11.

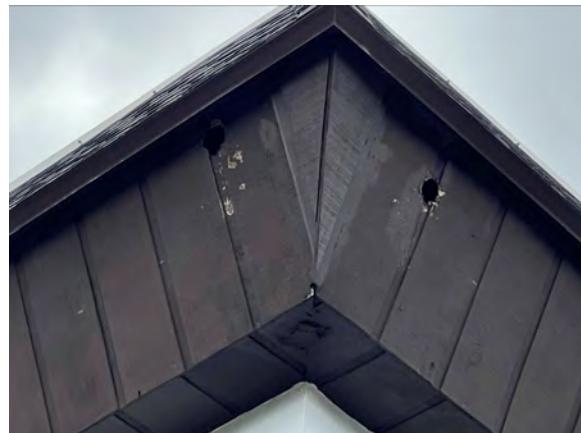
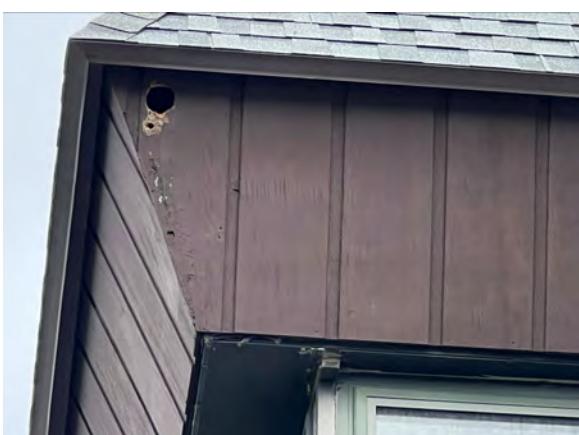
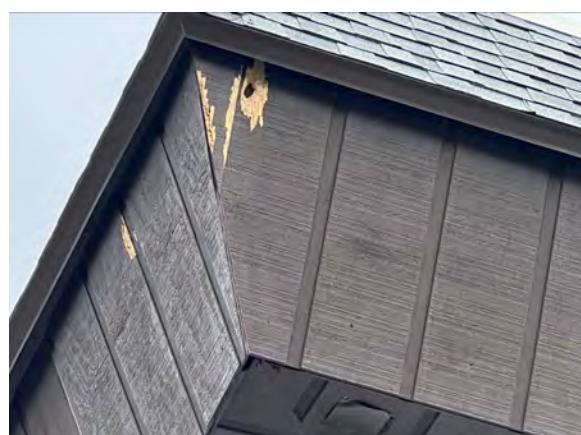
1.o.14

Minor spalling observed in elevated walkways and stairways. Holes in wood fascia were caused by woodpeckers and are not due to rotting wood.
