EP JN:	18000-19-43
Re:	<b>Structural Assessment Report</b> Leilani Community Association Metal Building Pavilioin 13-3441 Moku St, Pāhoa, HI 96778
TMK:	(3) 1-3-036: 048

On August 15, 2019 Engineering Partners (EPI) performed a site investigation at 13-3441 Moku Street located in Leilani Estates, Puna, Hawaii. The purpose of the investigation is to evaluate the structural condition of the pre-engineered metal building pavilion structure on site. The following is a summary of the results of the assessment.

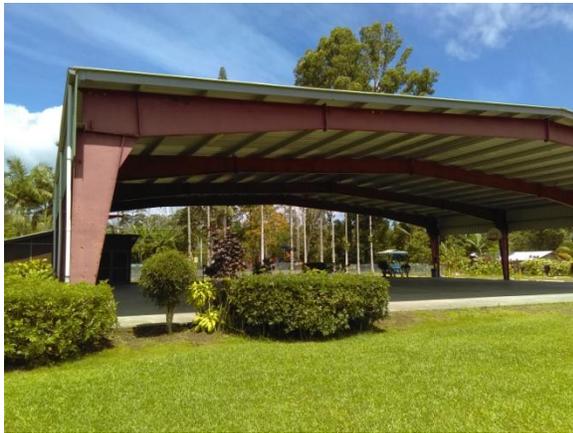
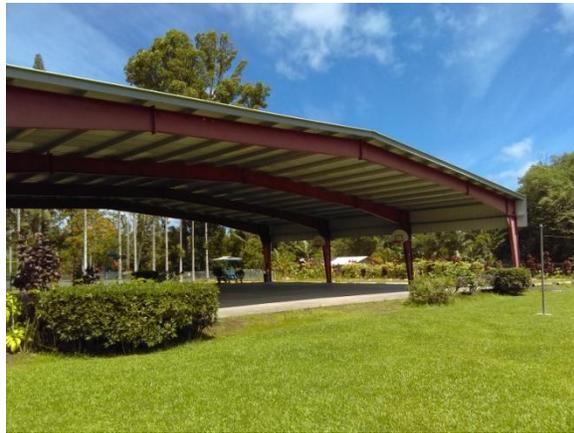
The subject building is a 7,500 square foot, single story, pre-engineered metal building originally permitted and built in 1989. Record structural plans were not made available for our review. The span of the rigid frames is 100 feet wide and there are four total frames spaced 25 feet apart. The foundation system consists of spread footings which measure approximately four feet square and a slab on grade over top. There are partial sidewalls near the top of the structure but otherwise it is considered an open structure. The wall and roof framing are light gauge metal purlins which support the metal roofing and siding. There is cable cross bracing in the roof and side walls.

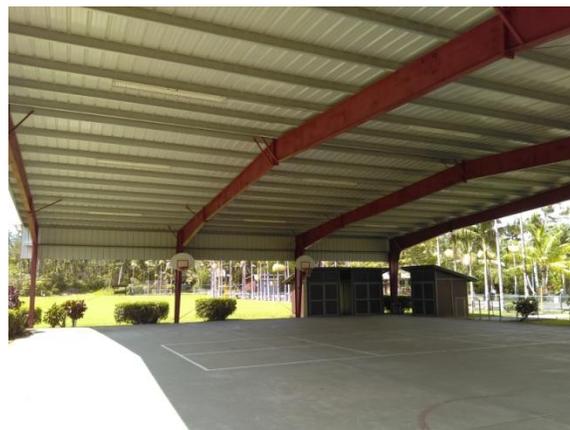
Overall the pavilion is in fair structural condition. Although the structure was originally built on this site in 1989, it was relocated from a previous site. Pre-engineered metal buildings typically perform well during seismic events. They are typically light-weight flexible buildings so large forces are not developed during seismic events. Due to the open nature of the structure, lateral loads from hurricanes or other wind events are also minimized. There do not appear to be any damages due to seismic or wind events, but corrosion due to rain exposure is a concern that should be addressed to ensure continued occupancy of the structure.

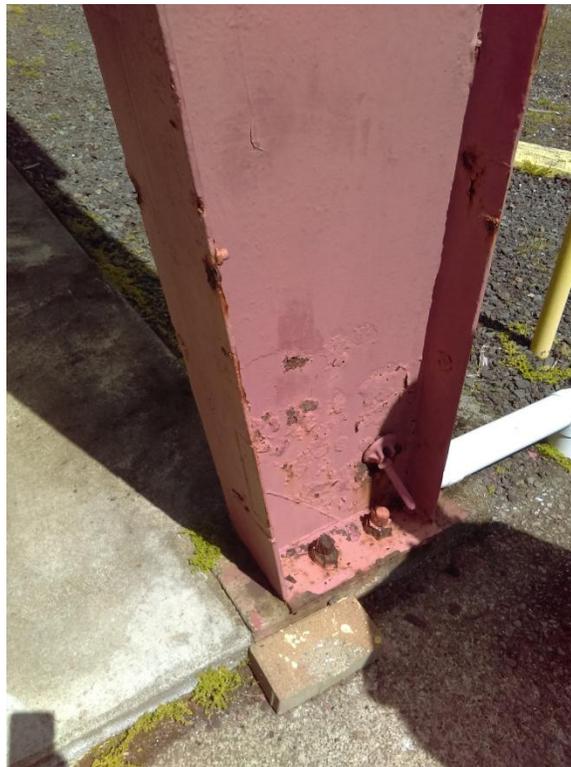
There appear to be welded patch plates in the frames and the column steel exhibits pitting and corrosion, especially near the base plates. Some of the corrosion and pitting appears to be below the finish paint, so it was most likely in that condition when the building was relocated. Some of the anchor bolts exhibit advanced corrosion and material loss, but overall each base plate has no less than three effective anchor bolts. The cable cross bracing in the sidewalls is someone loose, most likely due to the corrosion in the column near the attachment. The corrosion is worst in the bottom three feet of the column webs.

- 1) Tighten cable cross bracing, reinforce web near attachment with welded plate. (twelve months, estimated cost \$2,500)
- 2) Treat and replace corroded anchor bolts. Anticipate replacing or adding one anchor bolt per each of the eight columns. (twelve months, estimated cost \$20,000)
- 3) Grind corroded areas in bottom three feet of each column and weld patch plates to restore original section properties. (three to five years, estimated cost \$10,000)
- 4) Clean and blast paint from columns and rafters, then apply corrosion resistant paint system to the structural steel. (three to five years, estimated cost \$100,000)
- 5) While it is not required, it may be prudent to paint the roof purlins and wall girts while the rest of the structure is painted. The purlins and girts can be evaluated for corrosion closer to the time of the work. (three to five years, estimated cost \$100,000)

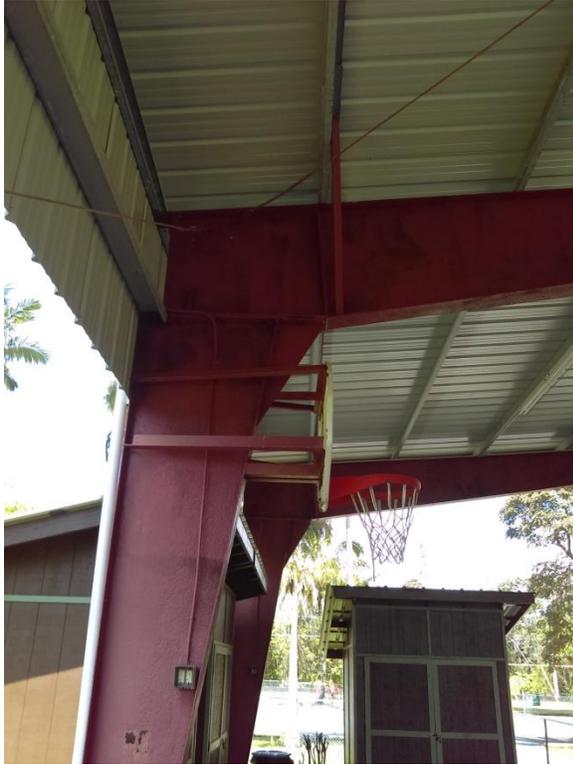
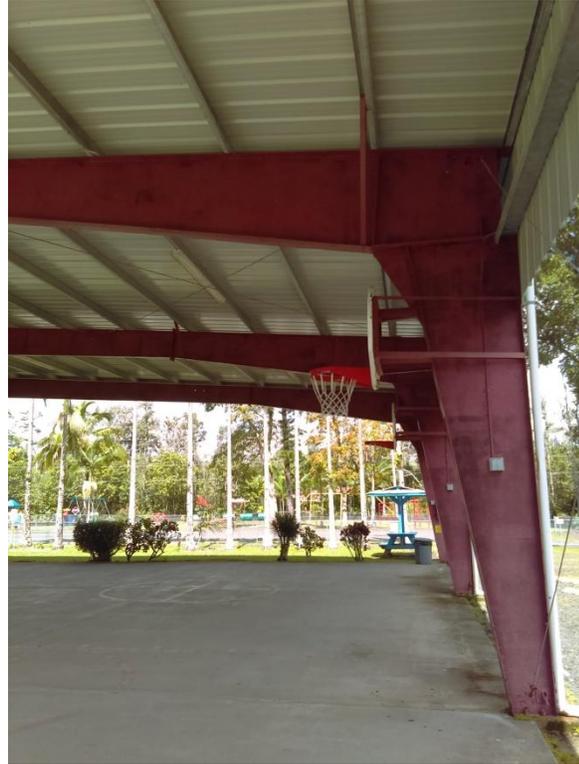
Although record plans were not made available, it seems that the rafter-to-column connection was modified when the building was relocated. There is a gusset on the inside of the column that appears to be field welded to the column and rafter. It seems likely that the columns were set about one foot wider than the original construction, but this cannot be confirmed. That said, it appears that the welds

and connections are in good condition, and the overall dimensions of the connection appear to be consistent with engineered rigid frames of this size.
