## **Construction Inspection Division**

### **Post-Construction Stormwater Drainage Inspection Report** 2616 Moon Creek Lane Clover, South Carolina 29710

**Stormwater Drainage Inspection**

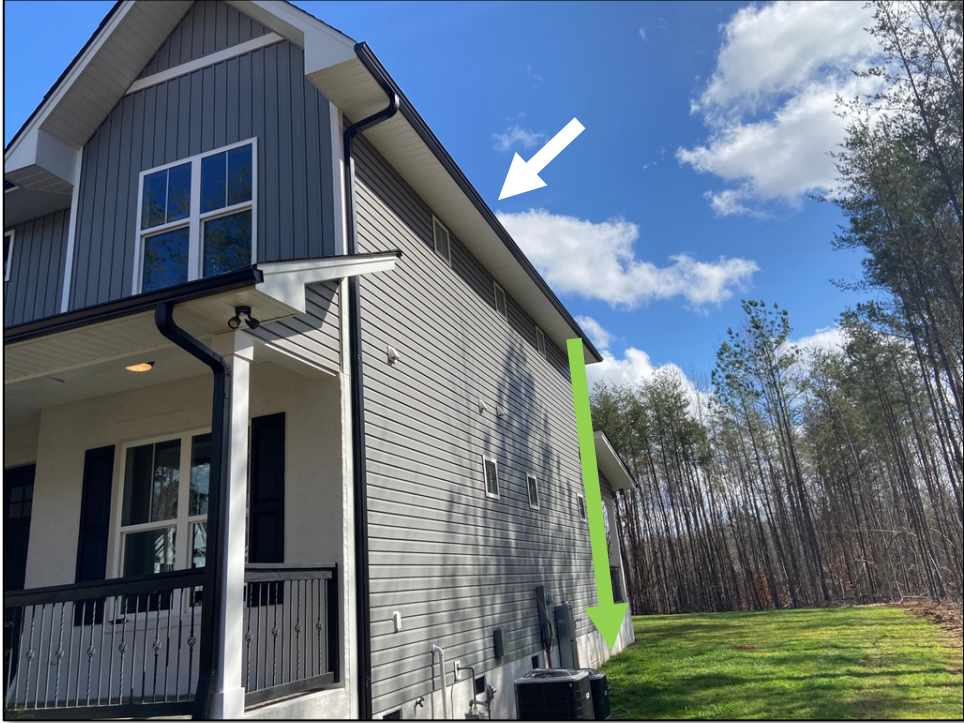
Illustration #1

The structure has a single downspout on the right side (southwest side) with a gutter span exceeding 30' (See Illustration #1, Page 3). This span continues around the back corner of the structure above the patio area, wraps around the back side of the structure (southeast side), and then continues around to the left side of the structure (northeast side) (See Illustration #2, Page 3). On the back side of the structure, there is a single downspout over the patio area that discharges water from three different roof surfaces (See white arrows). The amount of potential stormwater that will be discharged onto the shingle roof above the patio area will be significant. The surface of the shingles will deteriorate at a rapid pace with the increased amount and flow of stormwater. This will lead to roof damage and higher potential for water intrusion. This stormwater from the main roof, along with the stormwater from the patio roof, is then funneled down into a single downspout for discharge at the base of the structure. This is a tremendous amount of water for a single discharge point. **See Corrective Action Items #1 & 2 on Page 6.**

1. **Right Side (southwest side)**- Place another downspout to the left of the patio from the second story gutter down to ground level. Tie new and existing downspouts into buried 4" corrugated drainpipes to discharge stormwater out on the right-side slope of the lot near the property line. (See Green Arrows)
2. **Back (southeast side)**- Place another downspout to the right of the patio from the second story gutter down to ground level (see Red Arrow). Tie this new downspout, and the existing downspout on the left side of the patio into 6" corrugated perimeter drain system to discharge stormwater out on the right-side slope of the lot near the property line.
3. **Front (northwest side)**- Place a downspout from the second story gutter that follows the contour of the roof and diverts water down and around into the roof

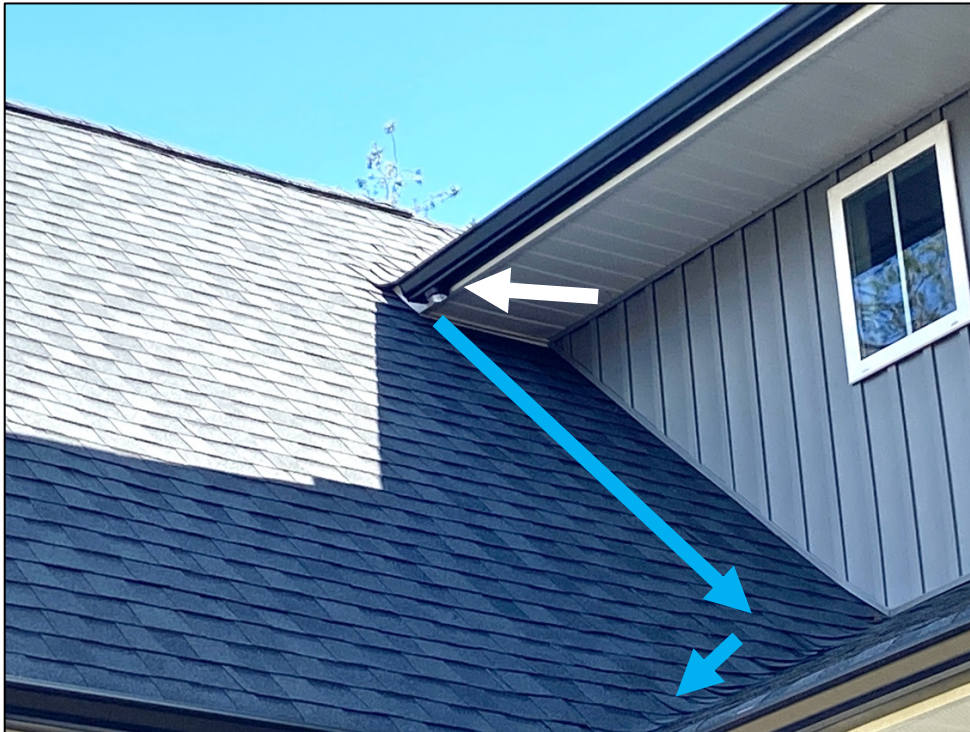
### Illustration #3

On the front of the structure (northwest side), on the second story gutter to the left of the front porch, there is a downspout connection with no downspout to direct stormwater into the gutter below (See Illustration #3 below). This gutter collects stormwater from three roof surfaces. This downspout connector sits immediately adjacent to the second story front wall, with no way to direct the stormwater down and into the gutter below. In addition, the amount and speed of the stormwater entering the roof valley below could easily be pushed up under the shingles and cause water intrusion and roof damage over the front porch area. All the above gutters empty into a downspout on the right of the front porch, which is attached to a poorly buried 4" corrugated drainpipe that discharges stormwater out by the property line. It was noted that this pipe was clogged with pine needles and leaves (See Illustration #5, Page 5). This will impair the ability of the gutters and downspouts to discharge stormwater as designed and may cause stormwater to backup and leak out at connection points at the base of the house. **See Corrective Action Item #3, Page 6.**

valley. Dig up and rebury the existing 4" corrugated drainpipe on the right front porch area (needs to be properly buried).

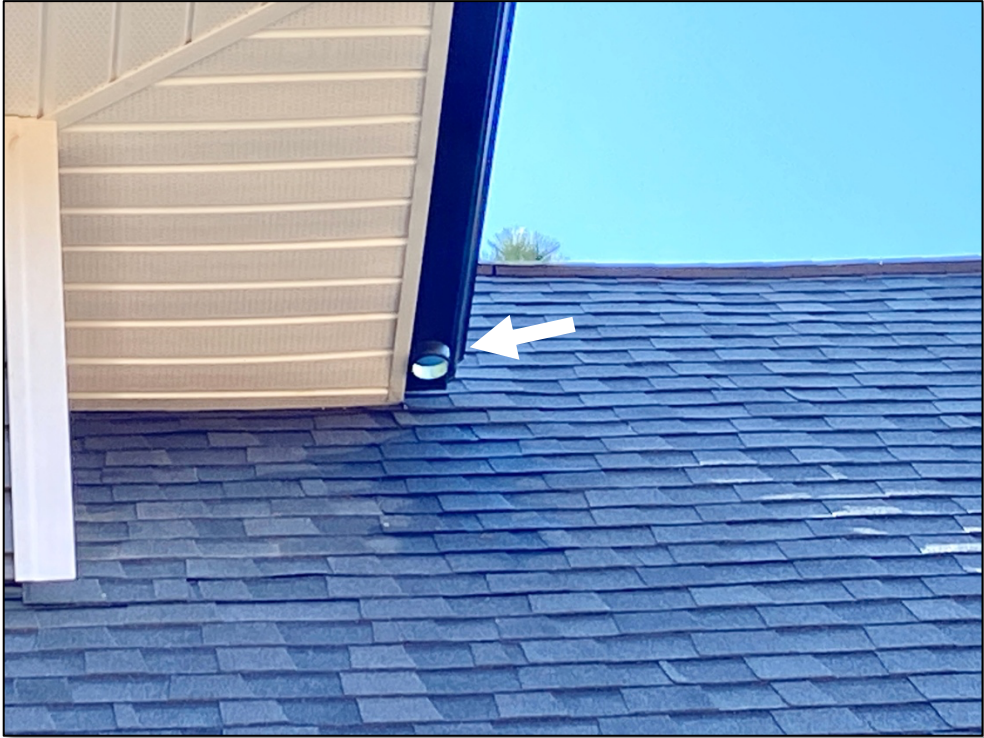
**Illustration #4**

Similarly, on the left side (northeast side) of the structure above the garage, there is a second story gutter with a downspout connection with no downspout to direct stormwater into the gutter over the garage door (See Illustration #4, Page 5). The second story gutter collects stormwater from four roof surfaces. The amount of stormwater collected from these four areas with a single, non-guided discharge point will lead to increased wear of shingles due to the amount of stormwater and increased flow. This will cause roof damage and has a higher potential for water intrusion. **See Corrective Action Item #4, Page 7.**

4. **Left Side (northeast side)**- Place a downspout from the second story gutter that follows the contour of the roof and discharges directly into the gutter over the garage. Place a downspout on the left side of the gutter above the garage down to ground level. Tie new downspout into 6" corrugated perimeter French drain system (left and backside only, see yellow line in Illustration #7 below) to direct stormwater around the side and back of the structure and discharge it on the right-side slope of the lot. These drains should NOT be discharged into the back yard due to the septic drain field. Extend to right side of structure.
5. **All gutters**- Have gutter guards installed to prevent gutters, downspouts and perimeter drains from clogging with leaves and pine needles.

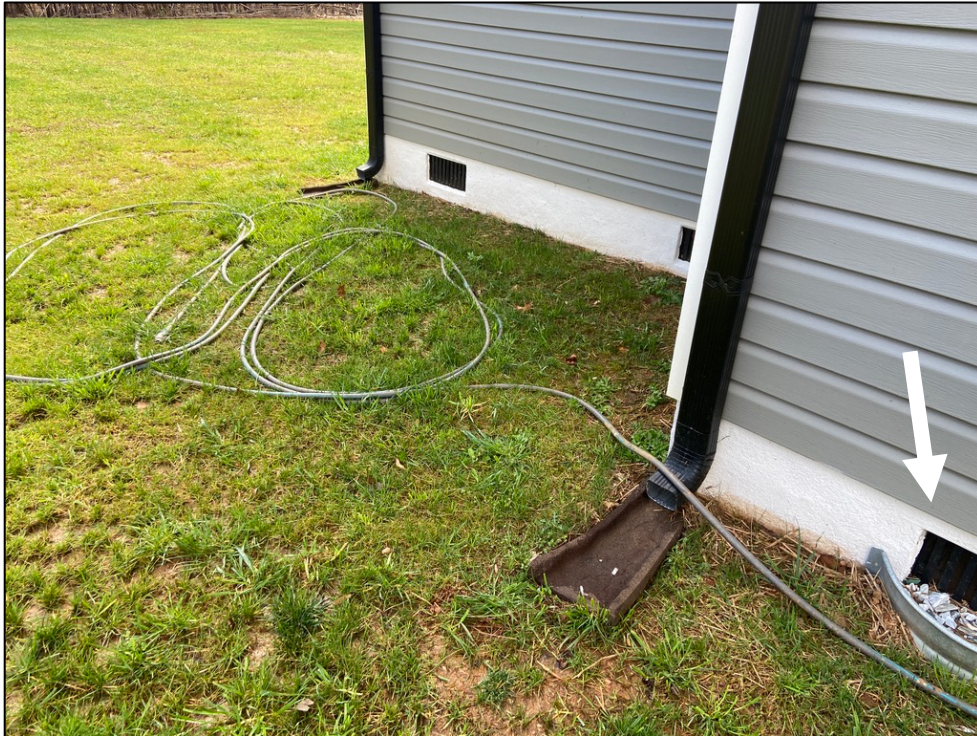
### Illustration #6

All but one of the downspouts discharge stormwaters at the base of the foundation without any type of structure perimeter drain system. This allows for water to sit in direct contact with the foundation wall. This is especially noted to the left of the garage area where two downspouts discharge water in a relatively flat area with no drainage next to the foundation wall (See Illustration #6 below). There is also one crawlspace vent that sits at ground level and could easily become flooded, allowing for direct water intrusion into the crawlspace (see white arrow below). **See Corrective Action Item #4, Page 7.**

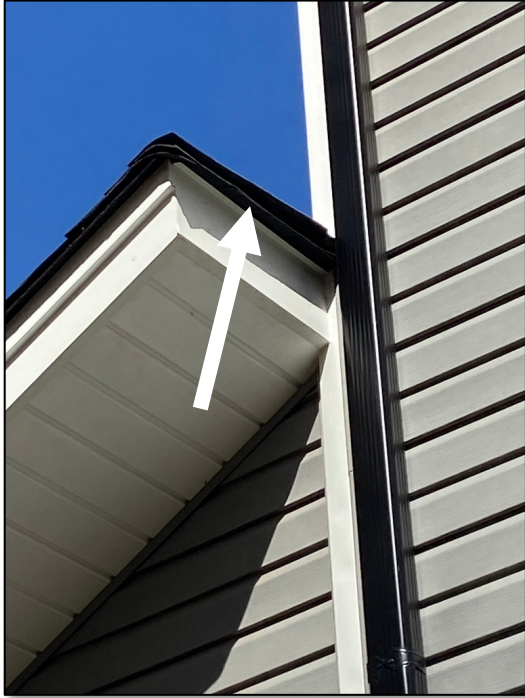
**Illustration #8**

Two areas of concern were noted with the roof. On the right side of the house there are two roof overhangs. One is connected to the front porch roof (See Illustration #8) and the other connected to the back patio roof (See Illustration #9). The shingles on both roofs are not properly connected to the structure. These shingles will flap in the wind and could easily be lifted, broken and torn way from the roof in windy conditions. Further, with driving rain conditions that frequent this geographical area, this could lead

to water intrusion in these two areas. Also, see incorrect installation of the aluminum trim on the soffit return on the left side of the patio roof (See Illustration #10) and patio post wrap miter joints not sealed (See Illustration #11). **See Correction Action Items #6, #7 & #8, Page 11.**

6. Have these two areas properly flashed and capped with a metal (or similar) cap to ensure that wind-driven water is not pushed up under the shingles.
7. Have aluminum trim recut and fitted properly.
8. Have miter joints in the post wrap sealed and painted.

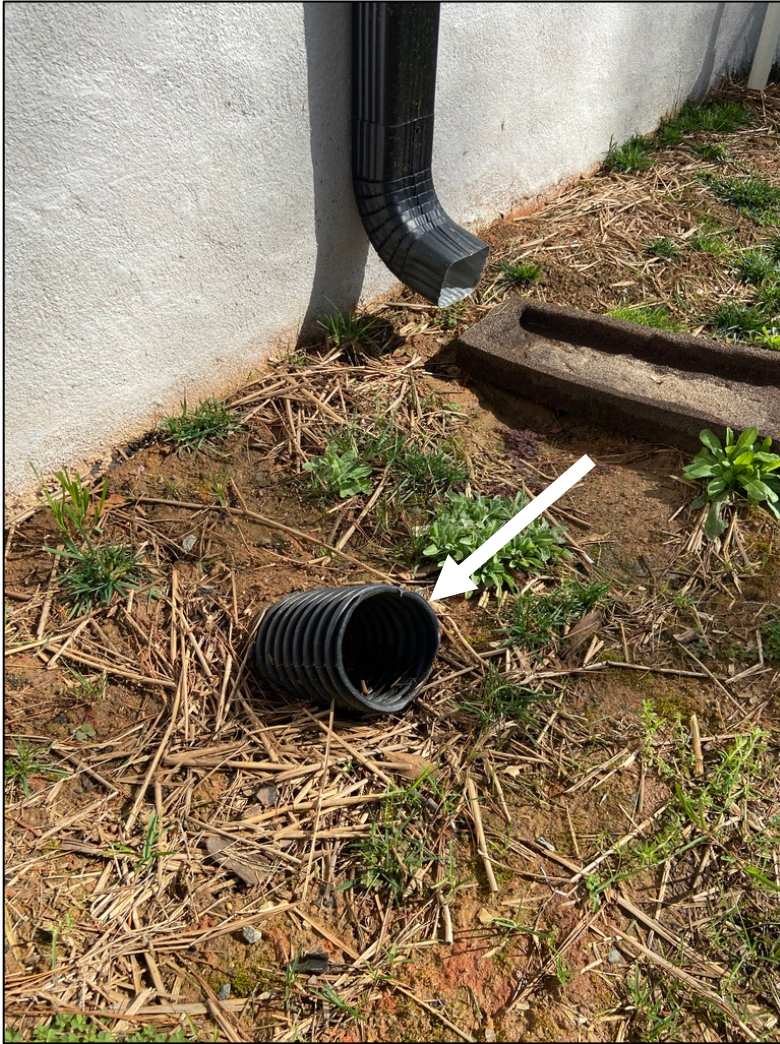
## Illustration #12

There is a drainpipe sticking out of the ground on the right front corner of the structure below the side of the porch. As shown in Illustration #12, this pipe will not drain correctly in its current configuration. It is undetermined what this is connected to. **See Corrective Action Item #9, Page 11.**

9. Determine what the drainpipe goes to and then have it properly sloped and buried so it will drain correctly.
10. Determine the reason the brick was covered over with stucco to begin with. Is there something being hidden or covered up? Next, make sure that all mulch and dirt are extracted from the base of the stucco and anywhere it comes into contact with moisture that it is properly waterproofed below the surface.

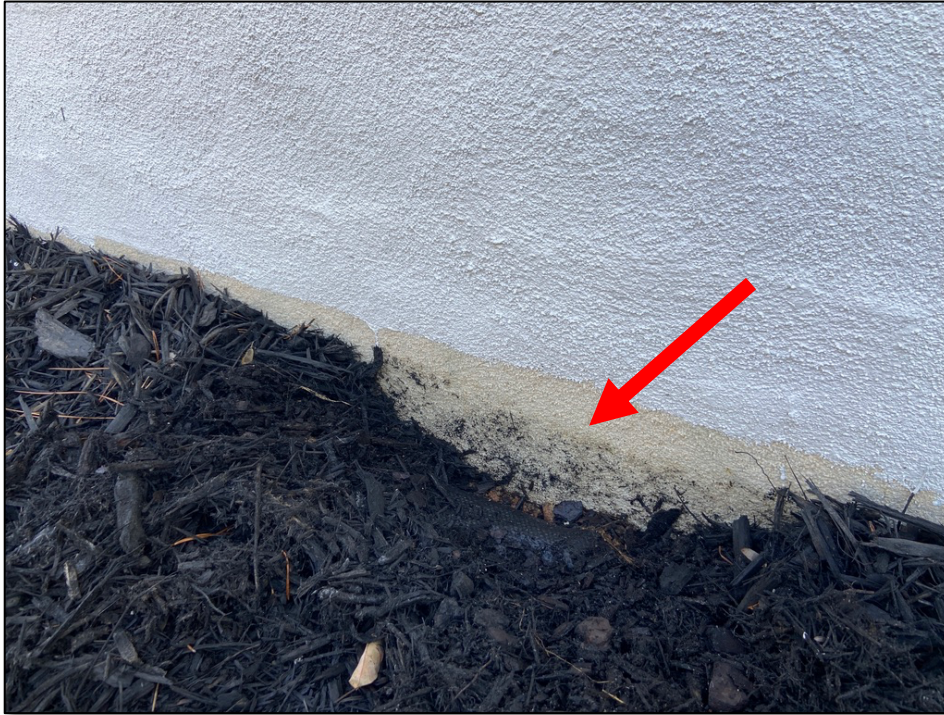
### Illustration #13

The brick facade on the front, sides and back of structure have been covered over with stucco and painted. The waterproofing sealant/paint does not go all the way down to where it terminates at the base of the structure (See Illustration #13). Absorption of water sitting at the base of the stucco and wicking it upward behind the brick will happen. This could present problems with the stucco cracking and peeling away from the brick facade. **See Corrective Action Item #10, Page 11.**
