**MILESTONE INSPECTION – PHASE I REPORT**

Hidden Lake Villas  
788 Park Shore Drive, Bldg. G  
Naples, Florida 34103

SOCOTEC Project Number 4352-010.01

December 2022

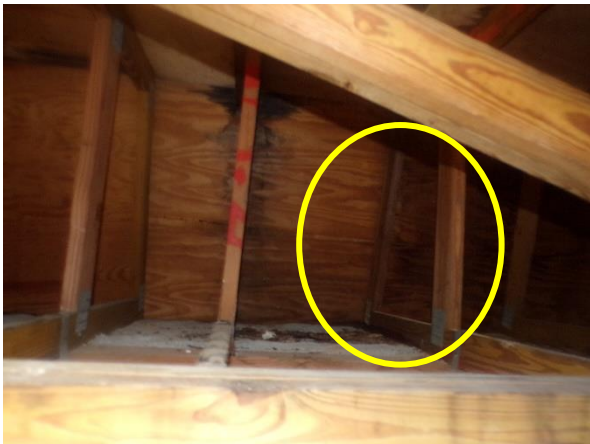
View of water staining on roof sheathing.

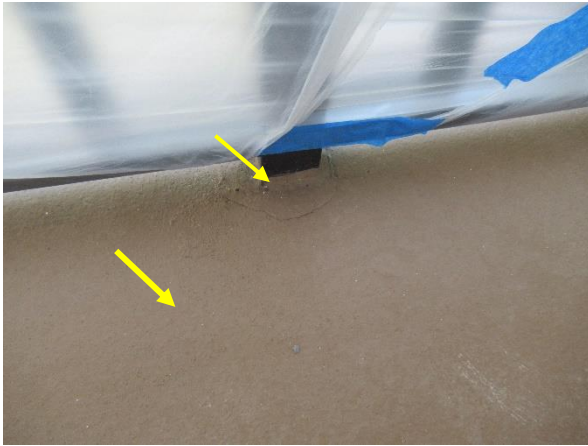
View of typical hairline crack on breezeway slab.

- Concrete hairline cracks in breezeways should be repaired as needed. (Legend Item 4)
- Unsealed penetrations should be properly sealed. (Legend Item 1)
