MILESTONE INSPECTION – PHASE I REPORT

Hidden Lake Villas
788 Park Shore Drive, Bldg. C
Naples, Florida 34103

SOCOTEC Project Number 4352-010.01

December 2022

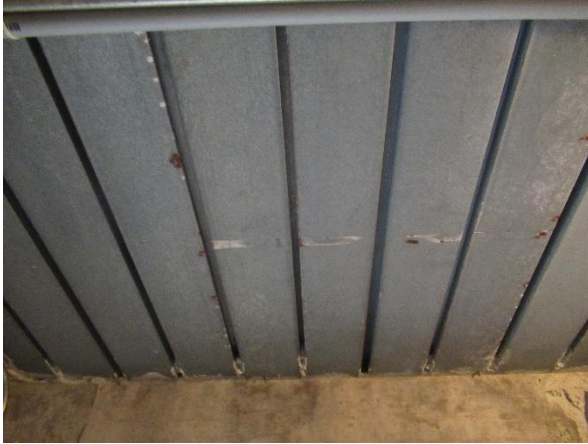
View of rust staining on steel deck on ceiling of 1st floor electrical room.

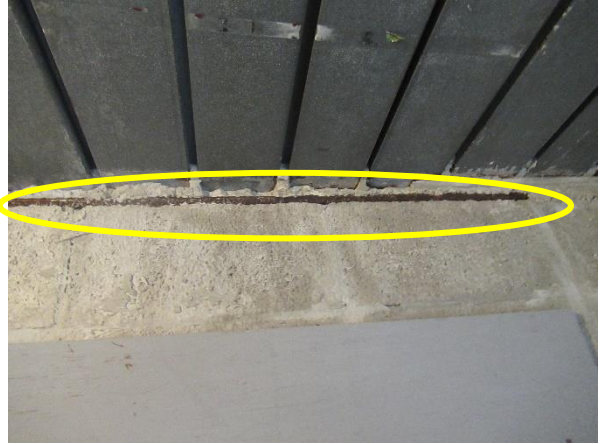
View of exposed rebar on wall of 1st floor electrical room.

- Stucco cracks should be repaired as needed. (Legend Item 8).
- Hairline cracking on concrete slab should be repaired as needed. (Legend Item 4)
- Concrete restoration will be needed in the 1st floor electrical room to address the exposed reinforcing steel. (Legend Item 9).
- The growing vegetation on the roof should be removed and the roof membrane should be checked for any distress at the subject area.

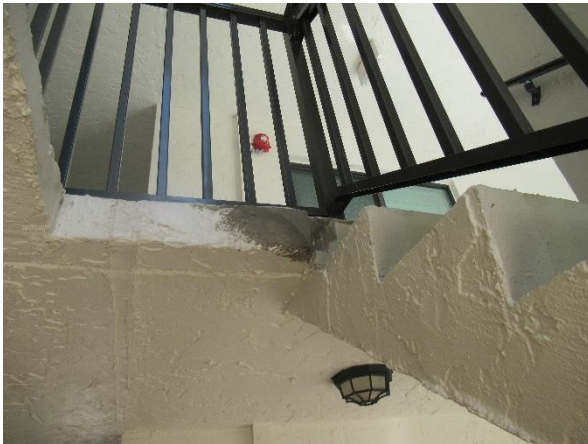
View of previous concrete repair.

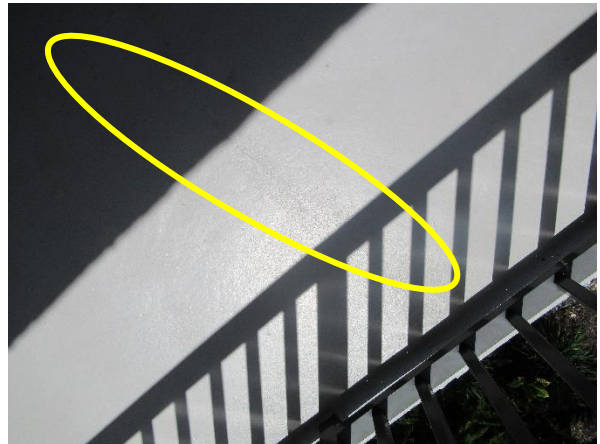
View of typical hairline crack on breezeway.

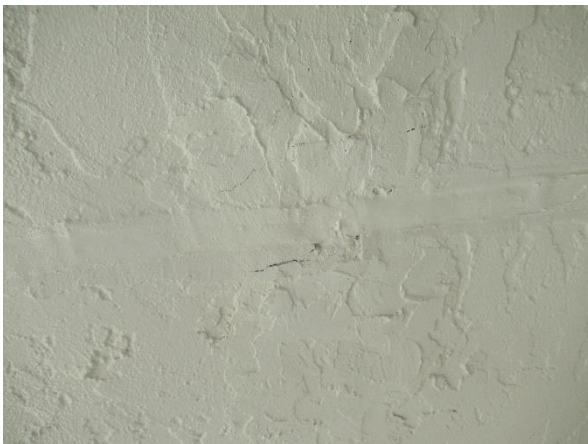
View of stucco crack on breezeway.

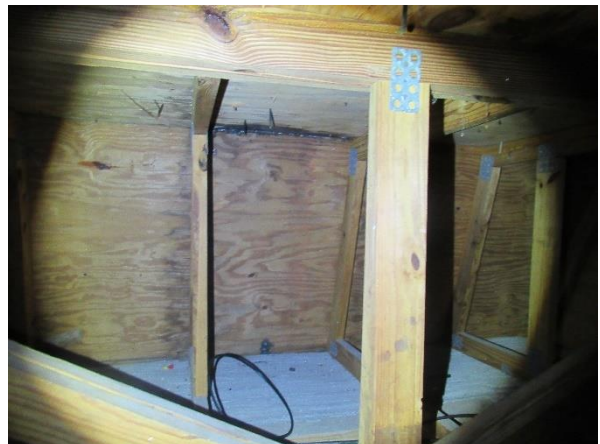
View of water staining on attic sheathing.

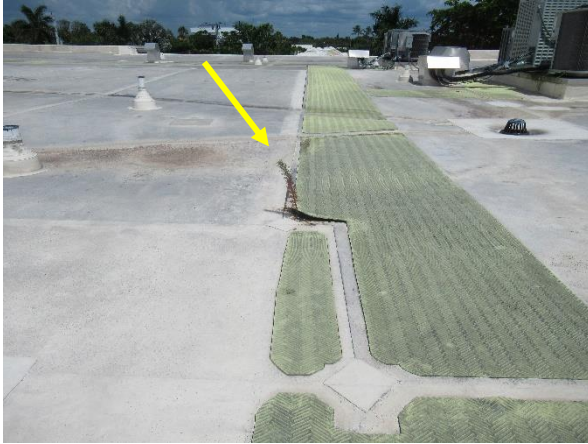
View of growing vegetation on roof.
