**MILESTONE INSPECTION – PHASE I REPORT**

Hidden Lake Villas  
788 Park Shore Drive, Bldg. F  
Naples, Florida 34103

SOCOTEC Project Number 4352-010.01

December 2022

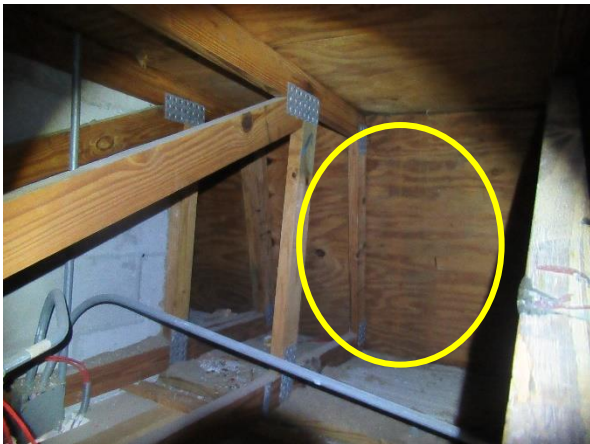
View of water staining on roof sheathing.

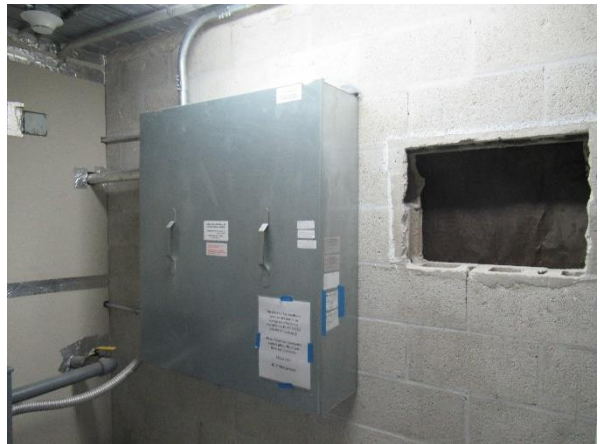
View of missing section of CMU wall.

- Repair concrete hairline cracks as needed. (Legend Item 4)
- Repair missing section of CMU wall in the 2<sup>nd</sup> floor mechanical room. (Legend Item 10)

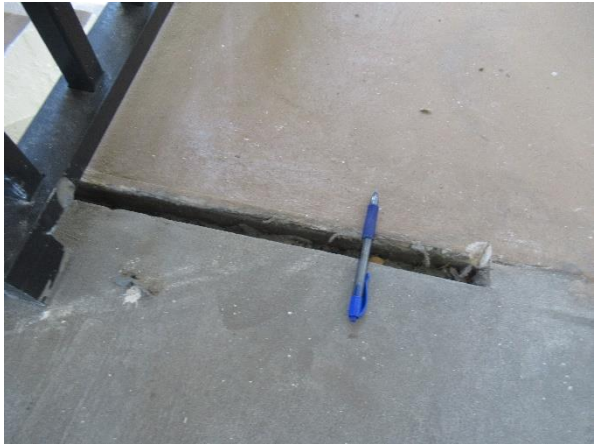
| View of typical breezeway. | View of unfinished expansion joint. |

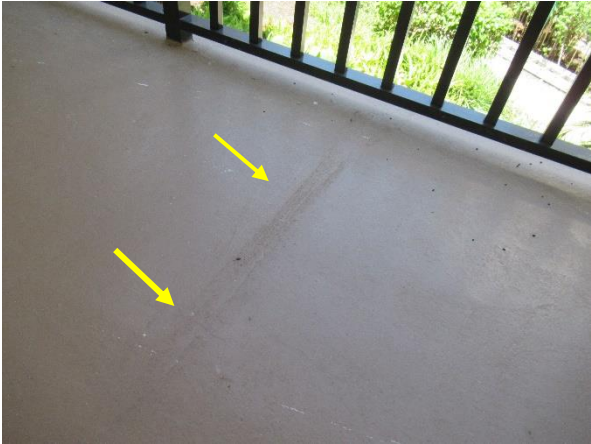
| View of typical hairline crack on breezeway slab. | View of typical hairline crack on lanai floor |

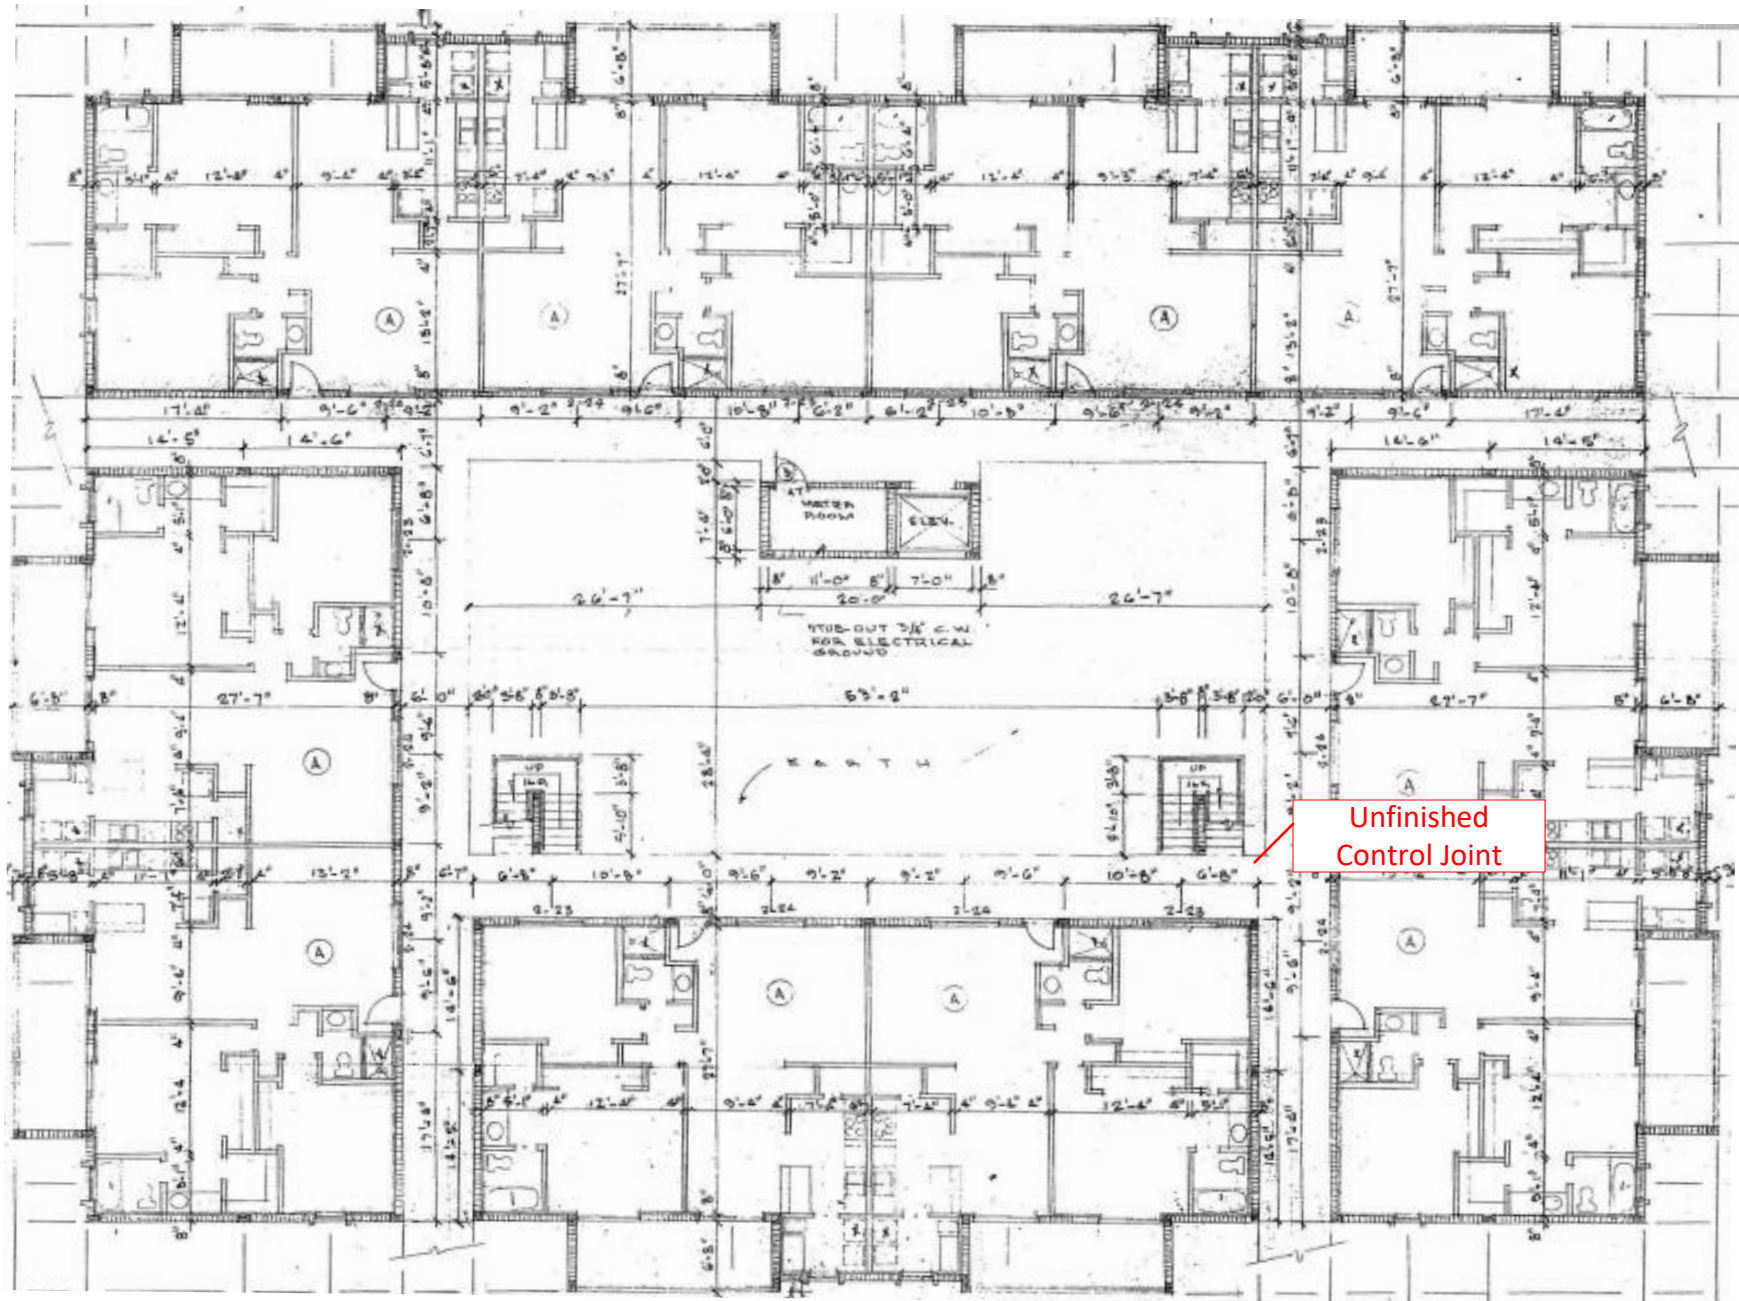
# 1<sup>st</sup> Floor Breezeways

Unfinished  
Control Joint
