MILESTONE INSPECTION – PHASE I REPORT

Hidden Lake Villas
788 Park Shore Drive, Bldg. E
Naples, Florida 34103

SOCOTEC Project Number 4352-010.01

December 2022

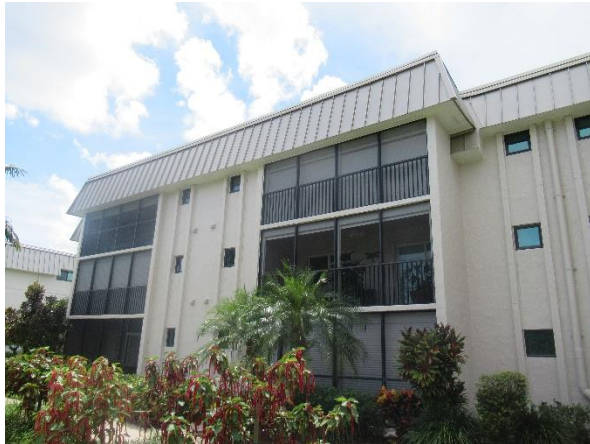
View of north elevation.

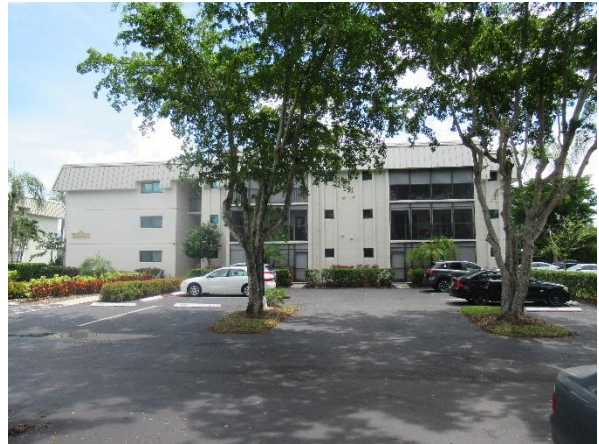
View of west elevation.

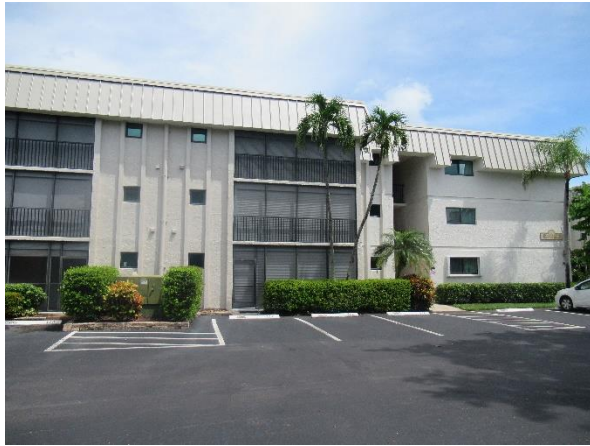
View of south elevation.

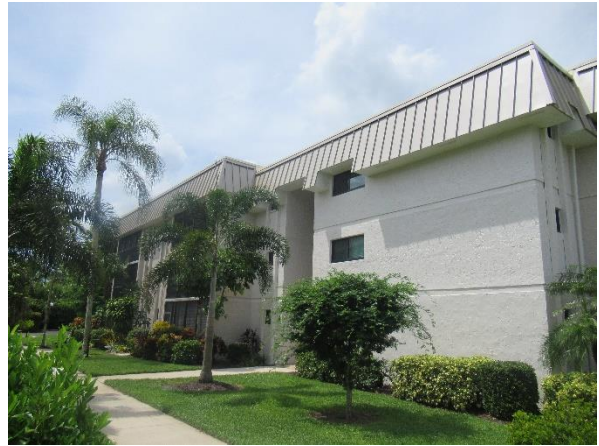
Partial view of east elevation.

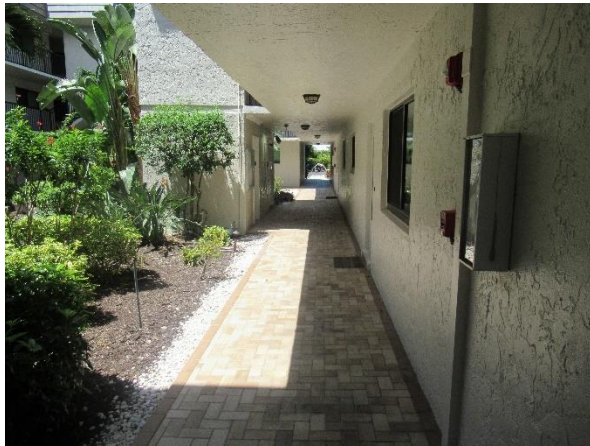
View of first floor walkway.

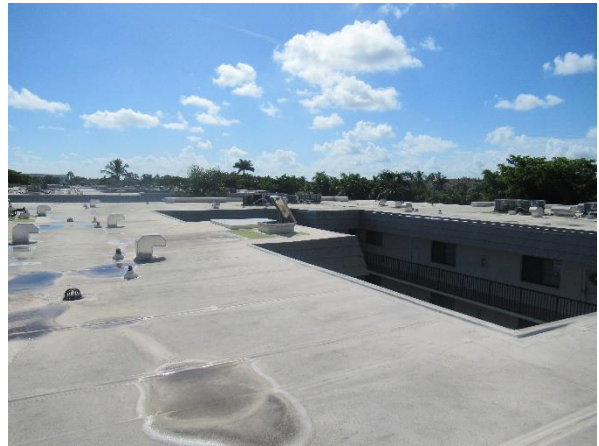
Overall view of TPO roof.

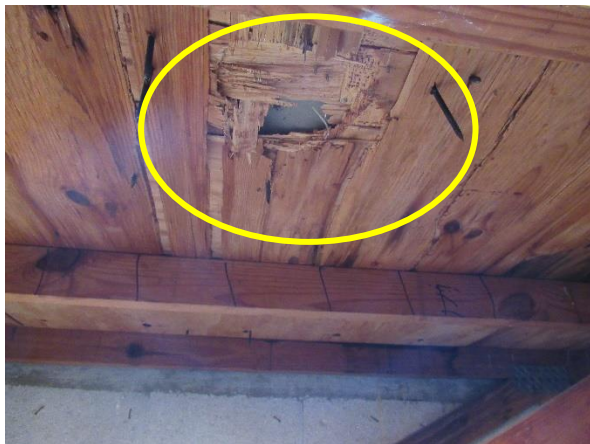
View of damaged roof sheathing.

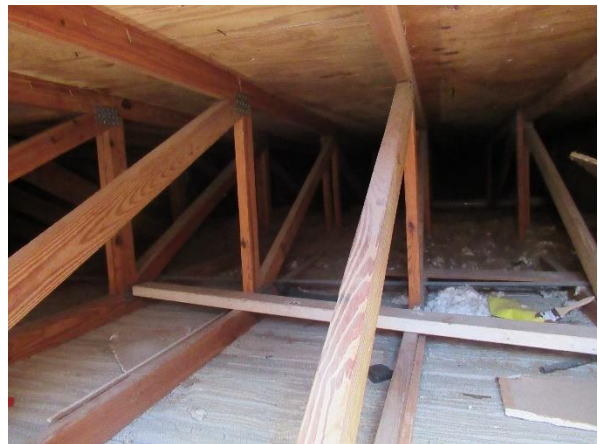
Partial view of attic.

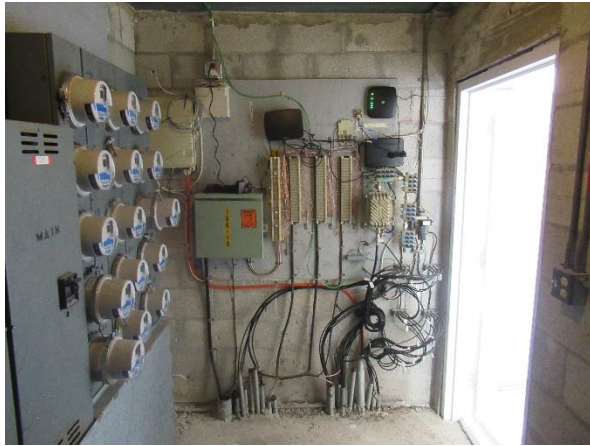
View of electrical room.

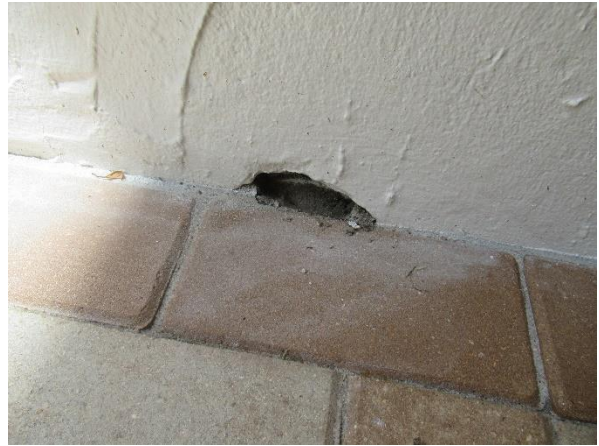
View of delaminated stucco on wall of 1st floor breezeway.

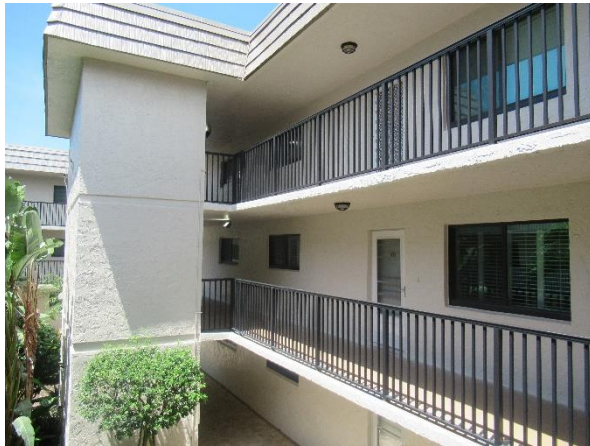
View of typical breezeways.

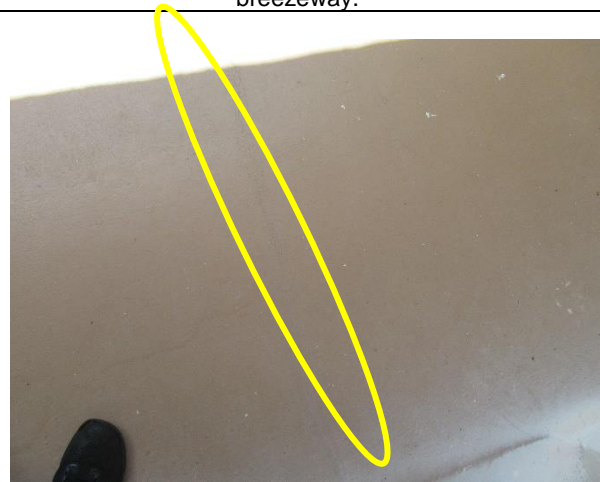
Typical hairline cracking on breezeway.

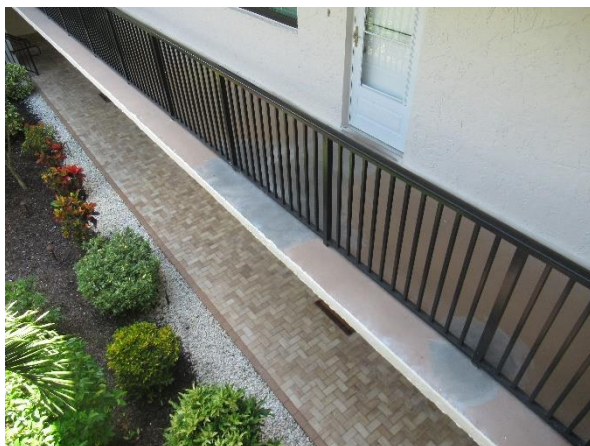
View of previous repairs on breezeway.

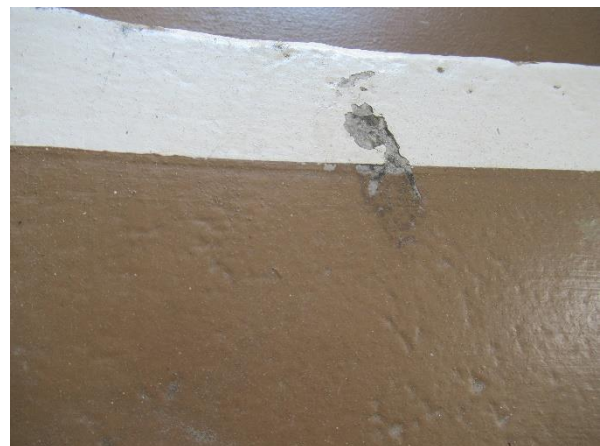
View of typical chipped coating on stairs.

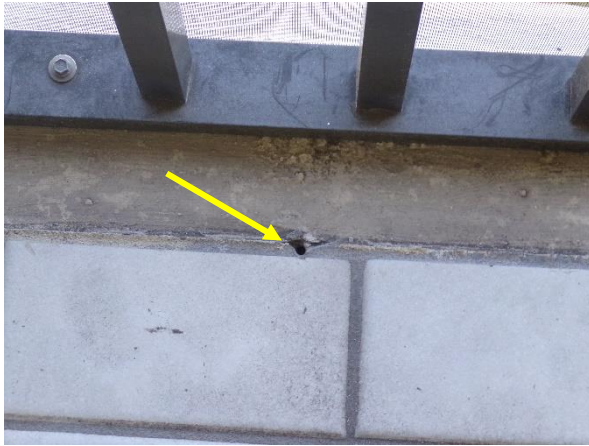
View of unsealed penetration in lanai of unit 33.

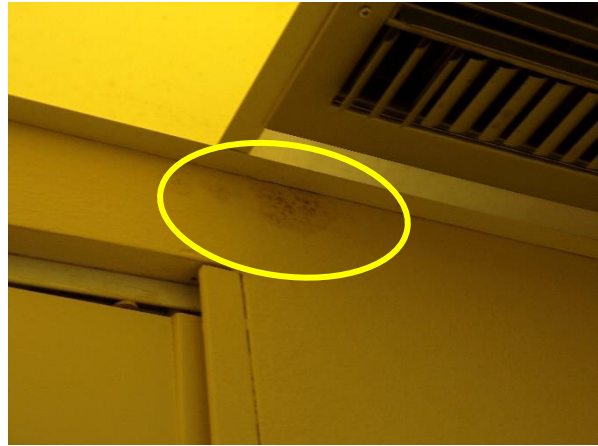
View of possible water intrusion in unit 31.

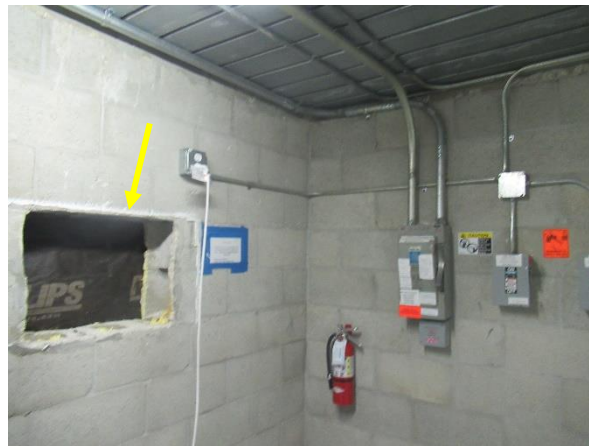
View of missing section of CMU wall.

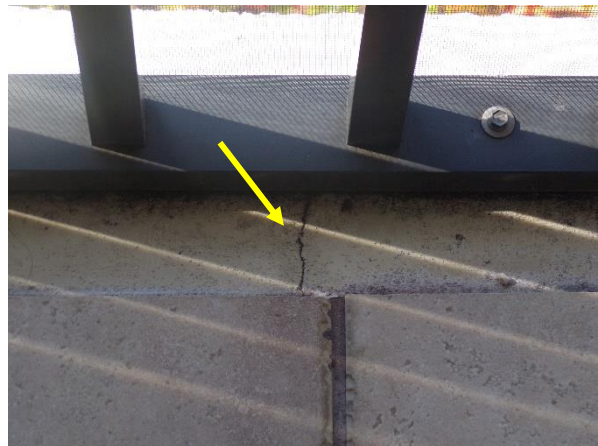
Typical hairline crack on slab edge, lanai of unit 28.
