MILESTONE INSPECTION – PHASE I REPORT

Hidden Lake Villas
788 Park Shore Drive, Bldg. A
Naples, Florida 34103

SOCOTEC Project Number 4352-010.01

December 2022

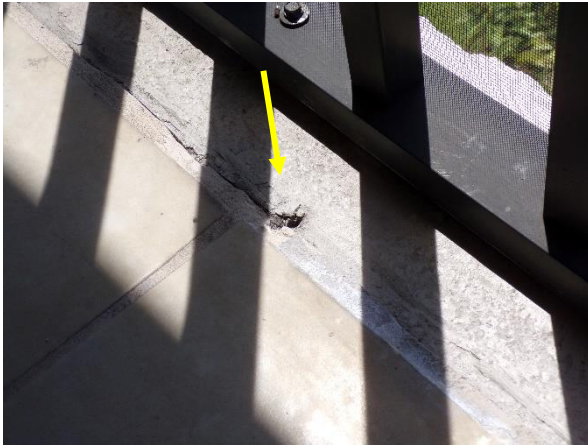
View of unsealed penetration in lanai, unit 37.

- All unsealed penetrations should be sealed as needed (Legend Item 1)
- Delaminated stucco should be further investigated and repaired as needed. (Legend Item 3).

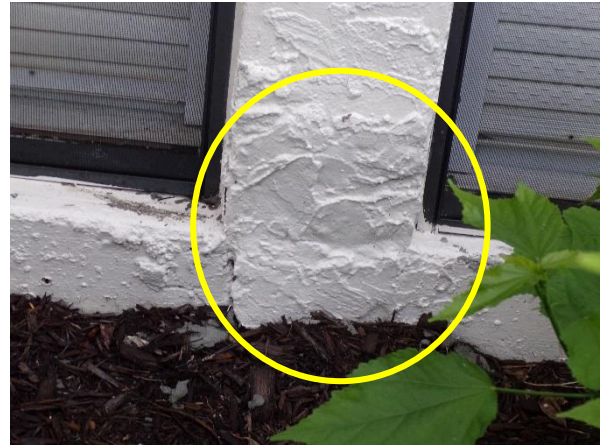
View of delaminated stucco on exterior wall.
