MILESTONE INSPECTION – PHASE I REPORT

Hidden Lake Villas
788 Park Shore Drive, Bldg. B
Naples, Florida 34103

SOCOTEC Project Number 4352-010.01

December 2022

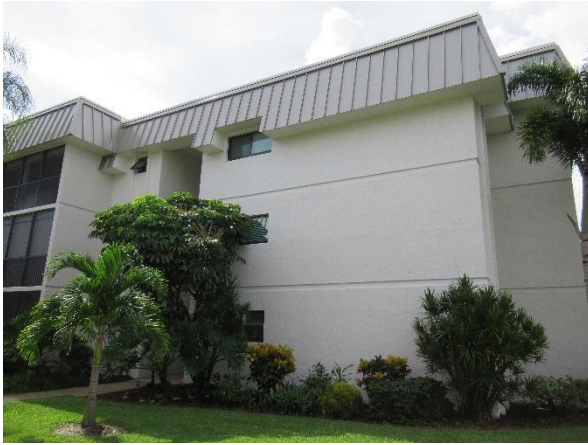
View of north elevation.

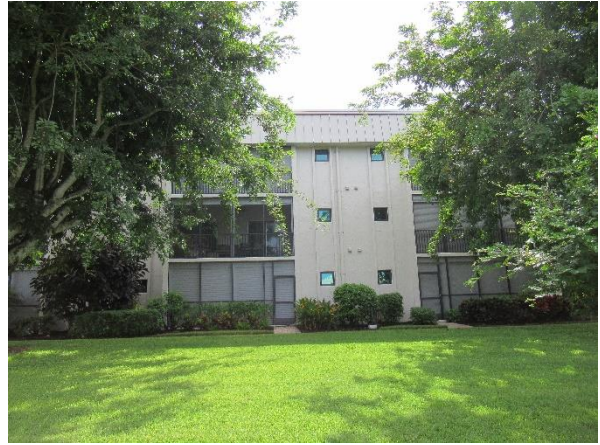
Partial view of west elevation.

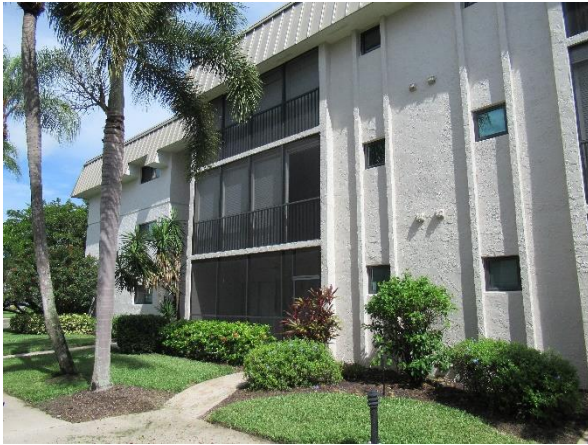
View of south elevation.

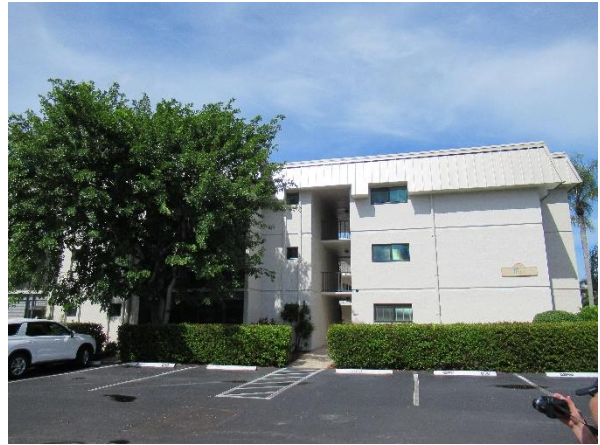
Partial view of east elevation.

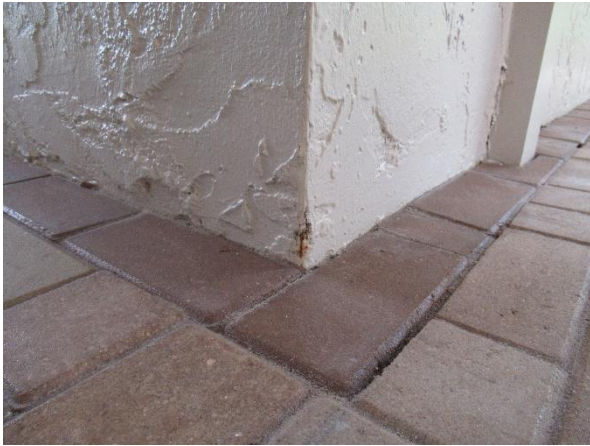
View of rust staining on breezeway of 1st floor.

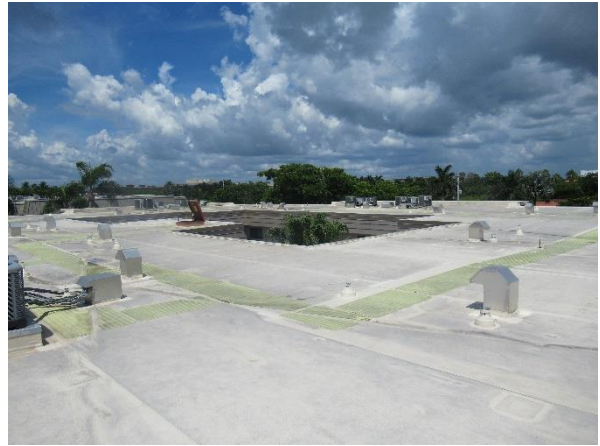
Overall view of TPO roof.

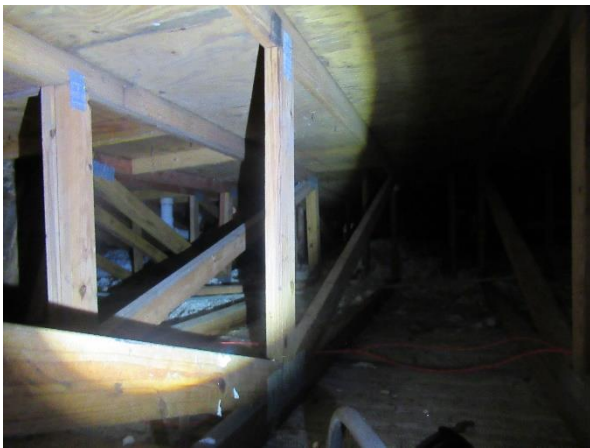
Partial view of attic.

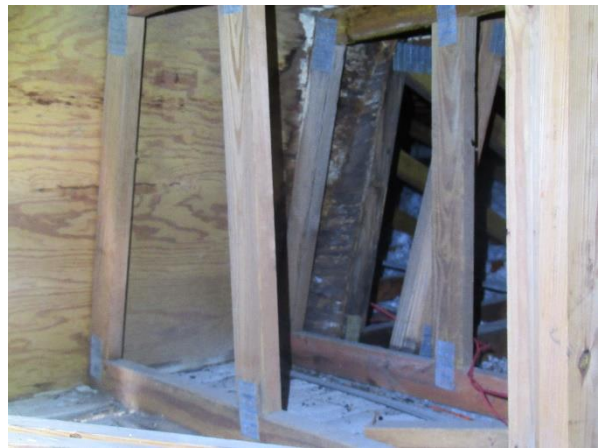
View of water staining in attic.

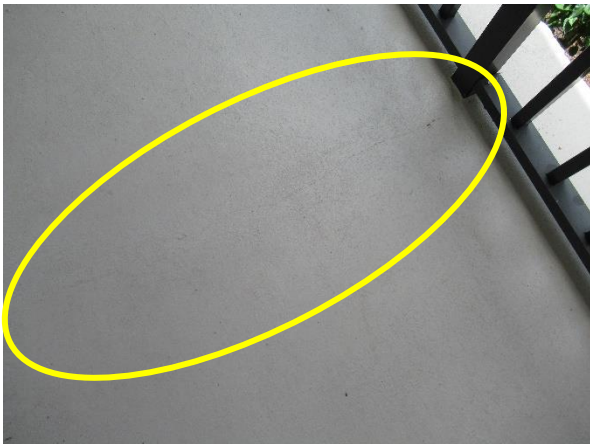
View of typical hairline crack on breezeway.

- Spalled concrete should be repaired. (Legend Item 5).
- Hairline cracking on concrete slab should be repaired as needed. (Legend Item 4).

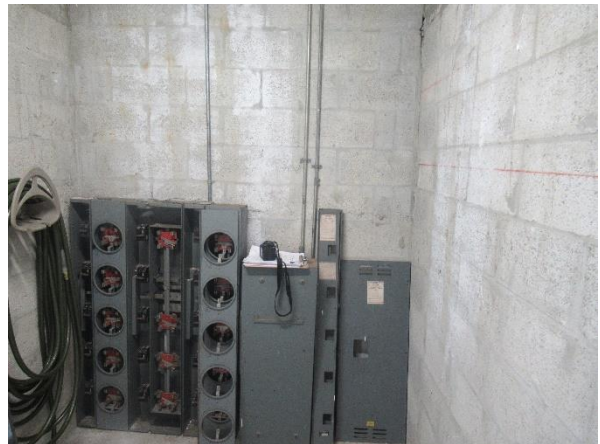
View of mechanical room.
