## **MILESTONE INSPECTION – PHASE I REPORT**

Hidden Lake Villas  
788 Park Shore Drive, Bldg. D  
Naples, Florida 34103

SOCOTEC Project Number 4352-010.01

December 2022

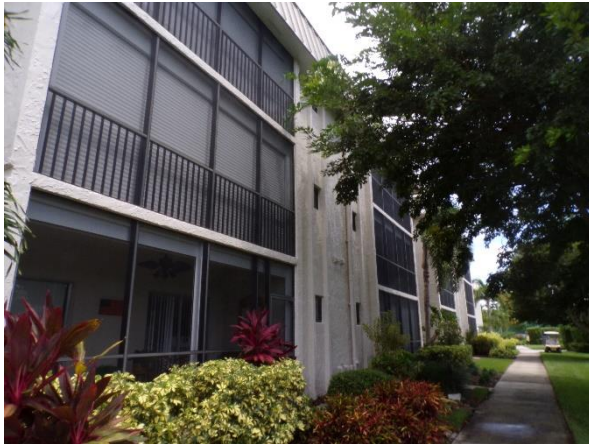
View of north elevation.

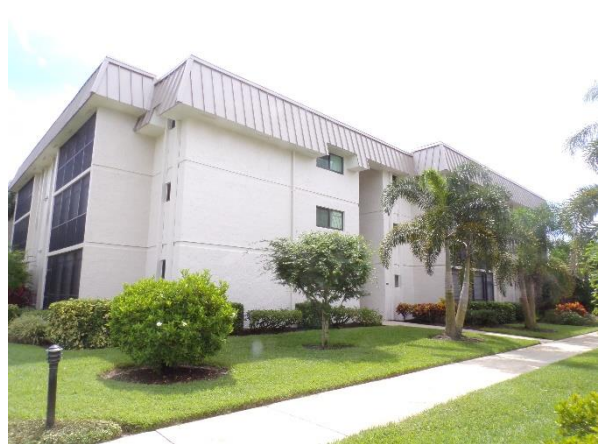
View of west elevation.

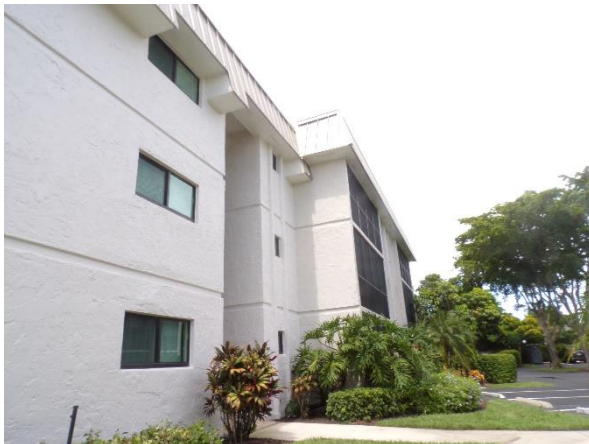
View of south elevation.

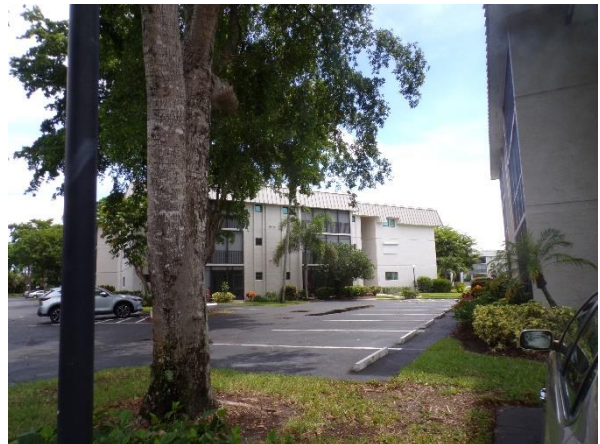
Partial view of east elevation.

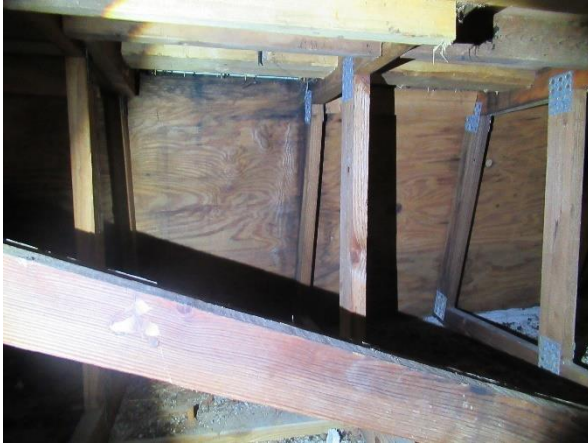
Partial view of attic and water staining on sheathing.

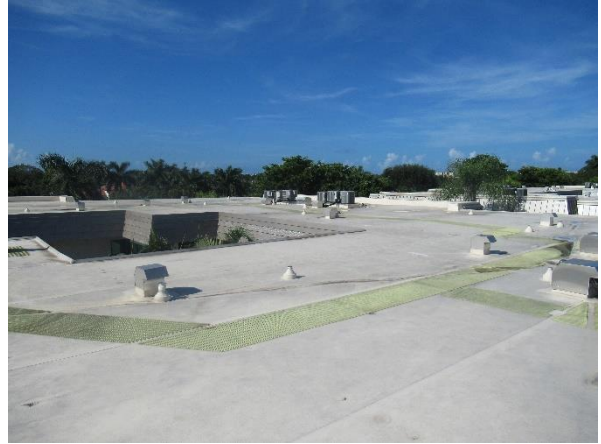
Overall view of single-ply roof.

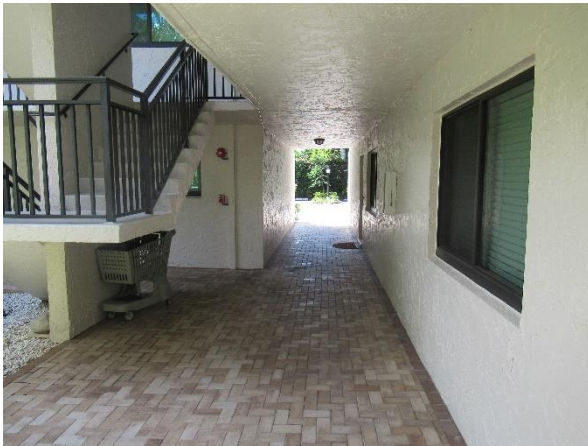
View of 1<sup>st</sup> floor walkway.

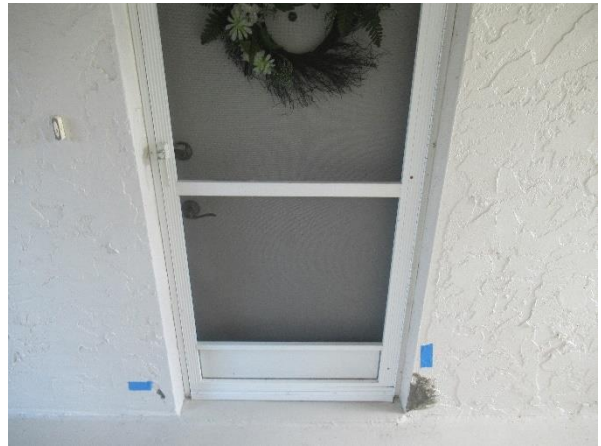
View of previous stucco repairs.

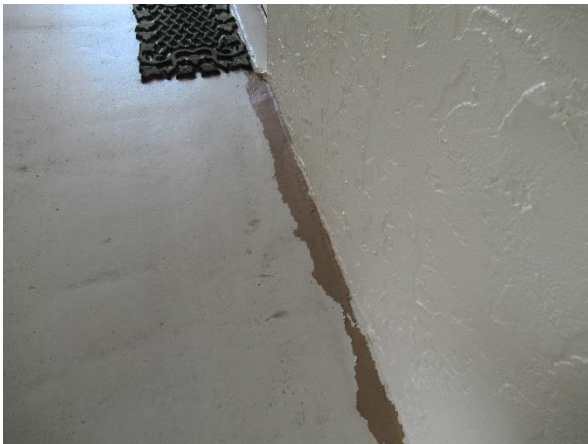
Typical breezeway chipped coating.

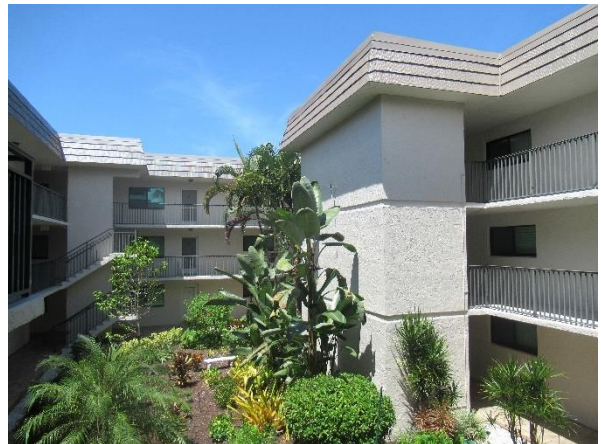
View of interior elevations.

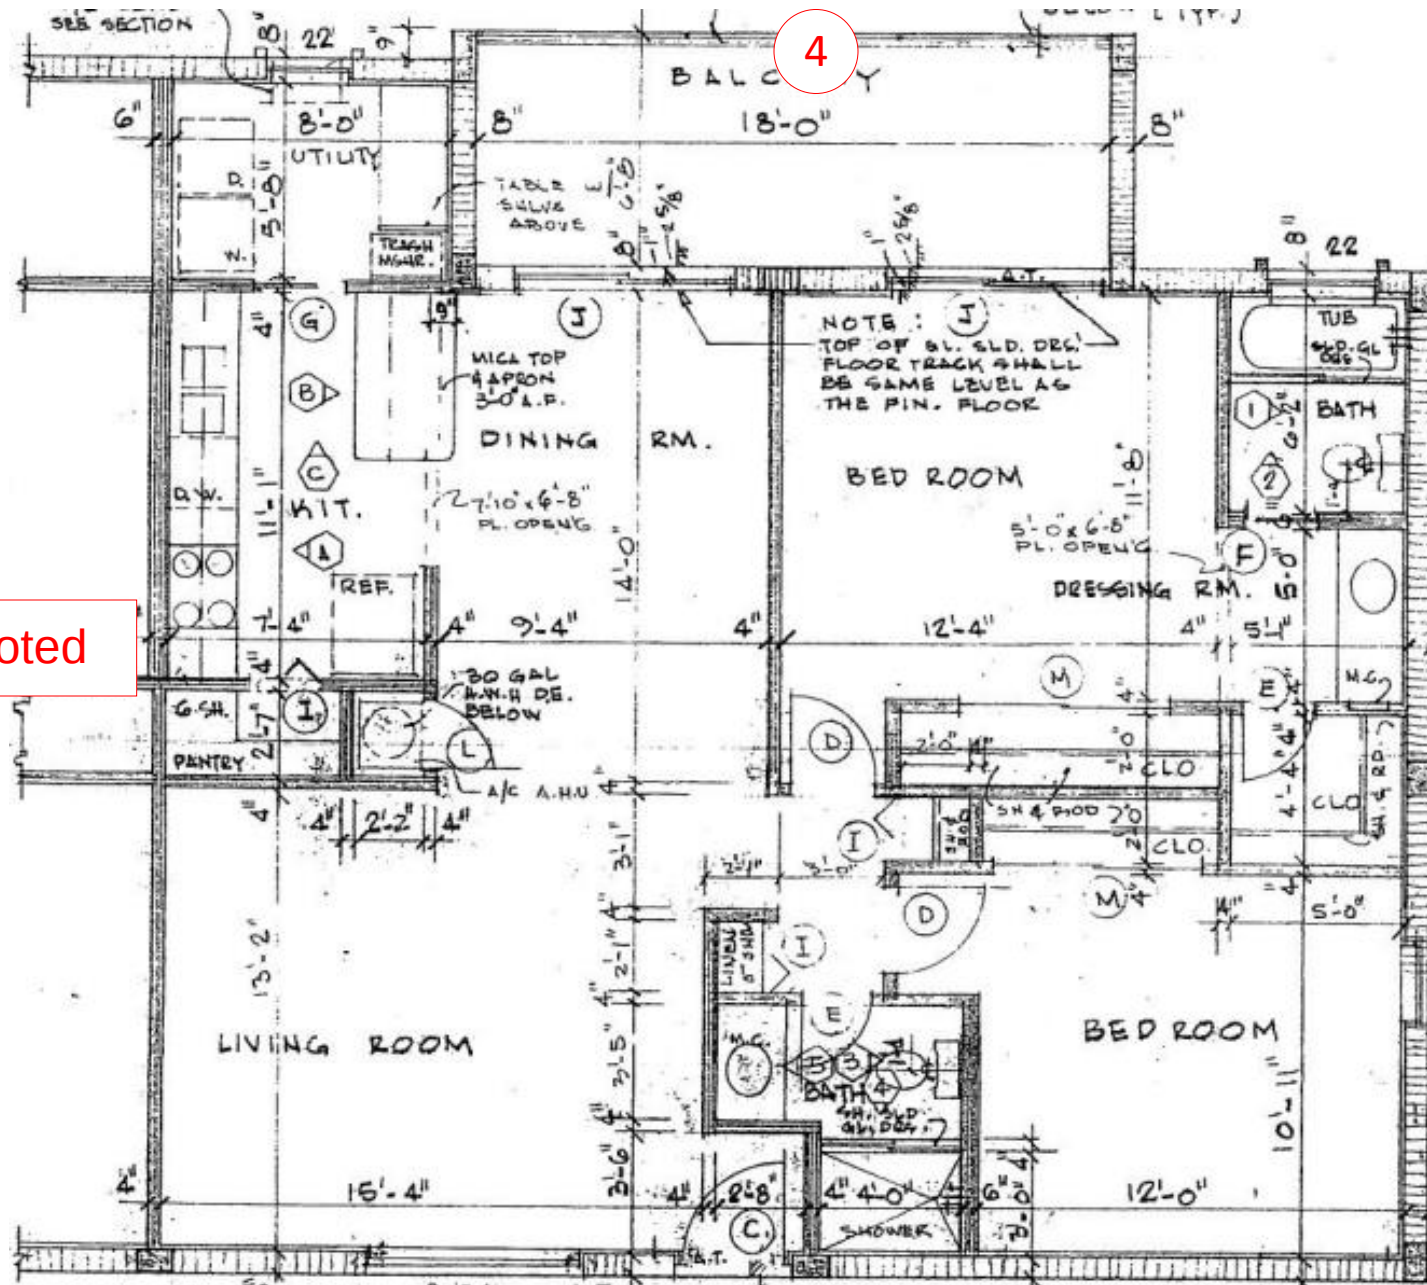
# Unit D-28

4

- Cracking observed on the edge of lanai of unit 28 should be further investigated and repaired as needed. (Legend Item 4)
