**MILESTONE INSPECTION – PHASE I REPORT**

Hidden Lake Villas  
788 Park Shore Drive, Bldg. H  
Naples, Florida 34103

SOCOTEC Project Number 4352-010.01

December 2022

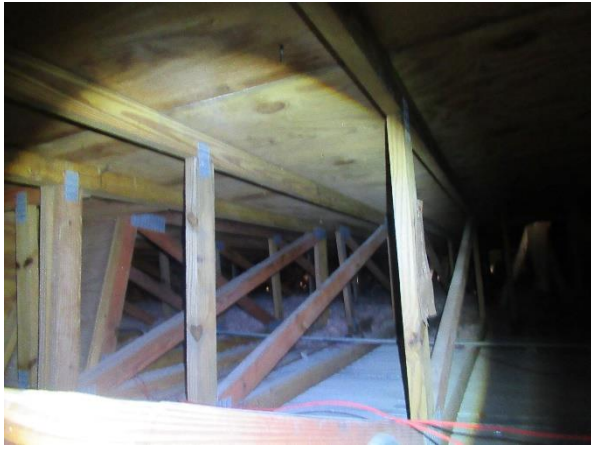
Partial View of attic.

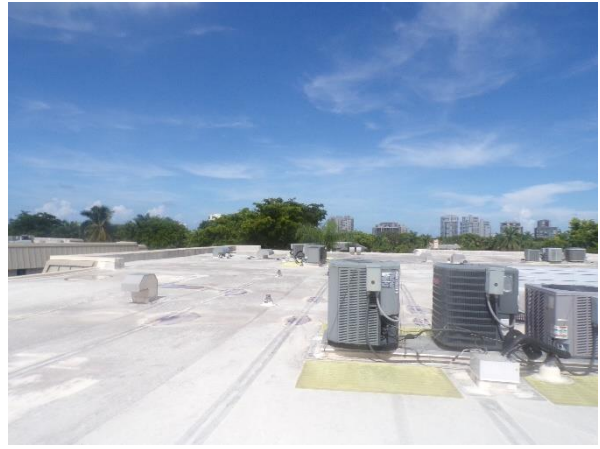
Overall view of single-ply roof.

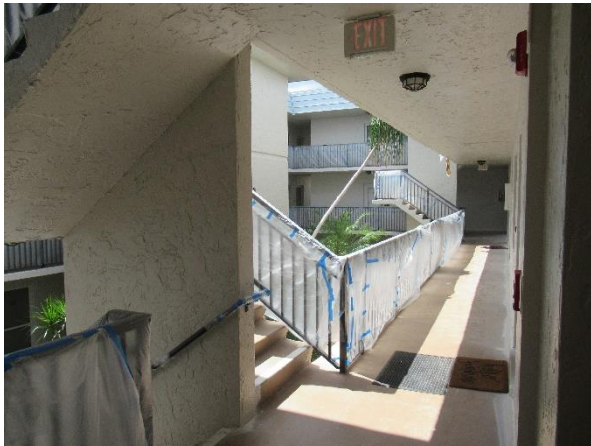
Overall view of 2<sup>nd</sup> floor walkway.

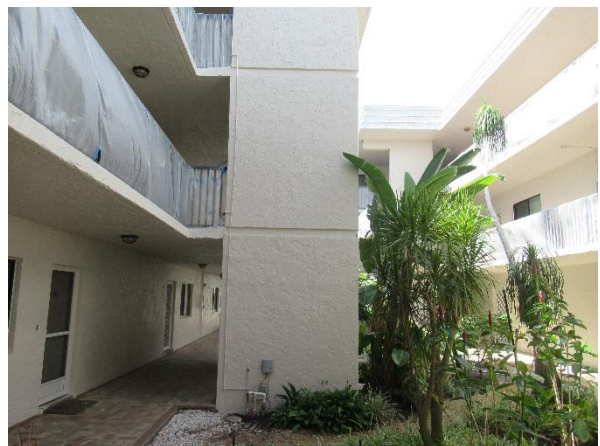
Overall view of courtyard.

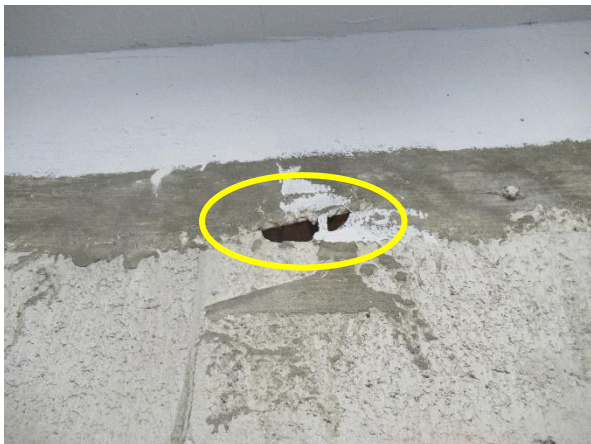
View of exposed rebar in 3<sup>rd</sup> floor mechanical room.

- Concrete hairline cracks in breezeways should be repaired as needed. (Legend Item 4)
- Unsealed penetrations should be sealed as needed. (Legend Item 1).
- Concrete restoration should be performed in order to repair the observed exposed reinforcing steel in 3<sup>rd</sup> floor mechanical room. (Legend Item 9)
- Repair unfinished control joint of 2<sup>nd</sup> floor breezeway.

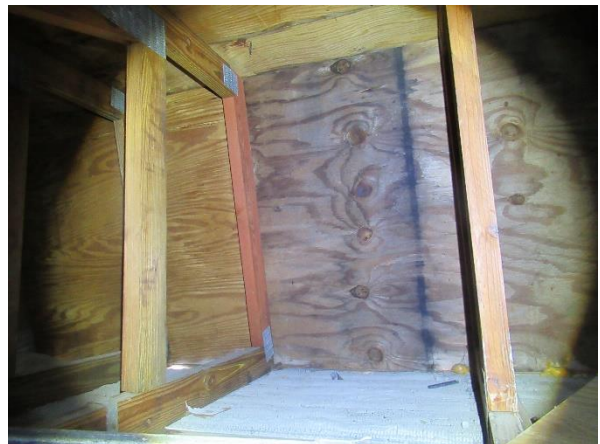
View of water staining on roof sheathing.
