## Saddlebrooke at Rock Creek HOA *Superior, CO*

Report #: 33508-3  
Beginning: January 1, 2025  
Expires: December 31, 2025

# RESERVE STUDY

## Update "With-Site-Visit"

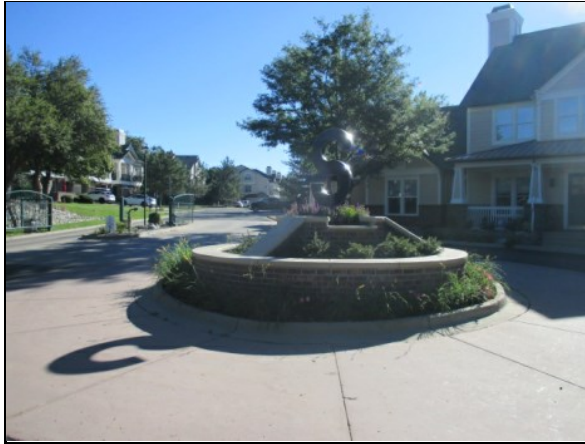
Monument signage determined to be in fair condition typically exhibits acceptable appearance and aesthetics in keeping with local area but with more weathering and wear showing on surfaces. If present landscaping and lighting are still in serviceable condition. At this stage signage may be becoming more dated and diminishing in appeal. As routine maintenance inspect regularly clean/touch-up and repair as an Operating expense. Plan to refurbish or replace at the interval below. Timing and scope of refurbishing or replacement projects is subjective but should always be scheduled in order to maintain good curb appeal. In our experience most clients choose to refurbish or replace signage periodically in order to maintain good appearance and aesthetics in keeping with local area often before signage is in poor physical condition. If present concrete walls are expected to be painted and repaired as part of refurbishing but not fully replaced unless otherwise noted. Costs can vary significantly depending on style/type desired and may include additional costs for design work landscaping lighting water features etc. Reserve Study updates should incorporate any estimates or information collected regarding potential projects.

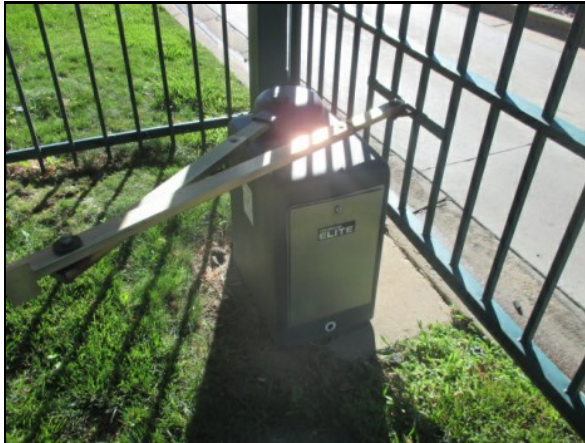
Minimal or no subjective/aesthetic value for this component. Useful life is based primarily on normal expectations for service/performance life in this location. Unless otherwise noted remaining useful life expectancy is based primarily on original installation or last replacement/purchase date our experience with similar systems/components and assuming normal amount of usage and good preventive maintenance. We recommend regular inspections (including service and repair as needed) be paid through the Operating budget. Even with ongoing maintenance plan for replacement at typical life expectancy indicated below. Useful life can vary greatly depending on level of use exposure to the elements etc. Monitor actual expenses closely for future Reserve Study updates. Unless otherwise noted funding to replace with similar units.

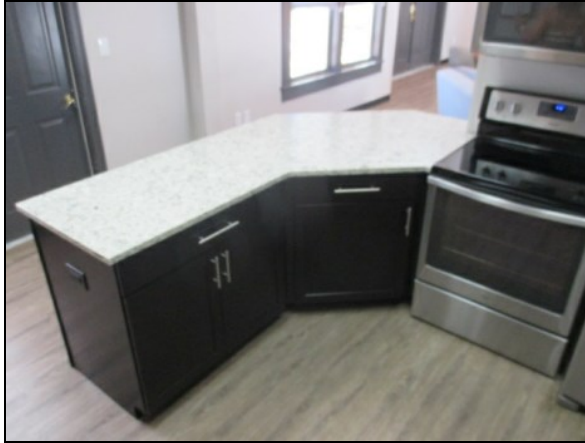
Kitchen was observed to be in fair condition. Counters and cabinets were clean and mostly free of issues. Fixtures appeared to be in fair condition. Kitchen materials typically have an extended useful life. However many clients choose to refurbish the kitchen periodically for aesthetic updating. This may include refurbishment/refinishing of kitchen cabinets and countertops replacement of sinks installation/replacement of under-cabinet lighting etc. Should ideally be coordinated with replacement of the kitchen appliances. Best practice is to coordinate this project with other amenity areas such as bathrooms or other amenity rooms.

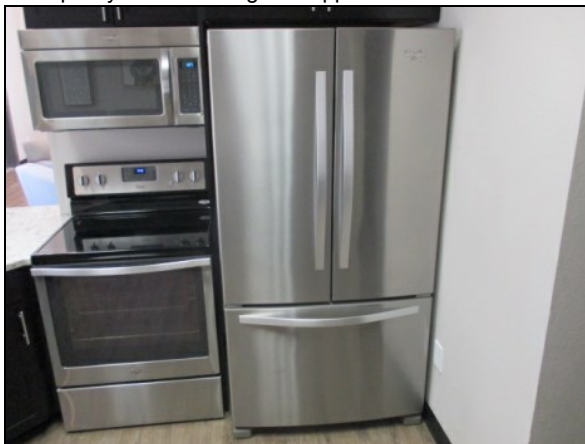
Individual appliances were not tested during inspection and are assumed to be in functional operating condition unless otherwise noted. Useful life can vary greatly depending on level of use quality care and maintenance etc. Funding recommendation shown here is for replacing with comparable quality commercial-grade appliances.
