CAWG Damage and Vulnerability Report:

Assessing the condition of rivers and riparian zones in the North River watershed

Cornwall and Area Watershed Group

March 27, 2024

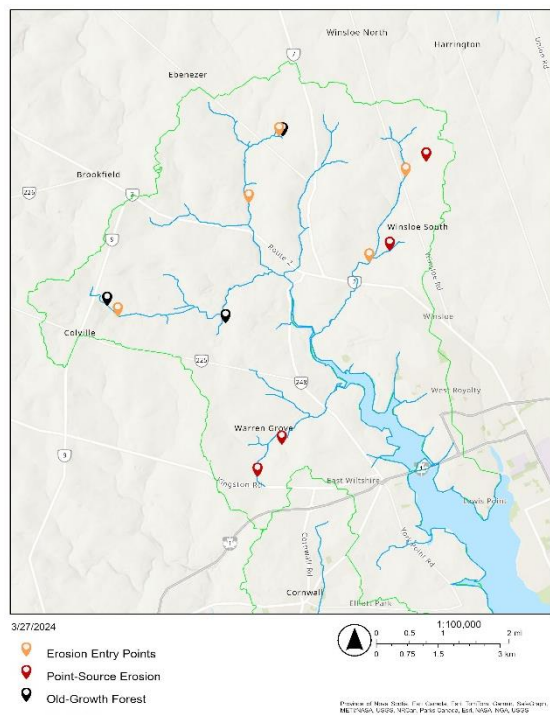
Figure 1

The most pressing issues observed were from current erosion (Fig. 1 and Fig. 2). Significant point-source erosion was found to originate from a shale pit near reach DVCC22, and from cattle access to the stream in reach DVCC12, both on Cole's Creek. Entry points for significant non-point-source erosion were identified in reaches DVCC21 and DVCC09 on Cole's Creek, DVNN03 and DVNN12 on the north branch of North River, and DVWC27 on Watts Creek. Severe non-point source erosion was recorded in multiple reaches (Fig. 3). These represent the lowest erosion health scores, while the reach experiencing the least erosion, DVWC09, had an erosion health score of 18.

Locations of significant erosion input and vulnerable old-growth forests.

Due to private land ownership and the upland origin of point-source and of non-point source erosion, the aforementioned sites cannot be improved by CAWG field work alone. Remediation in such areas will require collaborative solutions involving landowners, CAWG, and third parties such as PEI's Agri-Watershed Partnership, various provincial tree-planting programs, or in difficult cases, conservation enforcement. Entry-point locations for sediment input may be addressed by tree planting in riparian buffer zones, terracing deadwood in gullies and trenches, and live-staking of weak embankments; however these measures do not constitute long-term solutions on their own and should be followed up by addressing upland erosion issues as previously discussed.

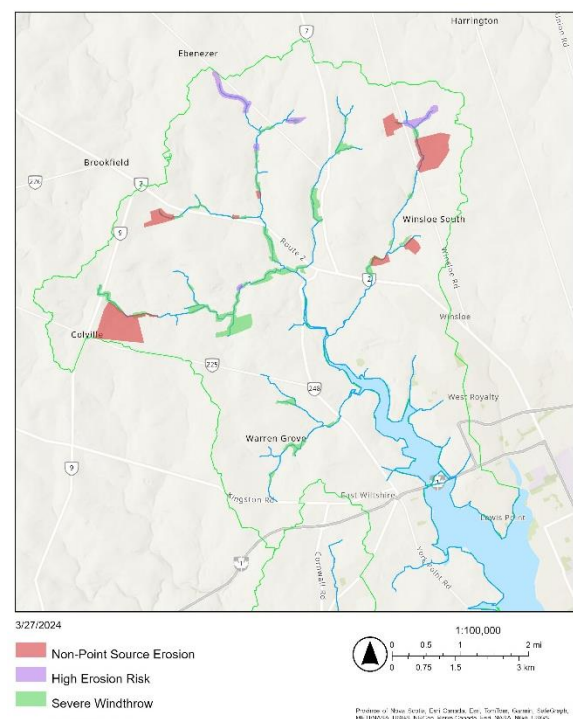
Figure 2

Widespread erosion areas, erosion risk areas, and windthrow areas identified within the North River watershed.

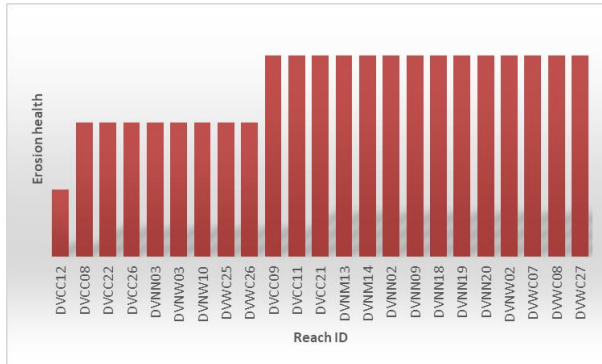
Figure 3

Reaches currently displaying the most severe non-point source erosion problems. Lower scores indicate greater levels of erosion. Only those reaches with the most severe erosion are displayed.

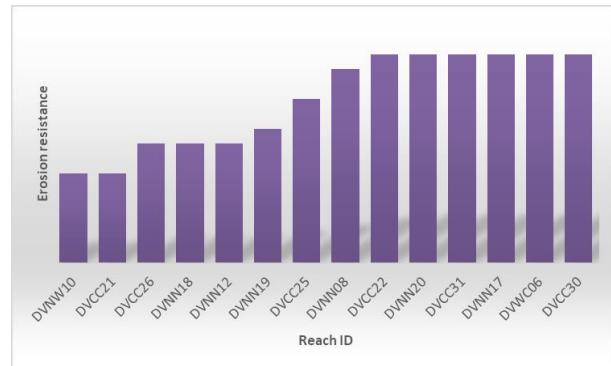
**Figure 4**

Many of the reaches that scored as highest erosion risk were among those found to already be experiencing erosion. Those that are not yet experiencing severe erosion but which remain at highest risk are shown in Fig. 4.

Reaches that are at the highest risk of erosion. Lower scores indicate a higher risk. Only those reaches at greatest risk are displayed.

Areas at high risk of future erosion should be considered priority areas for tree planting efforts. Collaboration with landowners is also a necessary component of erosion prevention in these areas. Areas identified as high erosion risk, as well as those identified as experiencing current erosion, should be among the first surveyed for wash-out following future hurricane disturbances.

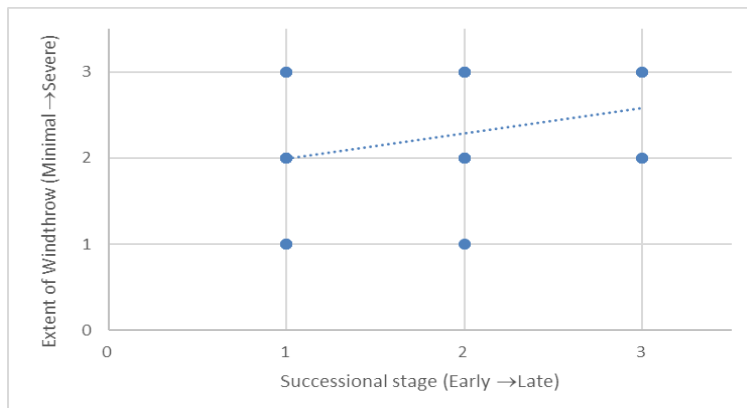
**Figure 5**

All forested areas of the watershed experienced storm damage. This had a significant impact on access in the largest forest patches. Despite designing a portion of the assessment with the goal of predicting areas most vulnerable to future windthrow, such predictions could not be made with any certainty from the collected data. A slight positive correlation was found between successional stage and extent of windthrow, with late succession forest stands being more likely to have experienced severe windthrow (Fig. 5).

Relationship between successional stage of forest stands and severity of windthrow experienced from hurricane Fiona in the riparian zones of the North River watershed.
