Church of the Assumption, Collooney

Repair works to valley between tower and roof over gallery and nave

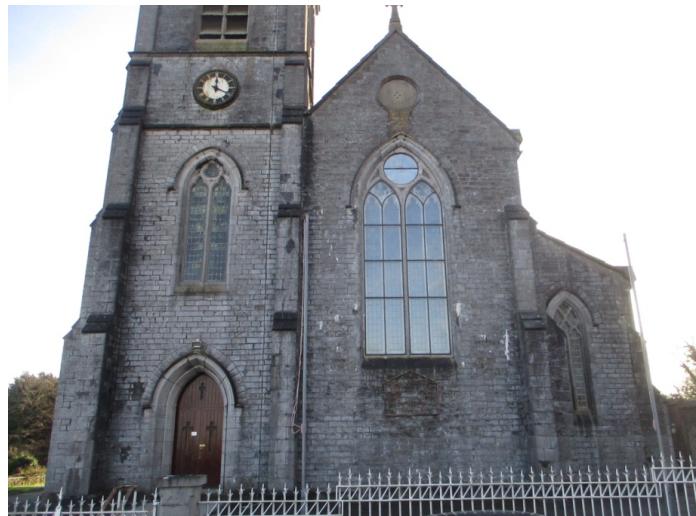
Front view of church. Note: The valley to be repaired is located between the tower and the gable

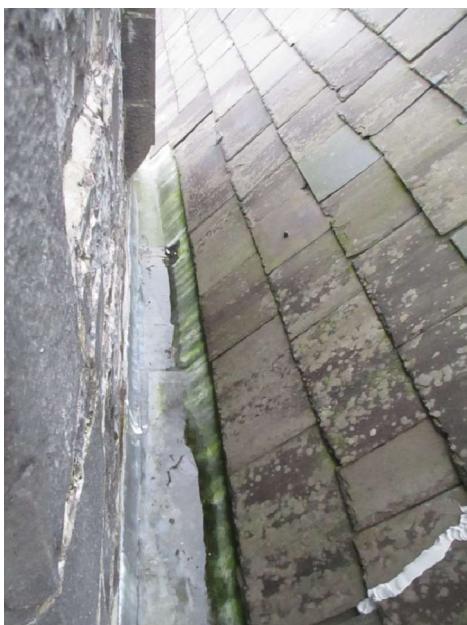
Detail of valley between tower and roof over gallery to be re-leaded and valley boards replaced . The tower is on the left and the roof over the nave is on the right.

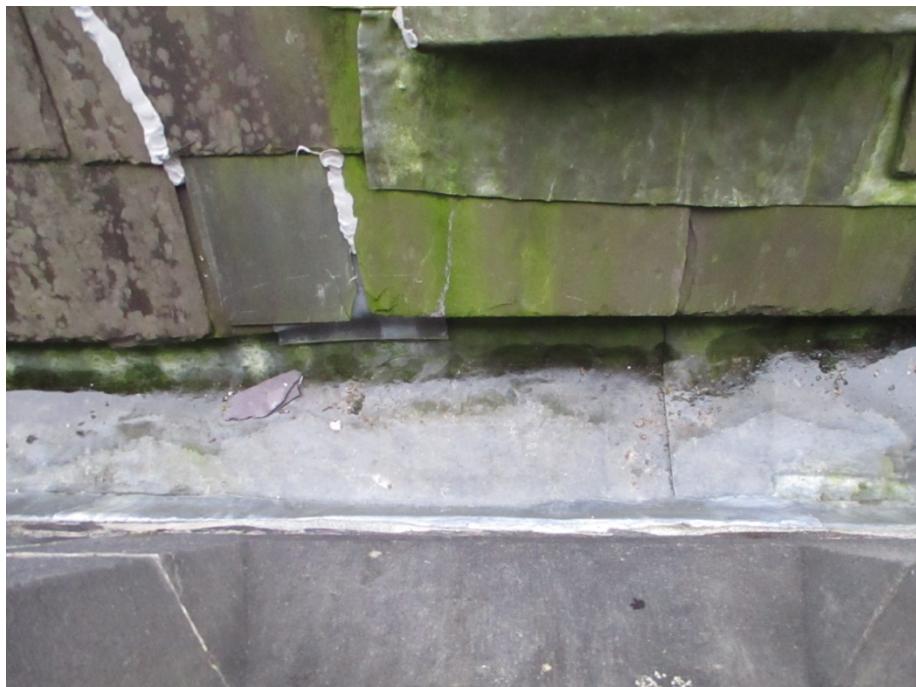
Detail of valley between tower and roof over gallery to be re-leaded.

Bottom of lead lined hatch is also visible.

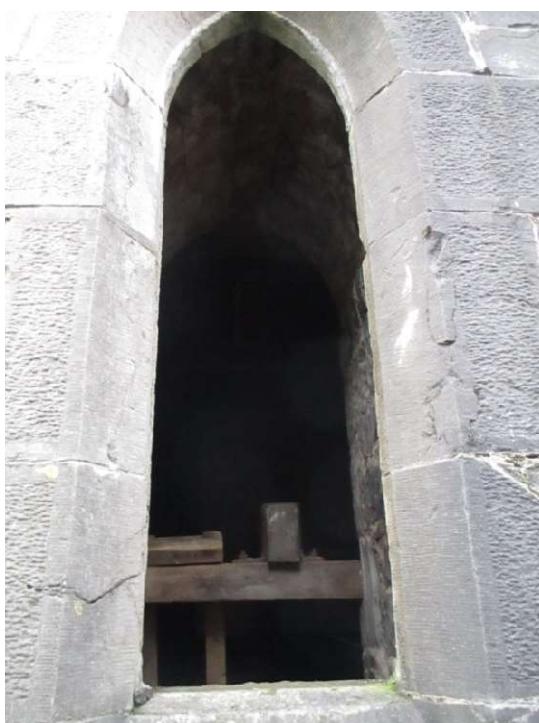
Access to external valley and hatch to roof space: A makeshift plywood panel was wedged into this opening. The original door has since been found in the tower and it is proposed to repair and re-fit this door.

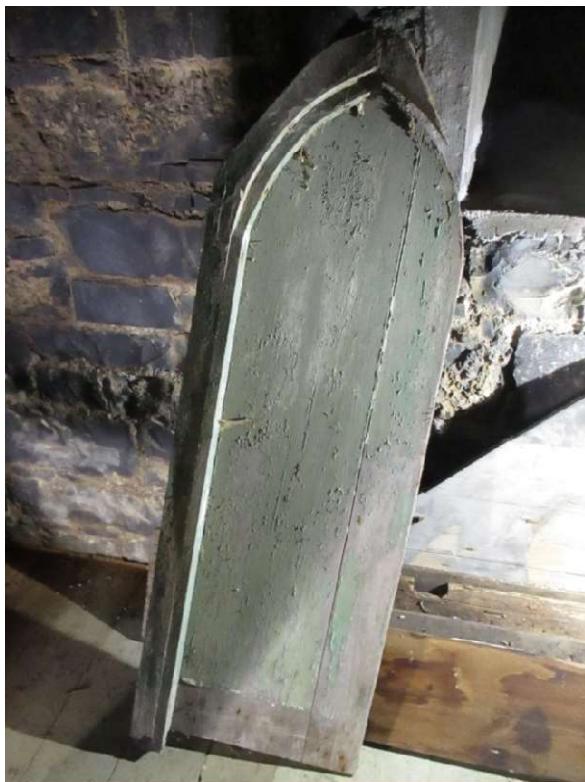
The original door which has been found in the tower. It is proposed to repair and re-fit this door in its original position.

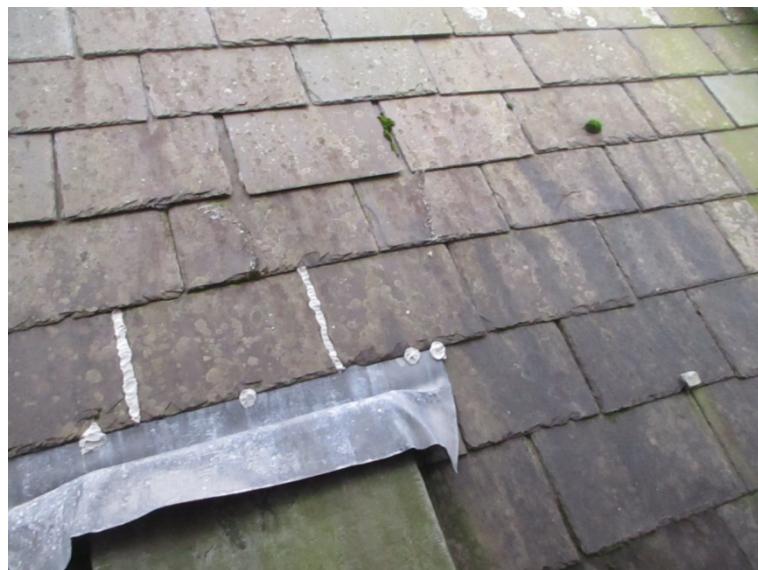
Top of lead lined access hatch with a temporary flashing to prevent leaks to the roof space

This emergency repair was carried out in the summer of 2023. It is proposed to replace this hatch with a patent Velux or similar side hung opening light to allow access into the roof space. Note: This is the only access into the roof space over the nave.

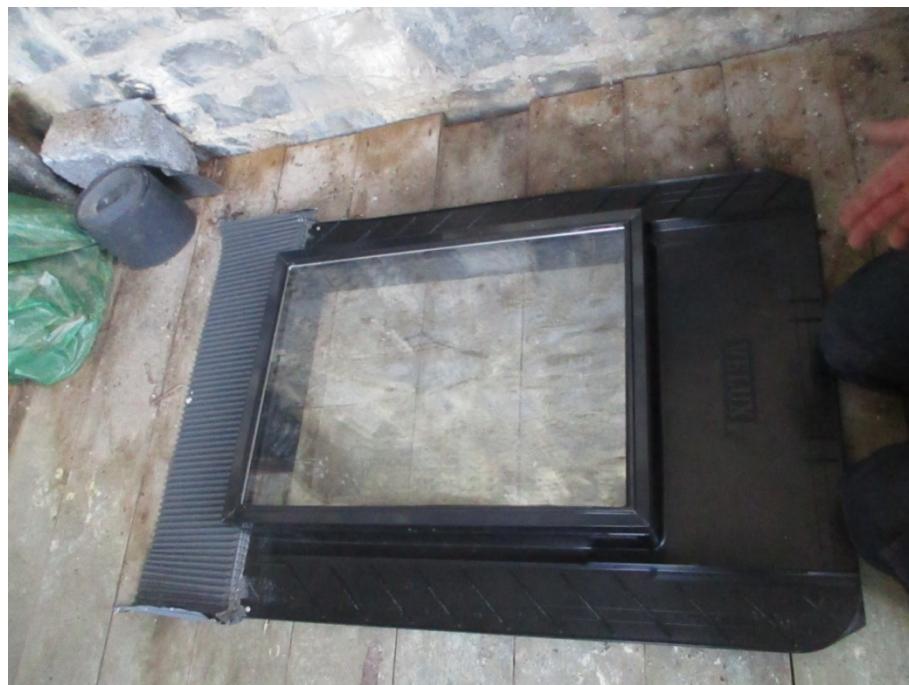
New access hatch being prepared for installation in roof

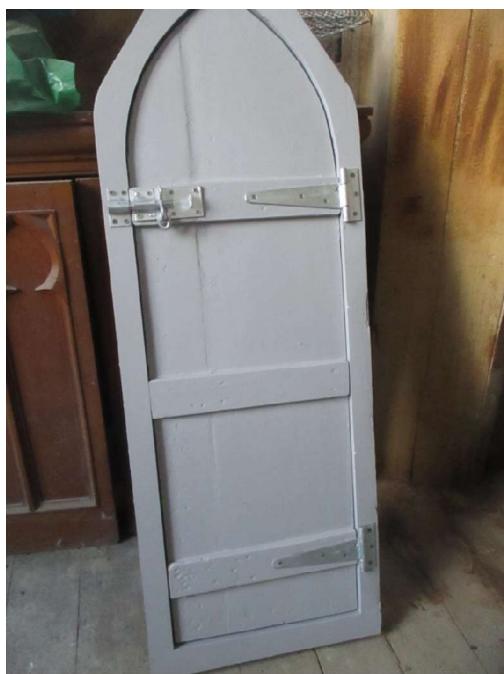
Original door and frame repaired and ready for installation in tower

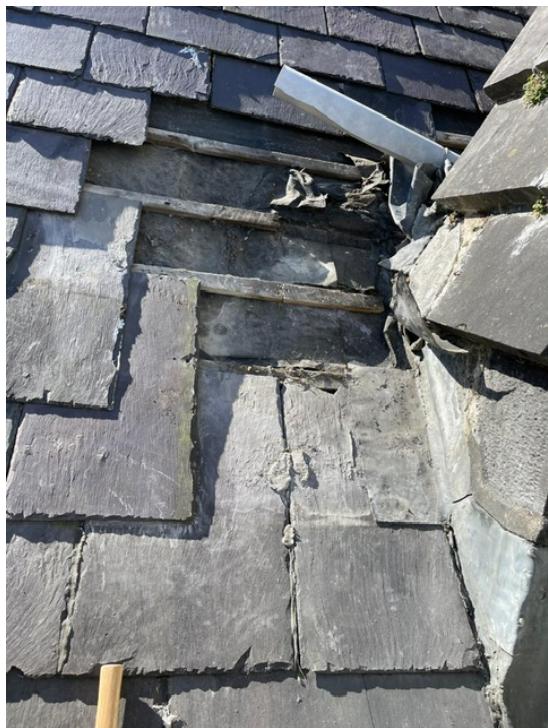
Pictures of work in progress at lead lined valley

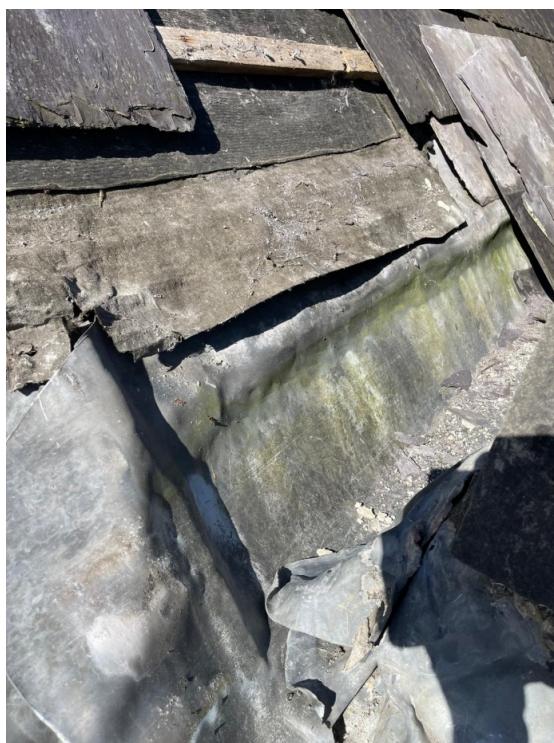
Picture of lead during the opening up at access hatch to roof space

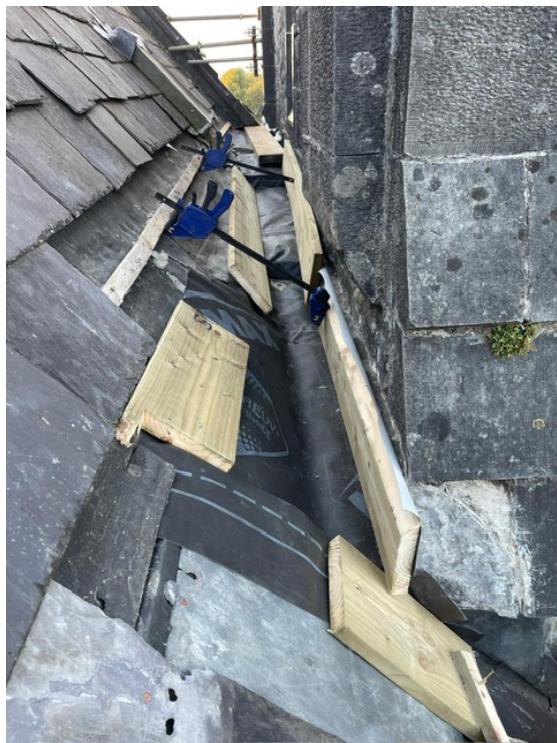
Lead valley: Works in progress

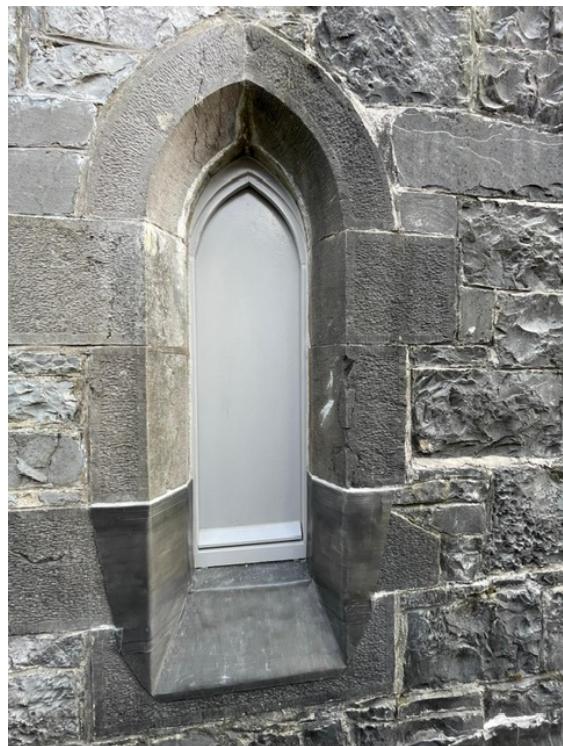
Original door and frame repaired and re-fitted in tower

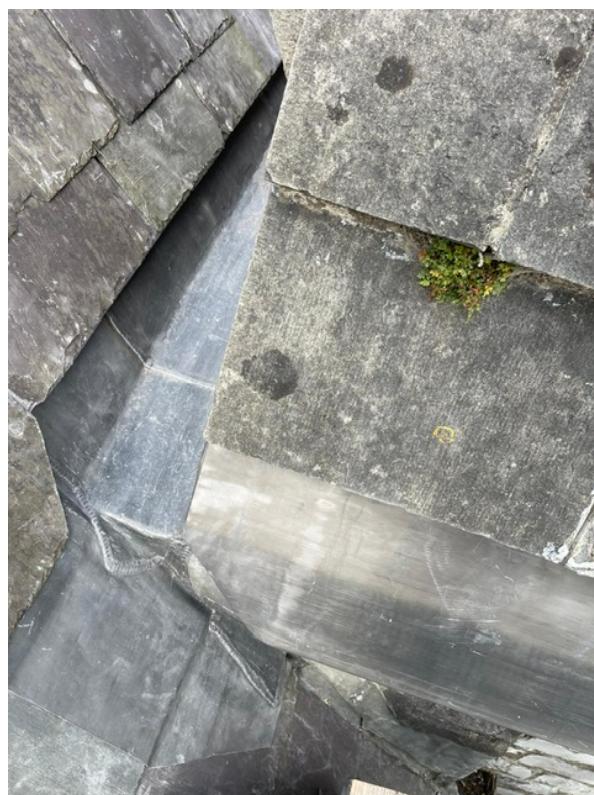
Detail of lead work at end of valley and corner of buttress

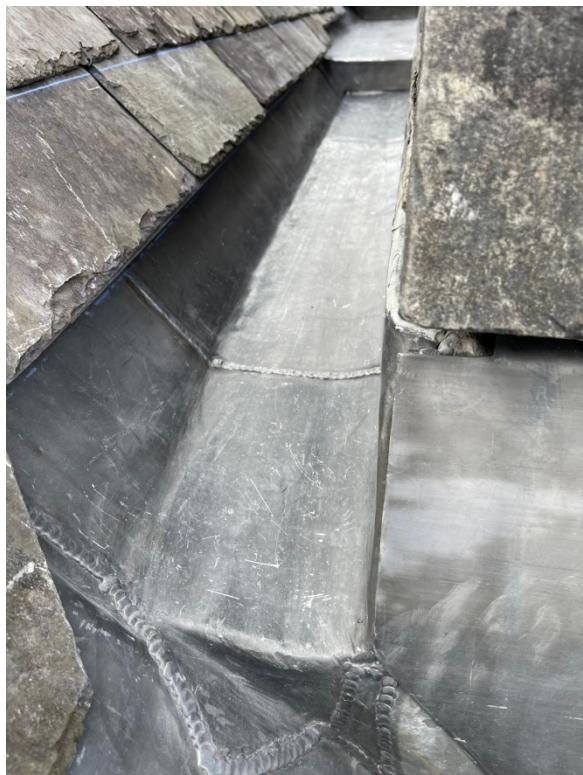
Valley re-lined with lead

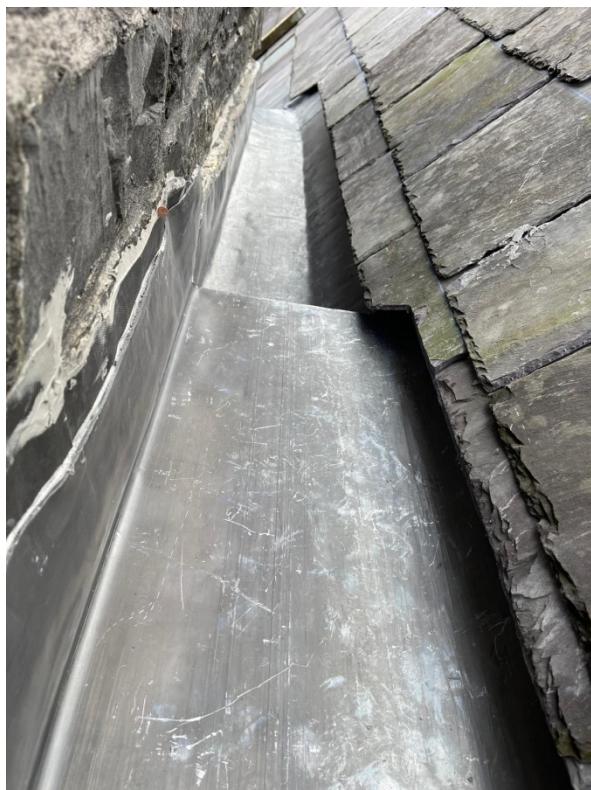
Valley re-lined with lead

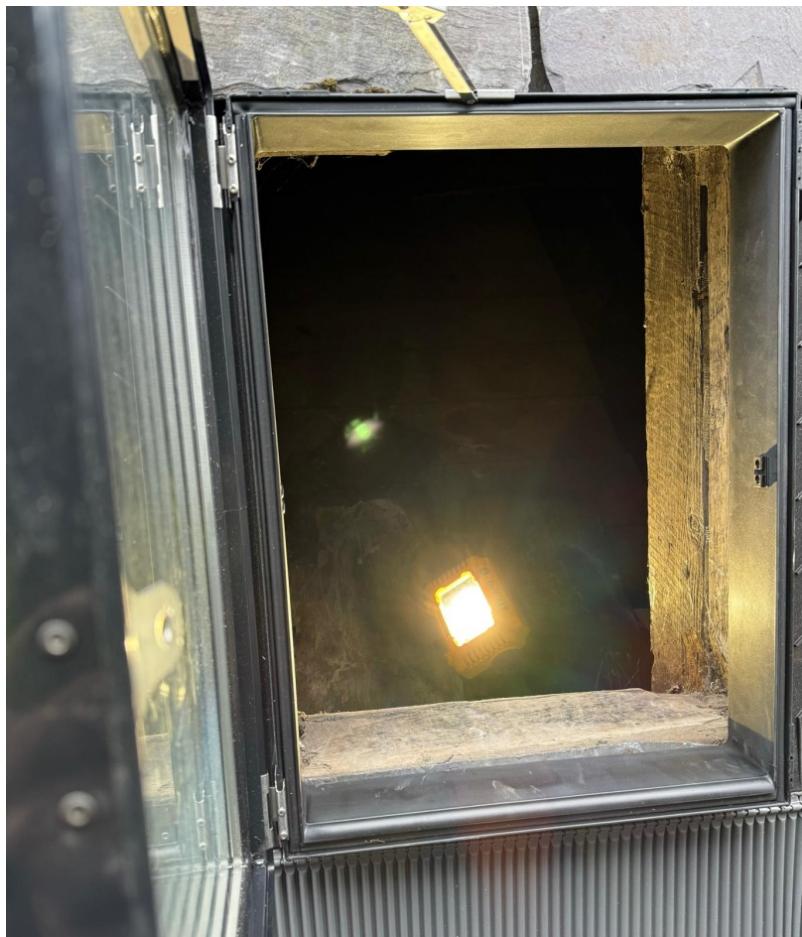
New access hatch in position

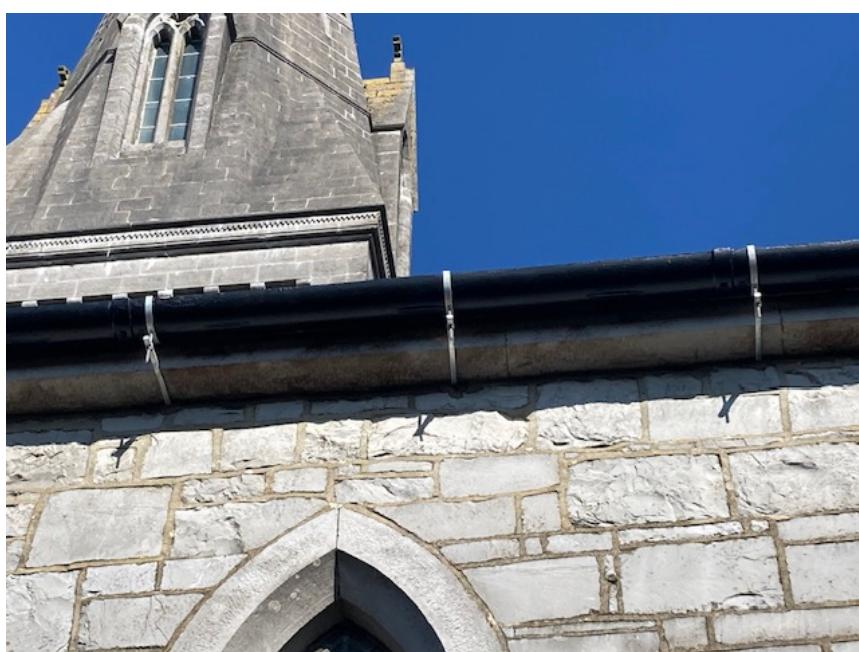
Detail of completed gutter and replacement brackets

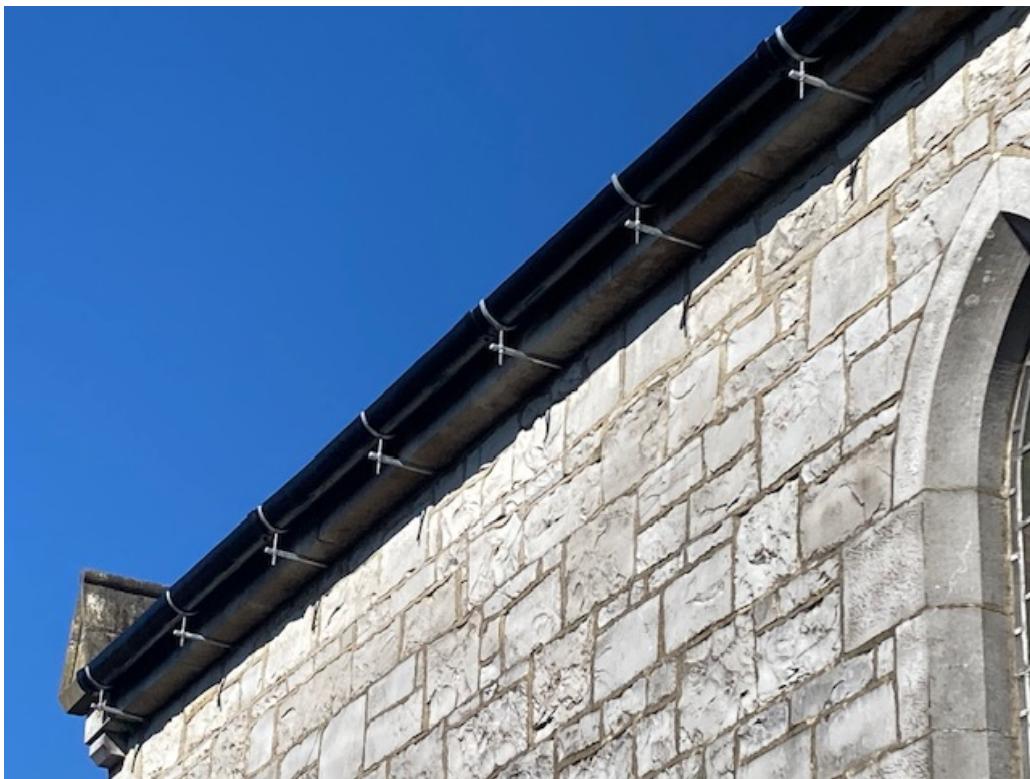
Detail of completed gutter and replacement brackets

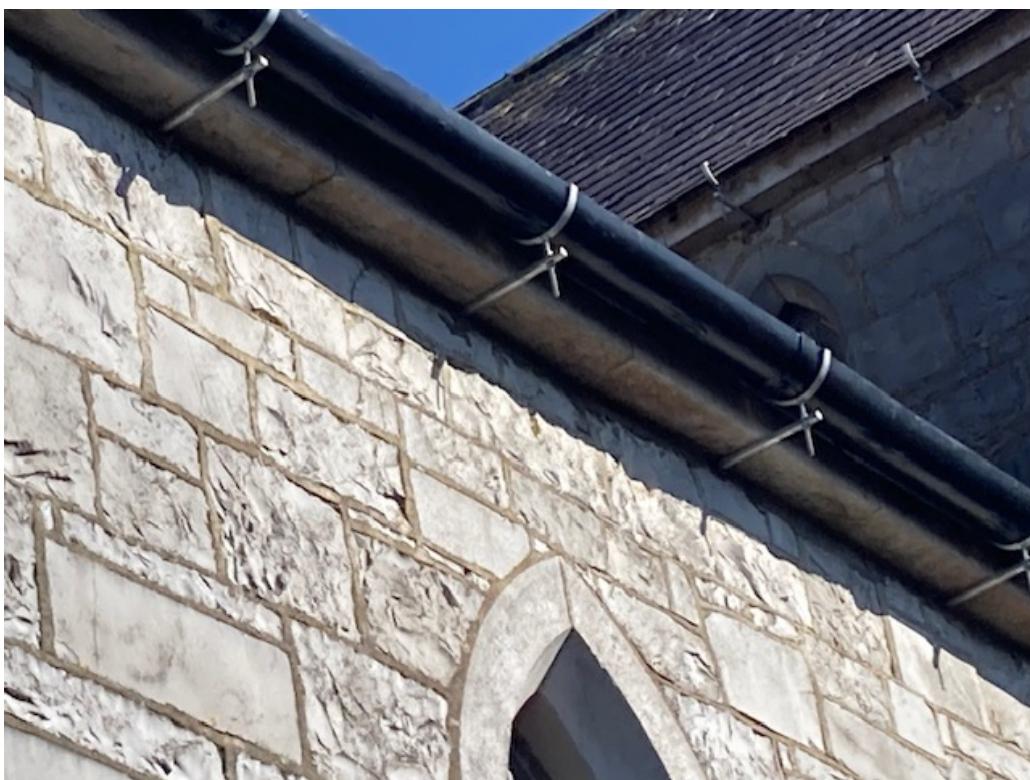
Detail of completed gutter and replacement brackets

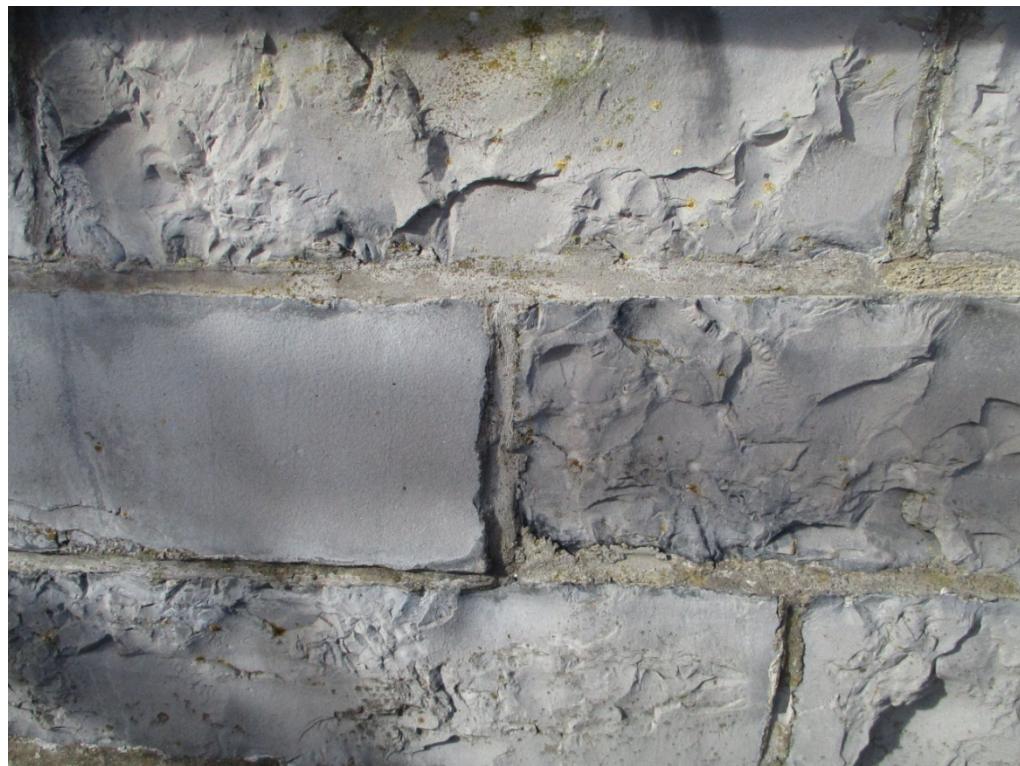
Detail of re-pointing of masonry on tower

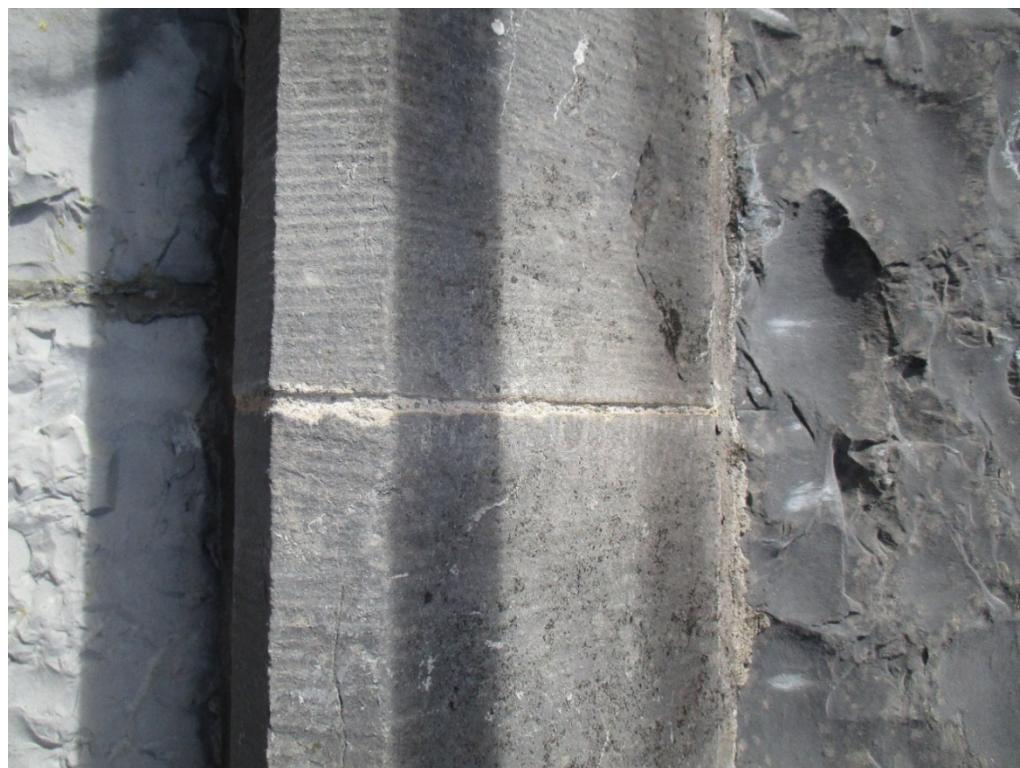
Picture of re-pointing of masonry on tower

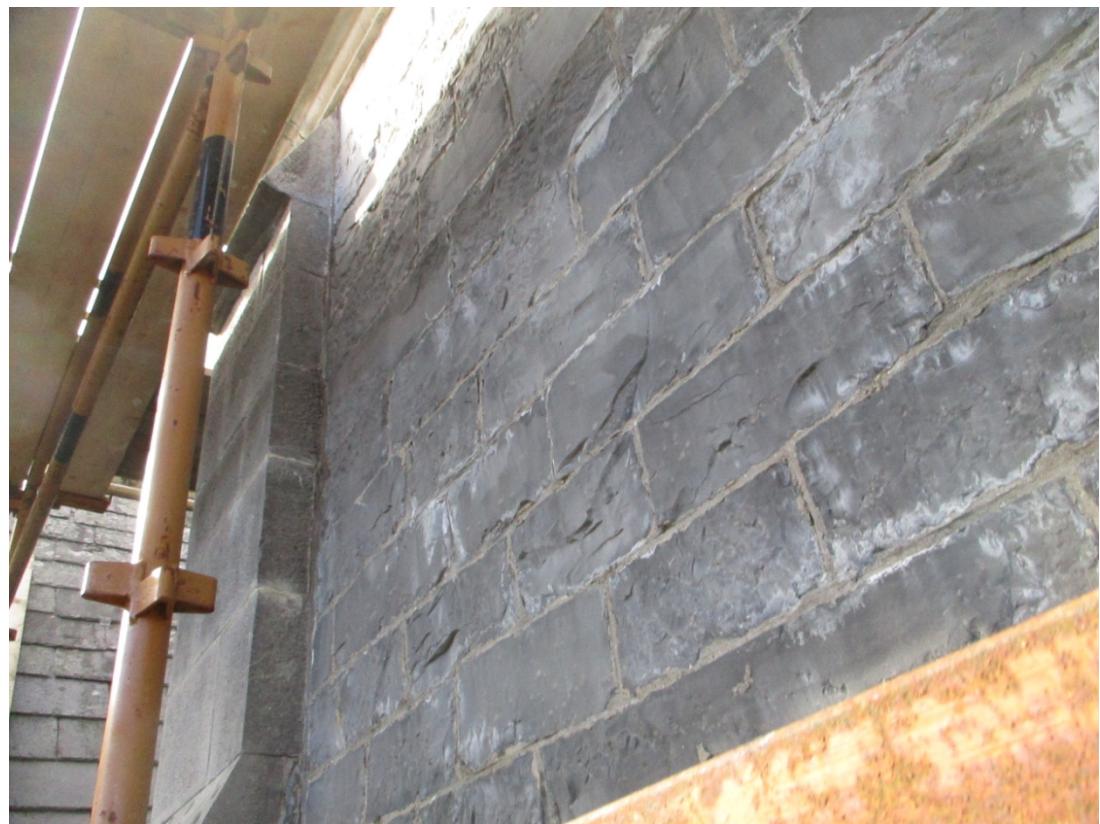
General view of re-pointing masonry on tower

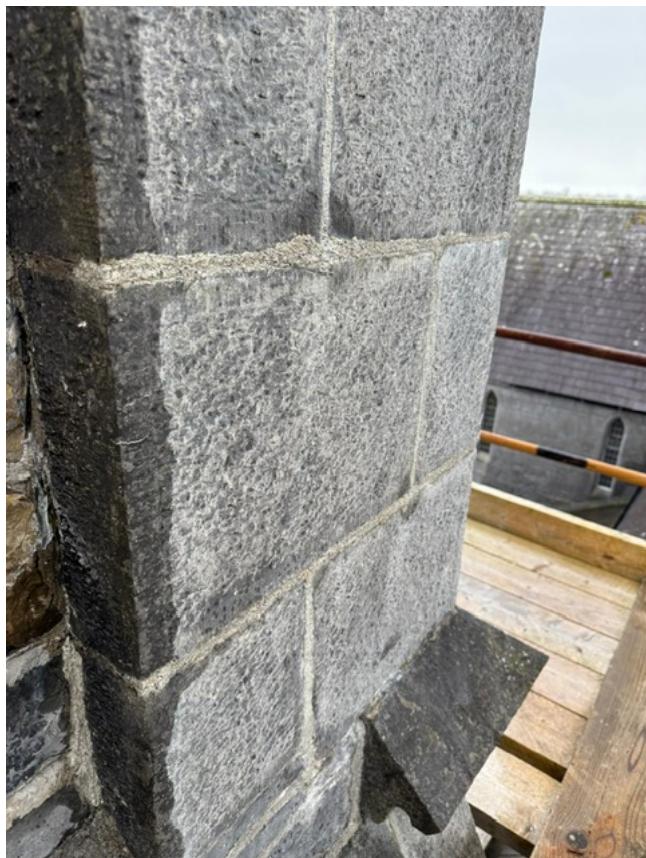
Detailed of re-pointing of masonry on corner of tower

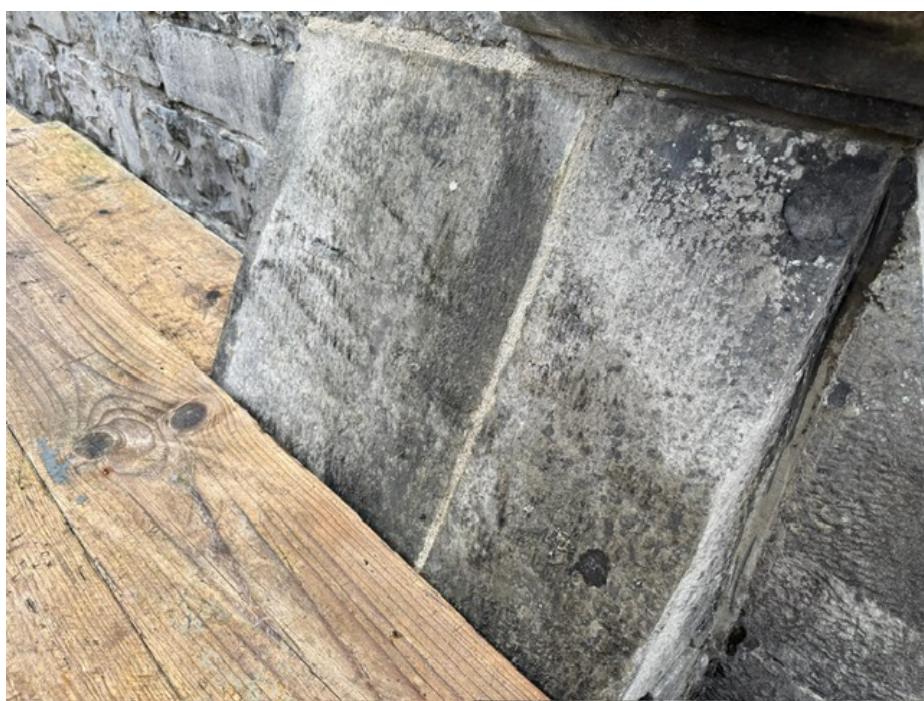
View of pointing on top of buttress

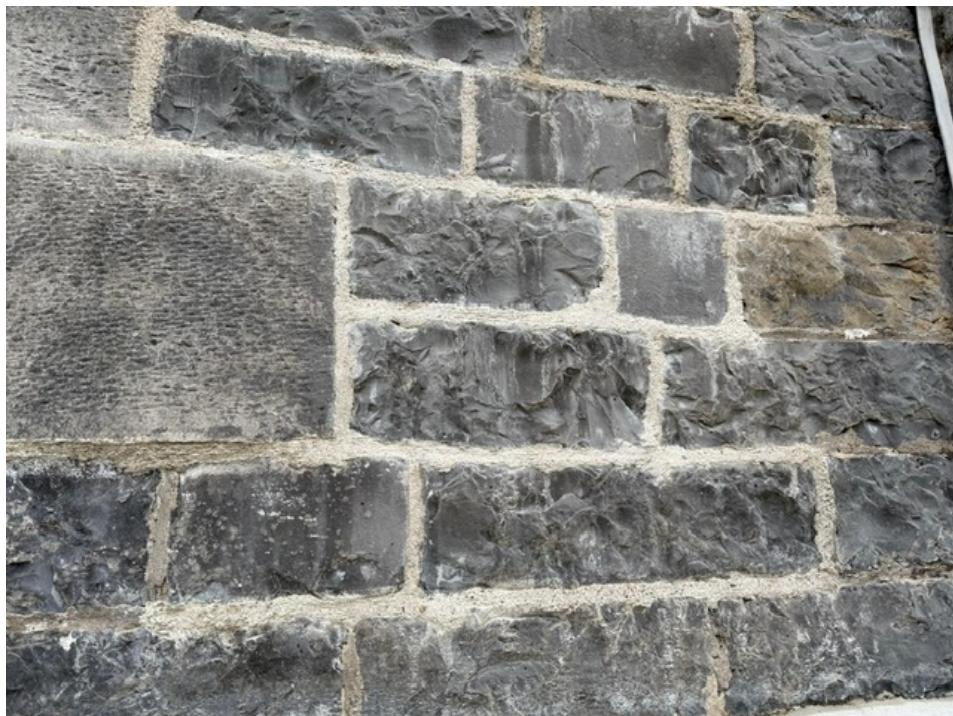
Re-pointed panel of stonework on tower

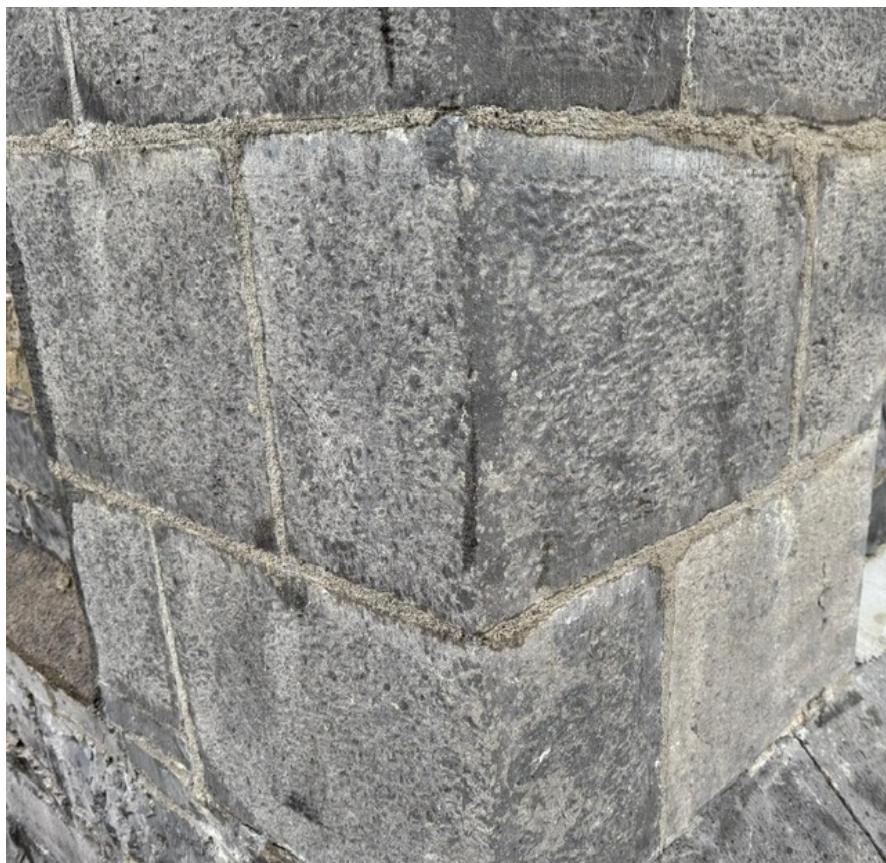
Re-pointed stonework on corner of tower

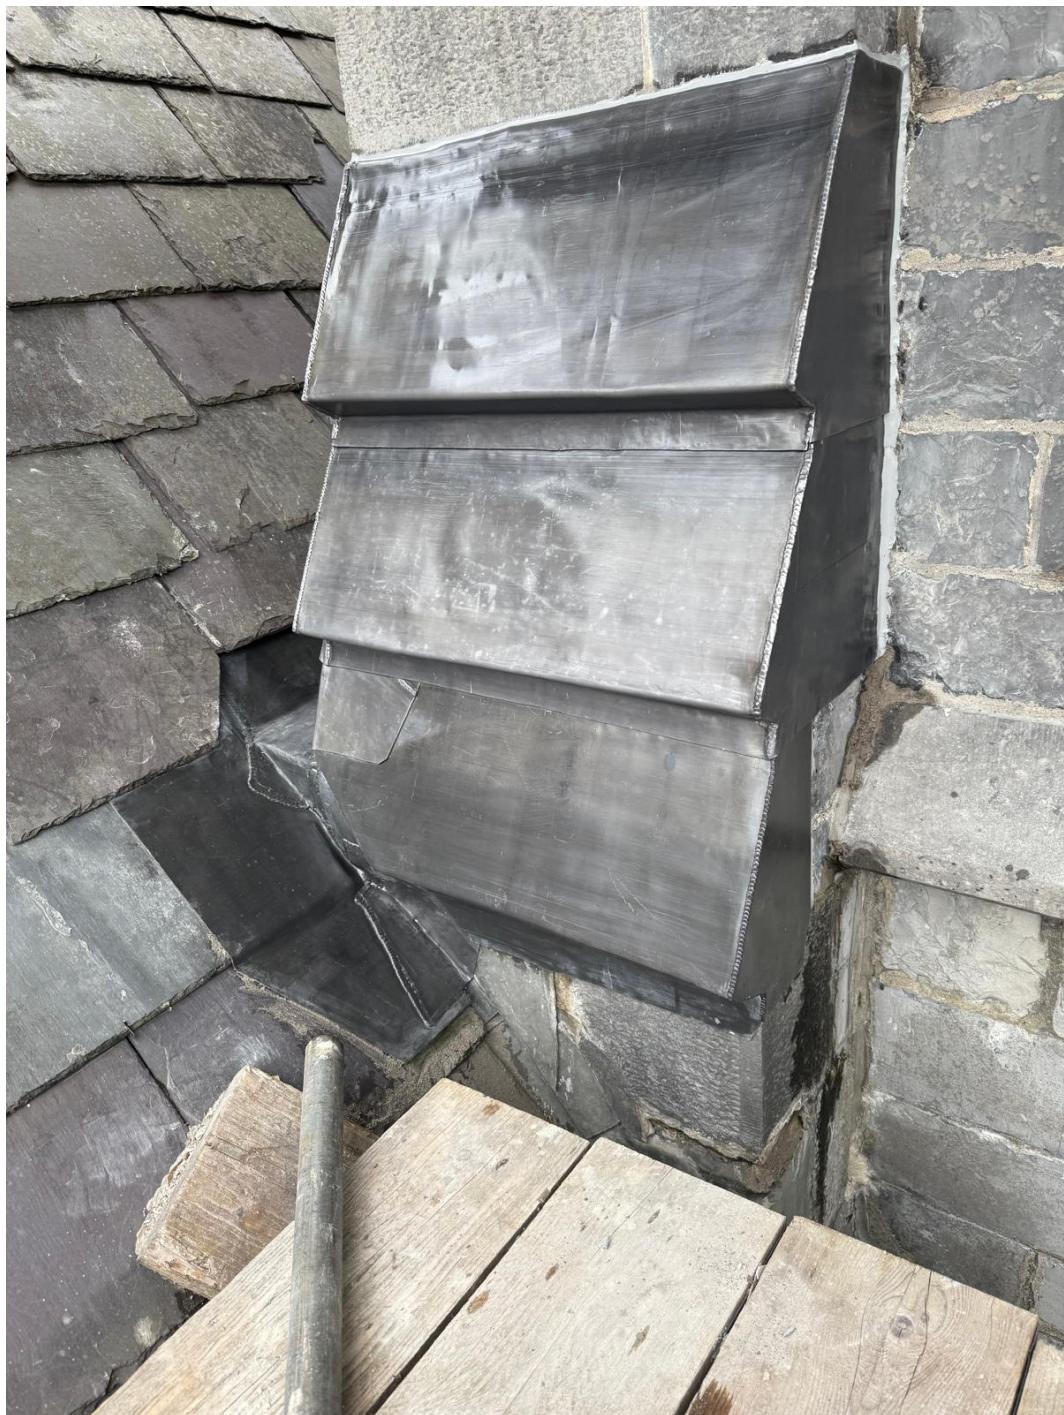
Lead cladding on top of buttress

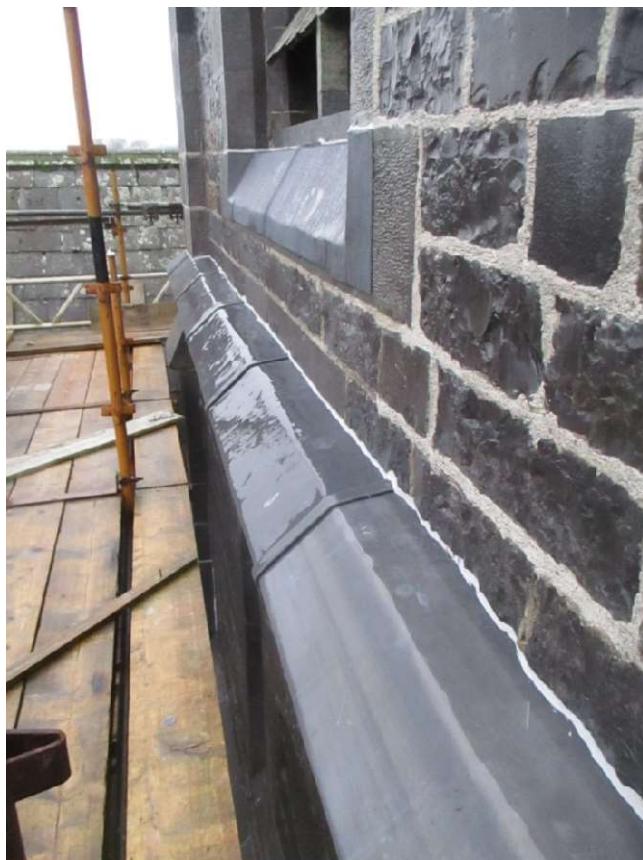
View of completed lead linings to sill and string course on SE face of tower. Some lime mortar pointing of stonework is also pictured to the RHS

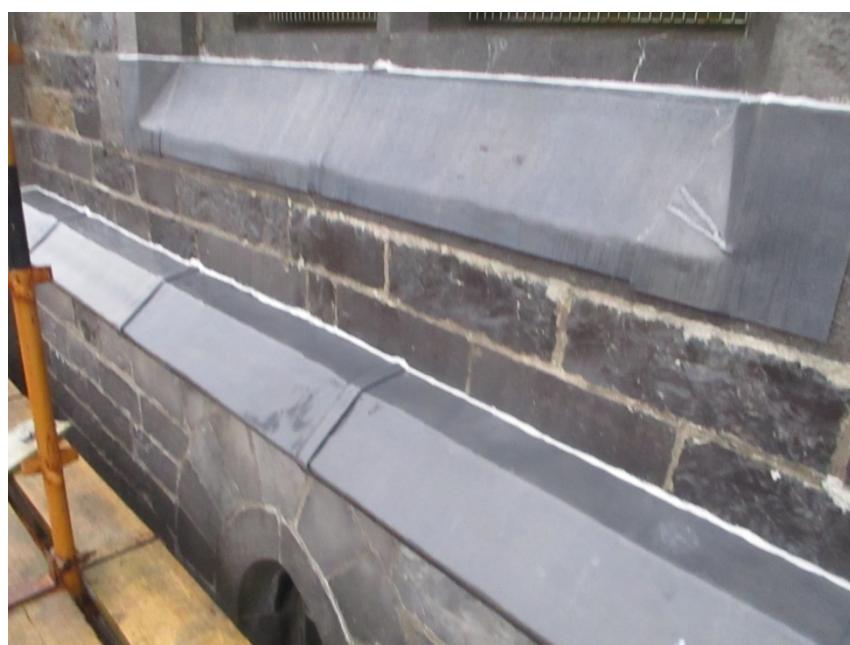
Detail of lead linings to string course and sill under louvred opening to the belfry

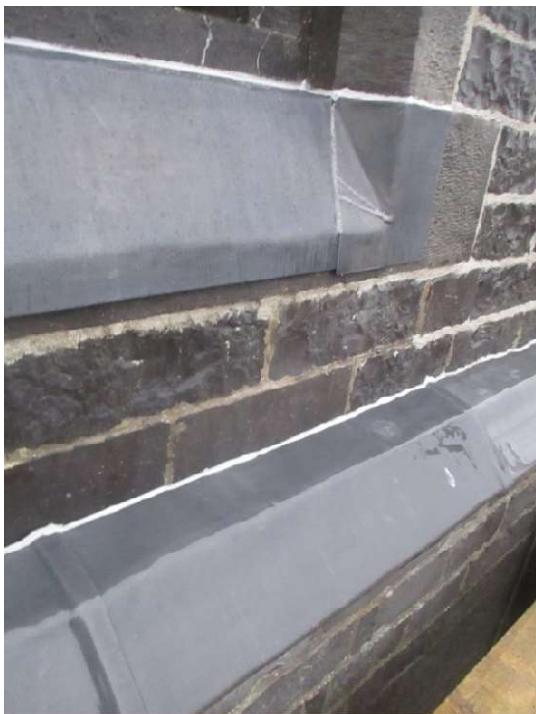
Detail of lead linings to string course and sill under louvred opening of belfry

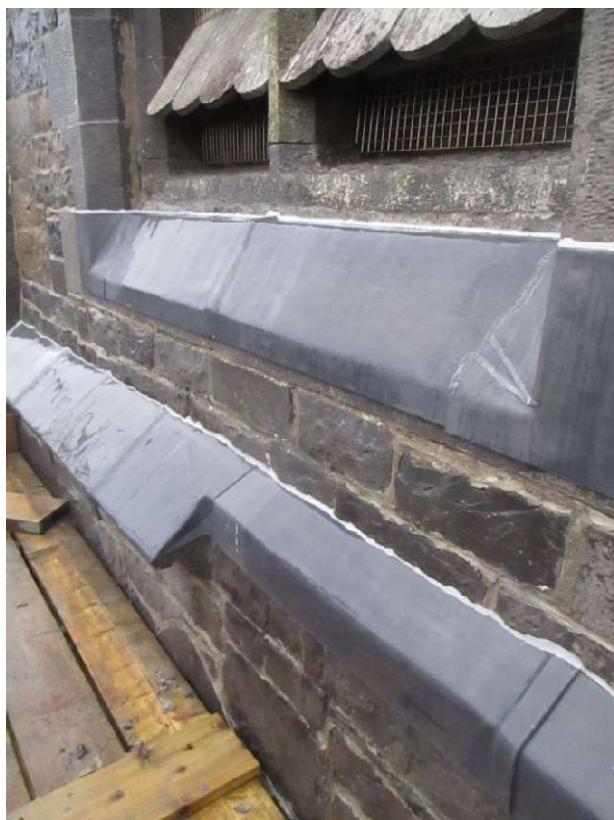
Detail of lead linings to string course and sill under louvred opening of belfry on the SW face of the tower.

Note that the string course was not constructed fully on this side and a ledge was left. This has been dressed with lead, the top part of which has been sloped

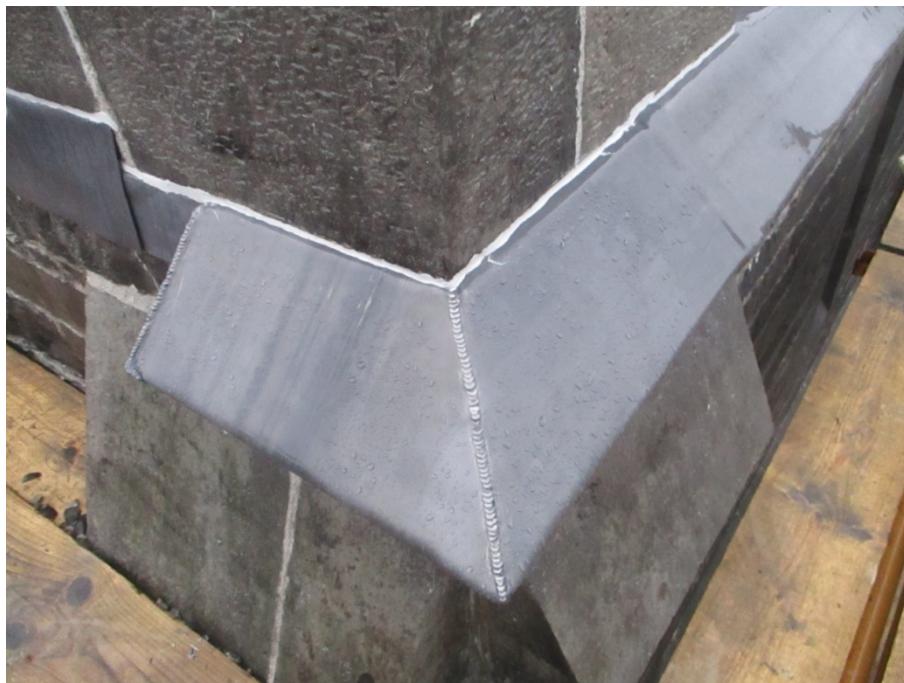
Detail of lead dressing to string course at corner of tower

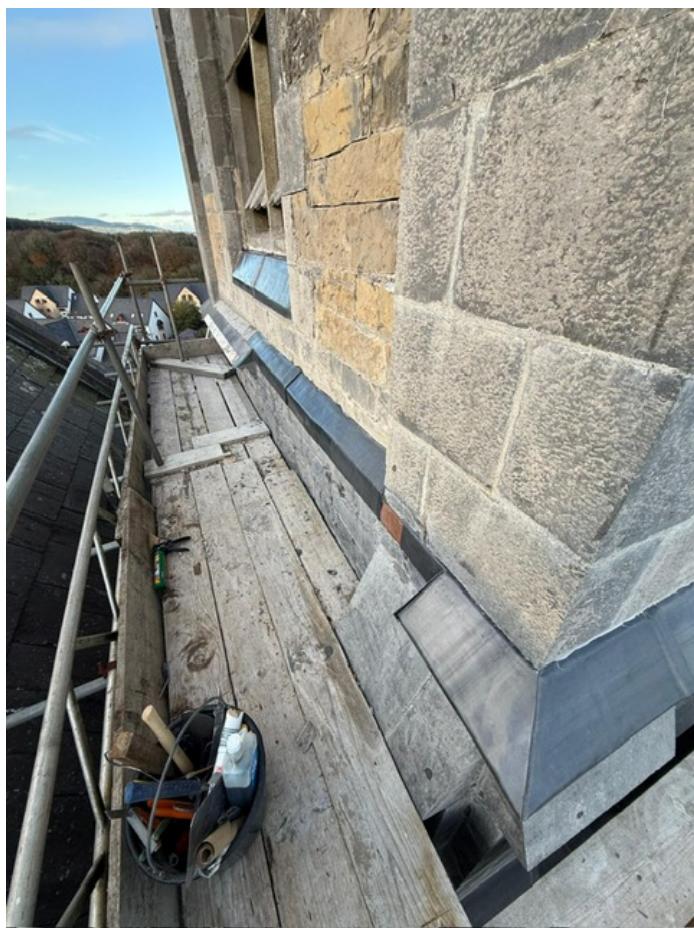
View of lead work in progress
