LEVEL 3

Your survey report...

Wed, 21 Jan 2026

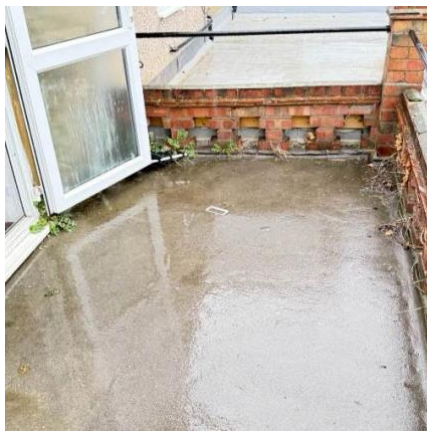
(Condition Rating 2)

This flat roof above the ground floor bathroom is substandard and suspect that this area will be reconfigured once put back into our house rather than a HMO.

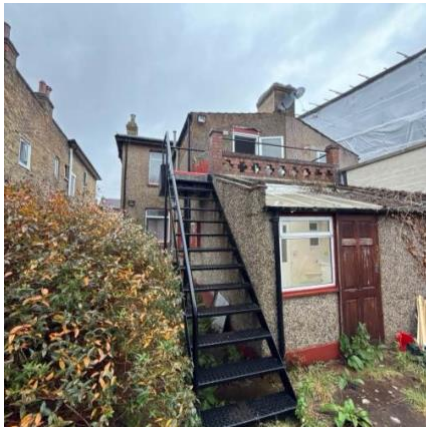
(Condition Rating 2)

The pebbledash is in poor condition on the rear elevation.

| R17 - Renew external rendering to rear elevations by hacking off the existing, raking out joints, hacking for key, and rendering in cement, lime and sand, 15mm. thick in two coats with steel trowelled surface, including flush joints including all necessary beads and scaffolding. Cut out defective brickwork half brick thick and install Helibars and lace up vertical fracture with brickwork to match existing, average 350mm wide in line with the crack, pointed to match existing, including all necessary scaffolding. www.helifix.co.uk | £20000 |

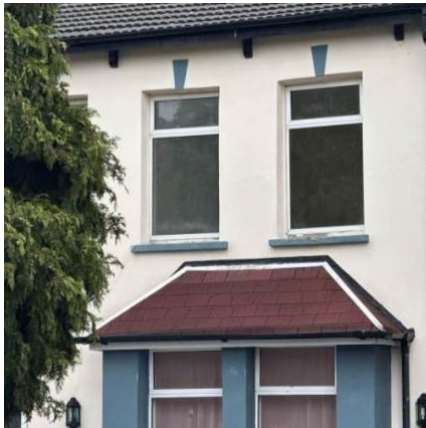
D5 Windows

(Condition Rating 2)

Although functional, the windows are generally at the end of their life cycle and would benefit from full replacement.

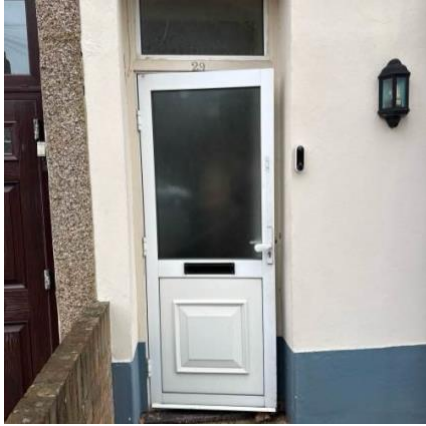
(Condition Rating 2)

Although functional, the door is generally at the end of its life cycle and would benefit from full replacement.

Cost of associated remedial work detailed in Section B, R4

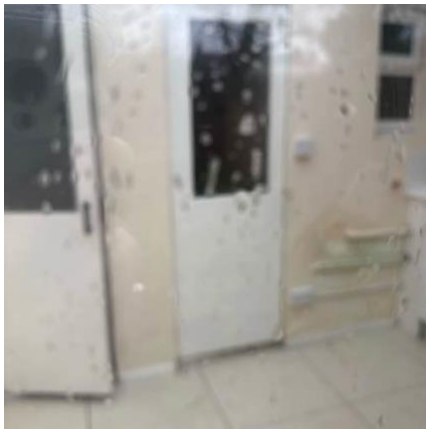
(Condition Rating 2)

Although functional, the door is generally at the end of its life cycle and would benefit from full replacement.

Cost of associated remedial work detailed in Section B, R16

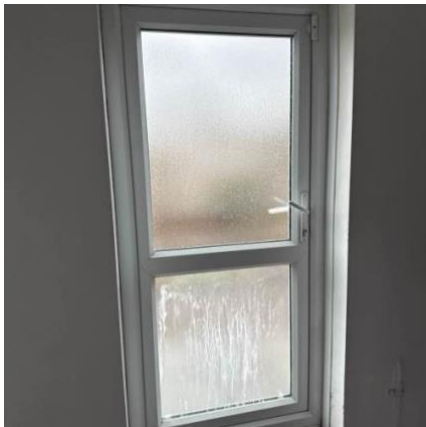
(Condition Rating 2)

Although functional, the door is generally at the end of its life cycle and would benefit from full replacement.

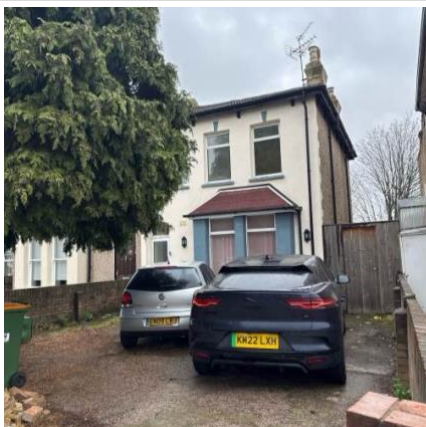
D9 Other

(Condition Rating 2)

External decorations are starting to deteriorate and would benefit from re-decoration. It is inevitable that some repairs and making good will be required when preparing to decorate, including isolated timber and masonry repairs.

| Repairs | Cost guidance (optional) |
|--|---|
| R2 - External decorations are starting to deteriorate and would benefit from re-decoration. It is inevitable that some repairs and making good will be required when preparing to decorate, including isolated timber and masonry repairs. | £3000 |

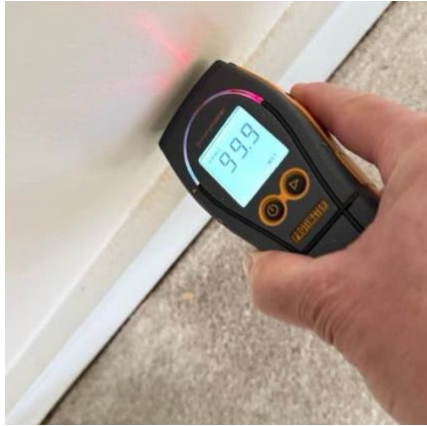
Damp meter readings were taken throughout this property and all of the ground floors have readings that give cause for concern and recommend the property has a thorough intrusive damp and timber survey carried out.

Cost of associated remedial work detailed in Section B, R20

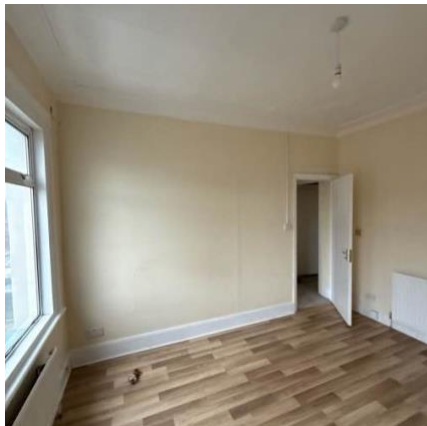
Bedroom 1

(Condition Rating 2)

Partition walls have been erected to divide the master bedroom into two.

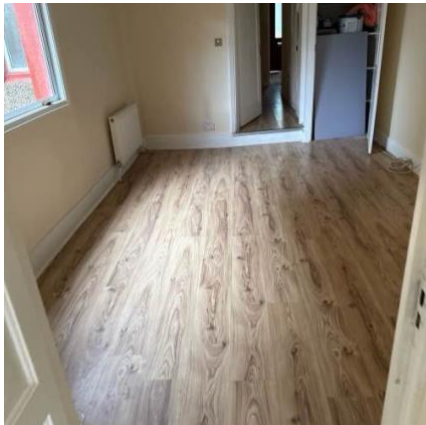
Floors to the ground floor are significantly uneven and suspect there to be rot or possibly structural failure below further investigation will be required to be conclusive.

| R19 - Allow provisional sum to take up ground floor floorboards, joists and girders for enabling works. Allow to re-build girder piers on adequate footing; subject to the condition of original timbers; supply | £10000 |

Cost of associated remedial work detailed in Section B, R19

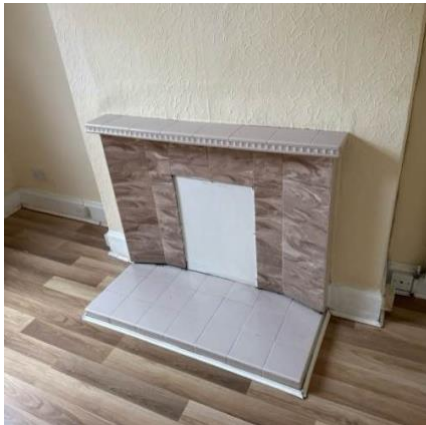
Bedroom 2

The chimney breast has an opening for a solid fuel fire. There was no up to date Smoke Test certificate visible at the time of inspection and therefore a Condition Rating 3 has been applied.

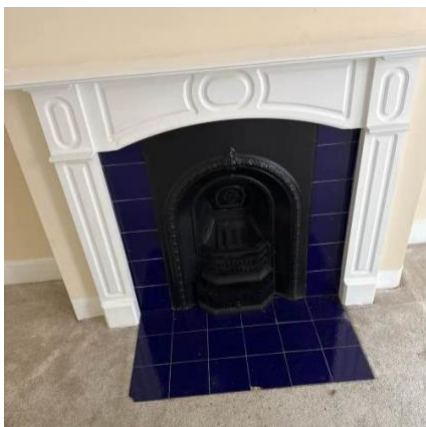
Living Room

The chimney breast has an open solid fuel fire. There was no up to date Smoke Test certificate visible at the time of inspection and therefore a Condition Rating 3 has been applied.

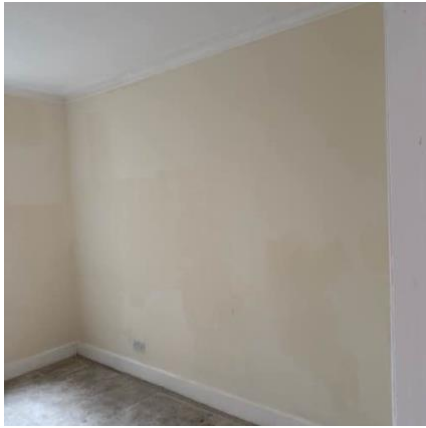
The chimney breast has been removed from this area and further investigation is recommended to ensure that this has been adequately supported along with specified building regulations.

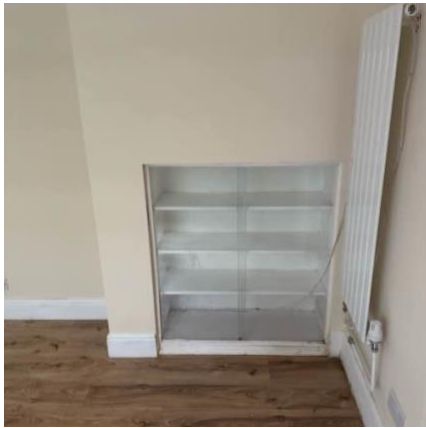
Kitchen

The chimney breast has an opening for a solid fuel fire. There was no up to date Smoke Test certificate visible at the time of inspection and therefore a Condition Rating 3 has been applied.

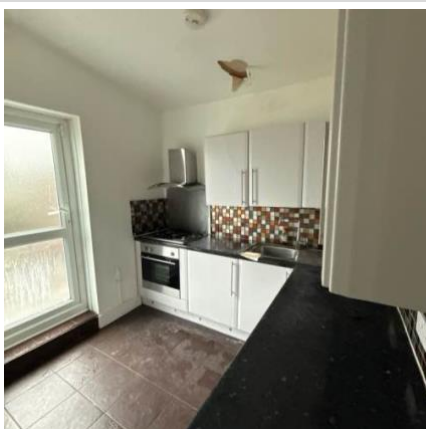
Bedroom 3

(Condition Rating 2)

Budget to remove all kitchen units and appliances and make good all areas disturbed.

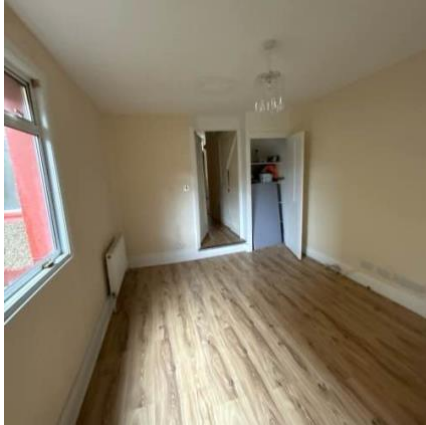
Kitchen

(Condition Rating 2)

Full refurbishment is recommended.

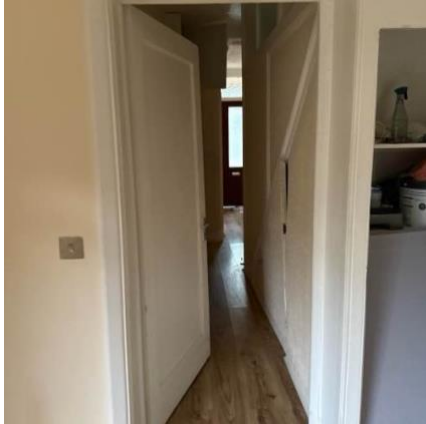
All doors are in poor condition and need replacing, including door furniture.

| R13 - Budget to replace all internal doors, including door furniture. | £5000 |

Cost of associated remedial work detailed in Section B, R13

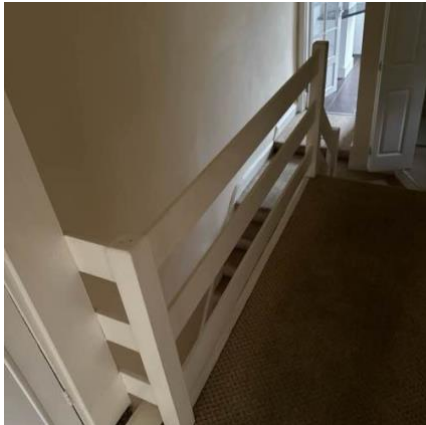
Landing

(Condition Rating 3)

The gaps in the balustrade are considerable and are considered to be unsafe, especially for young children. We therefore recommend a new balustrade be installed.

Cost of associated remedial work detailed in Section B, R7

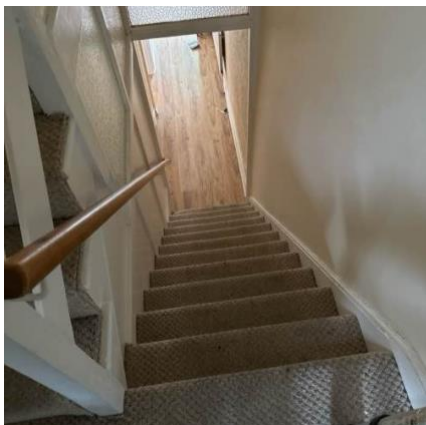
(Condition Rating 2)

The staircase has loose treads.

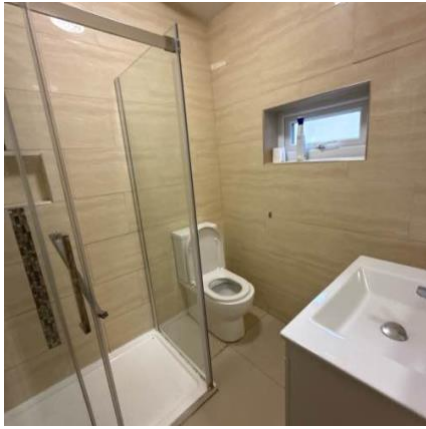
Bathroom 1

(Condition Rating 2)

The bathroom would benefit from complete refurbishment.

Cost of associated remedial work detailed in Section B, R8

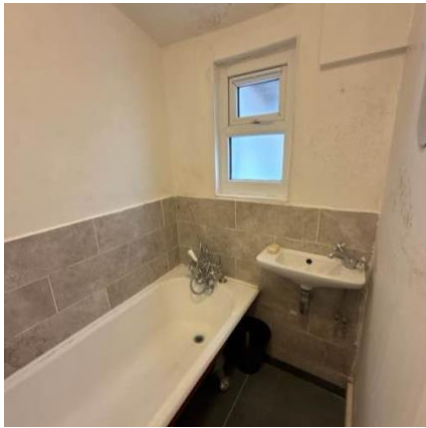
Bathroom 2

(Condition Rating 2)

The bathroom would benefit from complete refurbishment.

Cost of associated remedial work detailed in Section B, R12

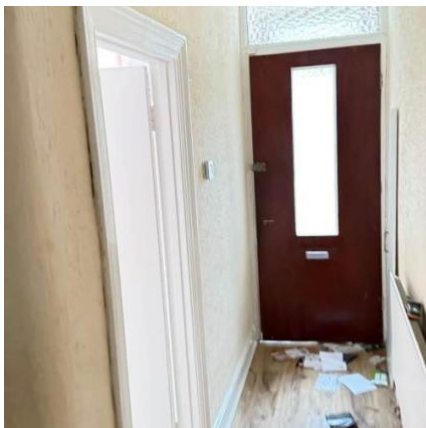
(Condition Rating 2)

This property would benefit from internal decorations.

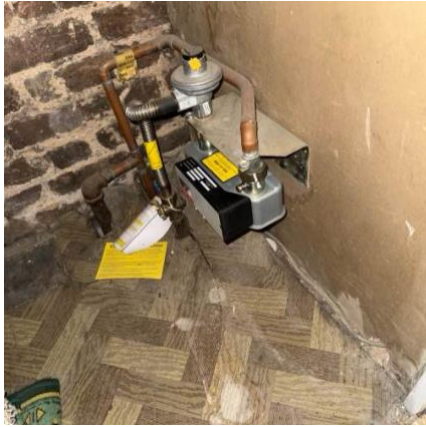
There is a mains gas supply to the property. The gas meter is located in the cupboard under the stairs.

There was no up to date Gas Safe certificate visible at the time of inspection and therefore a Condition Rating 3 has been applied.

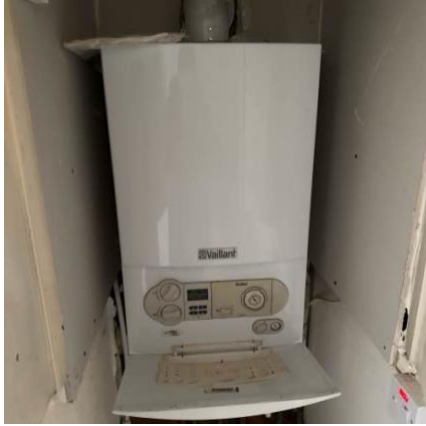
(Condition Rating 3)

We recommend a new heating and hot water system for this property.

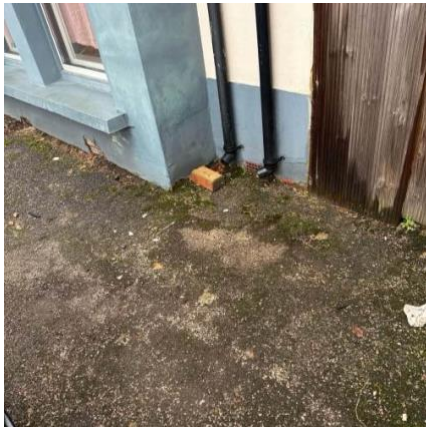
(Condition Rating 2)

There is no soakaway installed, potentially allowing rainwater to soak into the foundations of the building.

| Repairs | Cost guidance (optional) |
|--|---|
| R3 - Excavate soakaway 2.00m deep, lift/set aside/relay turf, remove excavated material, fill with hard, dry, broken masonry, stone or gravel, backfill with excavated material, dispose of surplus. | £5000 |

Cost of associated remedial work detailed in Section B, R3

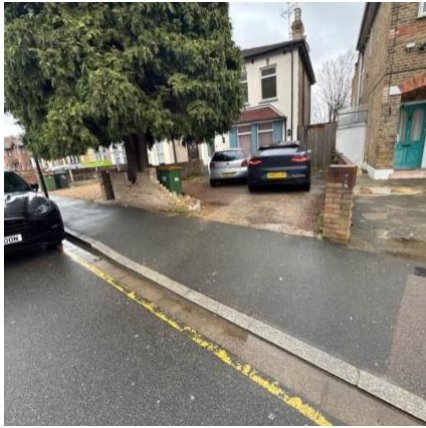
(Condition Rating 2)

The hardstanding to the front is uneven and needs to be re-landscaped.

The boundary wall is loose and needs to be re-built.

Cost of associated remedial work detailed in Section B, R15

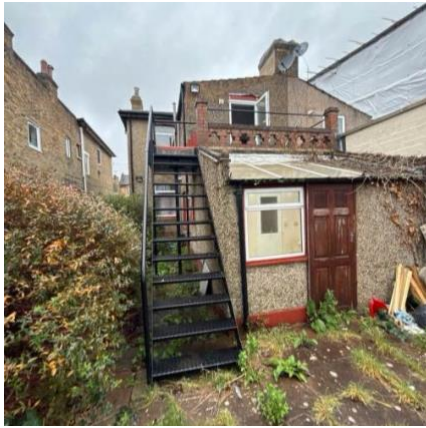
(Condition Rating 2)

The hardstanding to the rear is uneven and needs to be re-landscaped.

The fencing is in poor condition and needs to be replaced.

| R24 - The hardstanding to the rear is uneven and needs to be re-landscaped. The fencing is in poor condition and needs to be replaced. | £15000 |

Cost of associated remedial work detailed in Section B, R24

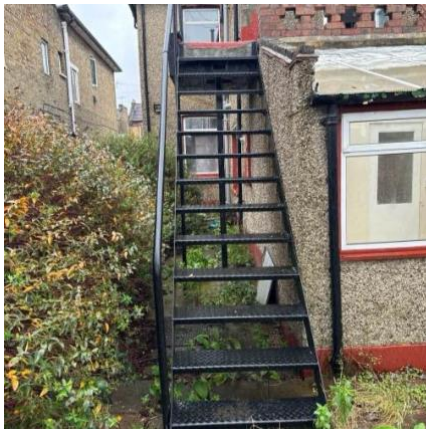
(Condition Rating 2)

The rear metal staircase is in poor condition and starting to fall apart.
