LEVEL 3

Your survey report...

Wed, 21 Jan 2026

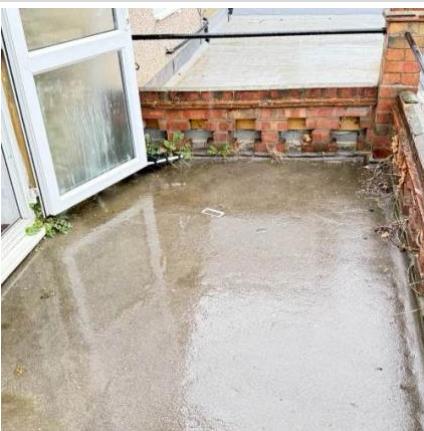
(Condition Rating 2)

This flat roof above the ground floor bathroom is substandard and suspect that this area will be reconfigured once put back into our house rather than a HMO.

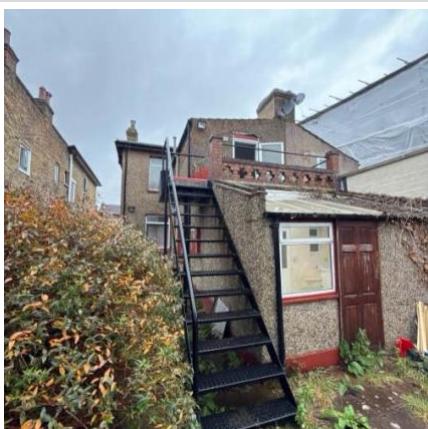
(Condition Rating 2)

The pebbledash is in poor condition on the rear elevation.

Cost of associated remedial work detailed in Section B, R17

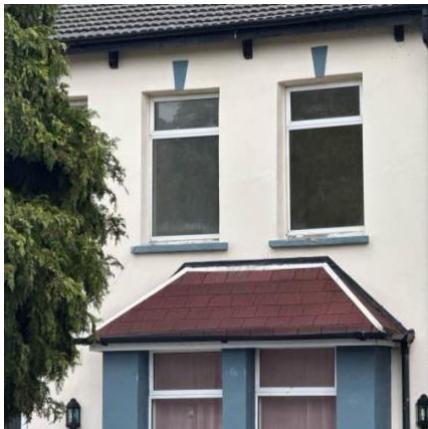
D5 Windows

(Condition Rating 2)

Although functional, the windows are generally at the end of their life cycle and would benefit from full replacement.

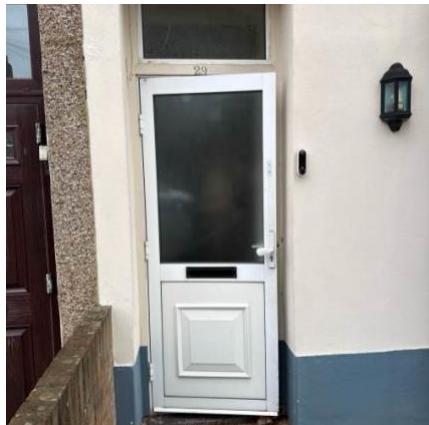
(Condition Rating 2)

Although functional, the door is generally at the end of its life cycle and would benefit from full replacement.

Cost of associated remedial work detailed in Section B, R4

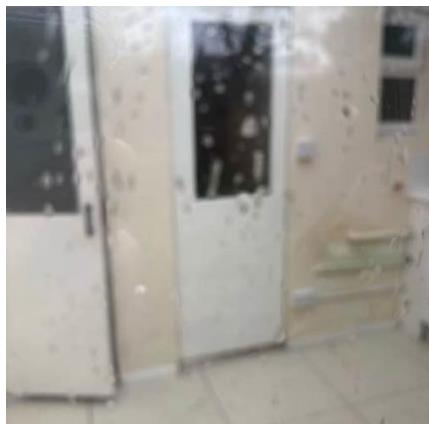
(Condition Rating 2)

Although functional, the door is generally at the end of its life cycle and would benefit from full replacement.

Cost of associated remedial work detailed in Section B, R16

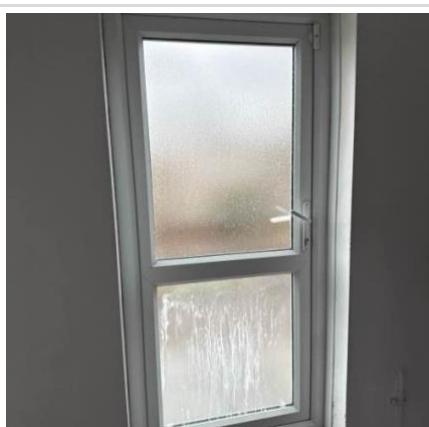
(Condition Rating 2)

Although functional, the door is generally at the end of its life cycle and would benefit from full replacement.

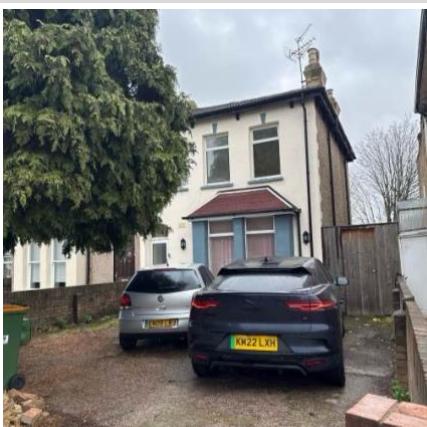
D9 Other

(Condition Rating 2)

External decorations are starting to deteriorate and would benefit from re-decoration. It is inevitable that some repairs and making good will be required when preparing to decorate, including isolated timber and masonry repairs.

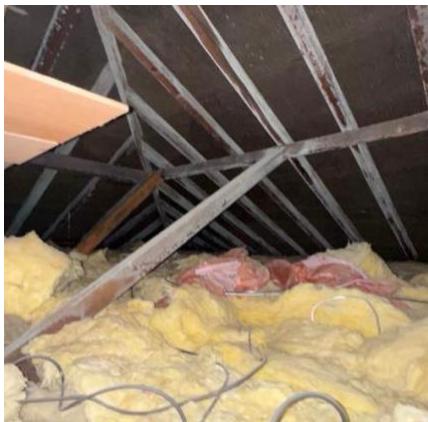
E1 Roof structure

The main roof space is accessed via a loft hatch on the landing. There is no fixed loft ladder. The roof is a cut and pitched timber construction. The roof appeared to be generally secure with no signs of thrust, deflection or water ingress.

It was only possible to carry out a head and shoulders inspection of the loft space, due to lack of safe access.

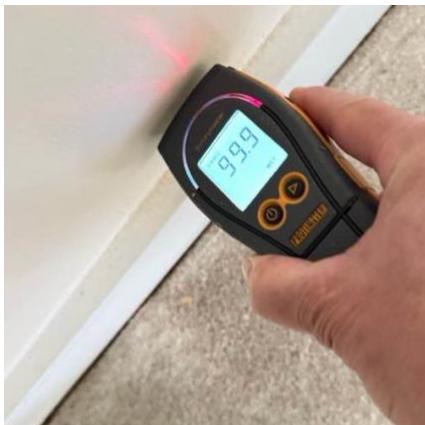
E3 Walls and partitions

Damp meter readings were taken throughout this property and all of the ground floors have readings that give cause for concern and recommend the property has a thorough intrusive damp and timber survey carried out.

Cost of associated remedial work detailed in Section B, R20

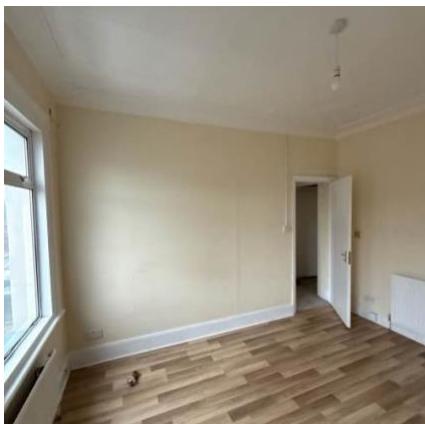
Bedroom 1

(Condition Rating 2)

Partition walls have been erected to divide the master bedroom into two.

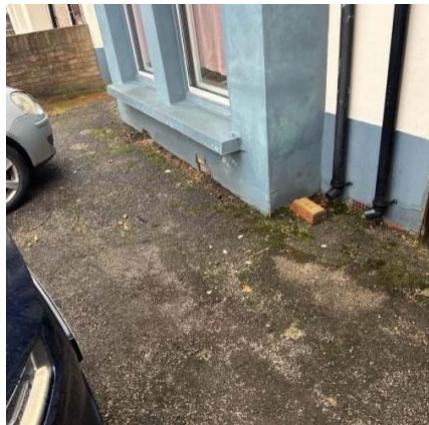
E4 Floors

There is ventilation to the sub-floor void visible in the form of airbricks. Care should be taken to ensure airbricks are not blocked as lack of ventilation can cause problems such as dry rot.

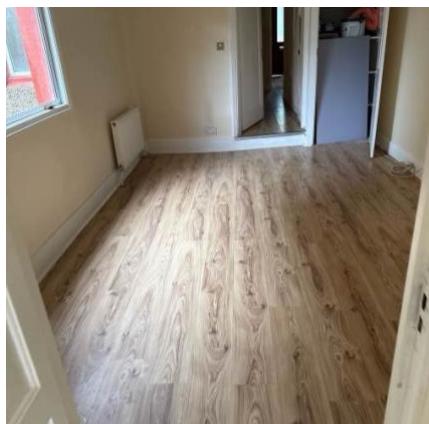
Floors to the ground floor are significantly uneven and suspect there to be rot or possibly structural failure below further investigation will be required to be conclusive.

Cost of associated remedial work detailed in Section B, R19

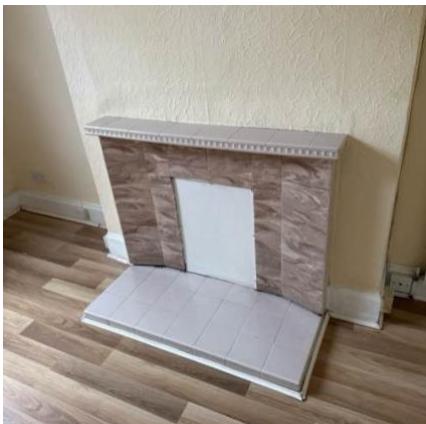
Bedroom 2

The chimney breast has an opening for a solid fuel fire. There was no up to date Smoke Test certificate visible at the time of inspection and therefore a Condition Rating 3 has been applied.

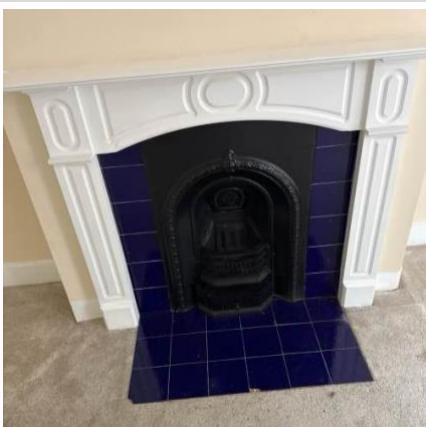
Living Room

The chimney breast has an open solid fuel fire. There was no up to date Smoke Test certificate visible at the time of inspection and therefore a Condition Rating 3 has been applied.

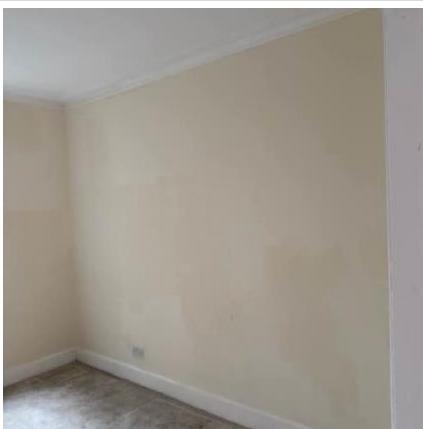
The chimney breast has been removed from this area and further investigation is recommended to ensure that this has been adequately supported along with specified building regulations.

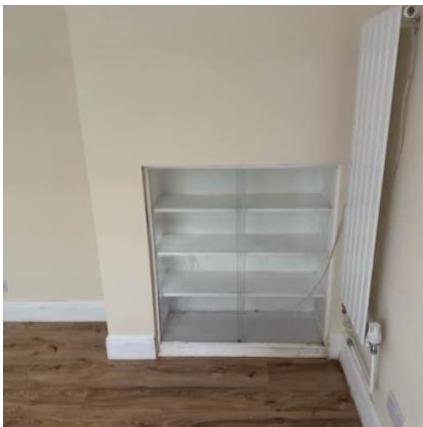
Kitchen

The chimney breast has an opening for a solid fuel fire. There was no up to date Smoke Test certificate visible at the time of inspection and therefore a Condition Rating 3 has been applied.

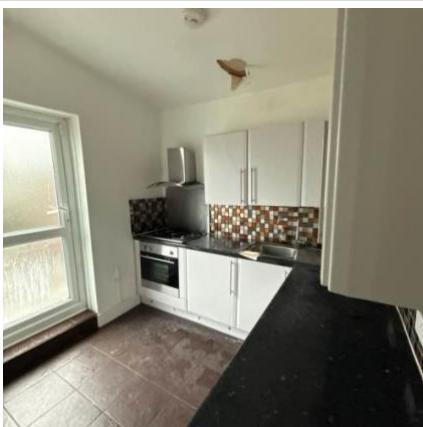
Bedroom 3

(Condition Rating 2)

Budget to remove all kitchen units and appliances and make good all areas disturbed.

Cost of associated remedial work detailed in Section B, R10

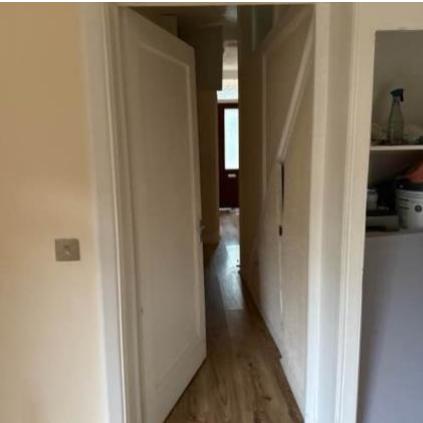
All doors are in poor condition and need replacing, including door furniture.

Cost of associated remedial work detailed in Section B, R13

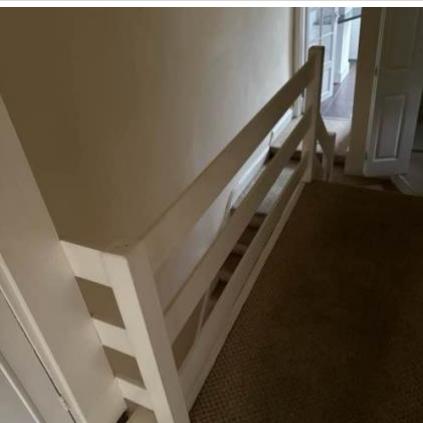
Landing

(Condition Rating 3)

The gaps in the balustrade are considerable and are considered to be unsafe, especially for young children. We therefore recommend a new balustrade be installed.

Cost of associated remedial work detailed in Section B, R7

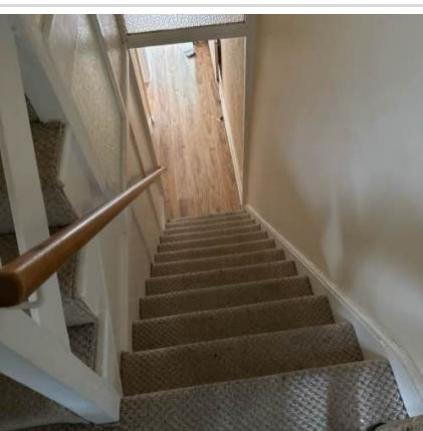
(Condition Rating 2)

The staircase has loose treads.

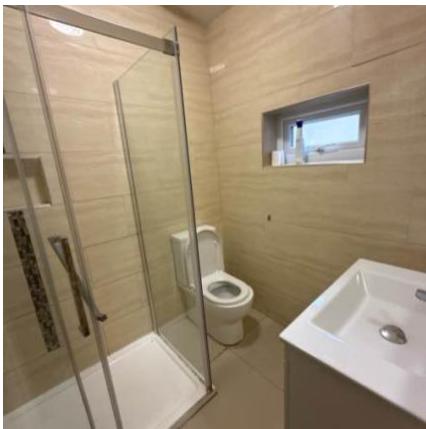
Bathroom 1

(Condition Rating 2)

The bathroom would benefit from complete refurbishment.

Cost of associated remedial work detailed in Section B, R8

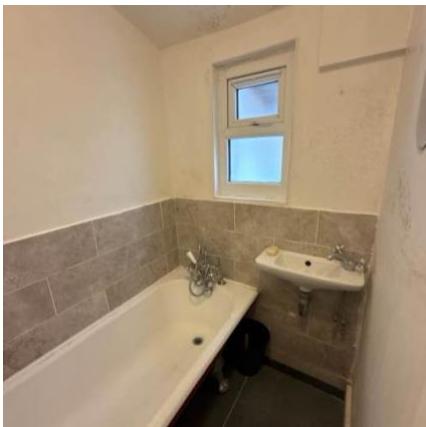
Bathroom 2

(Condition Rating 2)

The bathroom would benefit from complete refurbishment.

Cost of associated remedial work detailed in Section B, R12

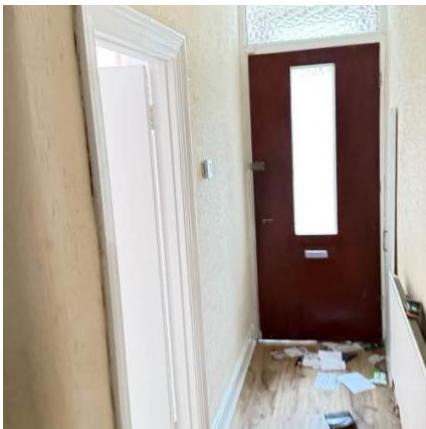
E9 Other

(Condition Rating 2)

This property would benefit from internal decorations.

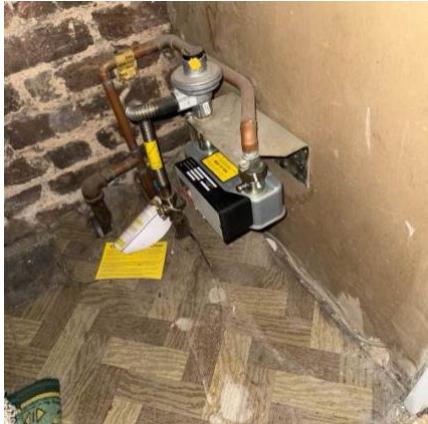
F2 Gas/oil

There is a mains gas supply to the property. The gas meter is located in the cupboard under the stairs.

There was no up to date Gas Safe certificate visible at the time of inspection and therefore a Condition Rating 3 has been applied.

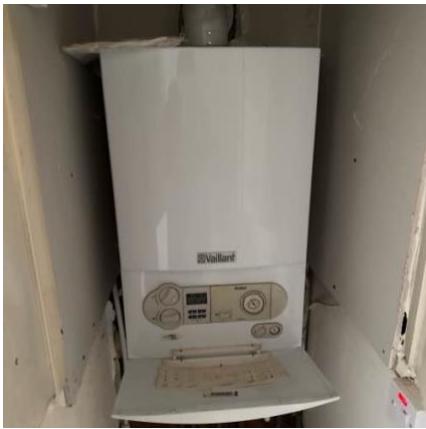
F4 Heating

(Condition Rating 3)

We recommend a new heating and hot water system for this property.

Cost of associated remedial work detailed in Section B, R5

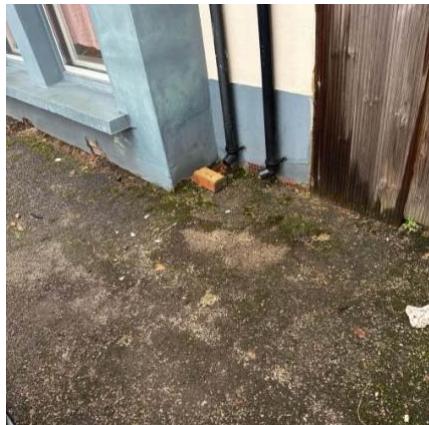
(Condition Rating 2)

There is no soakaway installed, potentially allowing rainwater to soak into the foundations of the building.

Cost of associated remedial work detailed in Section B, R3

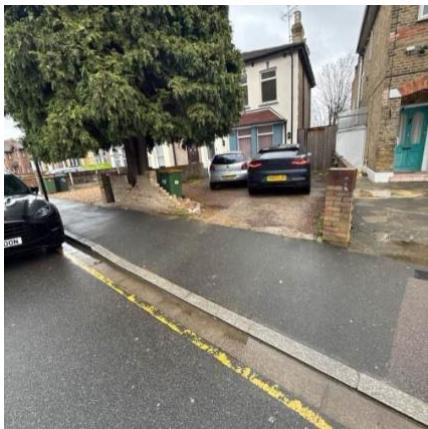
(Condition Rating 2)

The hardstanding to the front is uneven and needs to be re-landscaped.

The boundary wall is loose and needs to be re-built.

Cost of associated remedial work detailed in Section B, R15

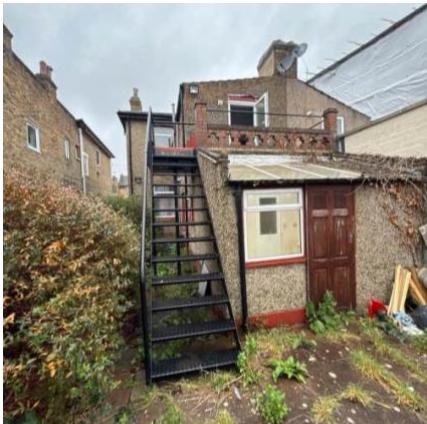
(Condition Rating 2)

The hardstanding to the rear is uneven and needs to be re-landscaped.

The fencing is in poor condition and needs to be replaced.

Cost of associated remedial work detailed in Section B, R24

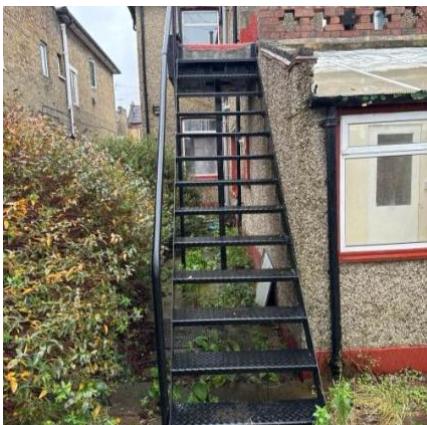
(Condition Rating 2)

The rear metal staircase is in poor condition and starting to fall apart.
