CHANNEL VIEW, CARDIFF Soil Resource Survey

CHANNEL VIEW, CARDIFF: Soil Resource Survey

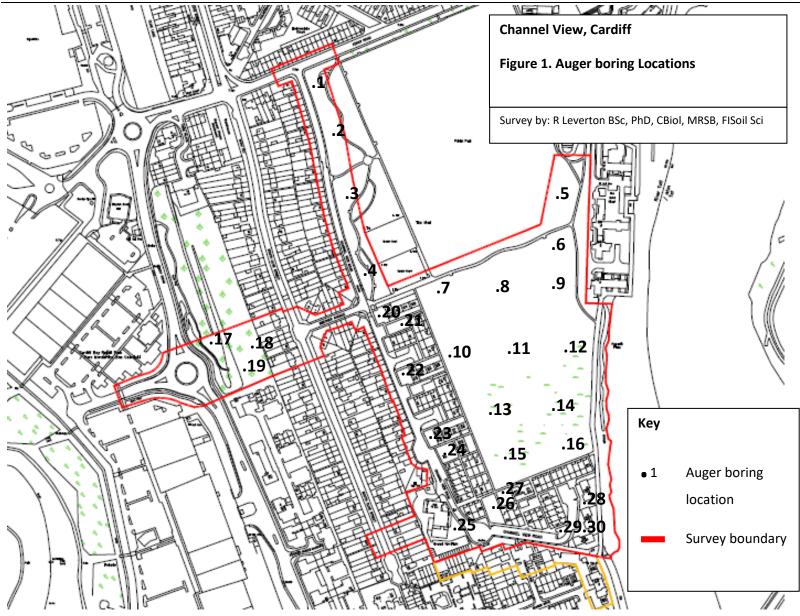
FIGURE 1

Auger Boring Locations
