# **Lower Putah Creek**

## **Gravel Bed Scarification**

### **Final Report (Amended)**

April 30, 2021

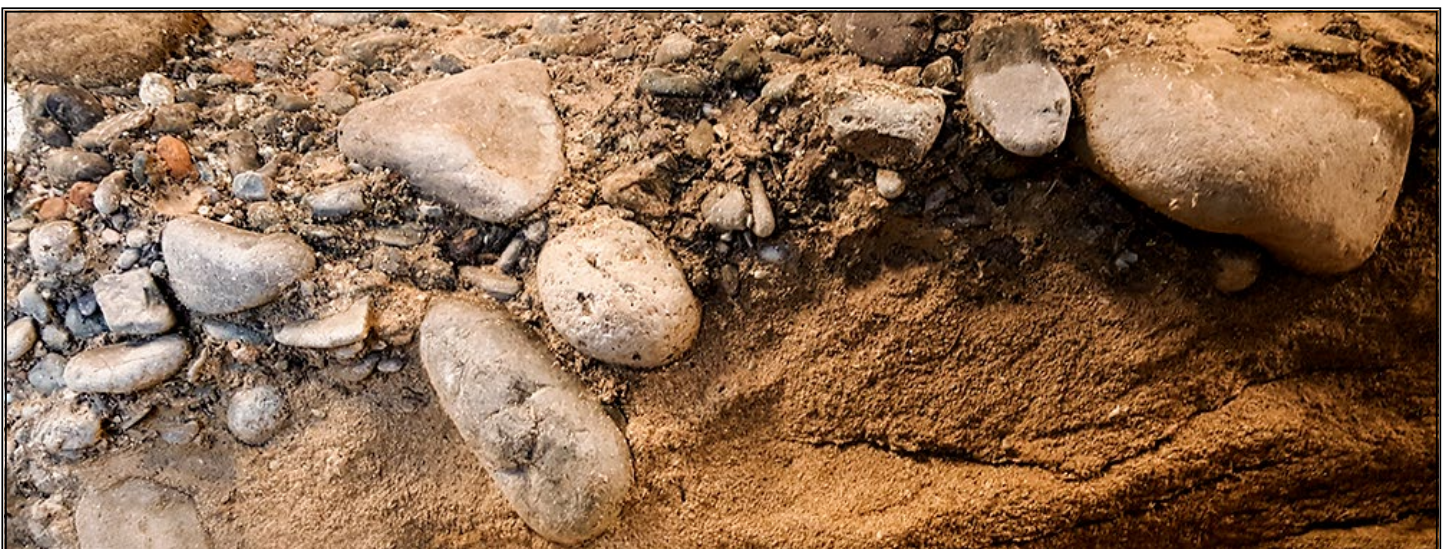
Cross section of large chunk of embedded gravel. Note the layers of small gravel (top), a layer of gravel, and a thick layer of sand and fines. Collected from a section of Lower Putah Creek in an area that is plagued by embedded and cemented gravel.

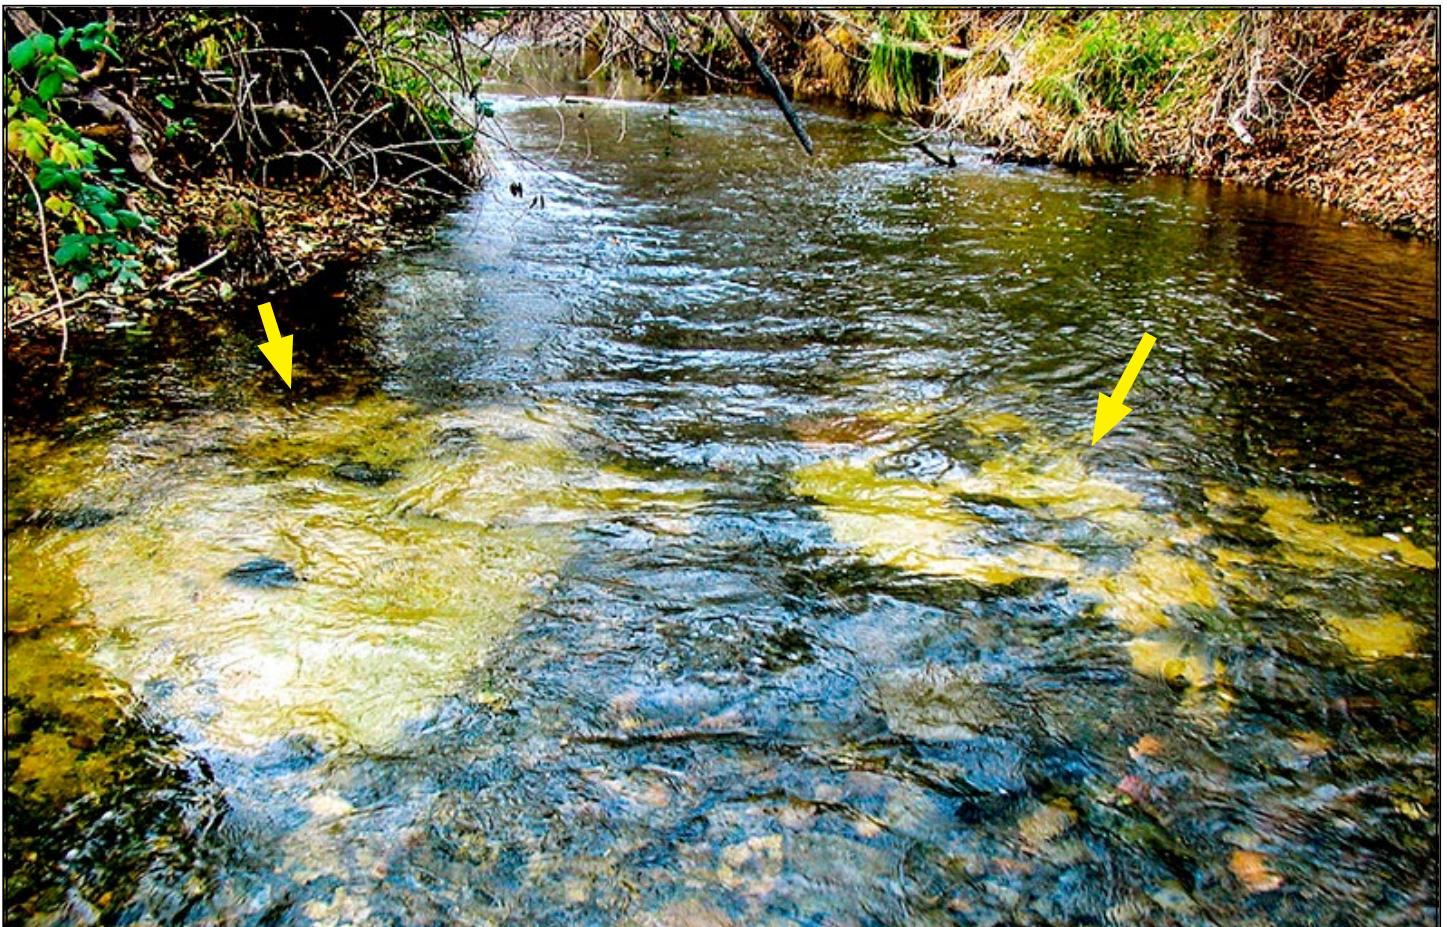
Failed 2004 salmon spawning site near Yolo Housing. Salmon moved a single layer of cobble and gravel exposing a thick layer of claypan. Salmon eggs were rolling downstream unprotected. Redds noted with yellow arrows.

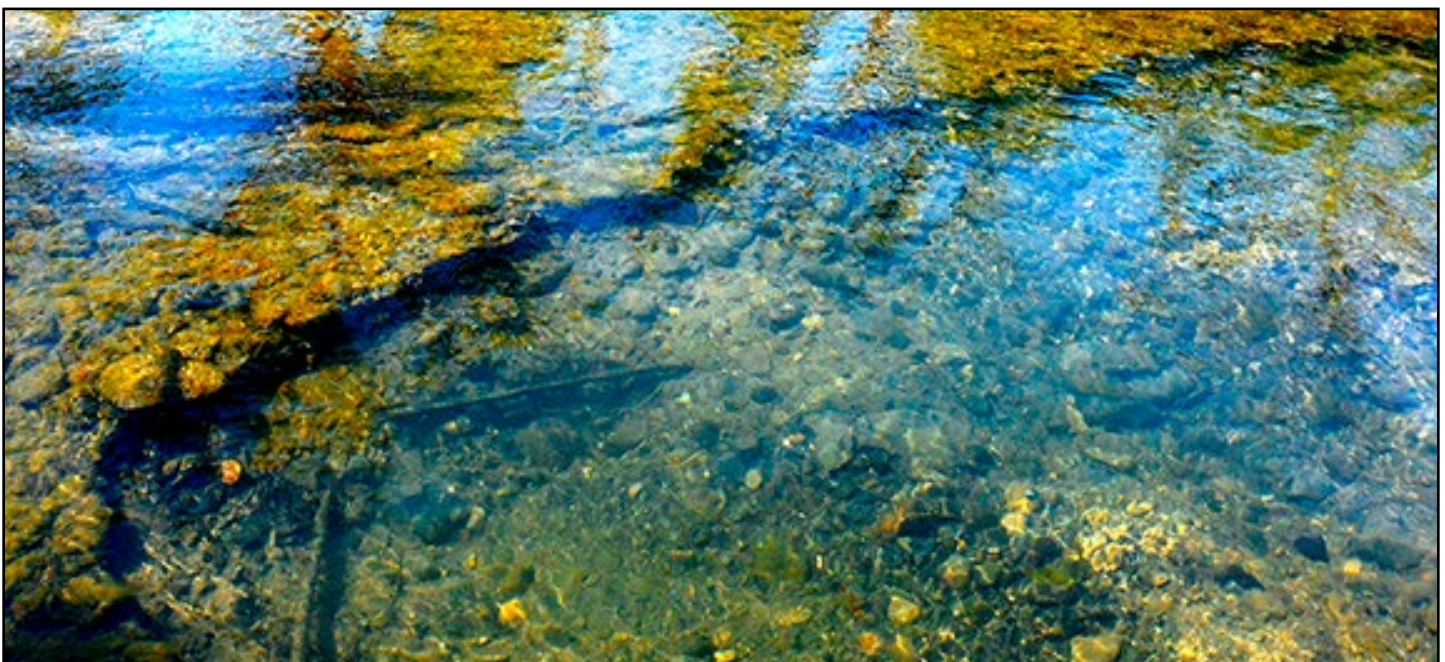
Scarification demonstration site in 2014. Image shows line of embedded cobble that was opened by a medium-reach excavator operating from the bank. Image Ken W. Davis.

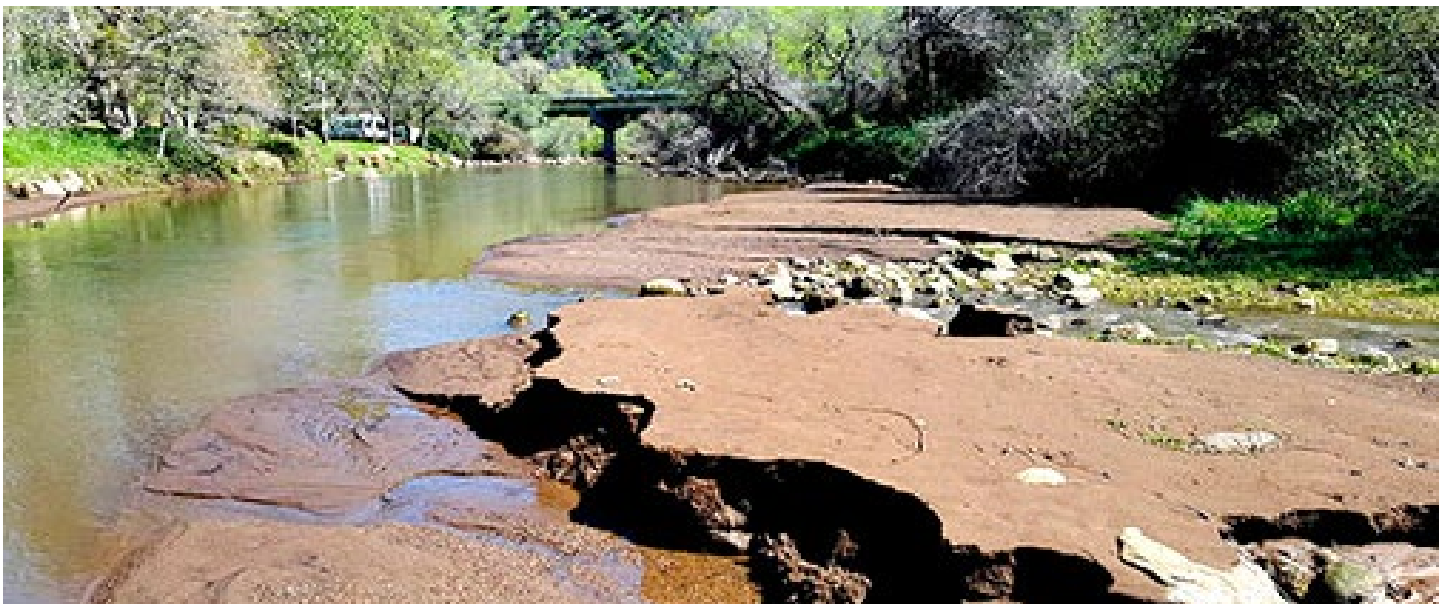
3-15-2016 image: Sediment and wildfire dregs from the Wragg fire near Lake Berryessa. In some areas, the sediment bank was 6 feet deep. Image Ken W. Davis.

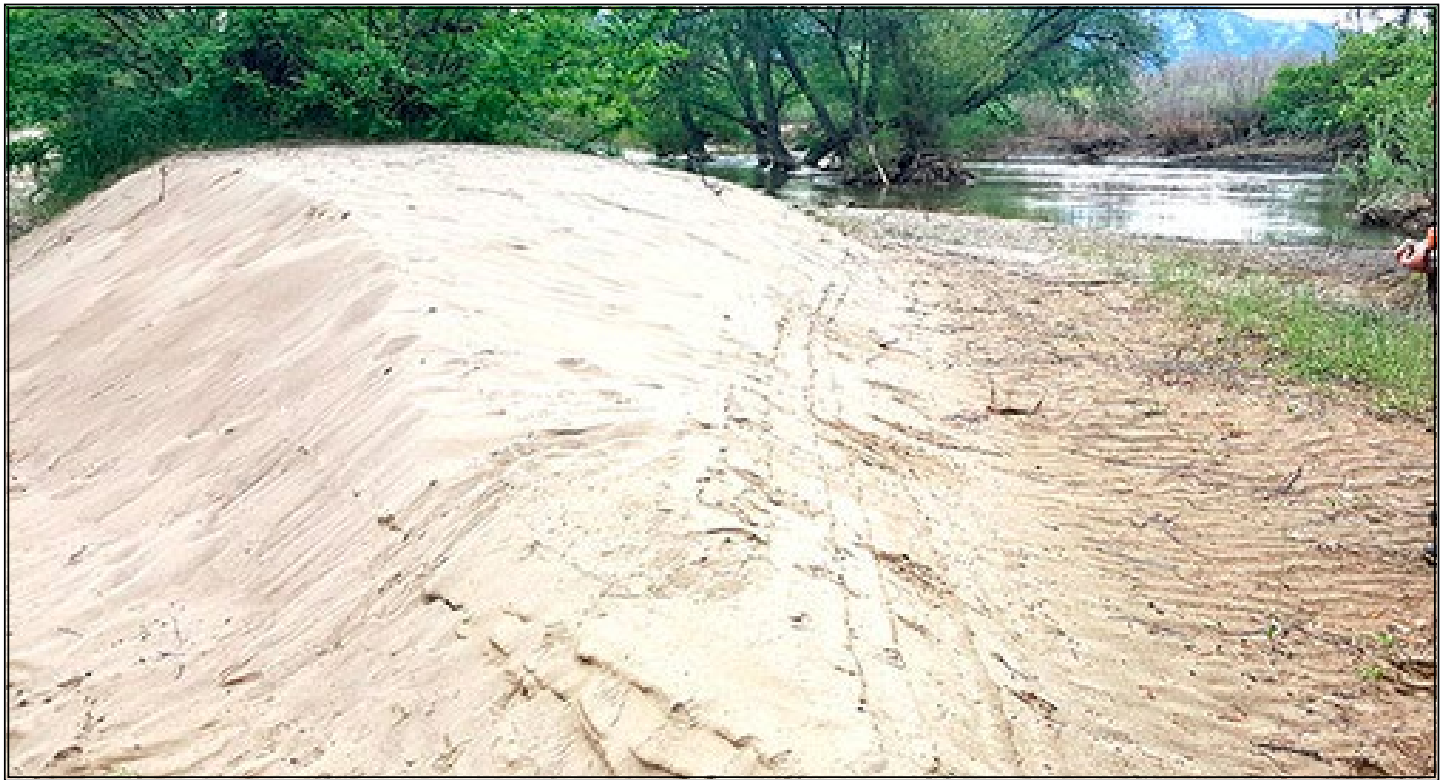
April 5, 2017 Lower Putah Creek image: Sand and sediment left by a high water event in Putah Creek. Site at a former scarification site about one-quarter mile downstream from the Putah Diversion Dam. Sand was approximately 6 feet deep. Image Ken W. Davis.

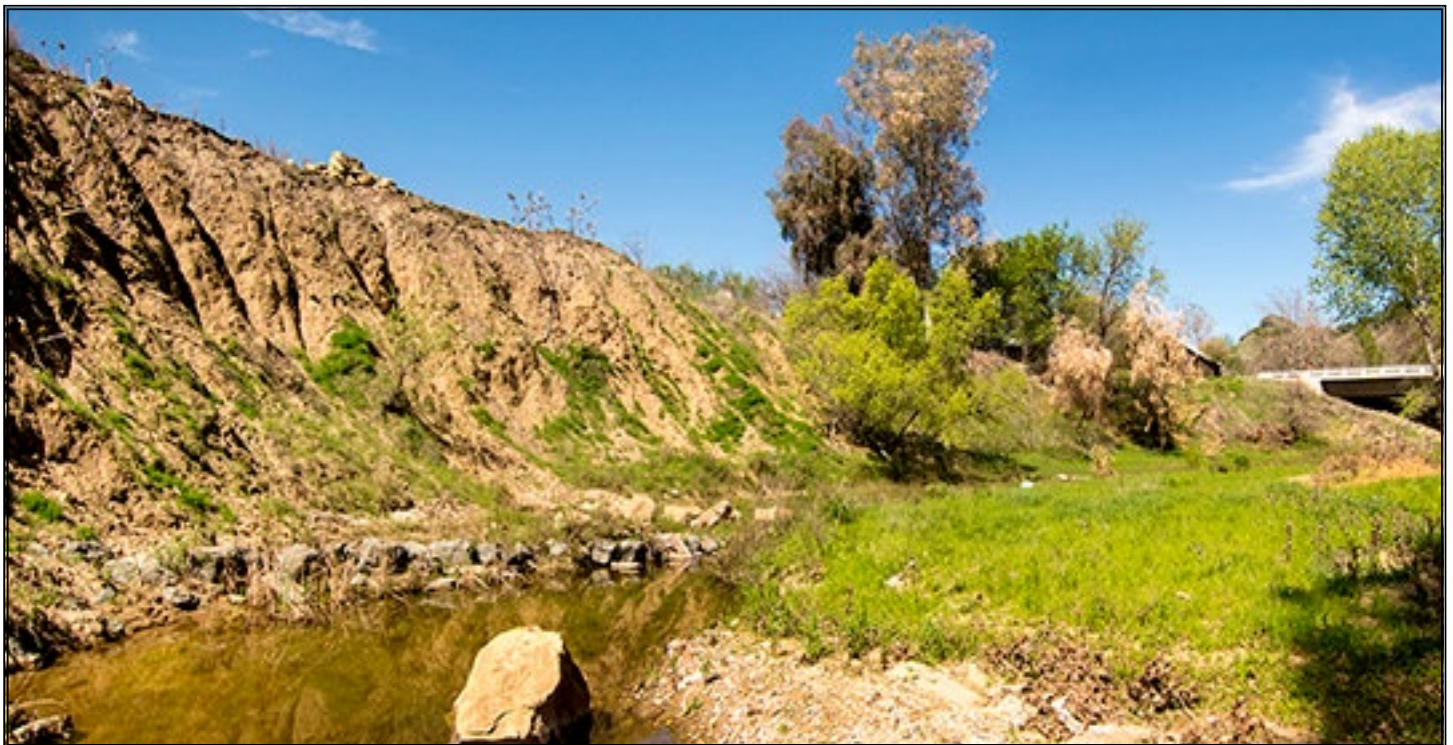
Pleasant Creek. Shows incised bank which characterizes much of the waterway. Current projects are attempting to remedy the situation.

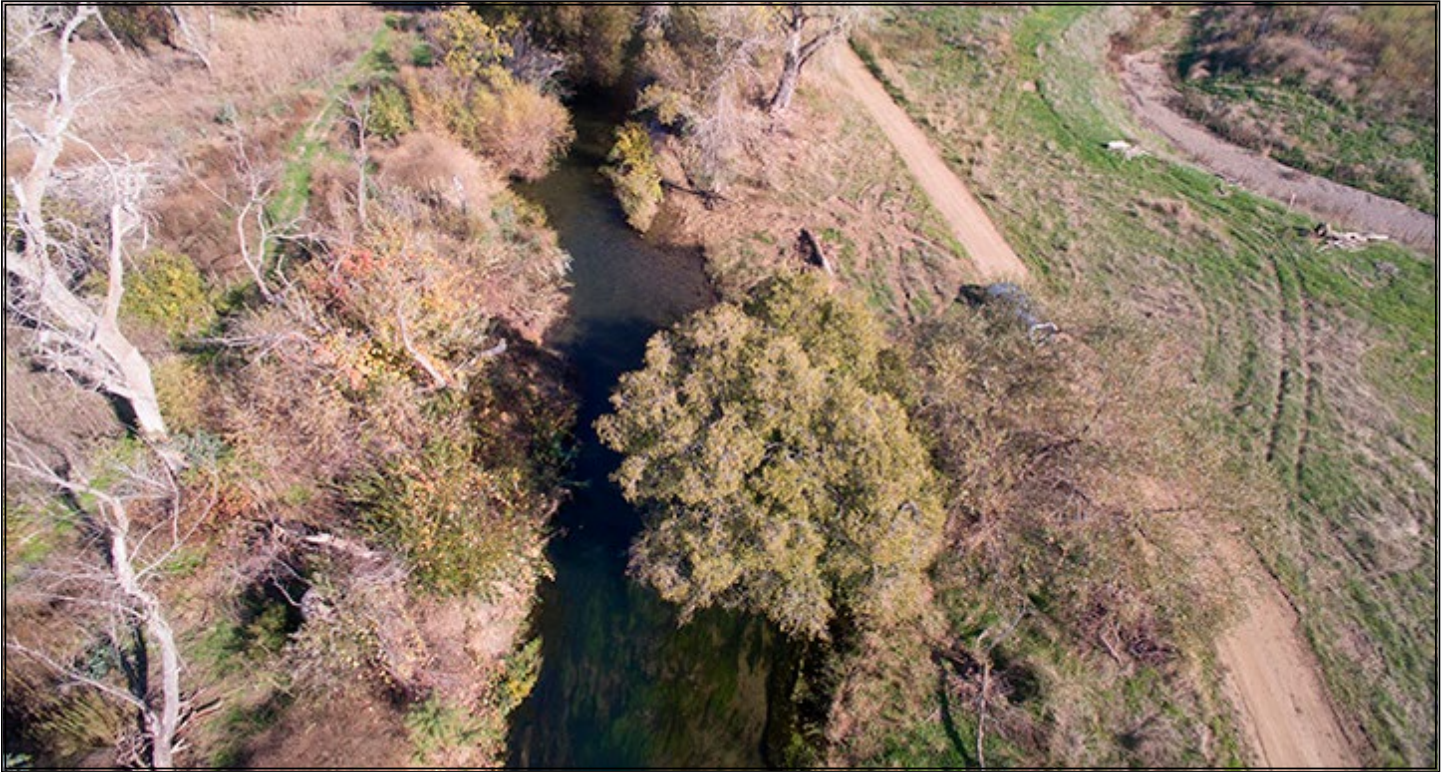
11-18-2016. Aerial image of the Morales site prior to scarification. Site was primarily wide, slow and not used by spawning salmon. Image Ken W. Davis.

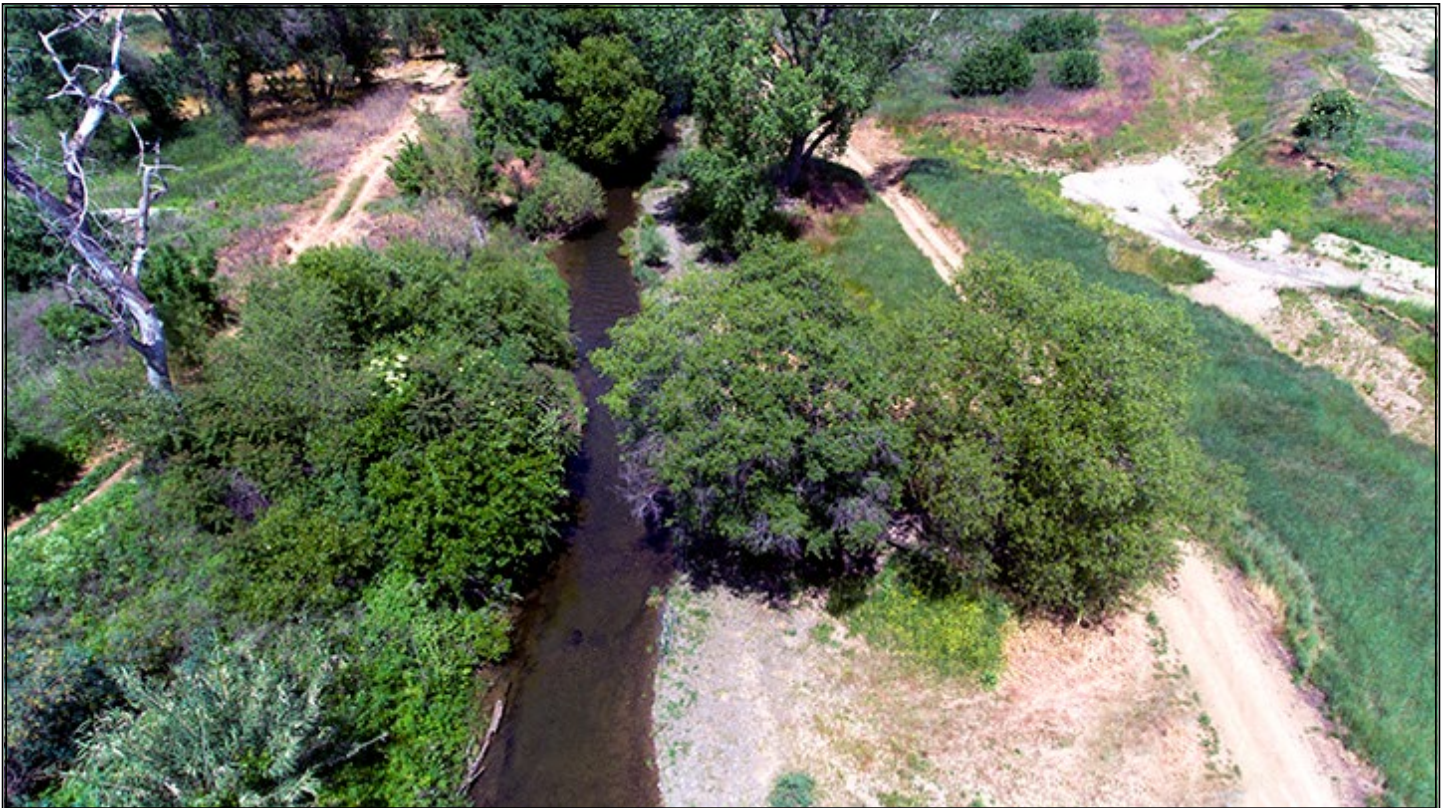
5-1-2018 image of the Morales Scarification Site after high water event. Image will be repeated in 2020. Note the sand deposited near the creek bed and in the in Mc Cune Creek on the right side of the picture. Image Ken W. Davis.

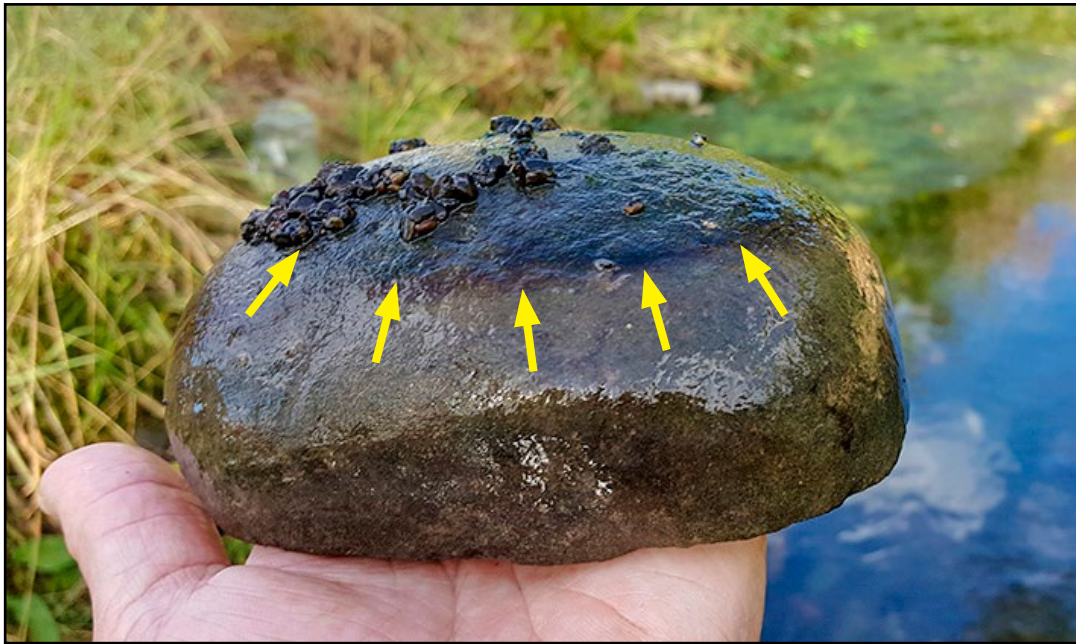
Shows a cobble that was approximately 80% embedded. The clean area was buried. Algae and caddisfly (*Glossosoma*) larval cases cover the top of the rock.

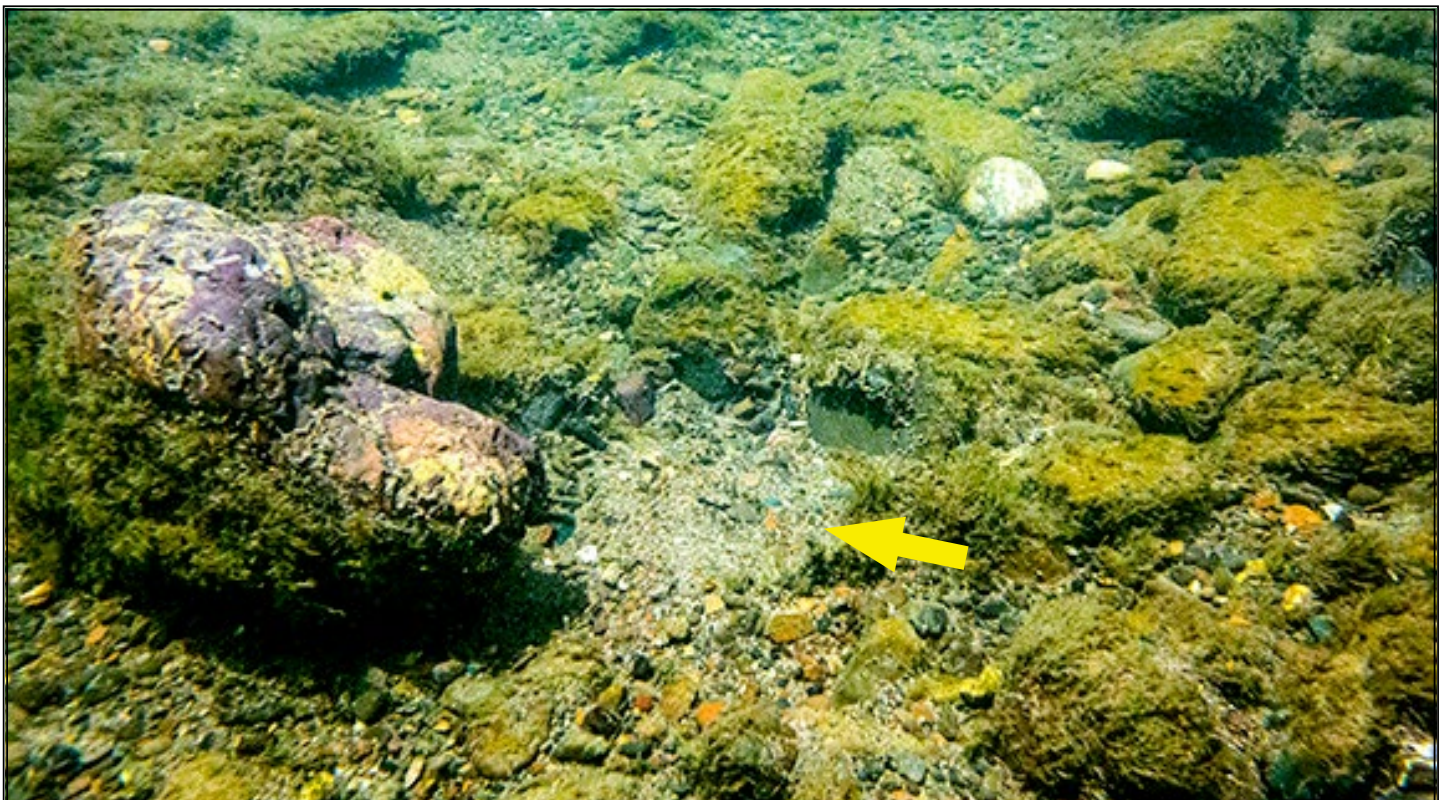
Shows a section of non-scarified creek bed at the Parker Study area The arrow points to a foot print of a surface cobble that was removed. All material below and around the cobble footprint are severely embedded. Ken W. Davis image.

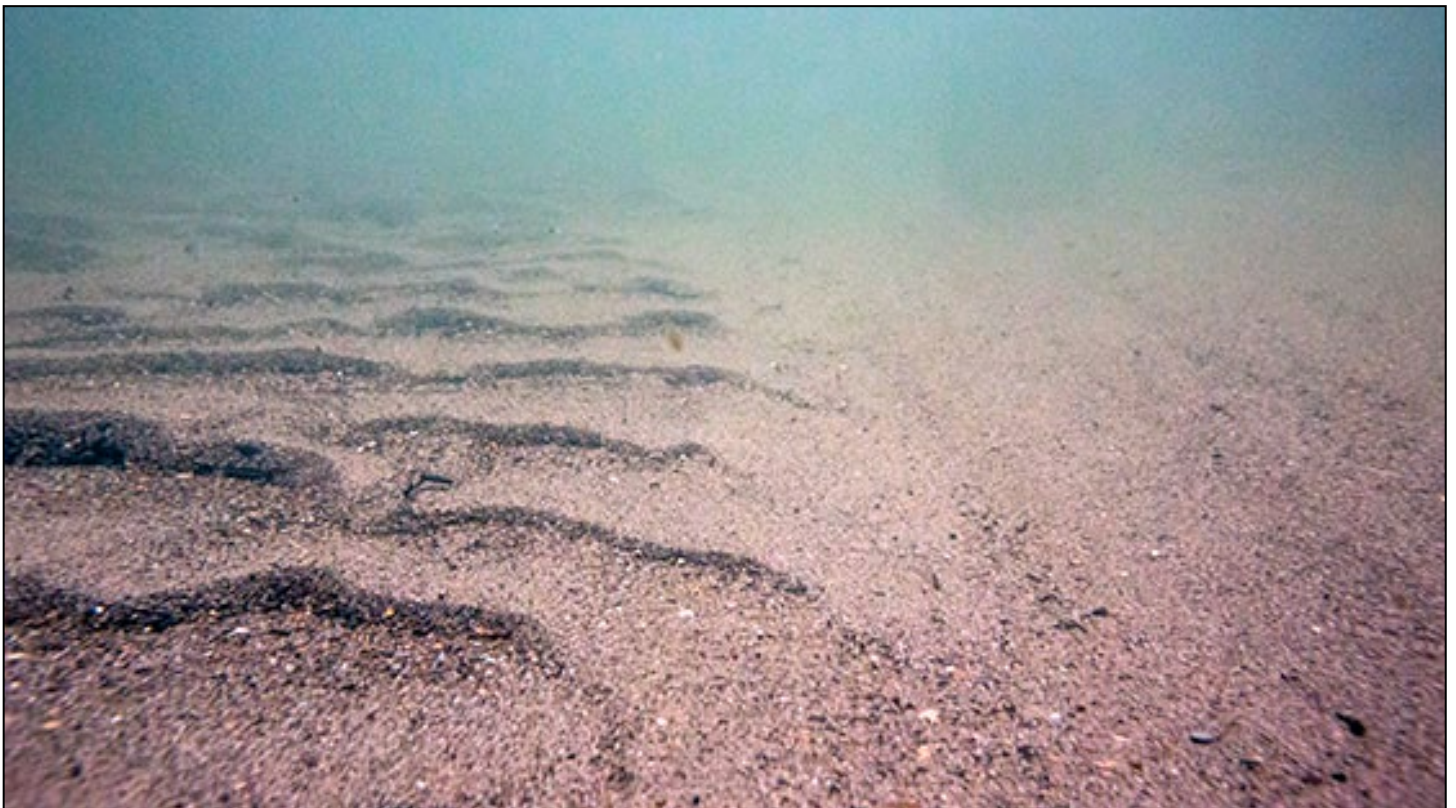
Image taken in 2018 after the 2017 floods: Sand deposited by flood waters over the Cody - Control site. Image Ken W. Davis

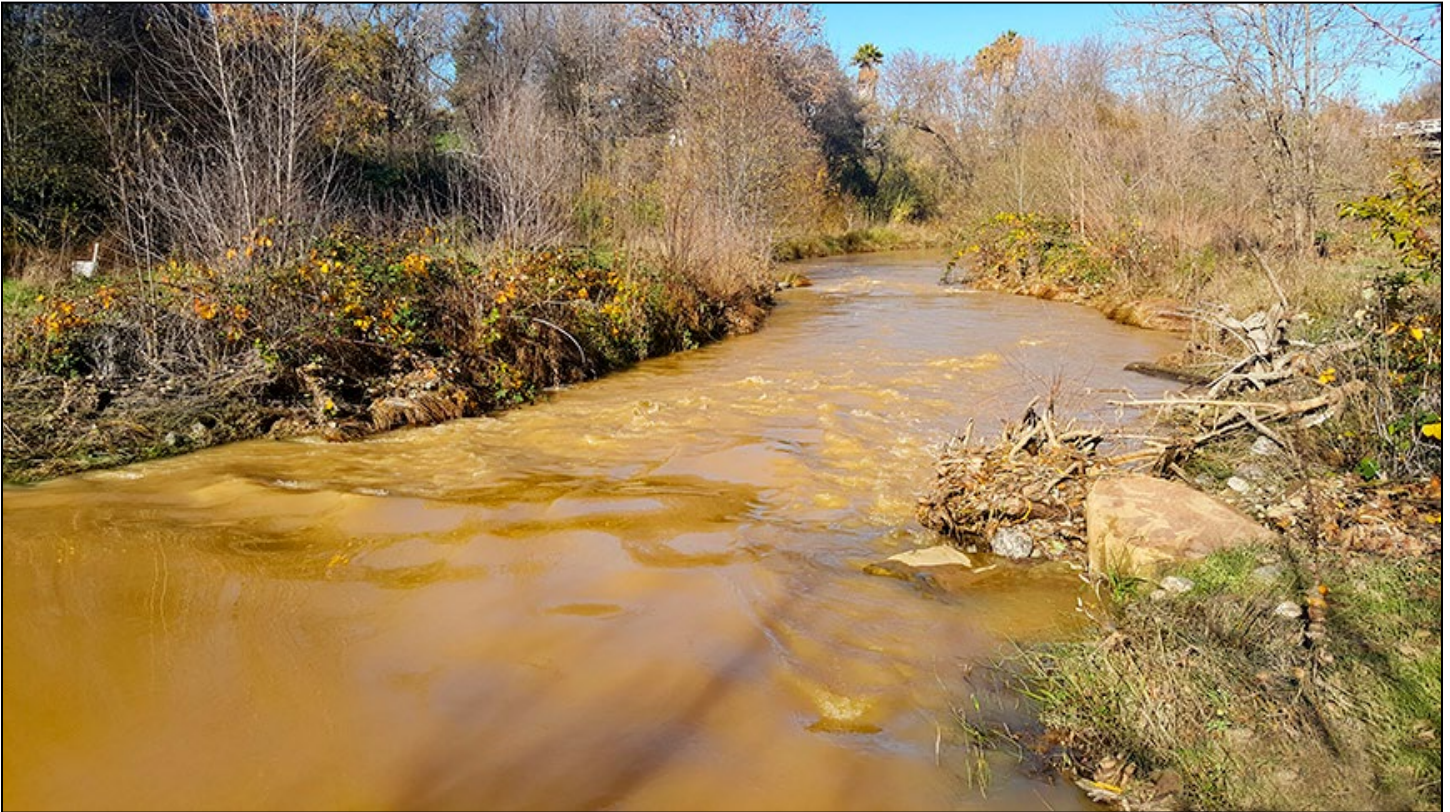
2016 image of post-storm turbidity near the Winters Car Bridge. Ken W. Davis image.
