- Same-Day Reports
- Post Repair Inspections
- 90-Day Home Warranty

## Property Inspection Report

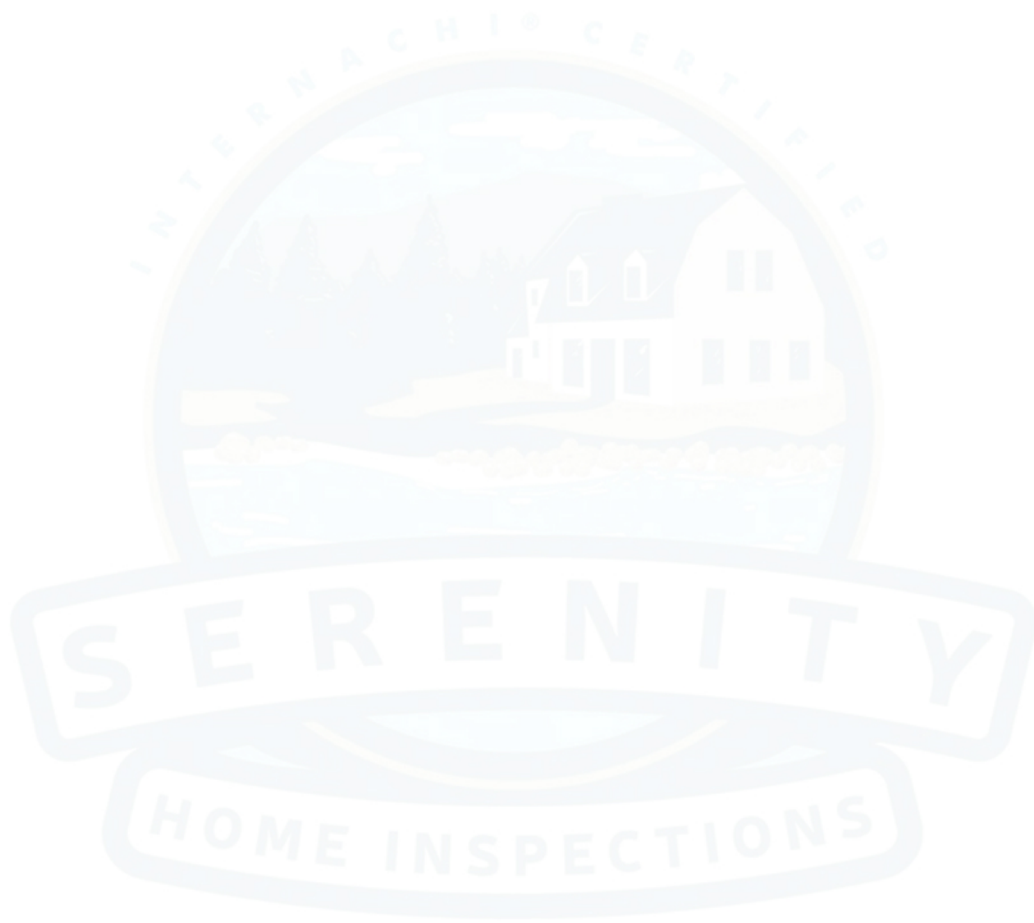
Did you know you can get free warranty protection with your home inspection??? Serenity Home Inspections believes in protection with the inspection, and via a third-party warranty company we provide [complimentary warranty coverage for our customers](#).

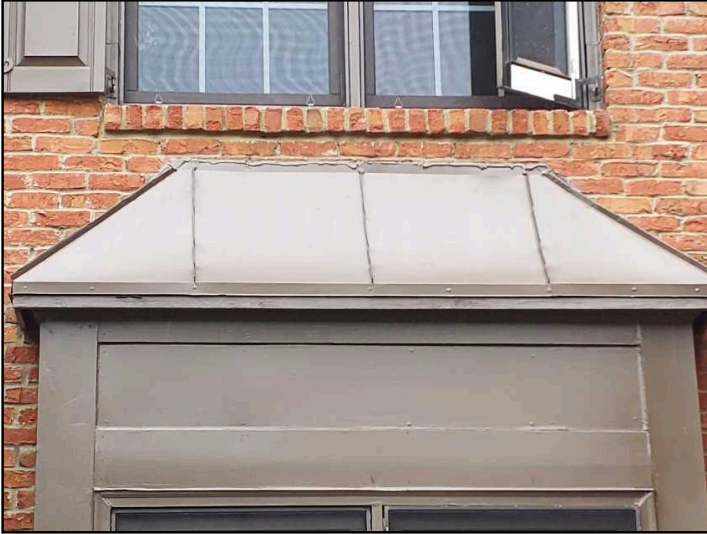
1.2. Remove wood debris on roof above garage door and install proper flashing if needed

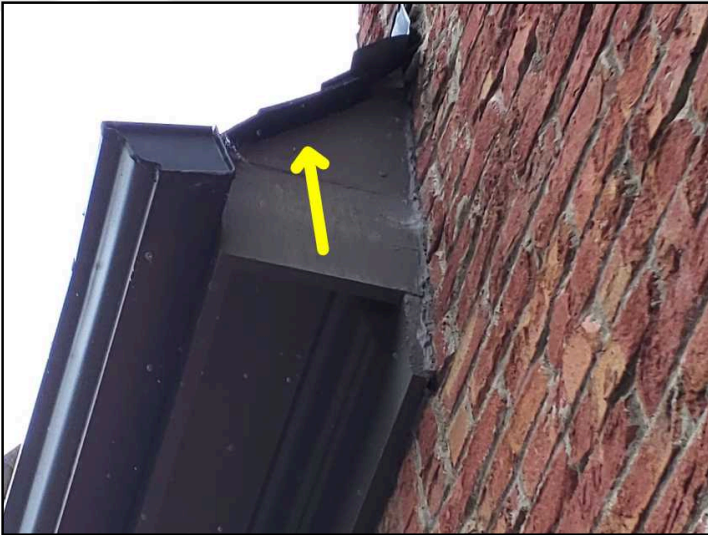
There is no drip edge flashing present where the roof shingles end to cover the connection at the lateral rake boards.

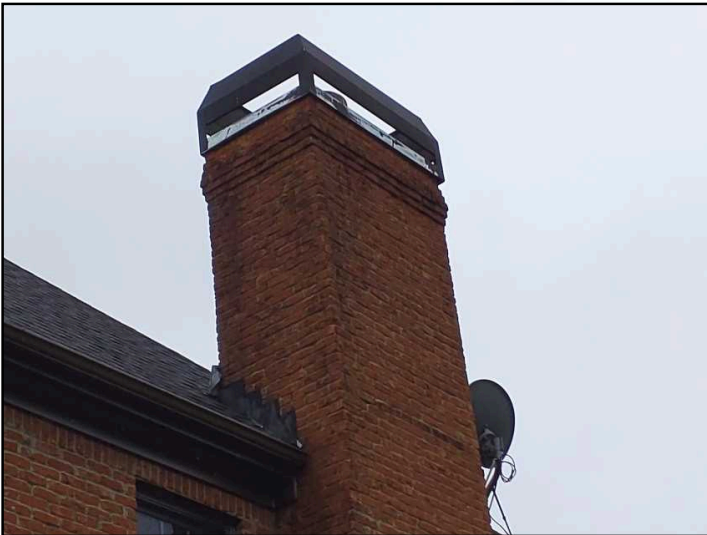
Horizontal and step cracking observed at exterior portion of chimney in brick veneer on right side of home near connection to gutter. Recommend further evaluation by qualified contractor to ensure structure of Chimney is not leaning or compromised and repair brick to prevent water intrusion

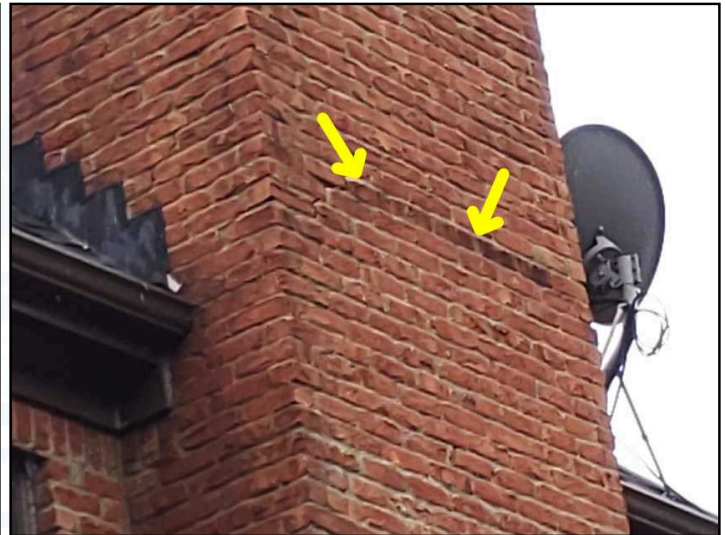
Horizontal and step cracking observed at exterior portion of chimney in brick veneer on right side of home near connection to gutter. Recommend further evaluation by qualified contractor to ensure structure of Chimney is not leaning or compromised and repair brick to prevent water intrusion

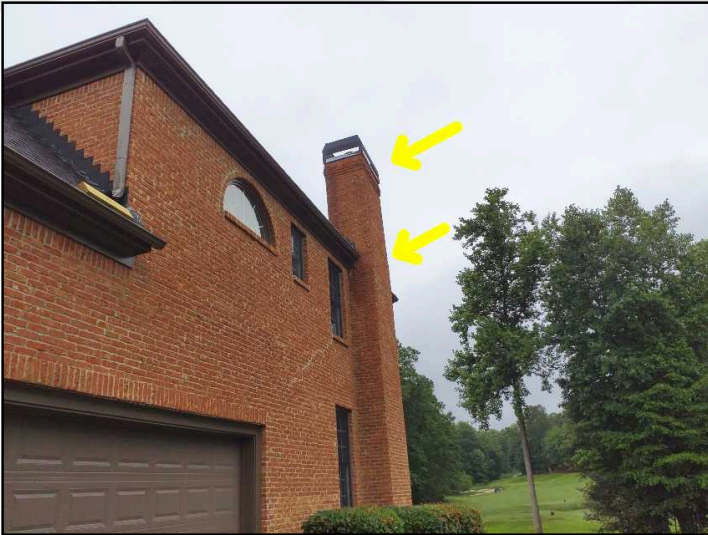
Horizontal and step cracking observed at exterior portion of chimney in brick veneer on right side of home near connection to gutter. Recommend further evaluation by qualified contractor to ensure structure of Chimney is not leaning or compromised and repair brick to prevent water intrusion

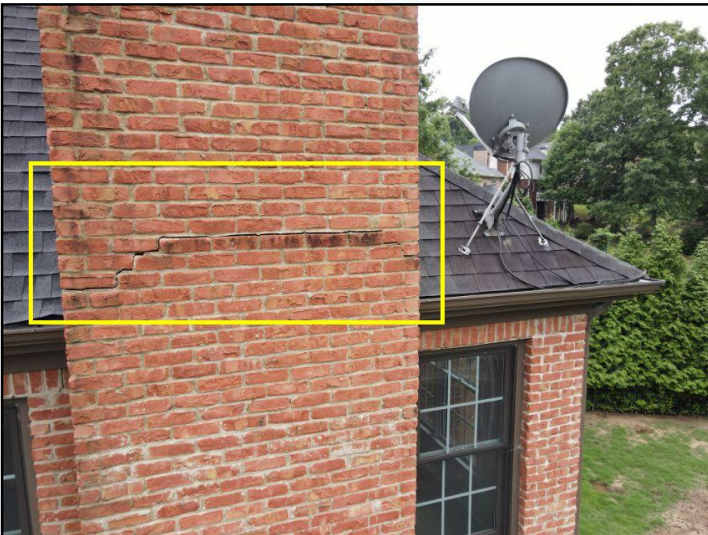
The chimney is leaning towards the home above the roof line. Horizontal cracks are noted in the siding at the roof line. Have a qualified contractor or structural engineer examine the chimney and determine if repairs are needed to correct the movement or stabilize it in its current condition and seal any cracks in the siding.

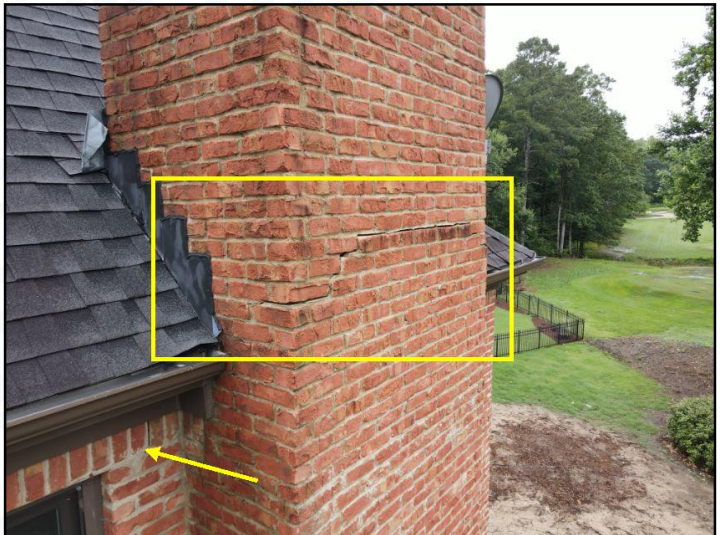
The chimney is leaning towards the home above the roof line. Horizontal cracks are noted in the siding at the roof line. Have a qualified contractor or structural engineer examine the chimney and determine if repairs are needed to correct the movement or stabilize it in its current condition and seal any cracks in the siding.

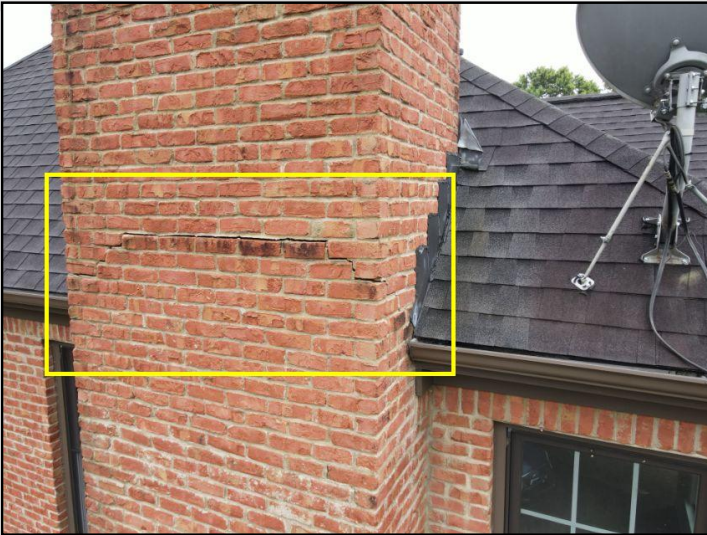
The chimney is leaning towards the home above the roof line. Horizontal cracks are noted in the siding at the roof line. Have a qualified contractor or structural engineer examine the chimney and determine if repairs are needed to correct the movement or stabilize it in its current condition and seal any cracks in the siding.

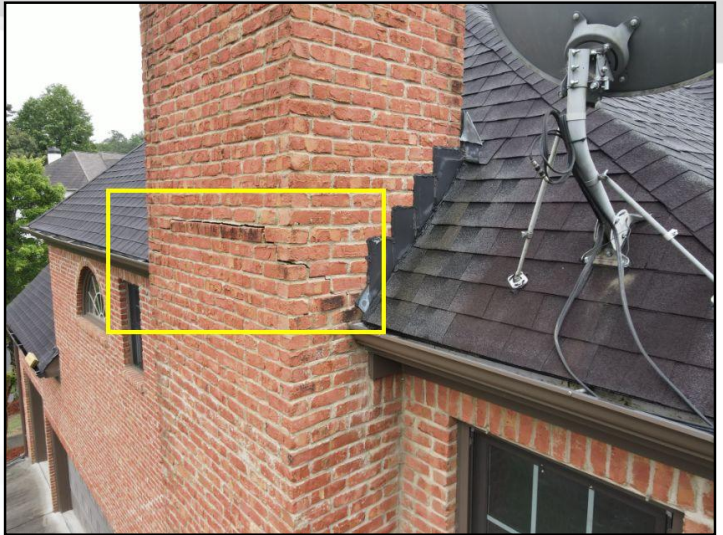
The chimney is leaning towards the home above the roof line. Horizontal cracks are noted in the siding at the roof line. Have a qualified contractor or structural engineer examine the chimney and determine if repairs are needed to correct the movement or stabilize it in its current condition and seal any cracks in the siding.

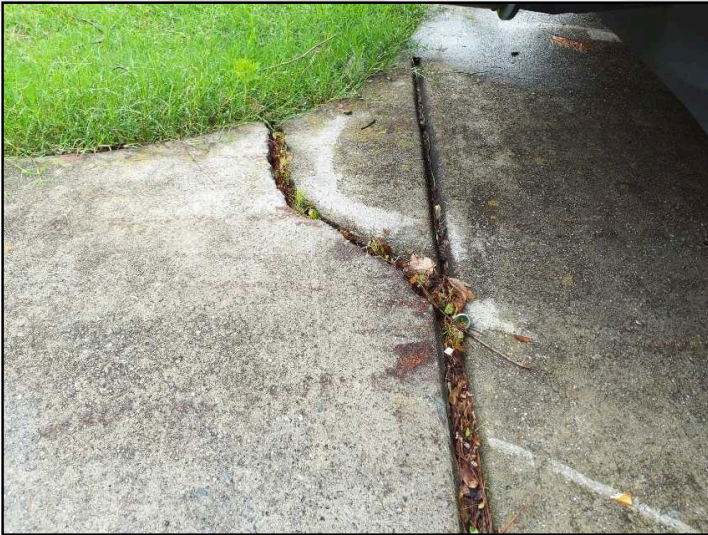
Settlement and uneven cracks noted in the exterior concrete surfaces. The cracks may present a trip hazard and should be leveled and repaired as needed.

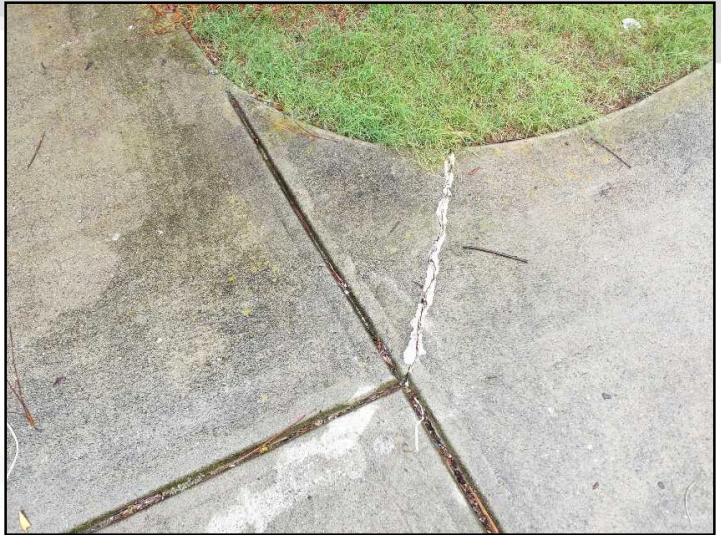
Typical cracking noted in driveway

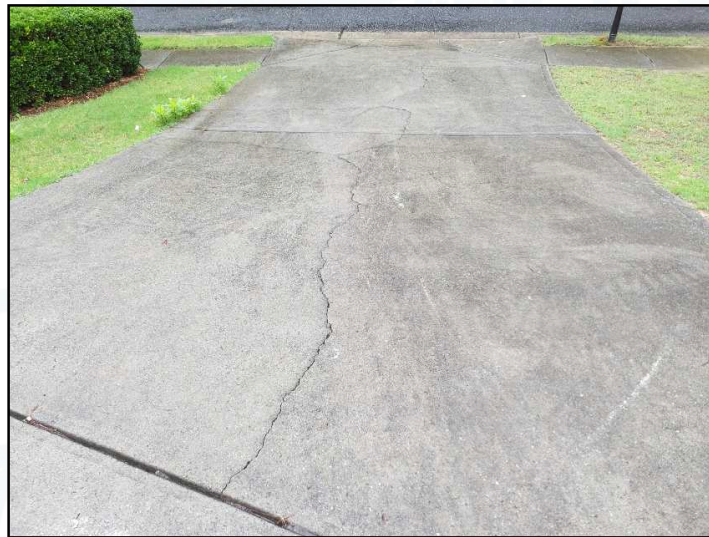
Typical cracking noted in driveway

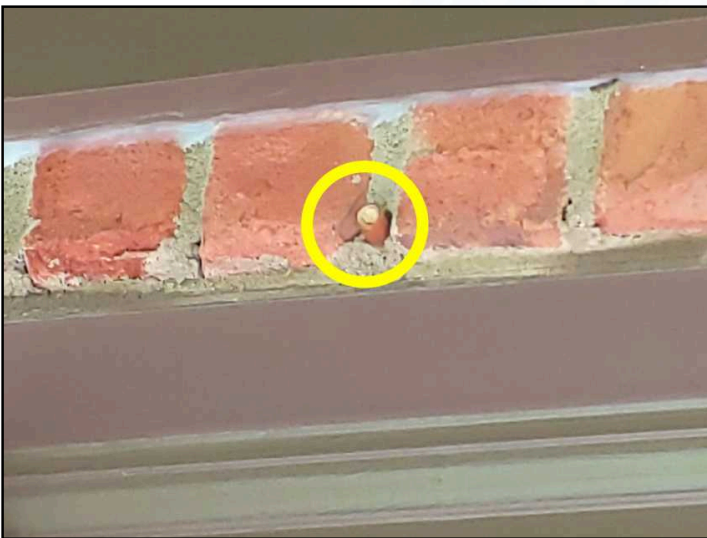
Drainage weep channels in exterior brick are clogged sporadic around home.

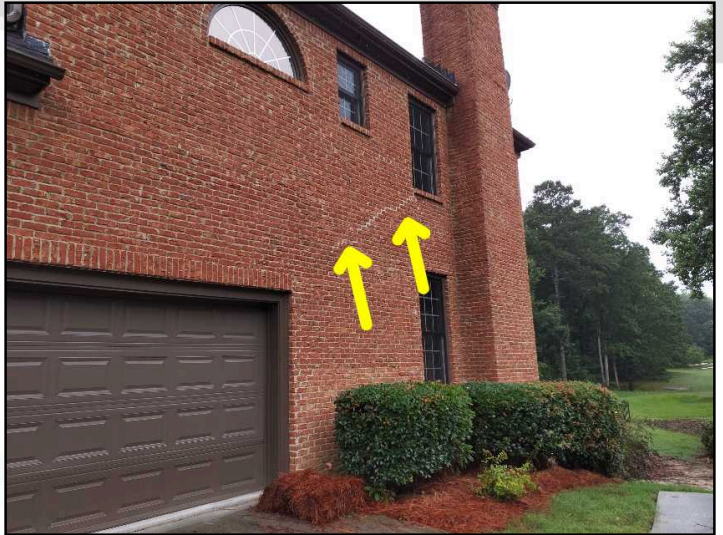
A large step crack at the right exterior brick veneer has been sealed. Inquire with seller for any available documentation on repair, continue monitoring and seek further evaluation by Brick Mason as desired

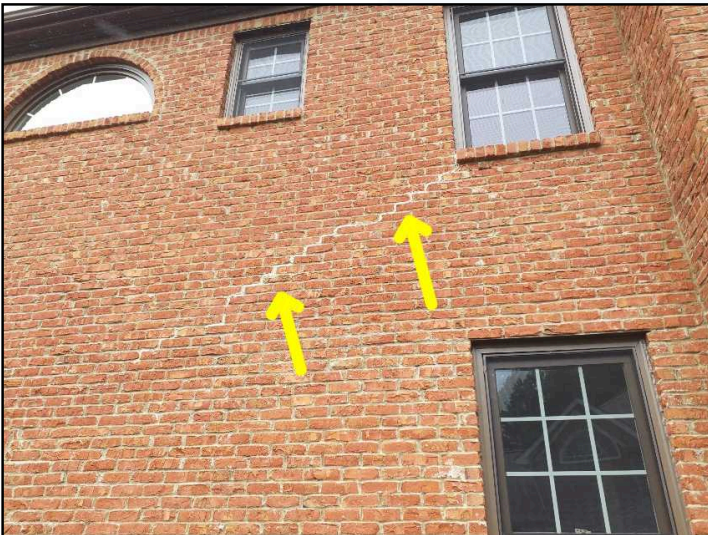
A large step crack at the right exterior brick veneer has been sealed. Inquire with seller for any available documentation on repair, continue monitoring and seek further evaluation by Brick Mason as desired

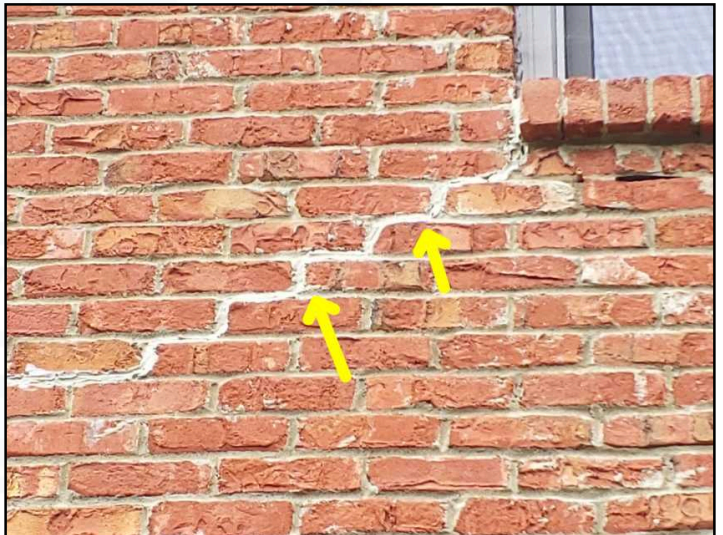
A large step crack at the right exterior brick veneer has been sealed. Inquire with seller for any available documentation on repair, continue monitoring and seek further evaluation by Brick Mason as desired

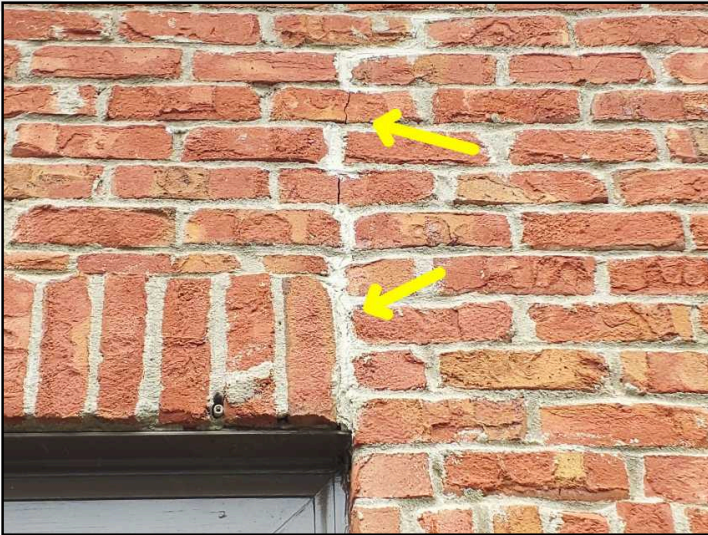
A vertical crack at the right exterior brick veneer above the garage has been sealed. Inquire with seller for any available documentation on repair, continue monitoring and seek further evaluation by Brick Mason as desired

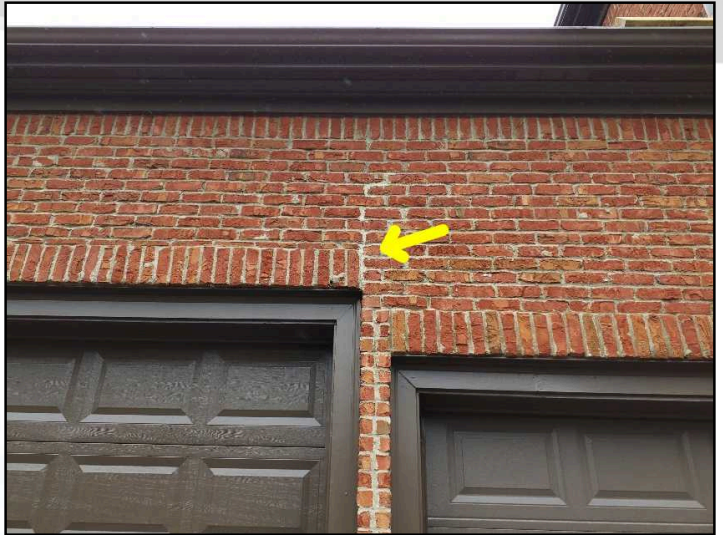
A vertical crack at the right exterior brick veneer above the garage has been sealed. Inquire with seller for any available documentation on repair, continue monitoring and seek further evaluation by Brick Mason as desired

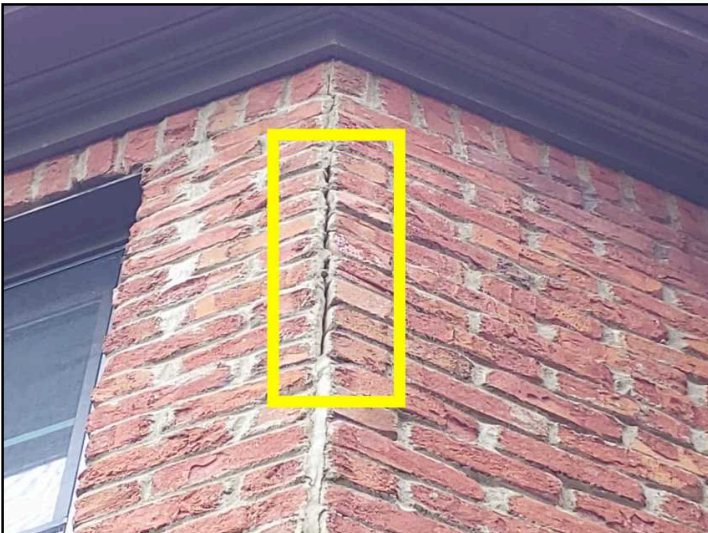
Repair crack in exterior brick veneer above deck door

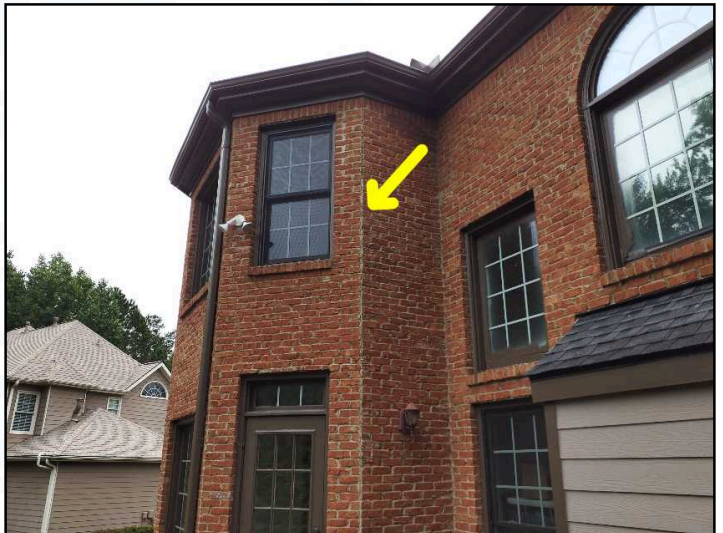
Repair crack in exterior brick veneer above deck door

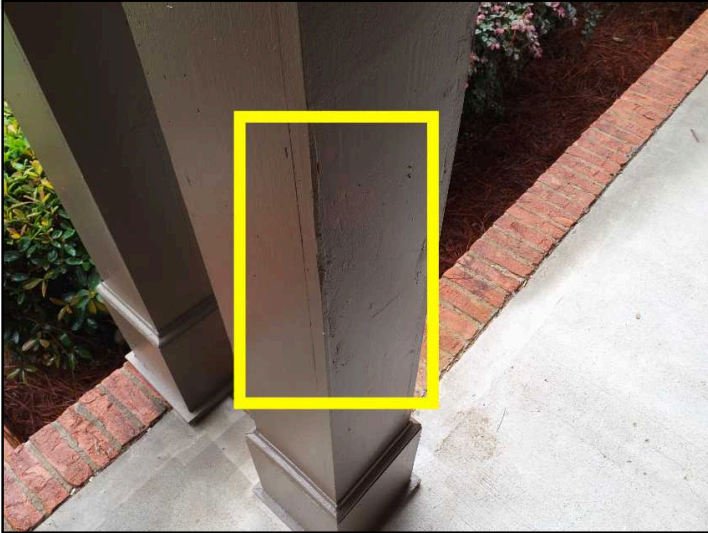
Patched water damage at exterior trim

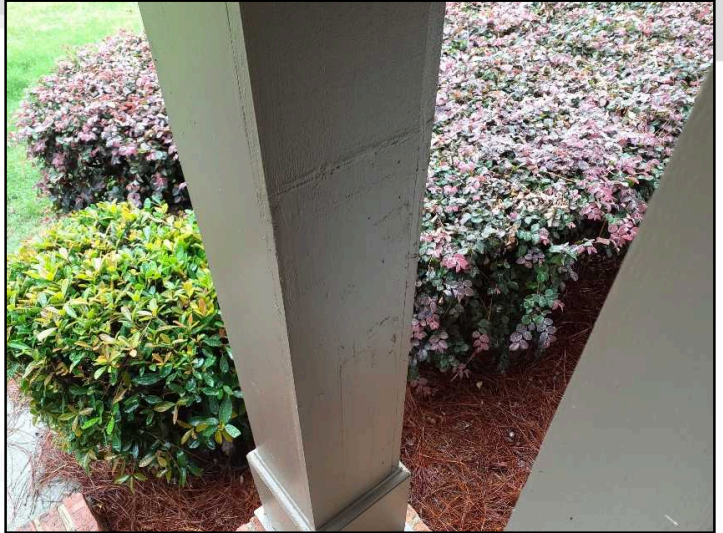
Patched water damage at exterior trim

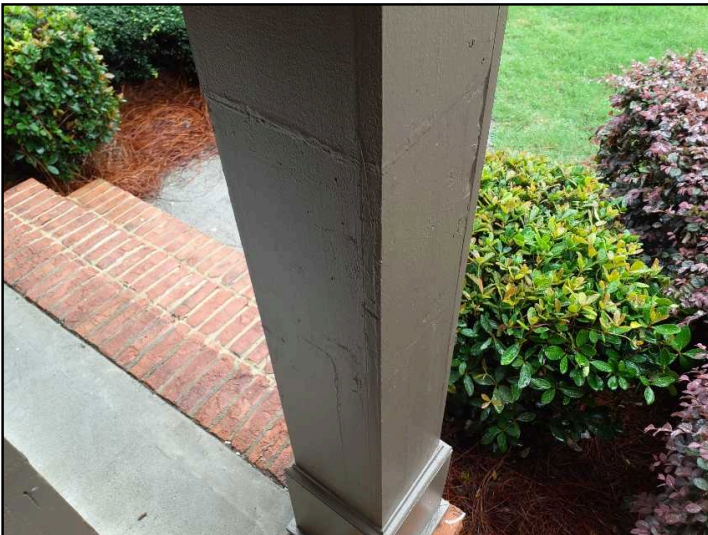
Patched water damage at exterior trim

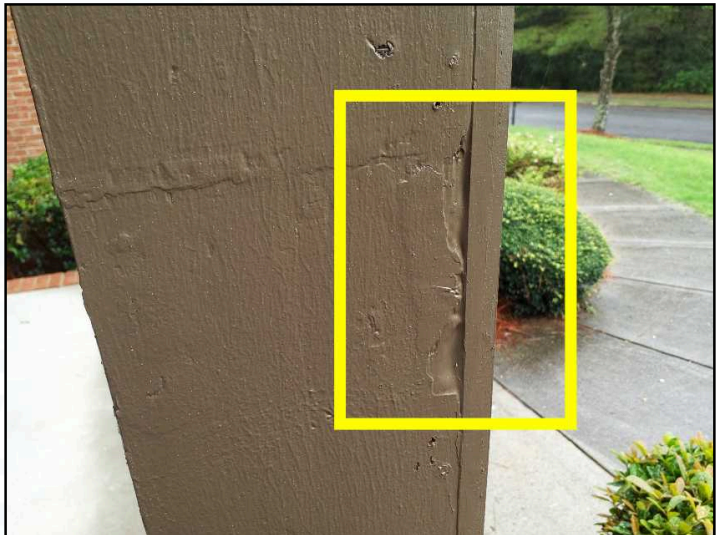
Patched water damage at exterior trim

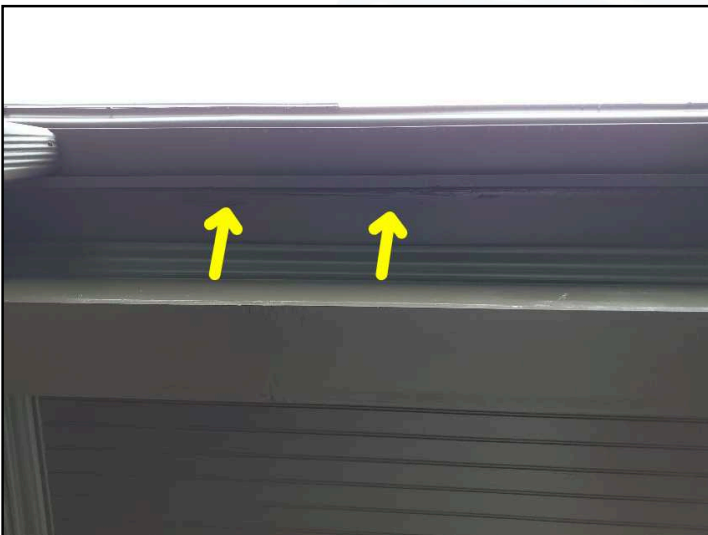
Patched water damage at exterior trim

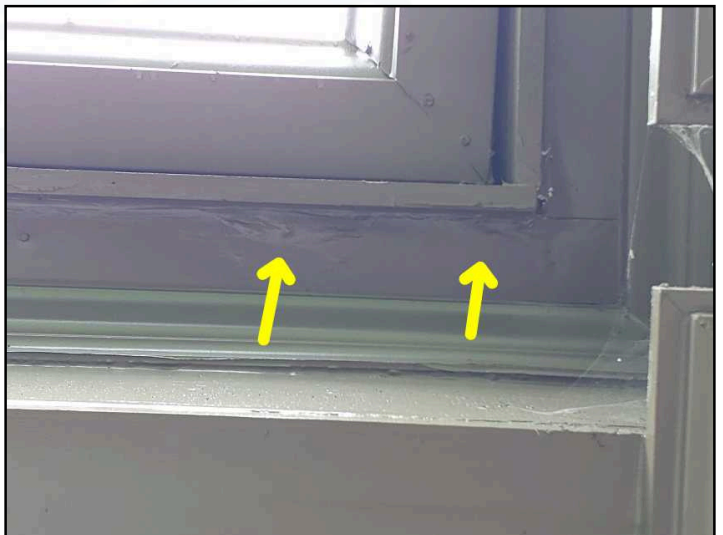
Patched water damage at exterior trim

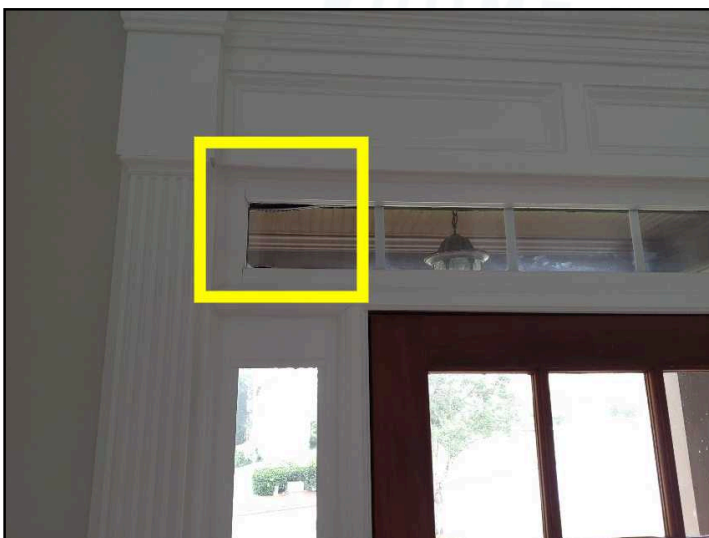
Bulging seals at window above front door

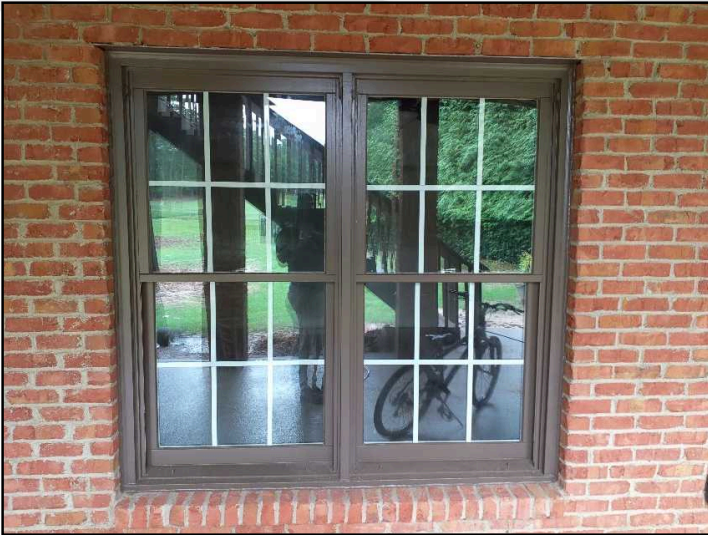
Missing window screens observed. Have screens installed for proper ventilation.

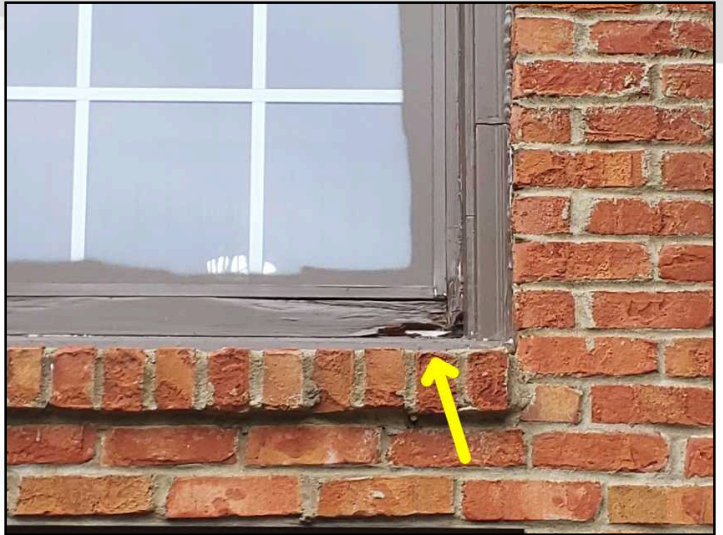
Replacement needed at extensive water damage to window frames above back deck

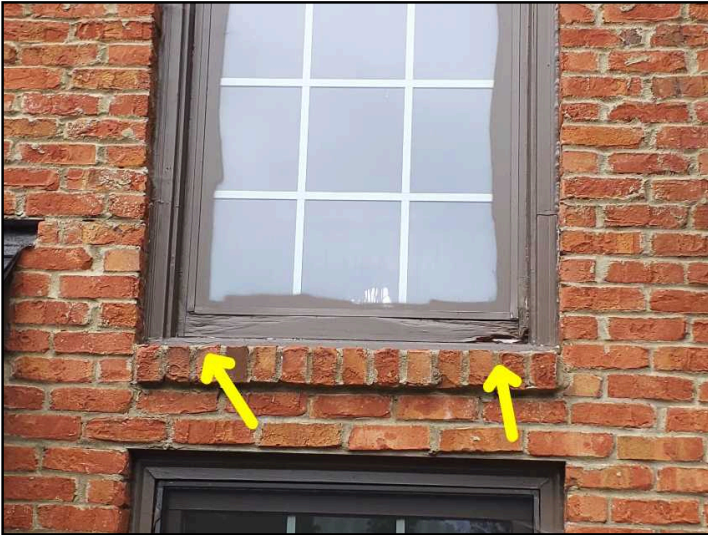
Replacement needed at extensive water damage to window frames above back deck

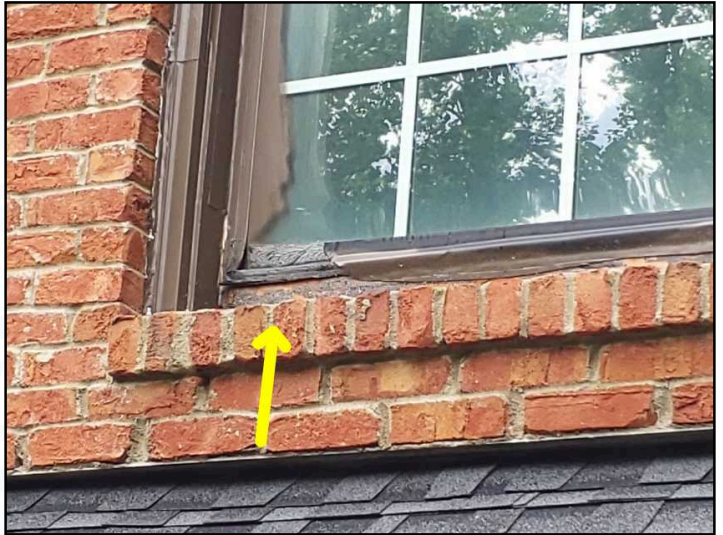
Replacement needed at extensive water damage to window frames above back deck

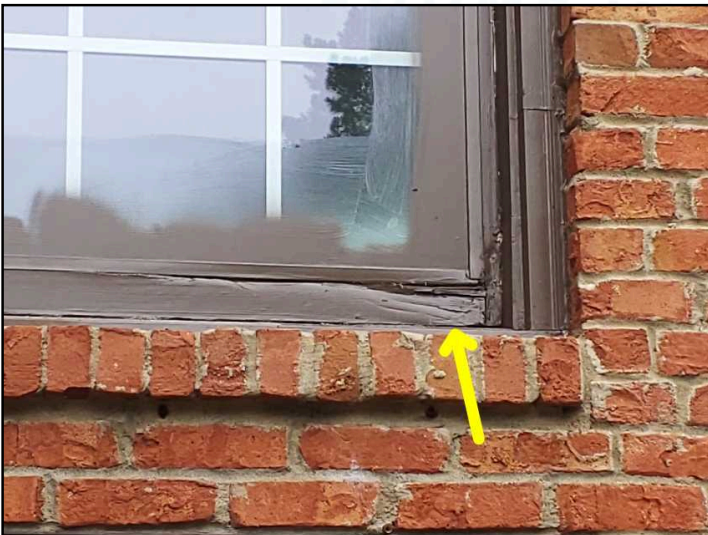
Replacement needed at extensive water damage to window frames above back deck

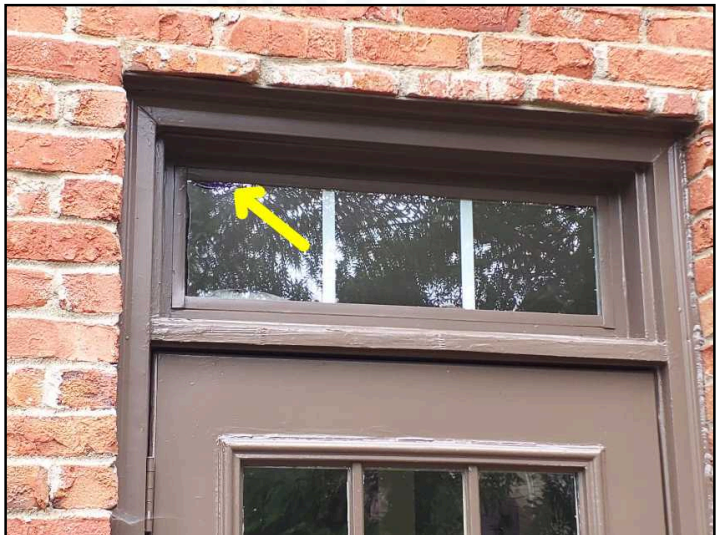
Warped/bulging seals noted at window above deck door

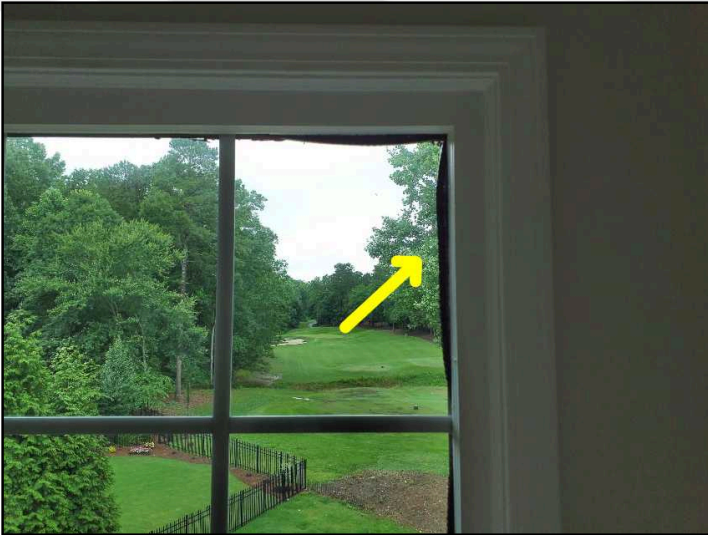
Warped/bulging seals noted at window in master bedroom

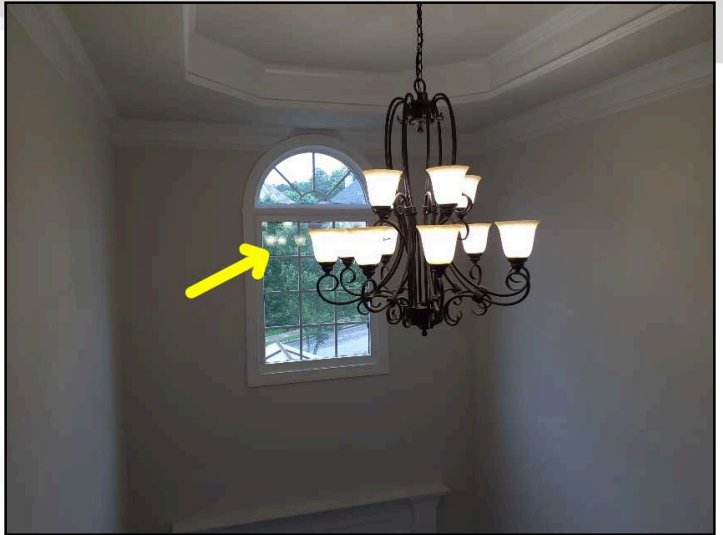
Warped/bulging seals noted at window above front door in foyer

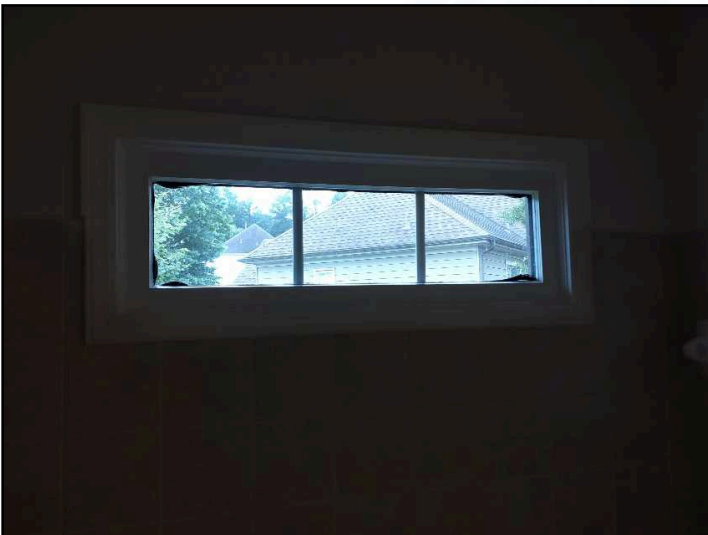
Warped/bulging seals noted at window above Jack and Jill bathtub

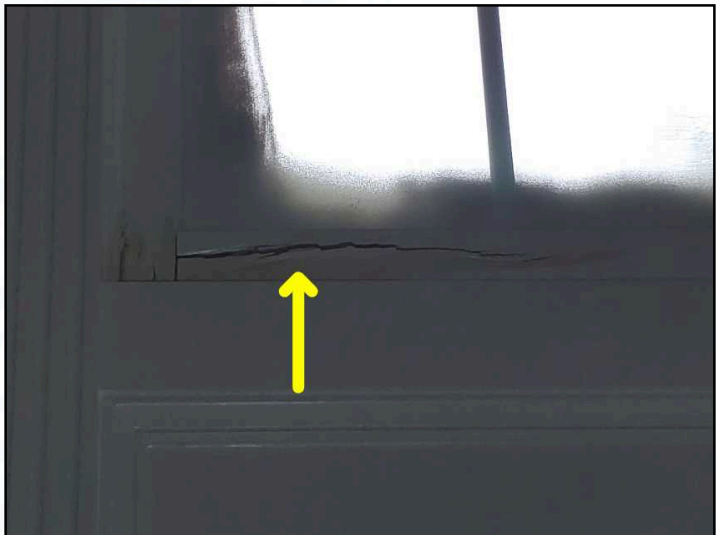
Replacement needed at extensive water damage to window frames above back deck

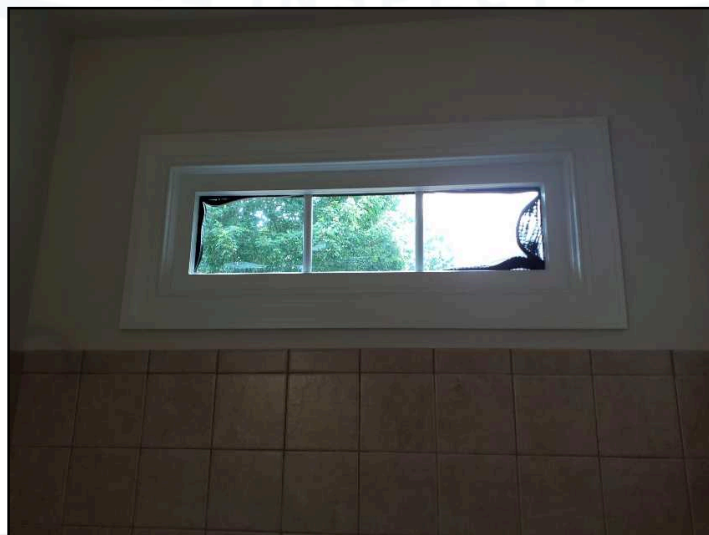
Warped/bulging seals noted at window in main level bathtub

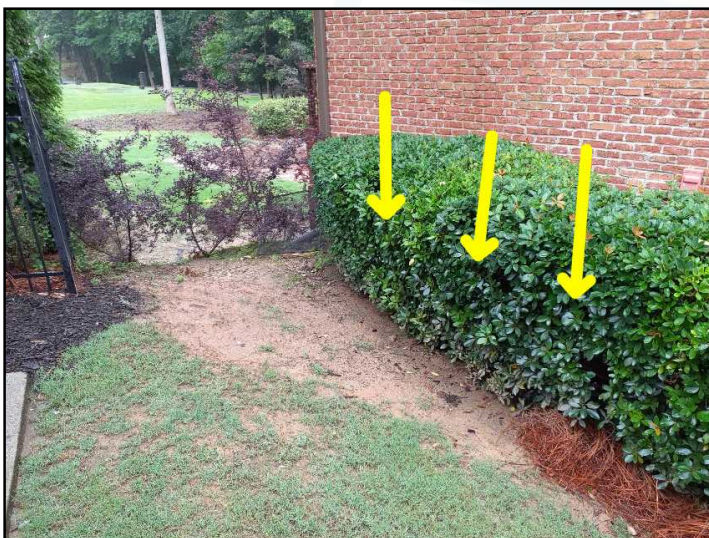
Incorrect soil slope at back left corner

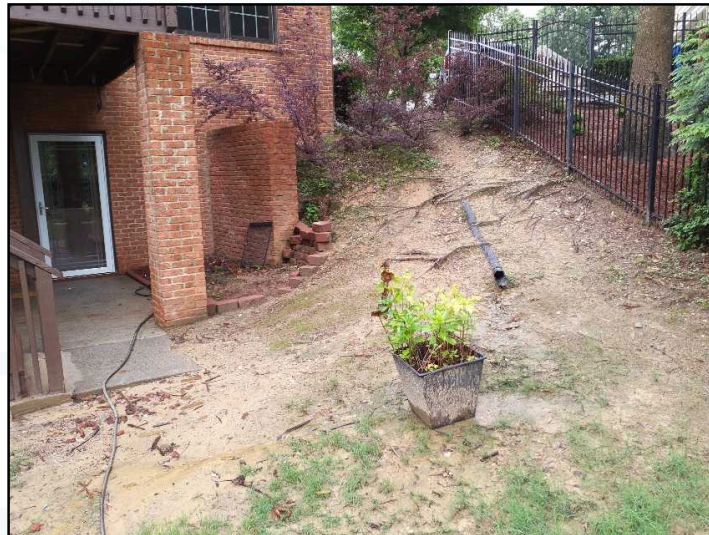
Landscaper needed for poor drainage, bare soil and erosion

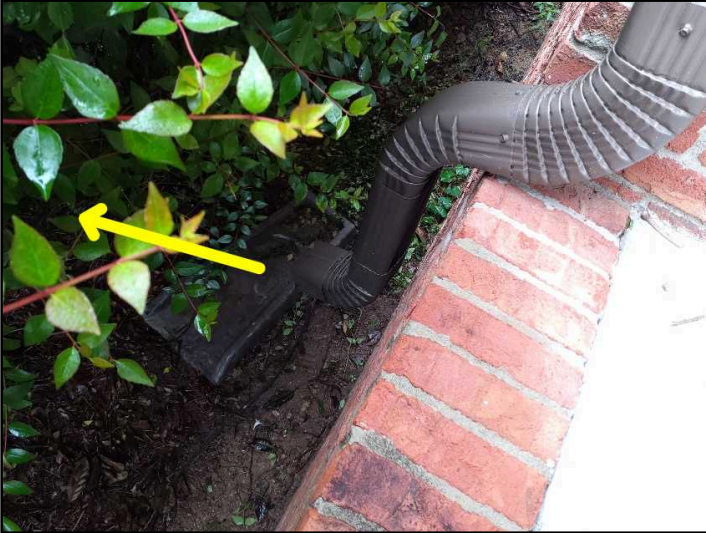
Reconnect extension to gutter down spout

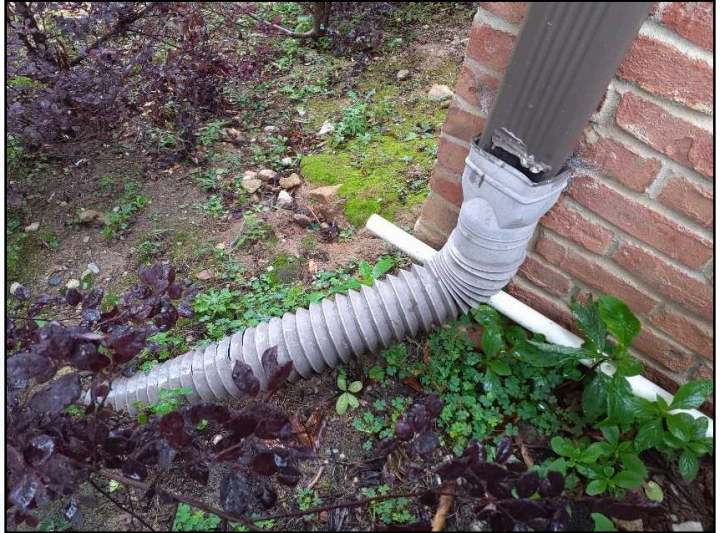
Underground drains noted at downspouts

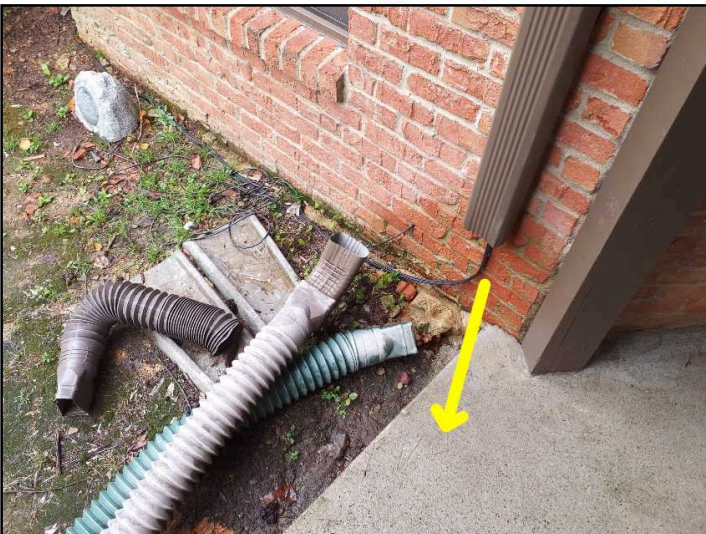
Reconnect extension to gutter down spout

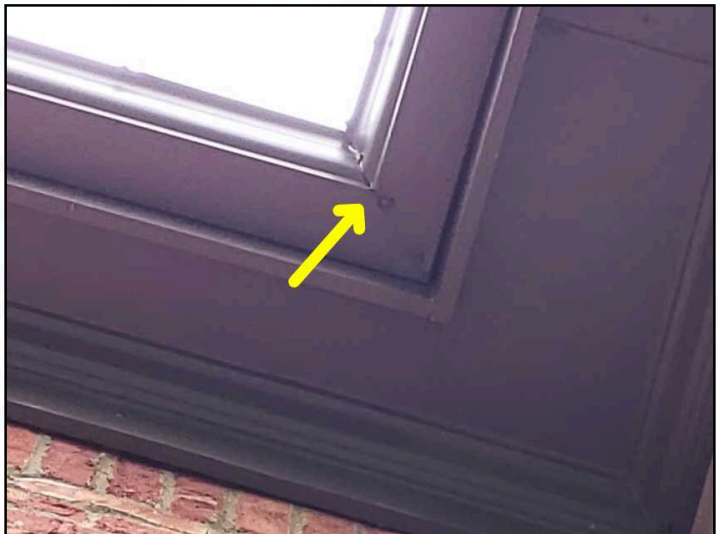
There were indications of gutter leaks at the referenced areas, which may include moisture staining or mildew at gutter joints, soffit areas, and/or fascia boards.

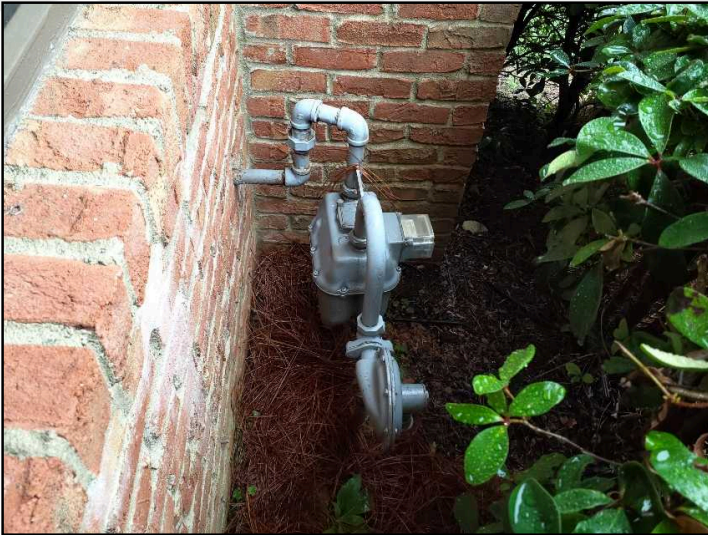
Gas meter at the right exterior side

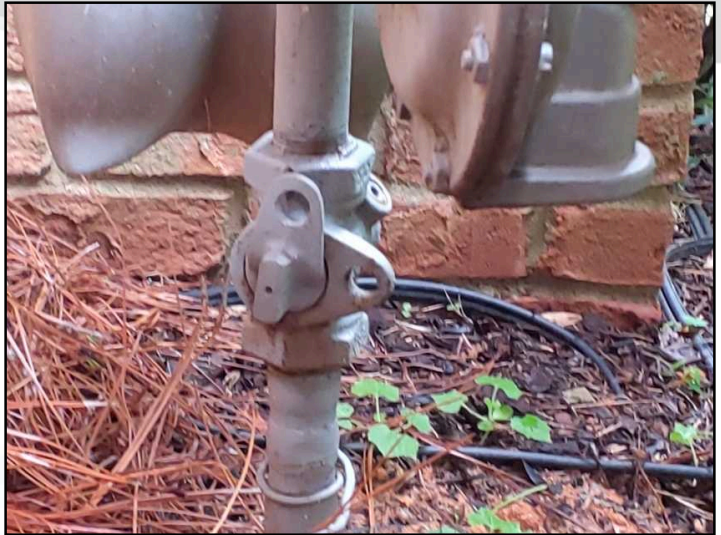
Gas meter at the right exterior side

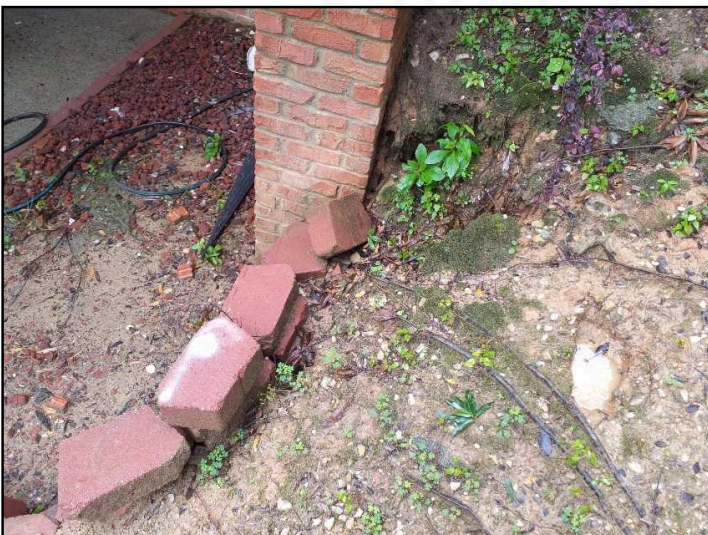
Concrete block portion of retaining wall at back left side of Home needs replacement

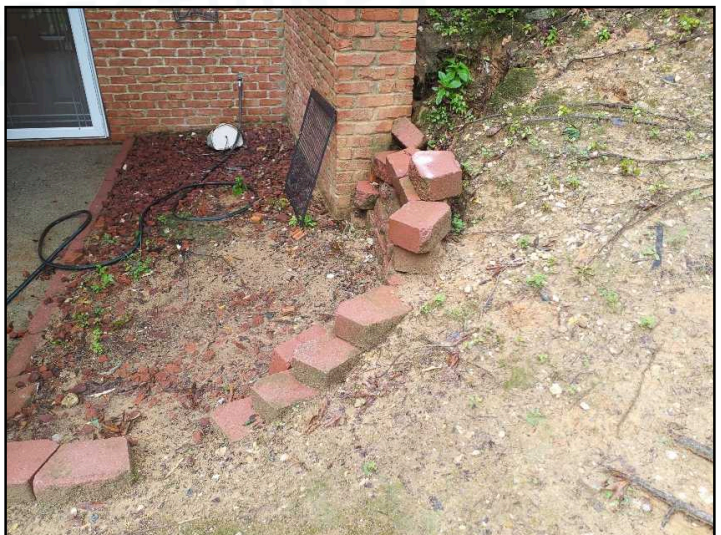
Concrete block portion of retaining wall at back left side of Home needs replacement

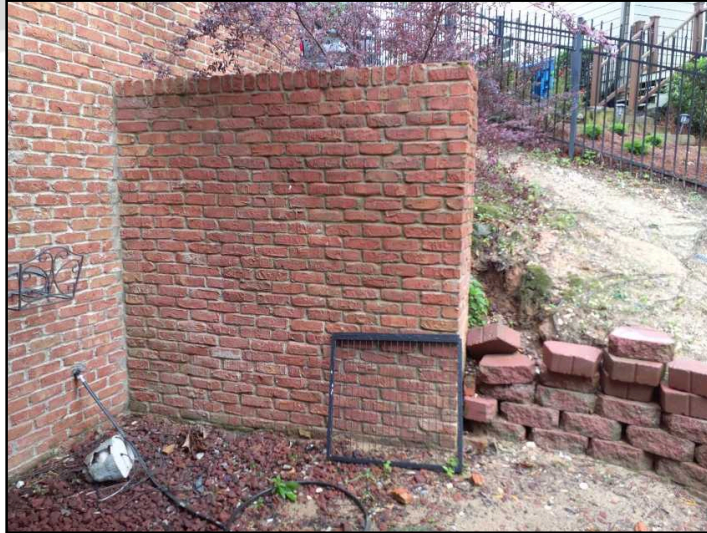
Retaining walls are only included in this inspection scope if their failure would directly affect the home's foundation. Retaining walls intended only for landscaping purposes are not evaluated as part of this inspection scope.

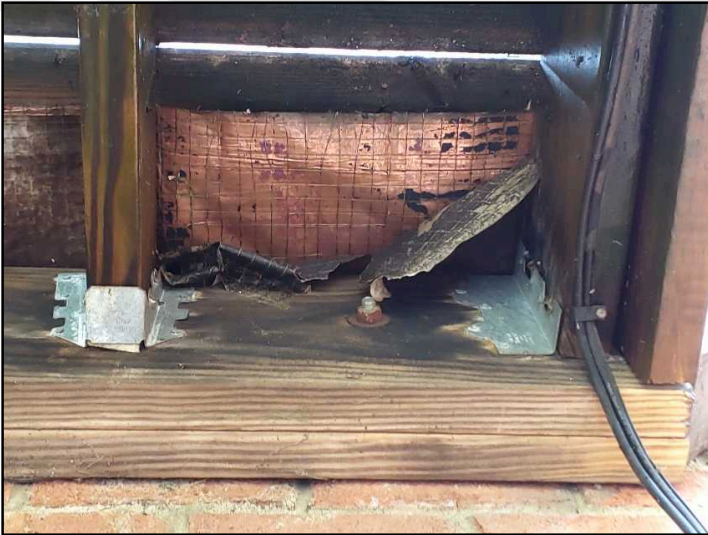
There is no visible flashing where deck meets house. The joint between the deck and the house should be flashed to prevent water penetration where the deck is bolted to the home.

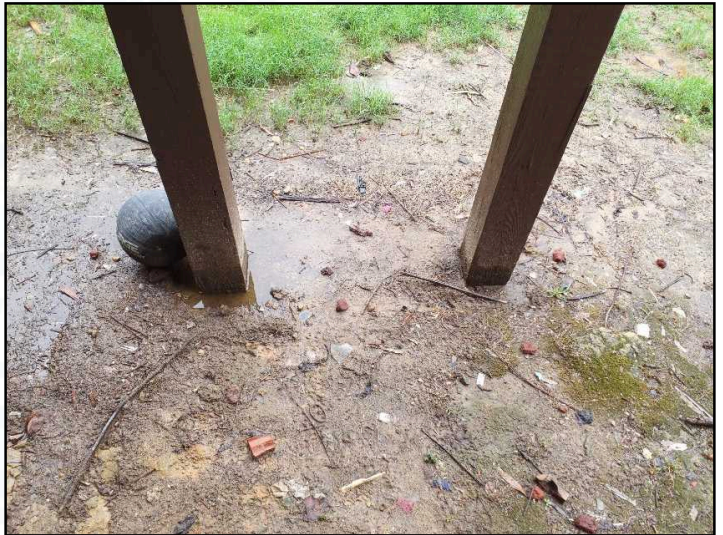
Wood deck support posts/framing should not be in direct contact with soil and will increase rate of deterioration and increase potential for movement/wood destroying organism activity

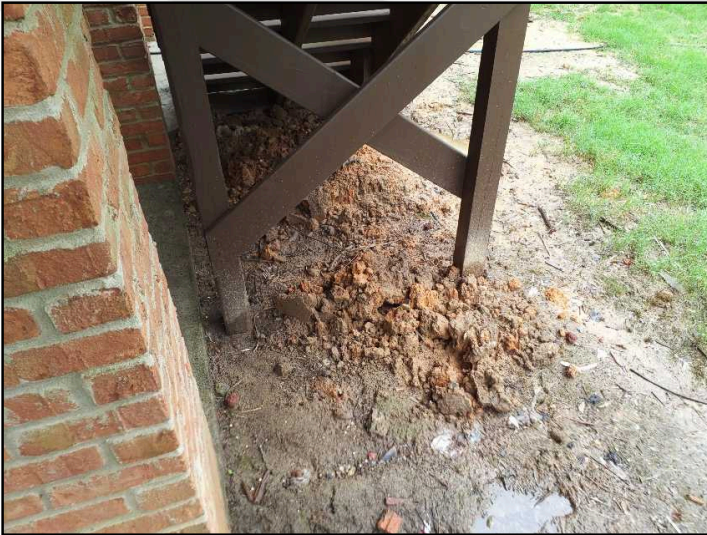
Wood deck support posts/framing should not be in direct contact with soil and will increase rate of deterioration and increase potential for movement/wood destroying organism activity

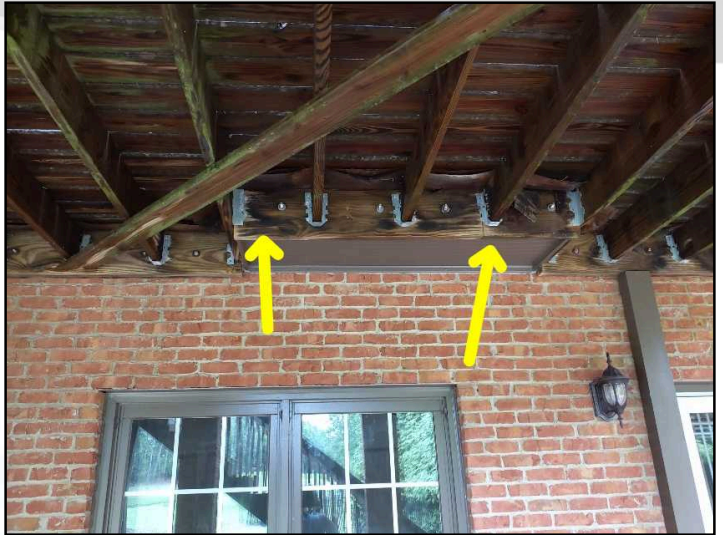
Decks or porches should only attach directly to the band board, not to brick or stone or any overhangs or cantilevered part of the home. These attachments are generally not designed to support the load of the deck. Current standards recommend for this to be constructed as a freestanding deck. Evaluation and repairs as needed for proper support of the deck is recommended to be performed by a qualified contractor.
