- Same-Day Reports
- Post Repair Inspections
- 90-Day Home Warranty

## Property Inspection Report

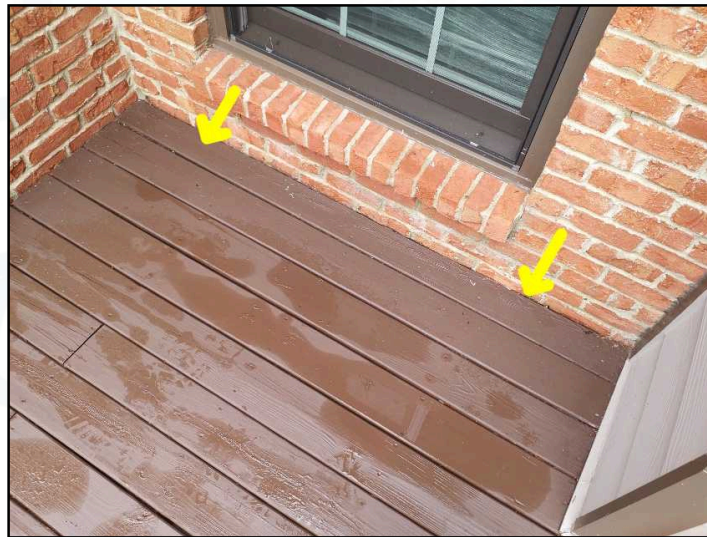
There is no visible flashing where deck meets house. The joint between the deck and the house should be flashed to prevent water penetration where the deck is bolted to the home.

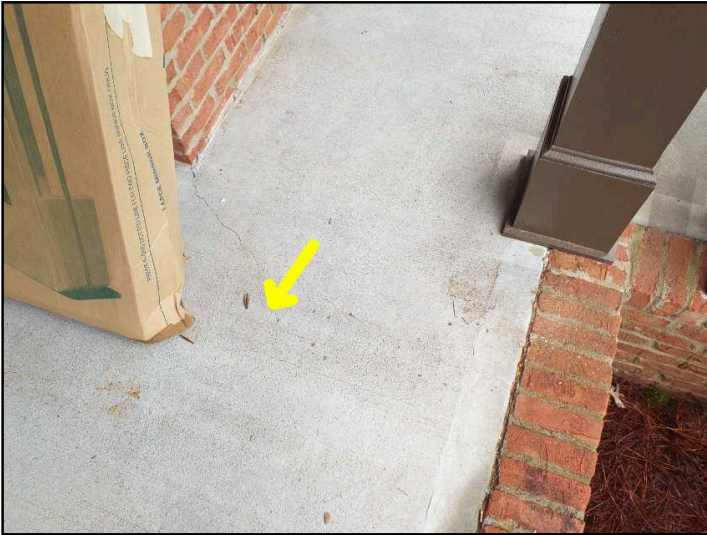
Monitor typical cracking at concrete front porch slab

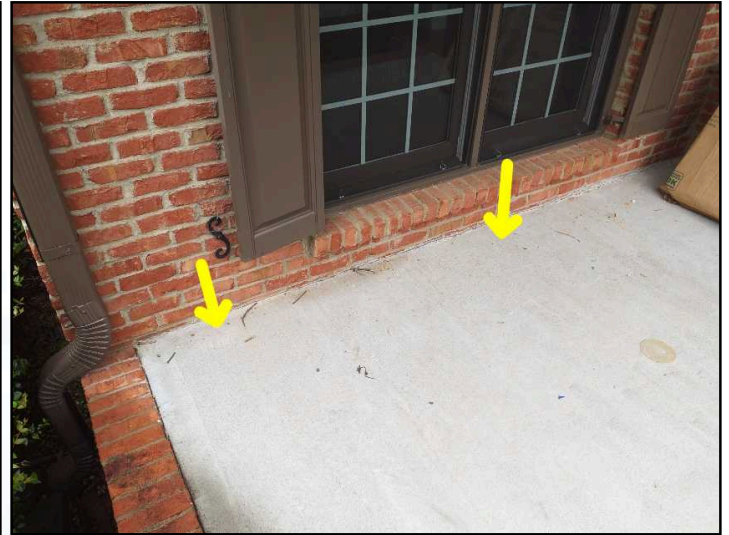
Seal gap where house and porch meet to prevent water from entering structure

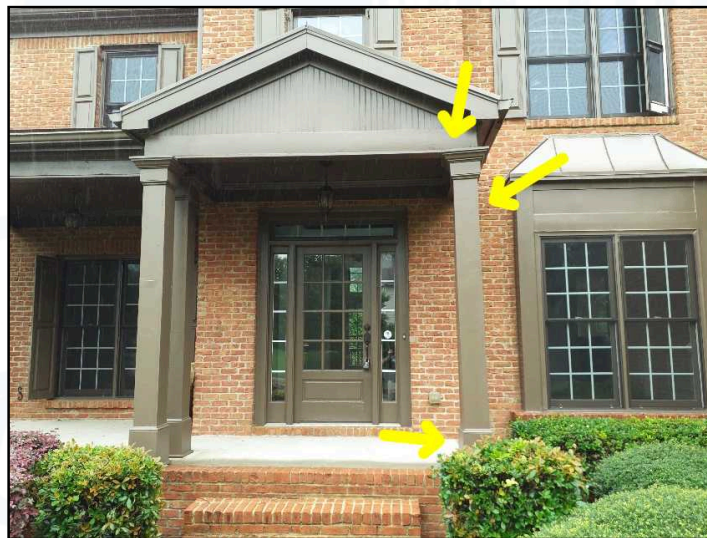
Decorative housing at front right porch support post is slightly warped or twisted. Unable to determine condition of structural member inside housing. Recommend further evaluation and correction as needed

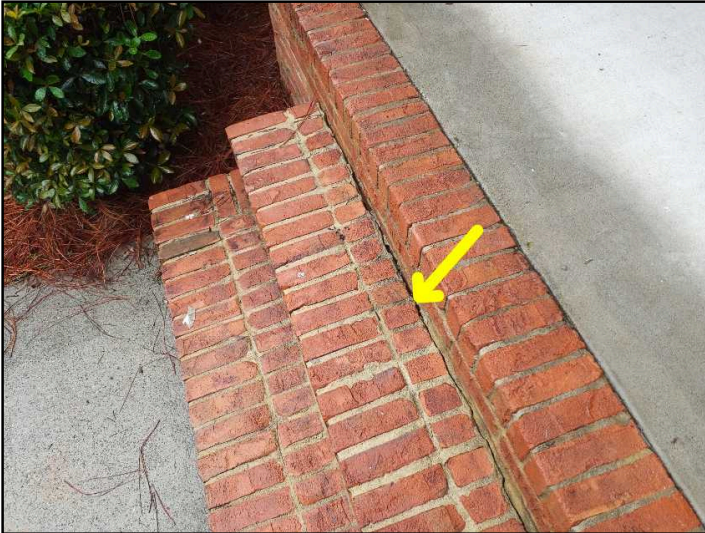
The front exterior brick steps have settled leaving a small Gap at connection to porch above. Recommend repair and continued monitoring

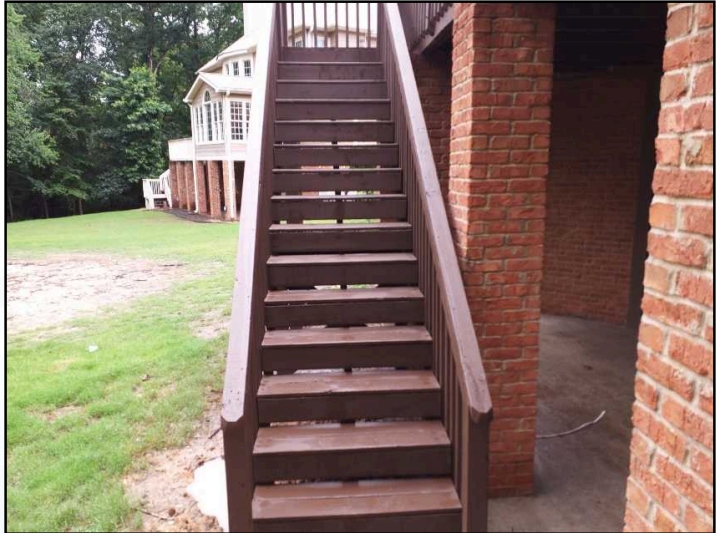
The handrail is not graspable. Deck/porch stairs require a graspable, continuous and smooth handrail for safety. A 2x4 or 2x6 board is not an acceptable hand rail.

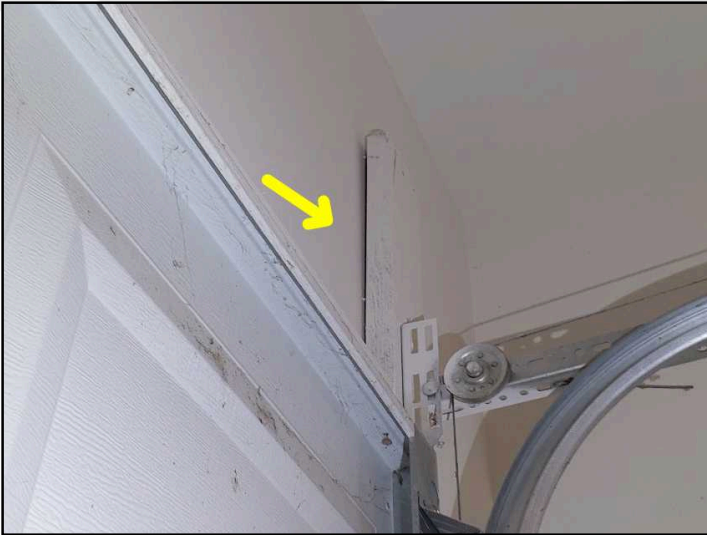
Loose framing noted at garage door(s)

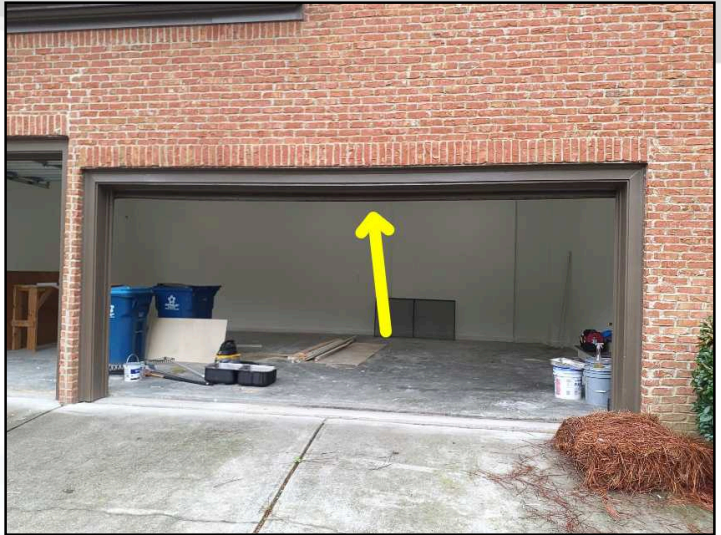
The two car garage overhead door stops slightly short of fully opening. Recommend adjustment

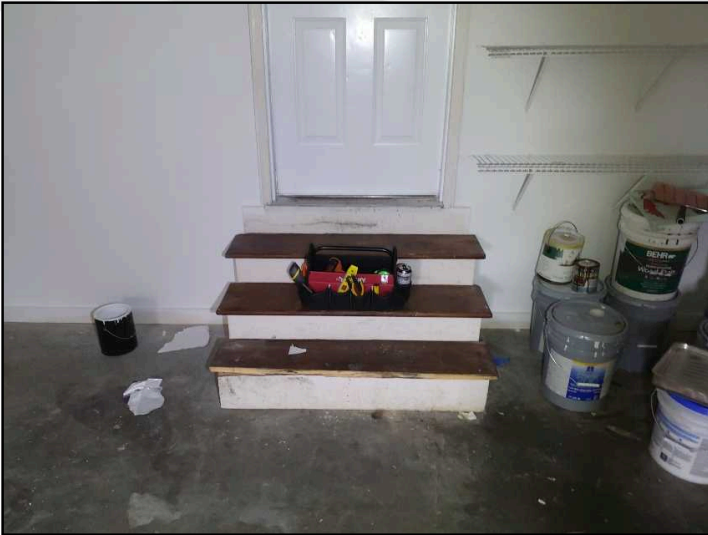
No handrail on stair to home from garage, whenever four or more stairs are present a handrail is usually required, we recommend adding for safety

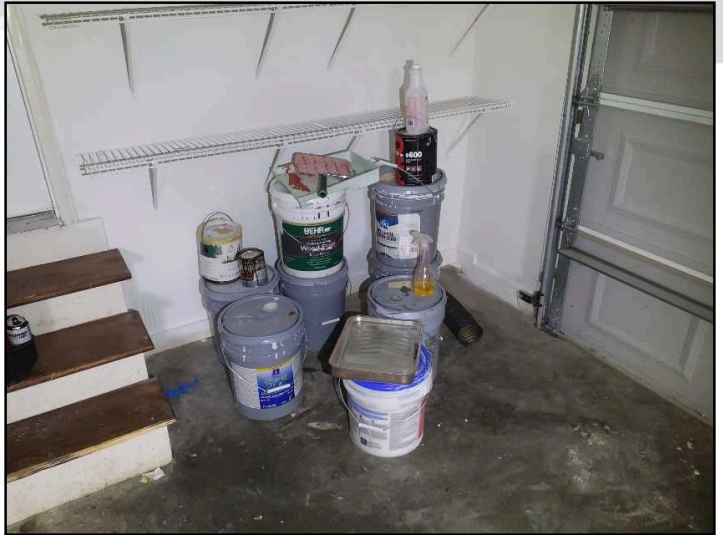
Personal storage in the garage

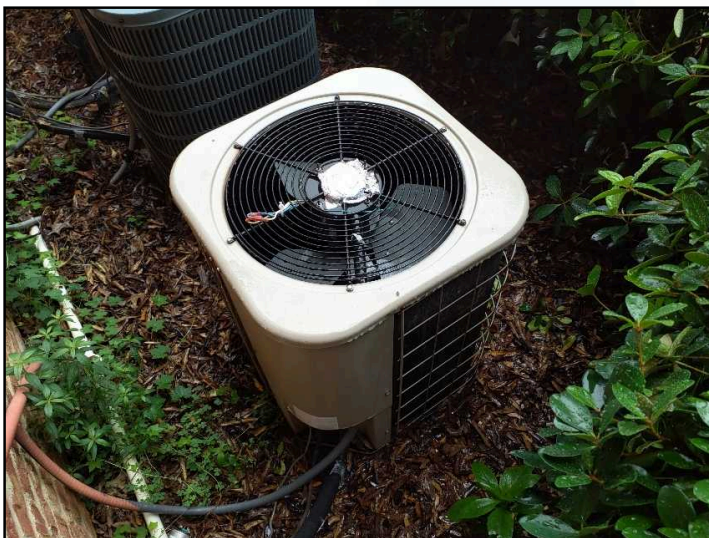
Amana exterior AC unit 2004 unit is beyond its normal life expectancy

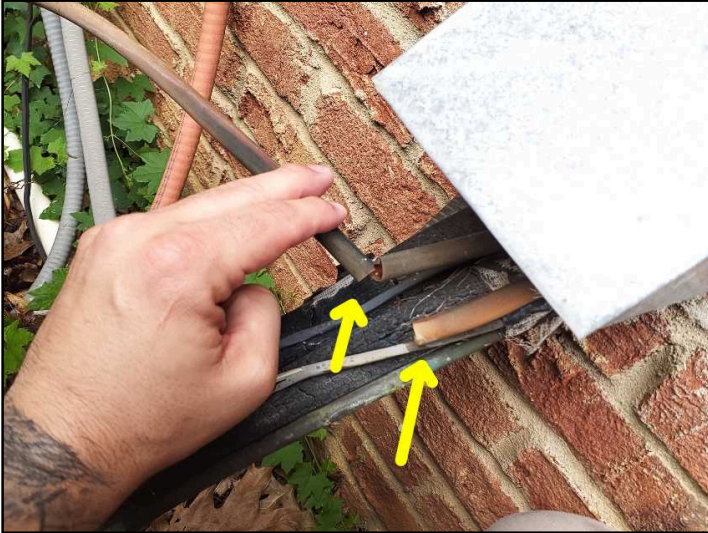
The condensate drain lines should discharge at least five feet from foundation walls to prevent water from collecting near or against the foundation walls as required by industry standards. Have a licensed HVAC or qualified contractor correct.

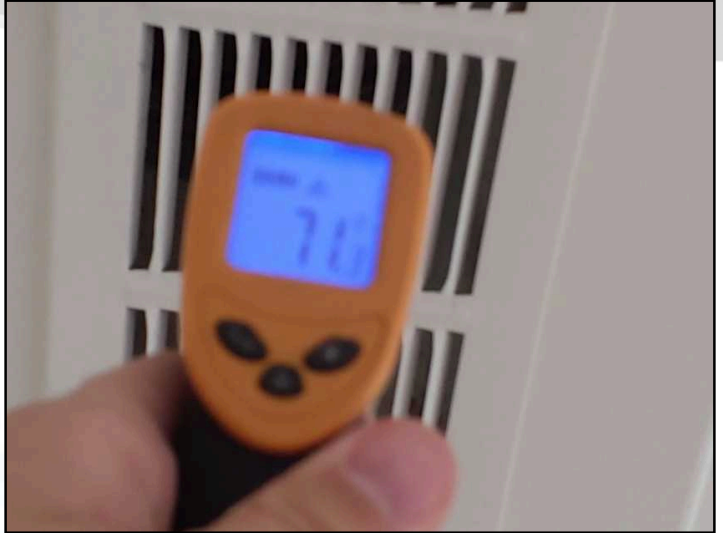
There was a 12 degree temperature differential when the air conditioning was tested at the upper floor level.

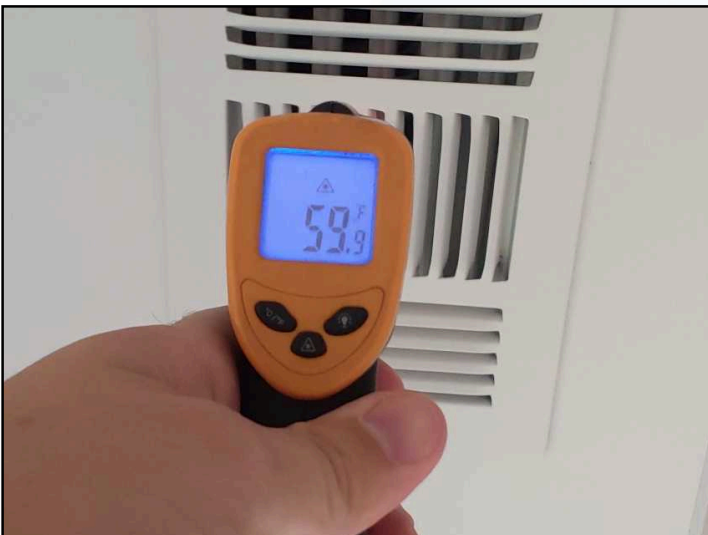
There was a 12 degree temperature differential when the air conditioning was tested at the upper floor level.

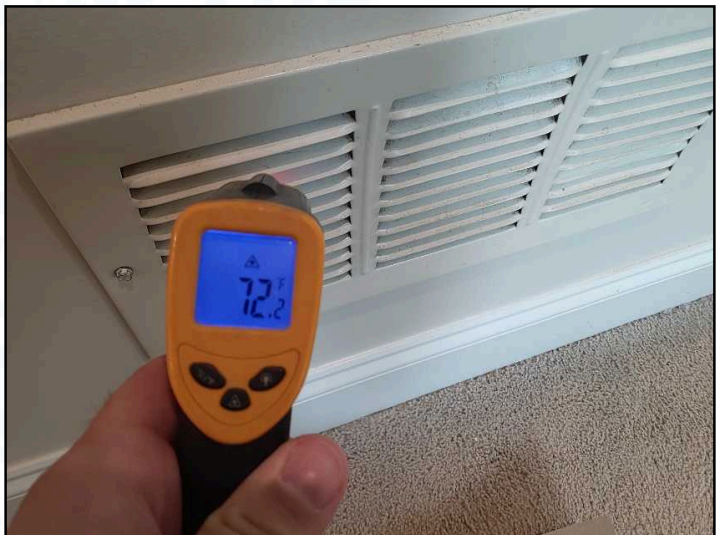
There was a 12 degree temperature differential when the air conditioning was tested at the main floor level.

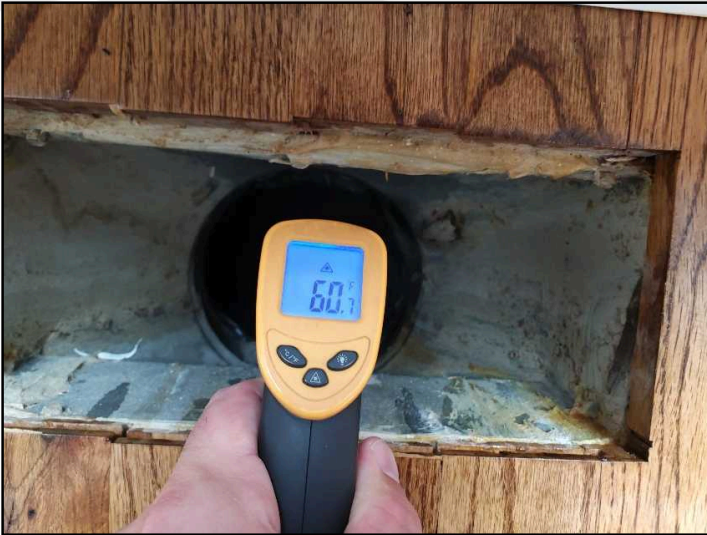
There was a 12 degree temperature differential when the air conditioning was tested at the main floor level.

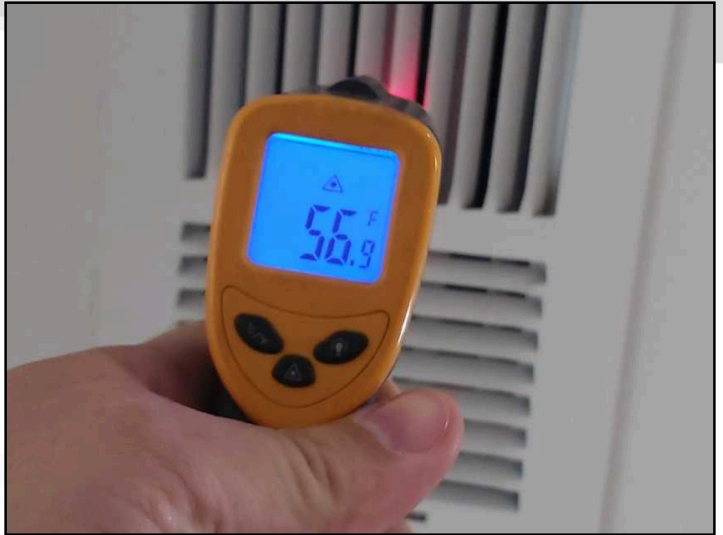
There was a 13 degree temperature differential when the air conditioning was tested at the basement level.

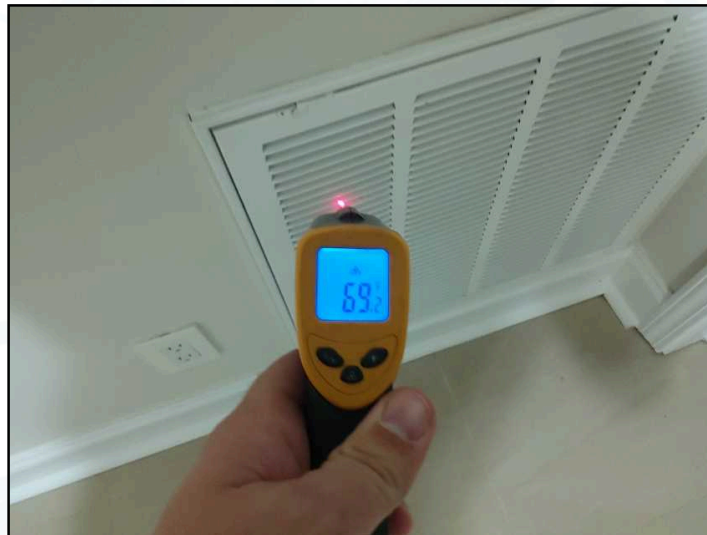
There was a 13 degree temperature differential when the air conditioning was tested at the basement level.

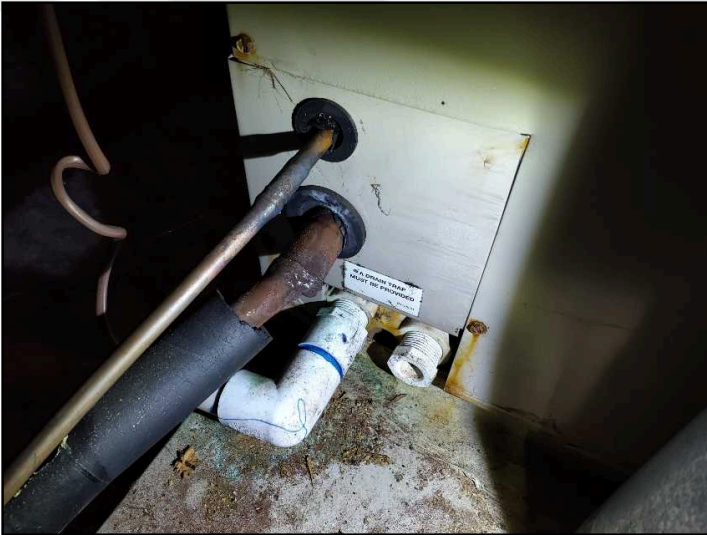
Seal and insulate the copper AC lines where they meet the coils at the top or side of the furnace. Conditioned air is being lost to the space around and condensation is dripping from the copper lines.

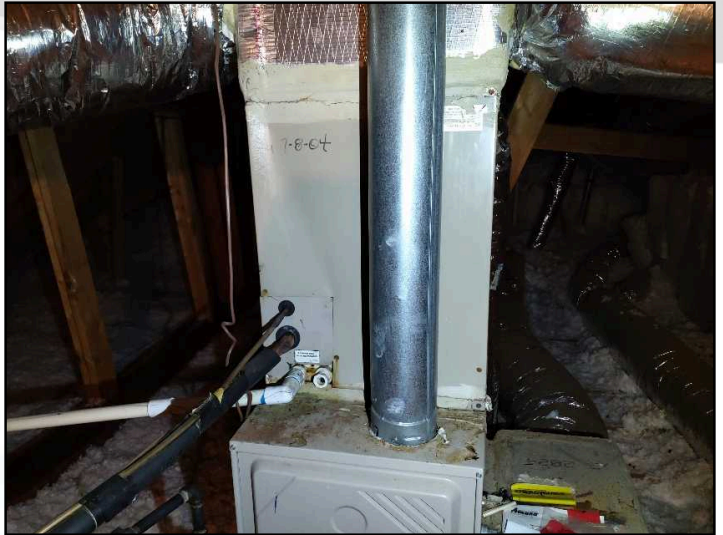
Evaporator coil portion in attic space 2003 unit is beyond its normal life expectancy

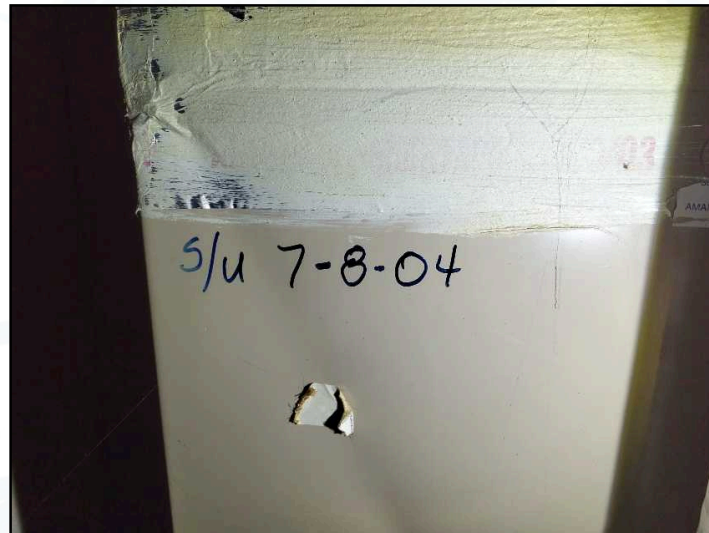
Evaporator coil in basement for main level HVAC system Amana 2004 unit is beyond its normal life expectancy

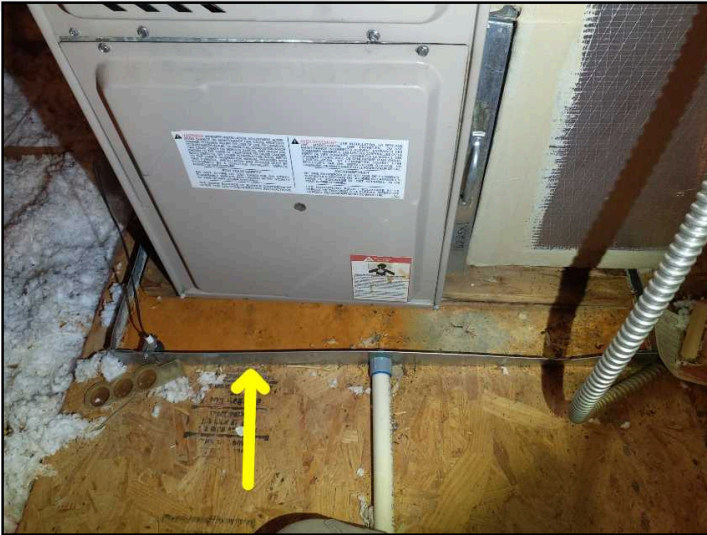
Rust is noted in the overflow pan under the attic unit. Have an HVAC contractor review condensate system to determine reason for rust and correct as needed.

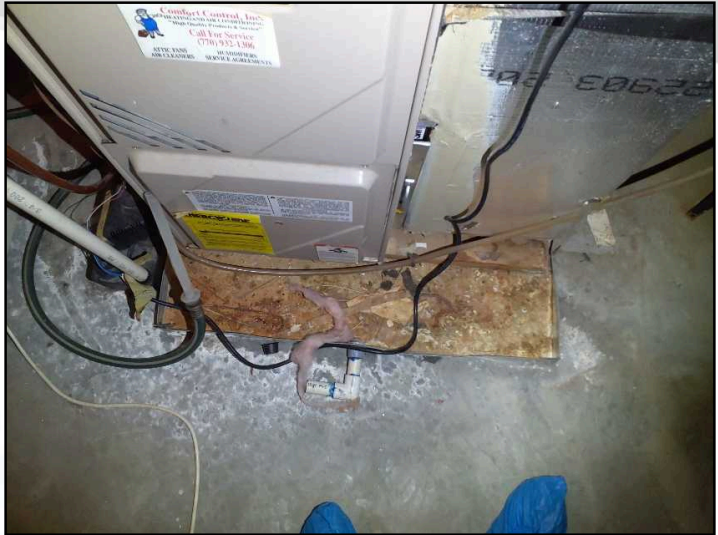
Rust is noted in the overflow pan under the attic unit. Have an HVAC contractor review condensate system to determine reason for rust and correct as needed.

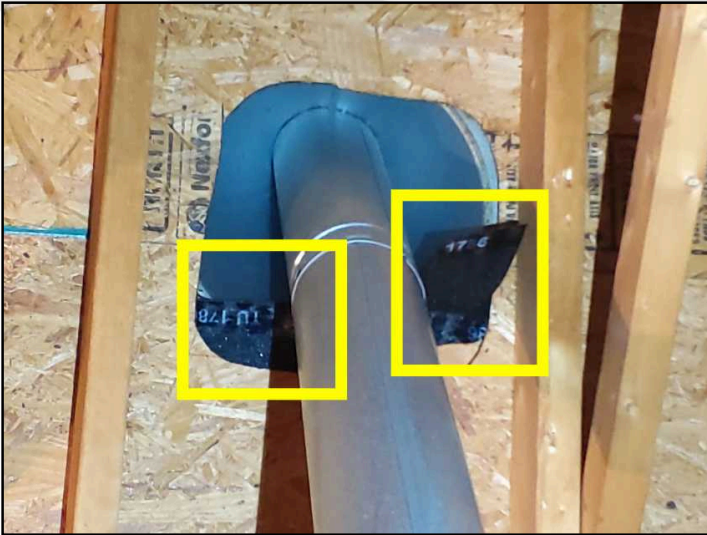
The exhaust vent pipe has inadequate clearance to in the attic space which is a safety concern. The vent is should have at least a 1" clearance from the insulation/felt paper. Have corrections made.

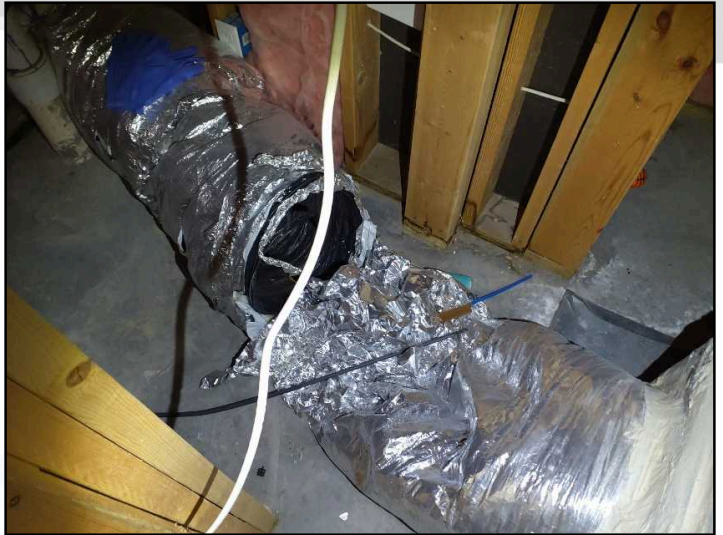
The supply duct for the basement HVAC system is broken and attached

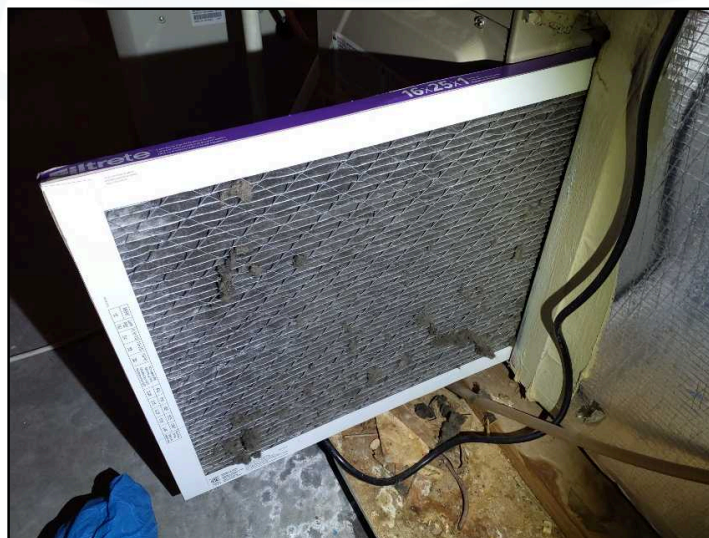
There it no way to determine the last time the filters were changed, and they were dirty at the time of inspection. It is suggested to install new filters once the buyers move into the home.

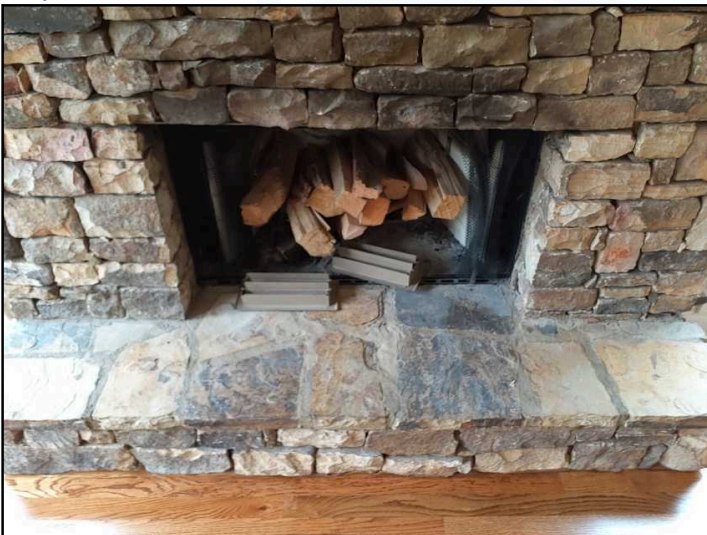
Fireplace in the family room

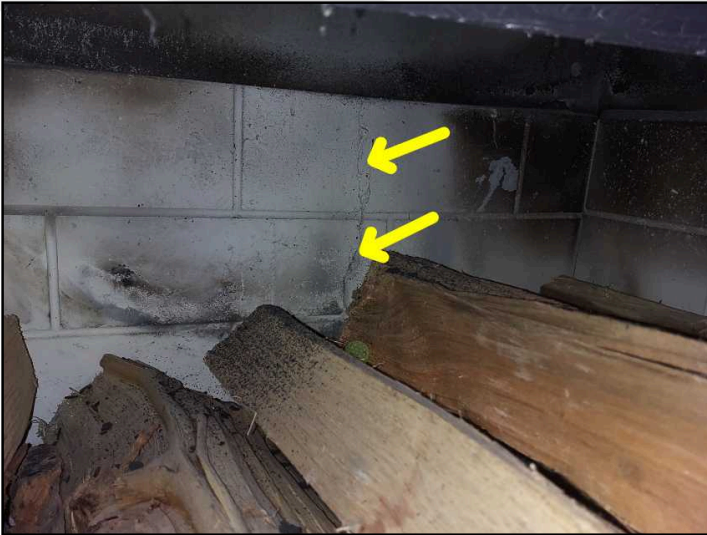
Minor cracking and deterioration on back fire brick. Have a chimney sweep examine and repair as needed for safe use.

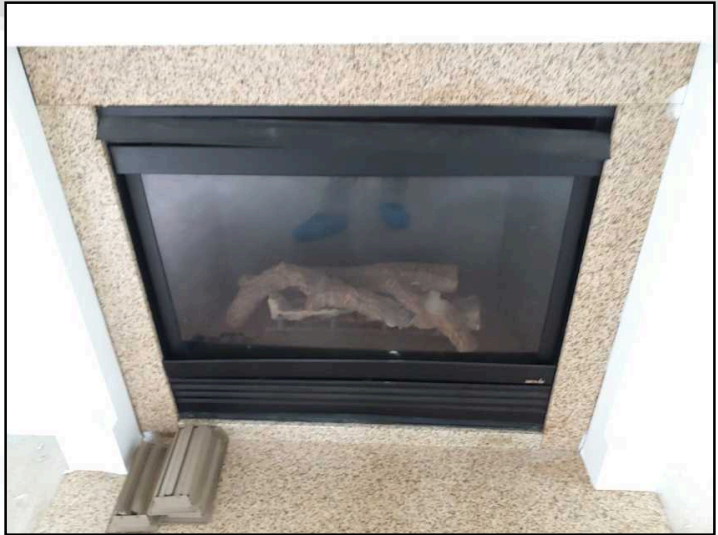
The gas line valve/pilot was shut off at the time of inspection.

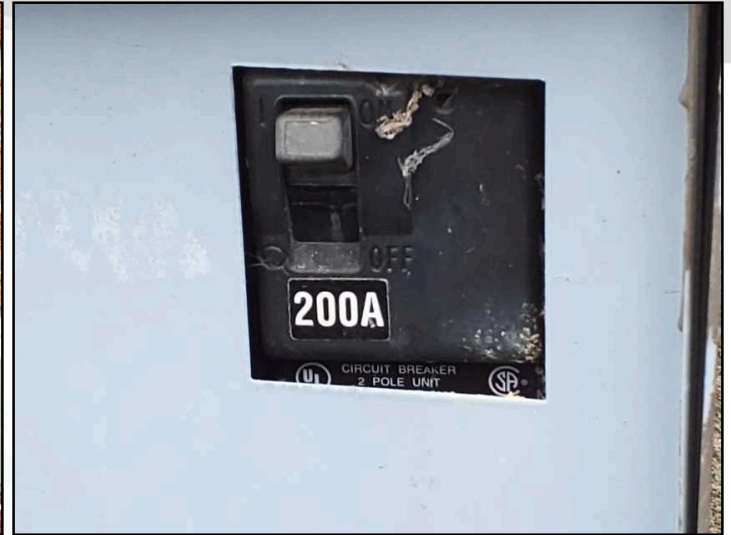
Electric meter and 200 amp shut off at the right exterior side

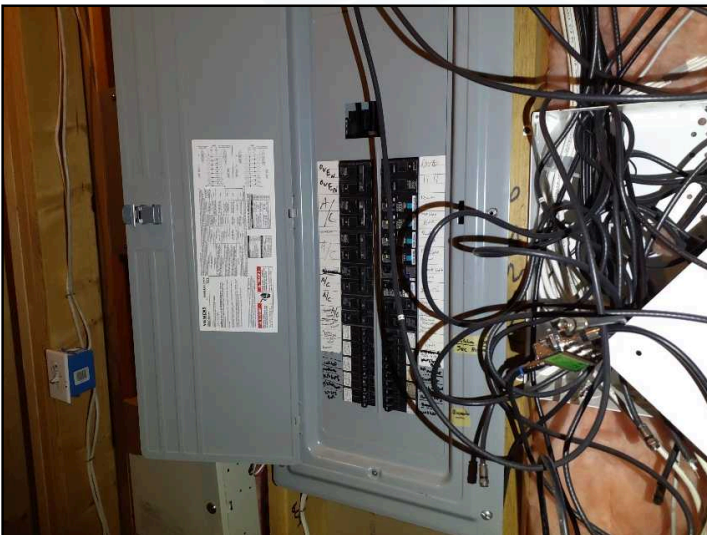
Main electrical panel located in the basement

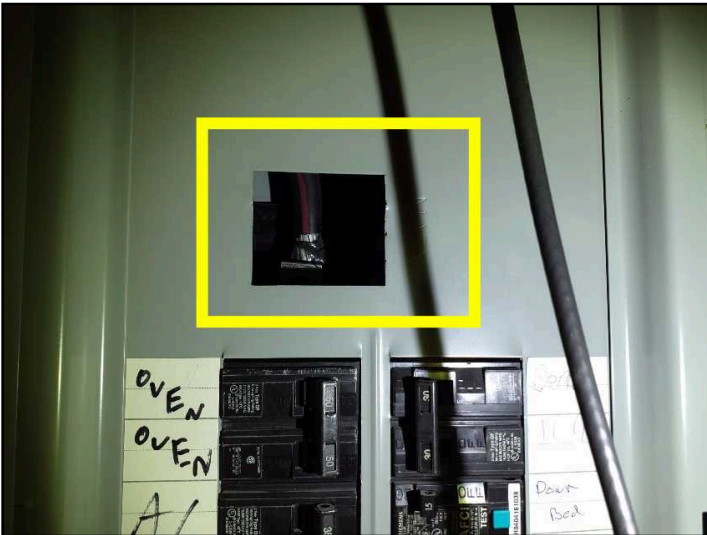
Open knockouts observed in service panel cover, suggest installing knockout plugs, as needed, for safety.

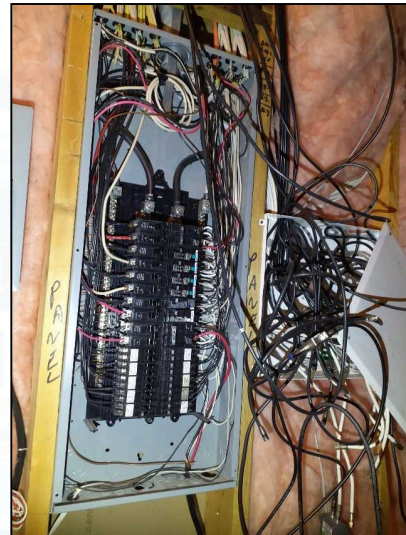
Interior of main panel

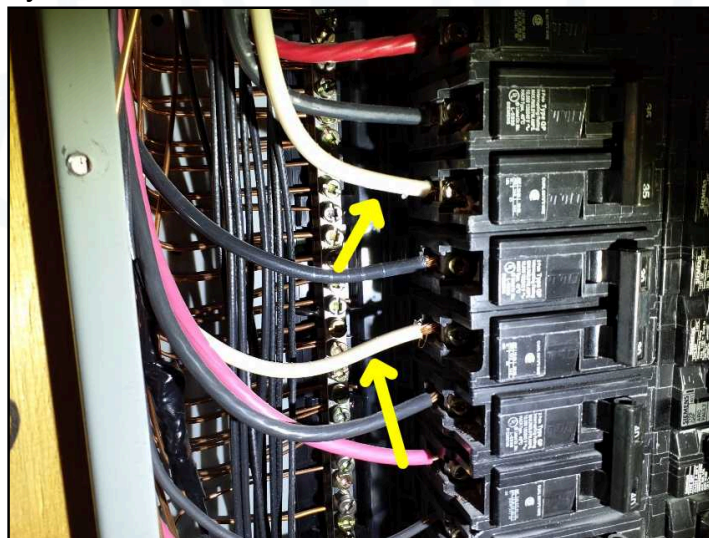
240 live white wires noted at main panel

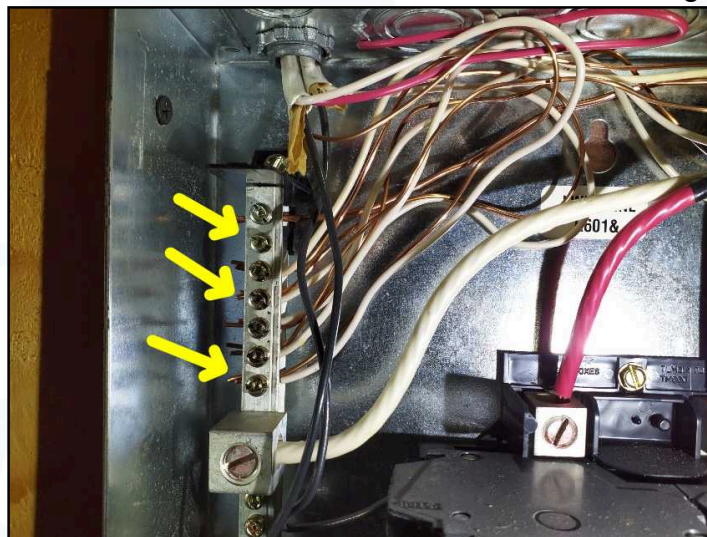
Ground and neutral wiring in sub electrical panel should be isolated on a separate buss.

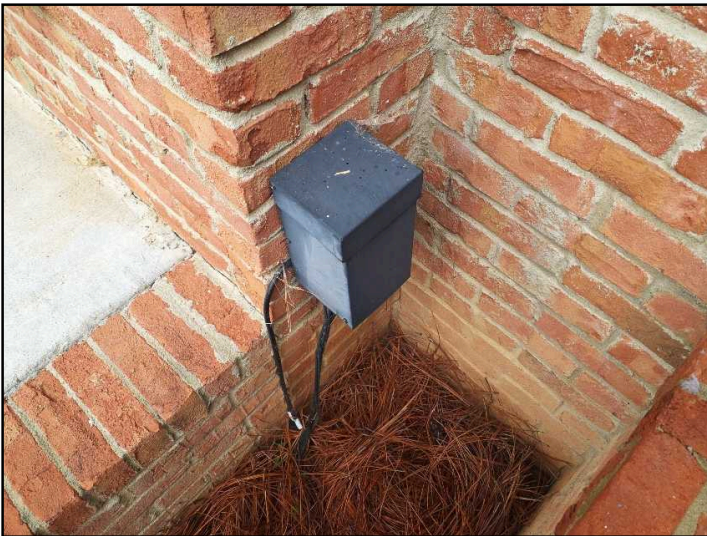
Lights are noted in the landscaping around the exterior of the home. These are not examined or tested as part of this inspection and should be evaluated and serviced as needed. These are often low voltage system and are on timers or photo controls.

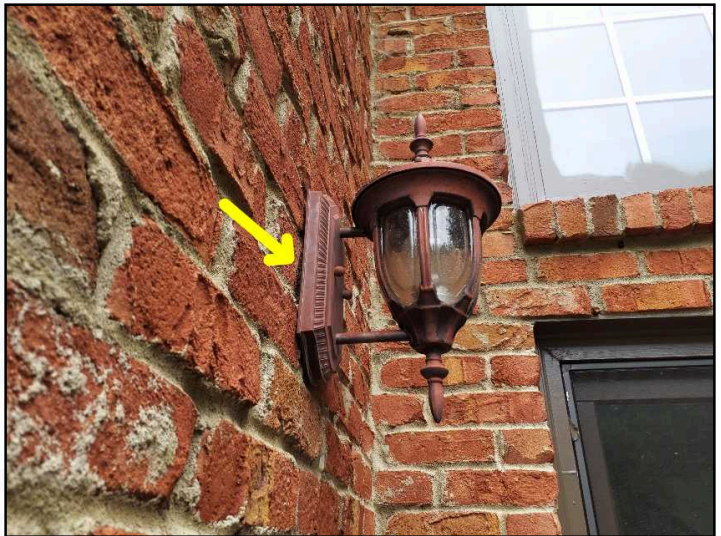
The bases of the exterior lights need to be sealed to the siding to prevent water entry into the wall cavity and wiring connections.

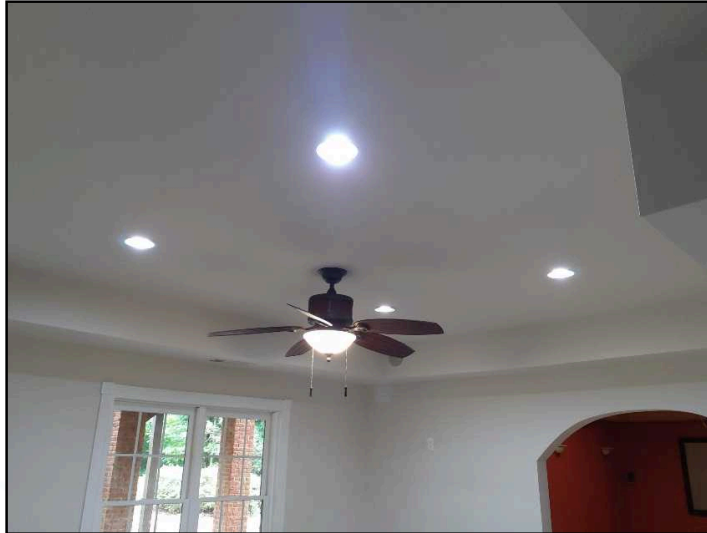
Flickering observed at recessed lighting in basement surrounding ceiling fan. Recommend further evaluation for cause and correction

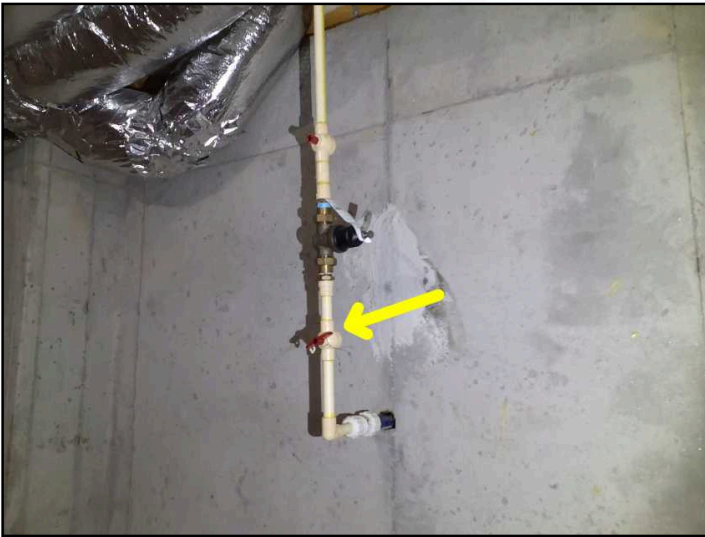
Main water shut off noted at the front basement wall

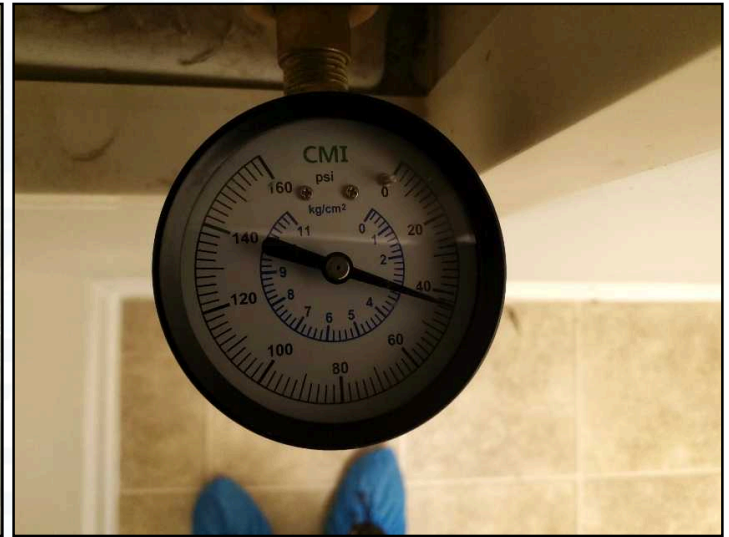
Water pressure measured 40-45 pounds per square inch (psi) at the time of the inspection. Acceptable water pressure is between 40 and 80 psi.

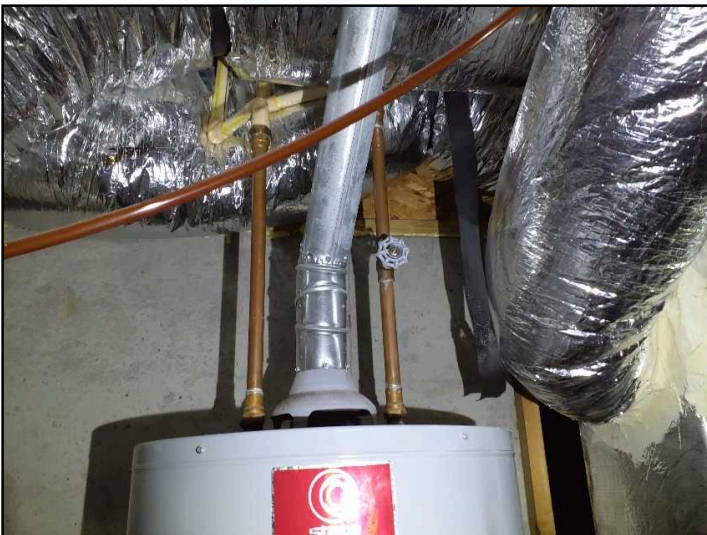
No visible expansion tank or device noted at water heater

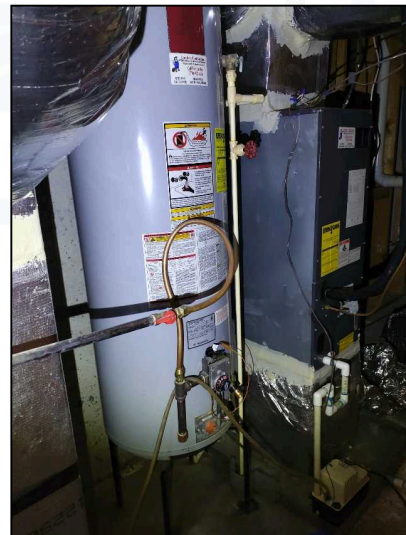
Water heater is undersized for home, well beyond its normal life expectancy and has visible rusting around burn compartment and base. Recommend evaluation by qualified plumber for likely replacement

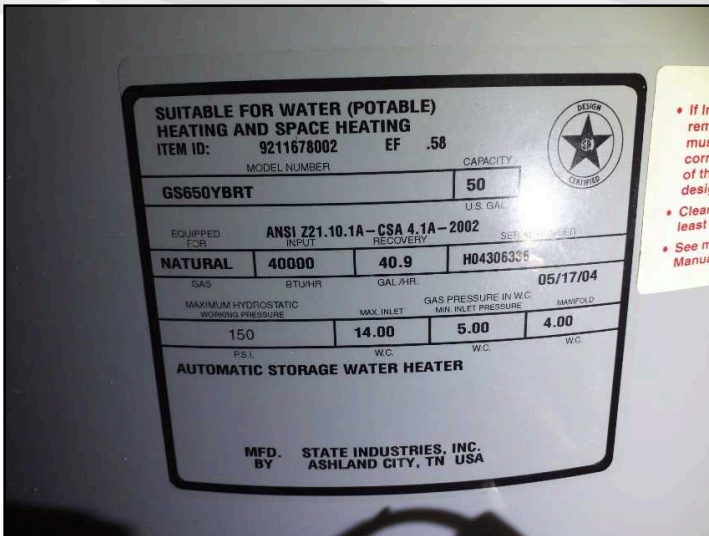
Gas water heater in basement 50 gallon State select 2004

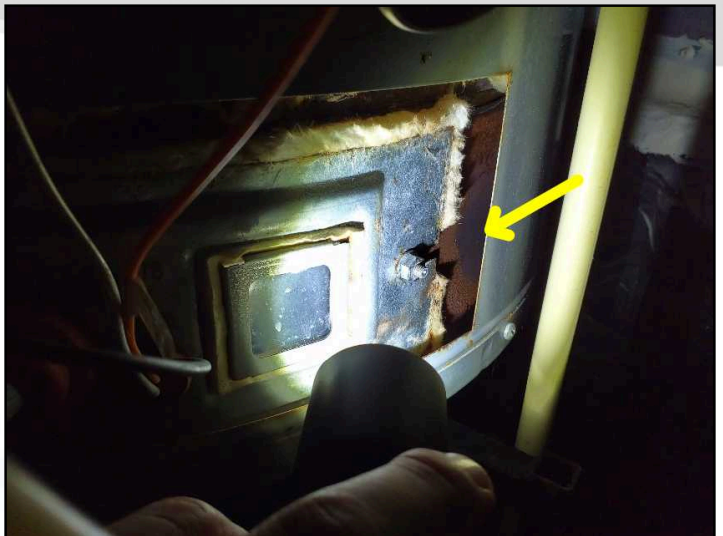
Water heater is undersized for home, well beyond its normal life expectancy and has visible rusting around burn compartment and base. Recommend evaluation by qualified plumber for likely replacement

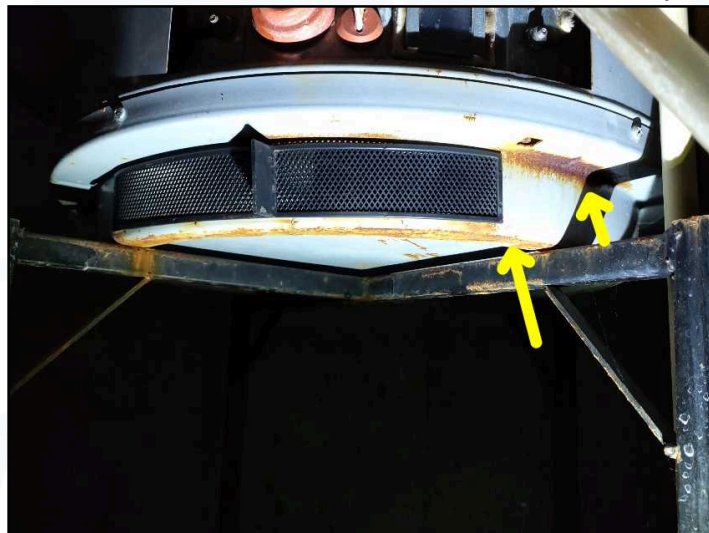
Water heater is undersized for home, well beyond its normal life expectancy and has visible rusting around burn compartment and base. Recommend evaluation by qualified plumber for likely replacement

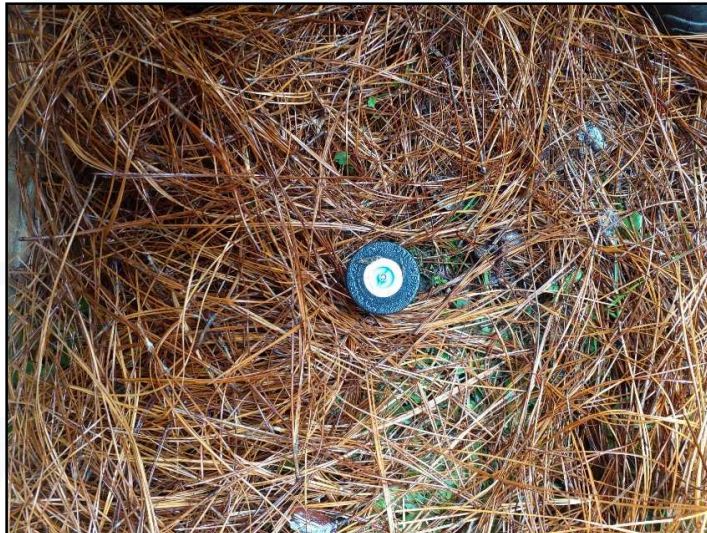
If the home is equipped with an automatic sprinkle system, it is not included as a part of this inspection. This system is primarily underground and beyond the scope of the home inspection. We recommend further review by a qualified professional, if concerned.

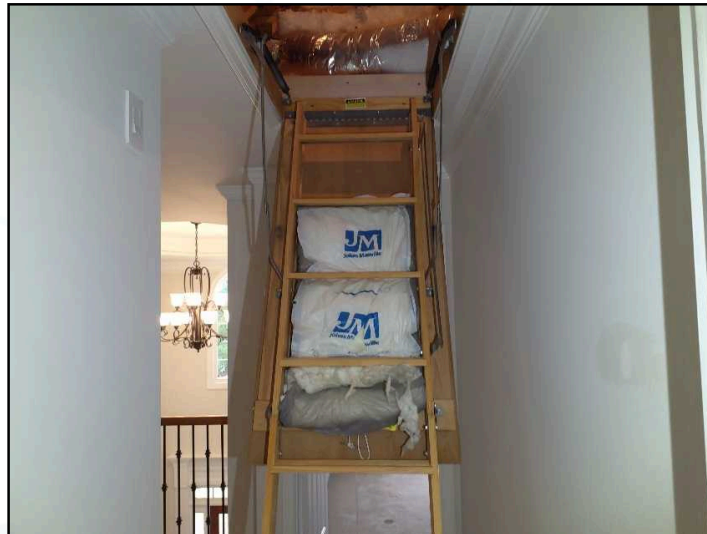
Weather strip and insulate all attic access at living spaces

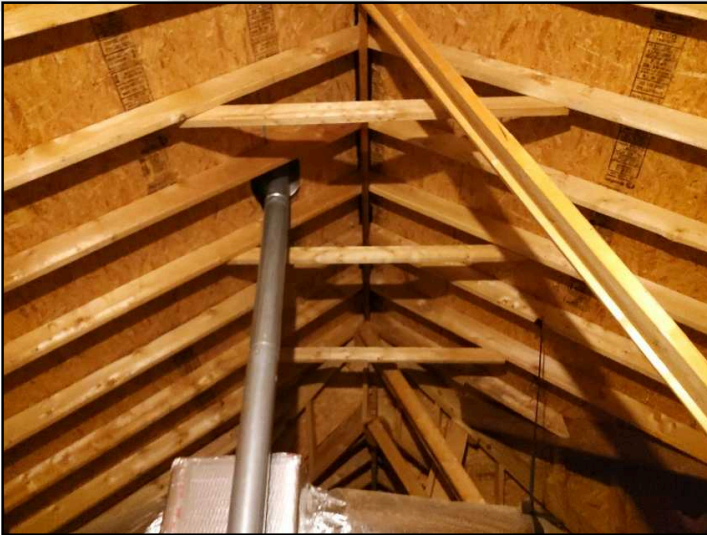
2.2. Lateral roof support framing in attic space between edge of roof line and entrance ladder is Warped and bent. Recommend repair or replacement by qualified contractor

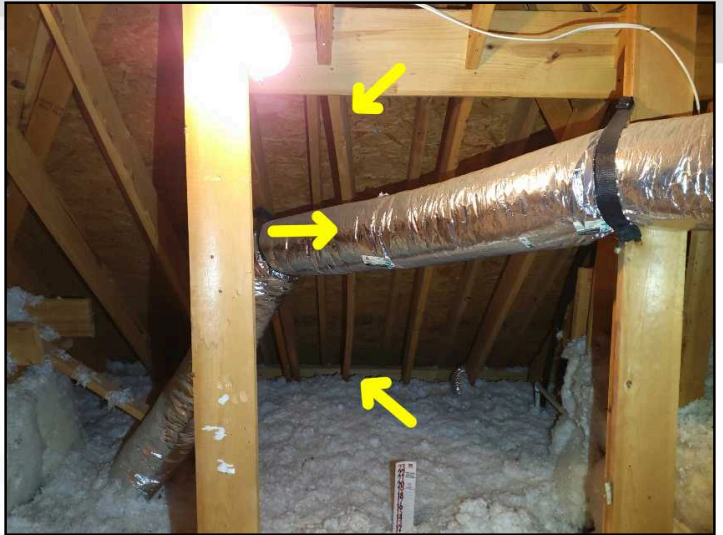
Lateral roof support framing in attic space between edge of roof line and entrance ladder is Warped and bent. Recommend repair or replacement by qualified contractor

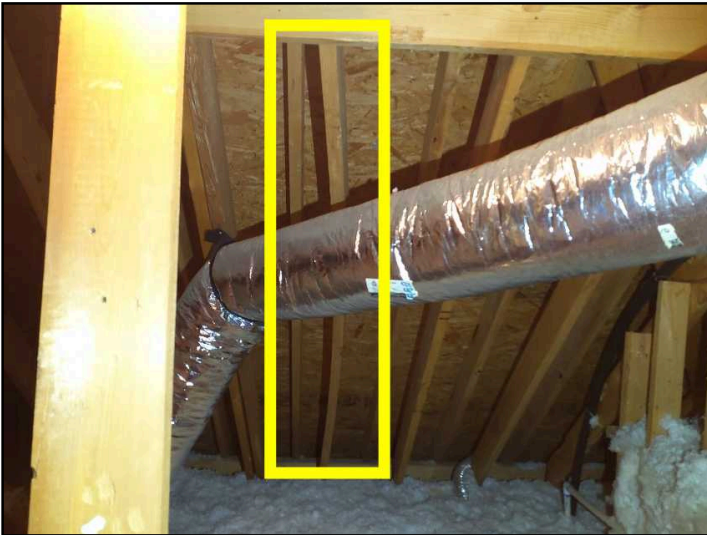
Lateral roof support framing in attic space between edge of roof line and entrance ladder is Warped and bent. Recommend repair or replacement by qualified contractor

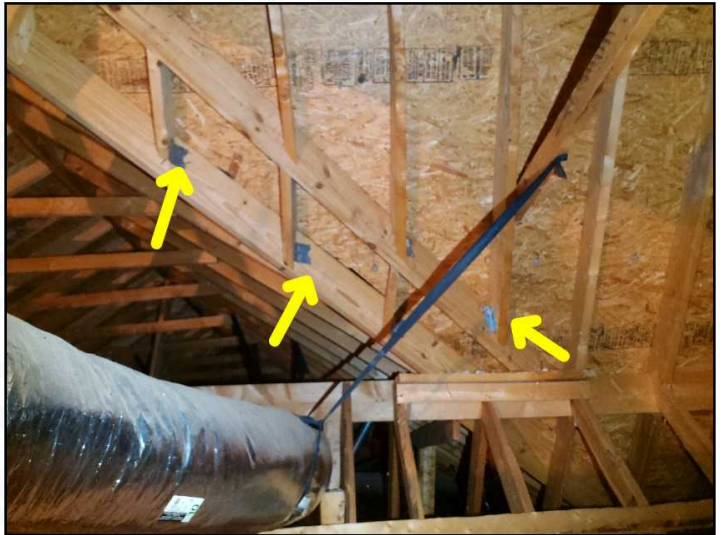
Some additional bracing and brackets have been added at connection points of attic roof framing to prevent or stop separation or movement. Inquire with seller, recommend continued monitoring and further evaluation as desired

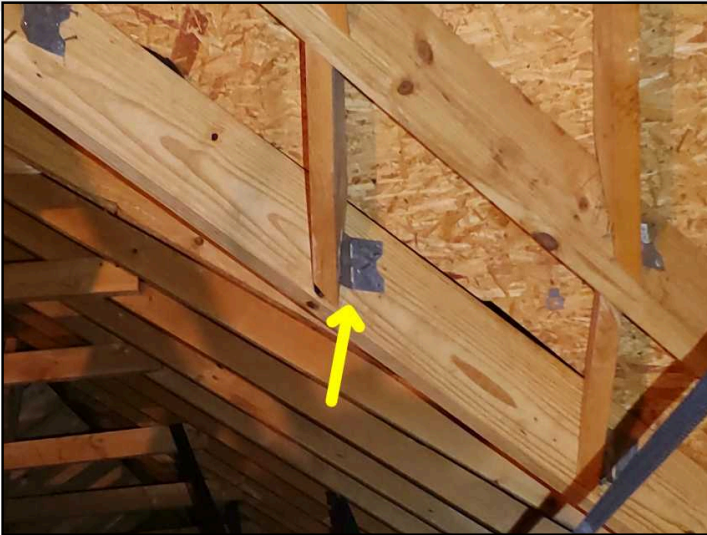
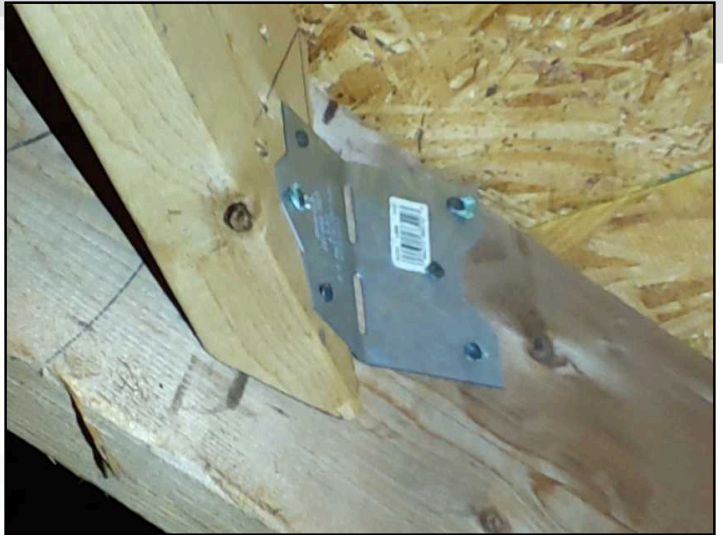
Some additional bracing and brackets have been added at connection points of attic roof framing to prevent or stop separation or movement. Inquire with seller, recommend continued monitoring and further evaluation as desired

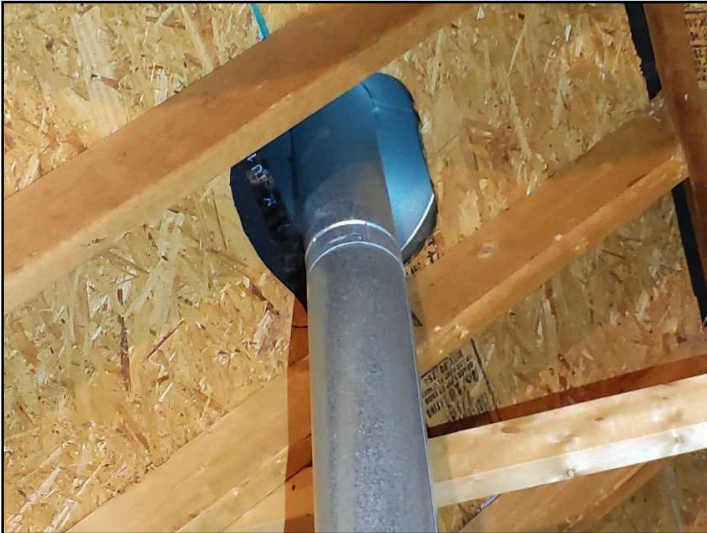
Underside of roof penetrations in attic

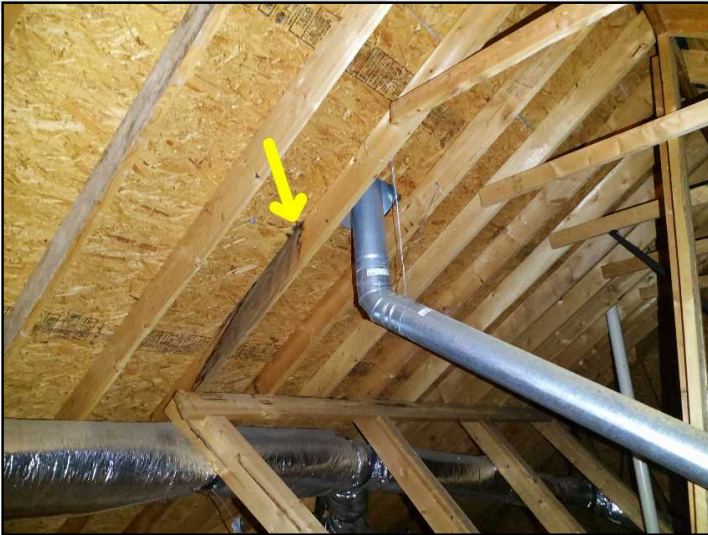
Evidence of water intrusion at exhaust pipe flashing Fastener with staining in attic space below. Recommend correction by qualified roofer

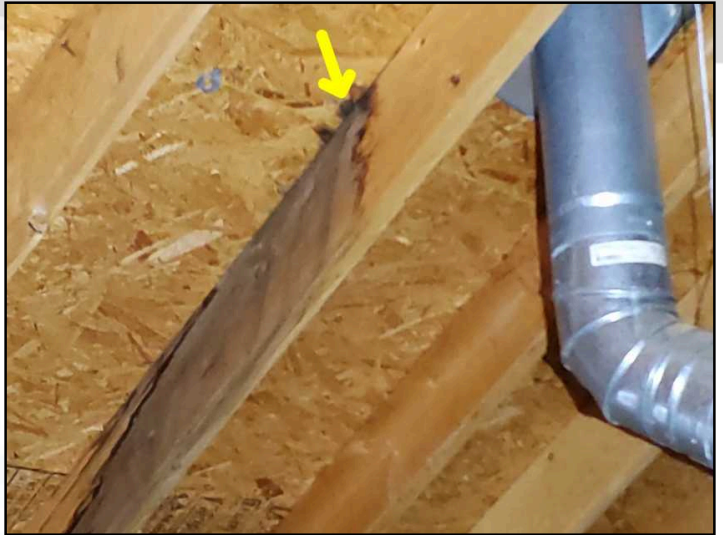
Evidence of water intrusion at exhaust pipe flashing Fastener with staining in attic space below. Recommend correction by qualified roofer
