- Same-Day Reports
- Post Repair Inspections
- 90-Day Home Warranty

## Property Inspection Report

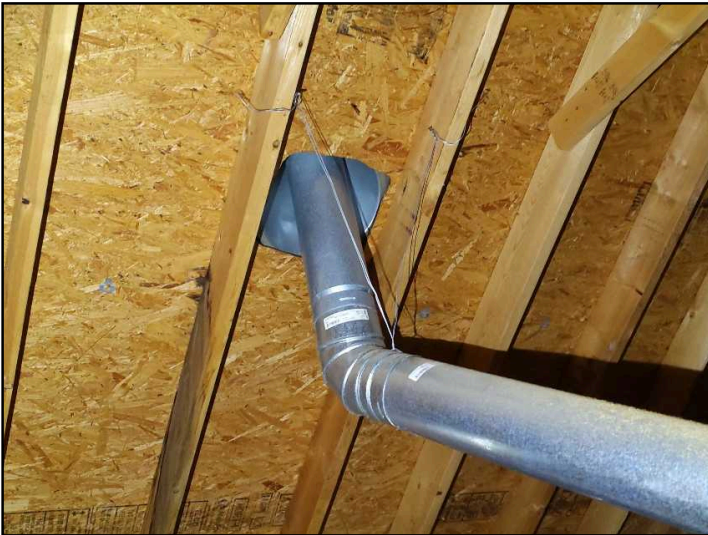
Underside of roof penetrations in attic

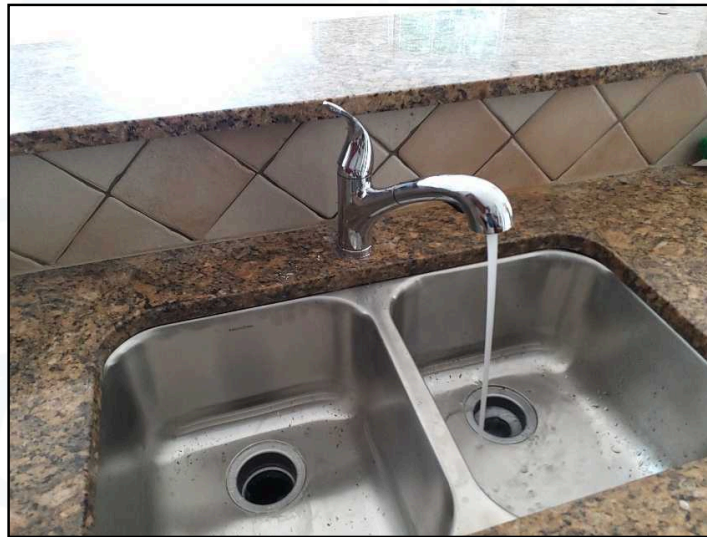
There is no cold water pressure at the kitchen sink faucet

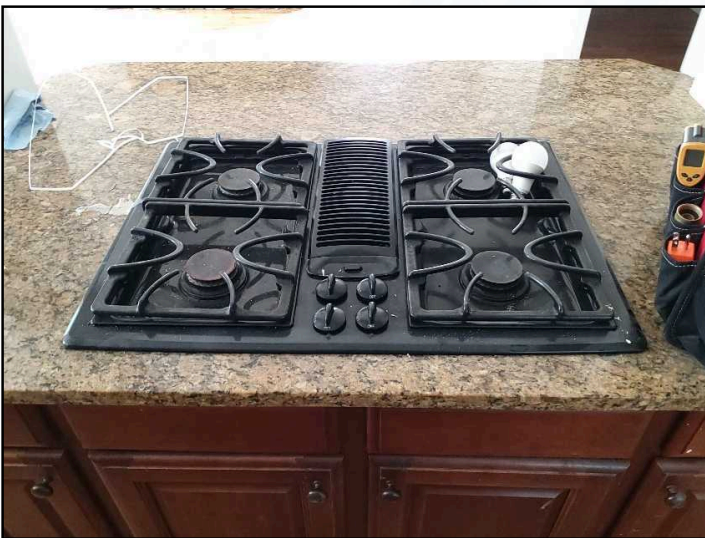
Multiple controls at the kitchen gas cooktop are not operational. Recommend repair or replacement

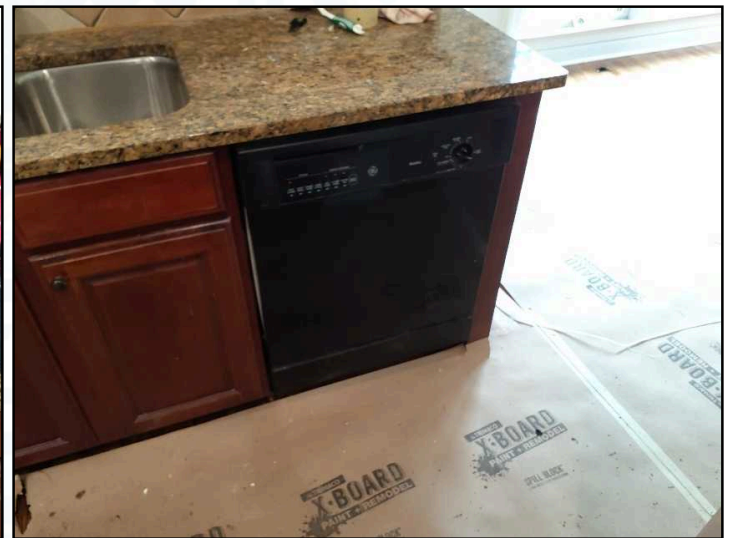
The dishwasher was not operational when tested. Our inspection is limited to operating on the normal setting and using standard controls.

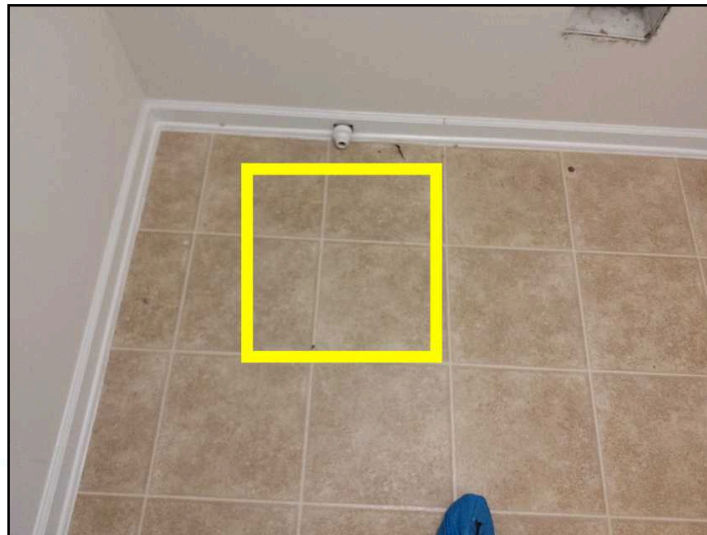
There should be a drain pan and drain line installed under the clothes washing machine. This is recommended when the laundry area is located over finished space OR to protect the flooring in and around the laundry room.

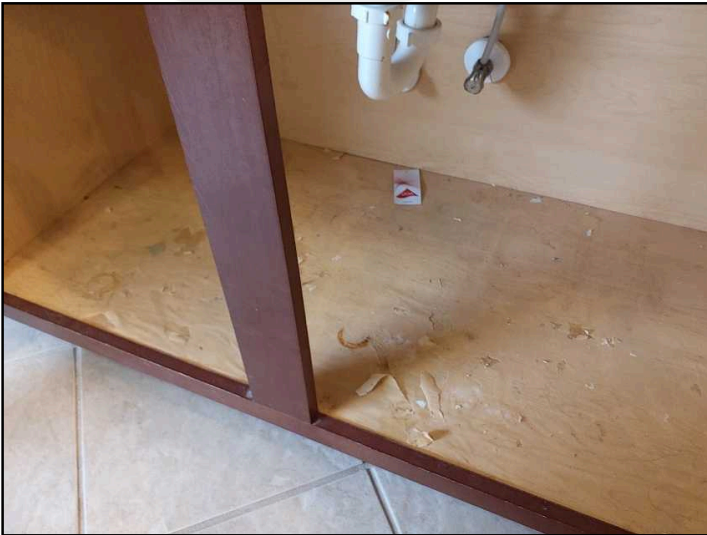
Water stains/damage at vanity cabinet

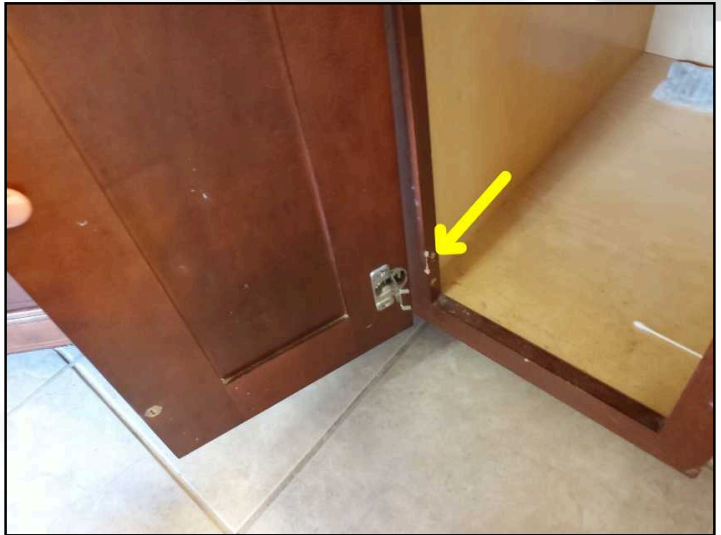
Misaligned or loose cabinets or drawers noted in one or more bathrooms inside the home. Have adjusted as needed.

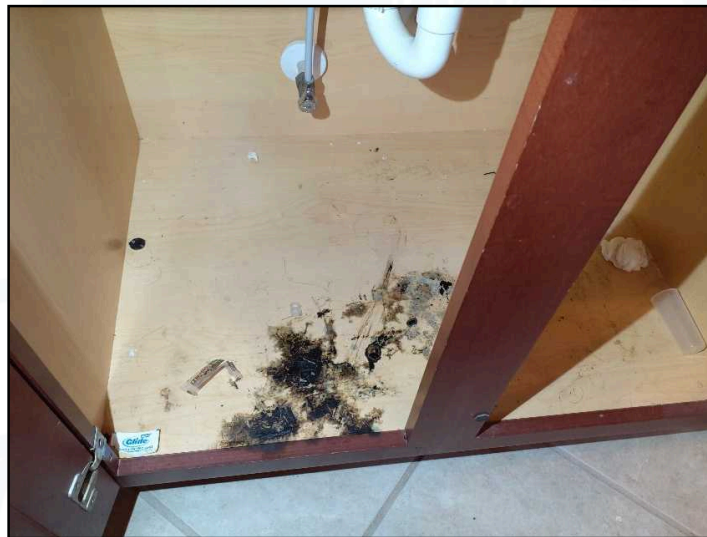
Water stains/damage at vanity cabinet

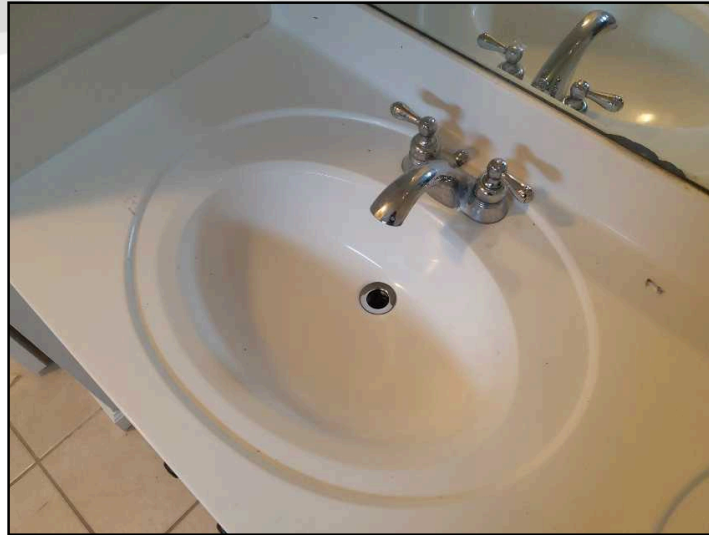
Non-functioning drain stopper noted in the Jack N Jill Bath

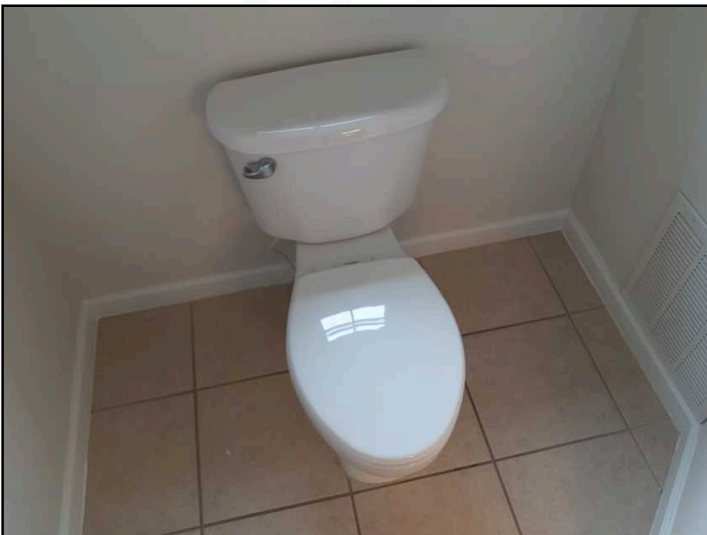
The water was turned off to the toilet in the Master bath bath room at the time of the inspection. This may have been a temporary fix for a running toilet. Have examined and repaired by a plumbing contractor.

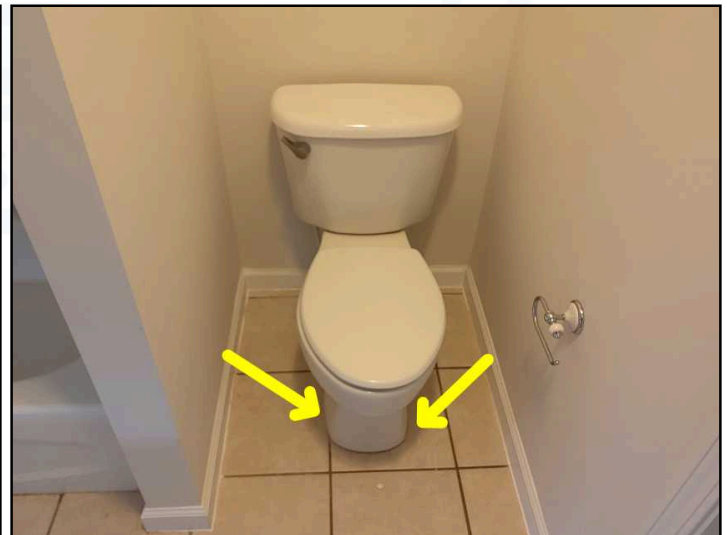
Repair the leak at the base of the toilet in the Jack N Jill bath room. The wax ring may have failed.

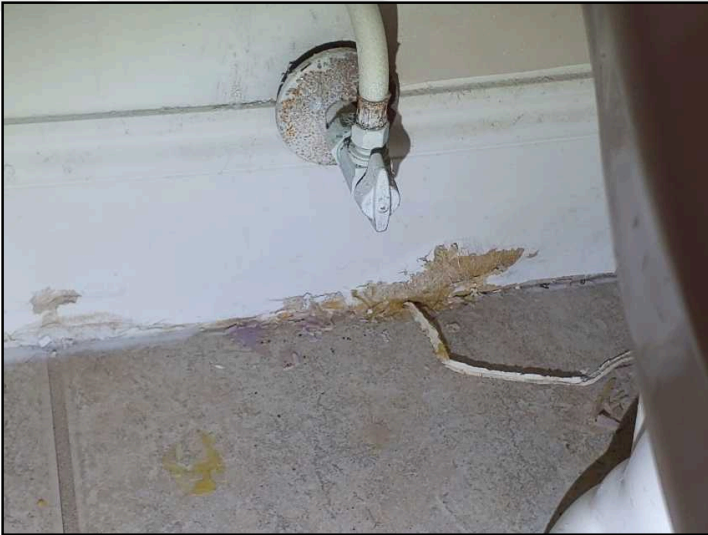
Water damage at baseboard behind main level toilet from leak at toilet tank above

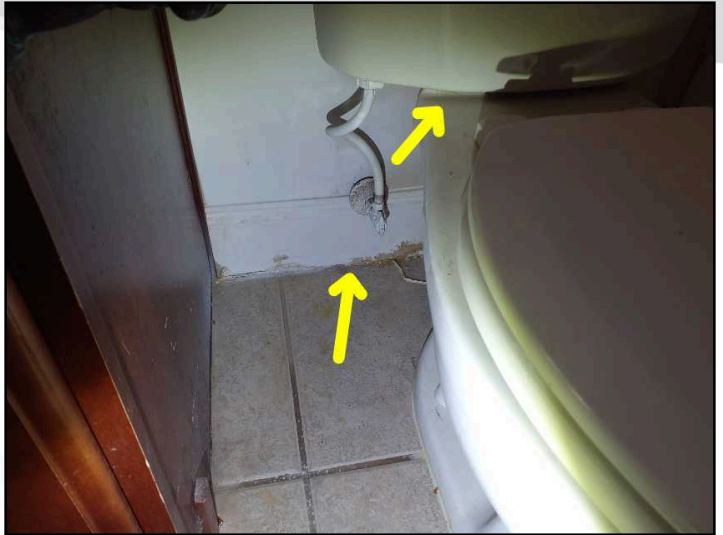
Water damage at baseboard behind main level toilet from leak at toilet tank above

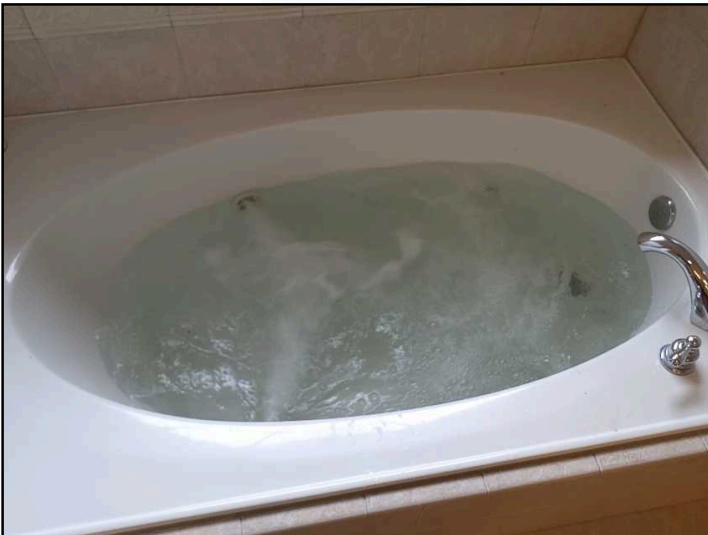
Jetted tub filled and briefly tested

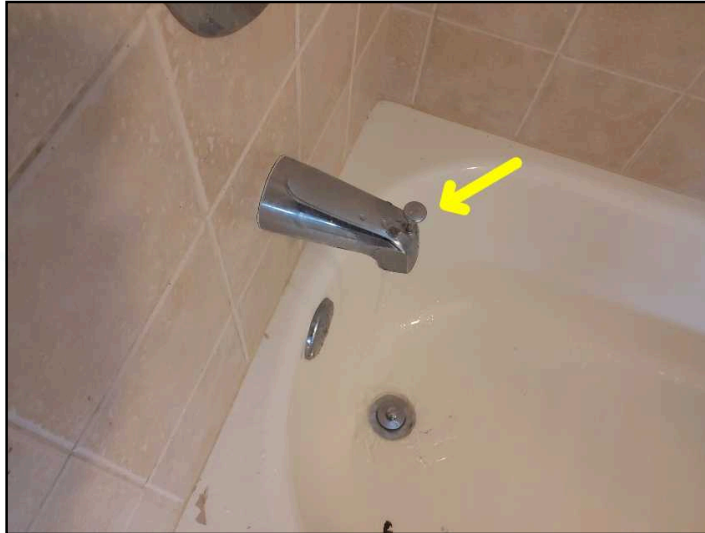
Shower diverter valve does not fully engage at the tub spouts and should be repaired.

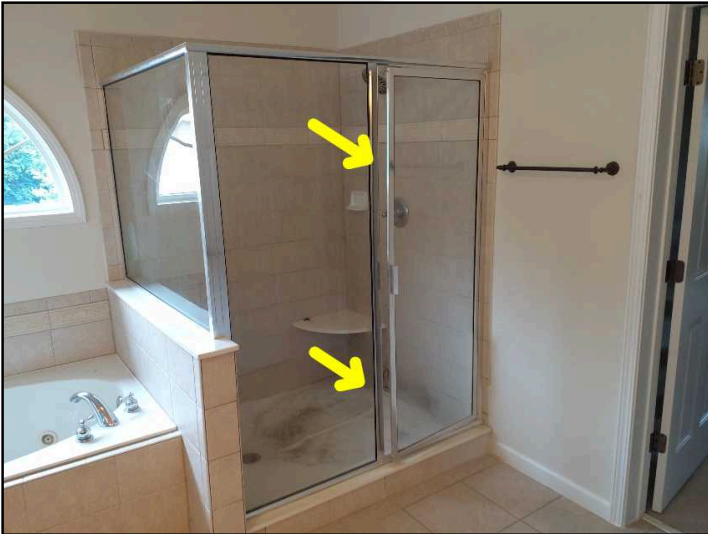
the master bathroom shower stall door is loose, misaligned or sticking making proper operation more difficult. Repair or replace as needed.

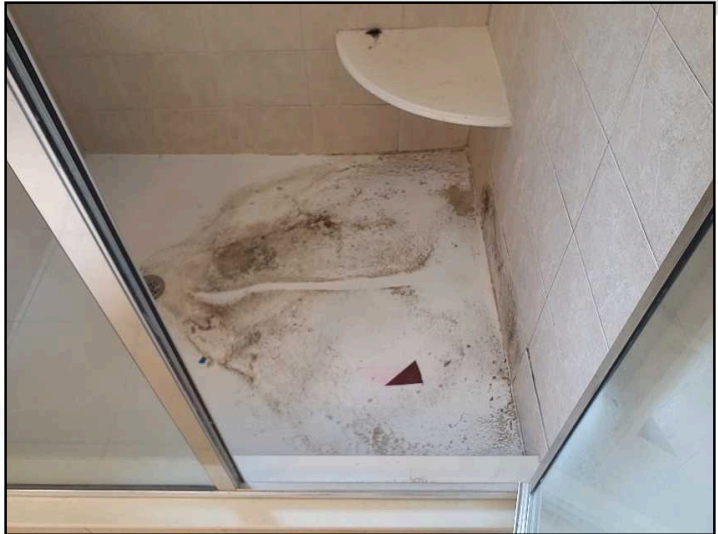
Evidence of leak at master bathroom shower head resulting in mold like growth inside shower stall. Recommend testing to determine type of growth present which Serenity Home Inspections can perform and correction of leak and treatment of growth

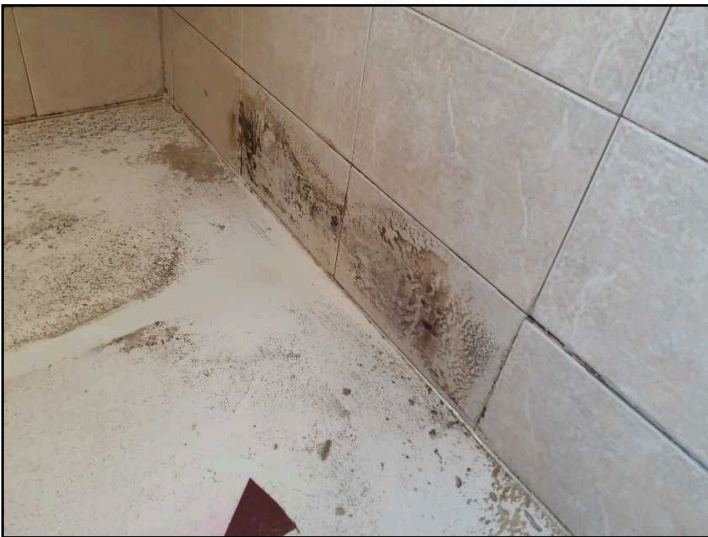
Evidence of leak at master bathroom shower head resulting in mold like growth inside shower stall. Recommend testing to determine type of growth present which Serenity Home Inspections can perform and correction of leak and treatment of growth

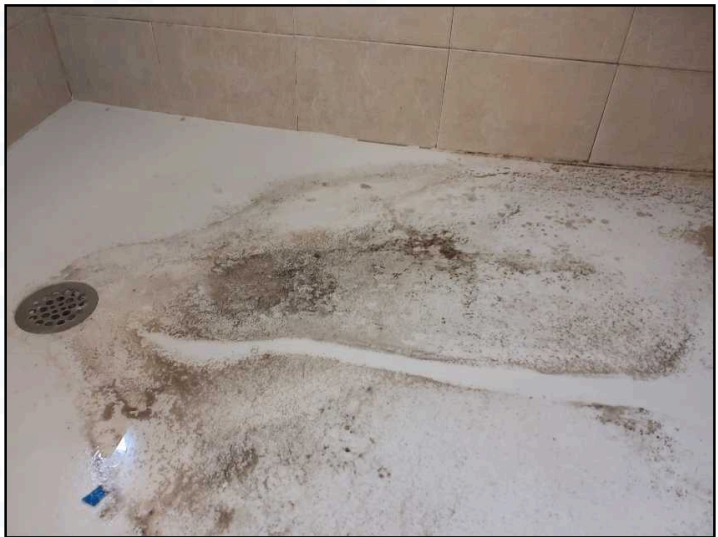
Evidence of leak at master bathroom shower head resulting in mold like growth inside shower stall. Recommend testing to determine type of growth present which Serenity Home Inspections can perform and correction of leak and treatment of growth

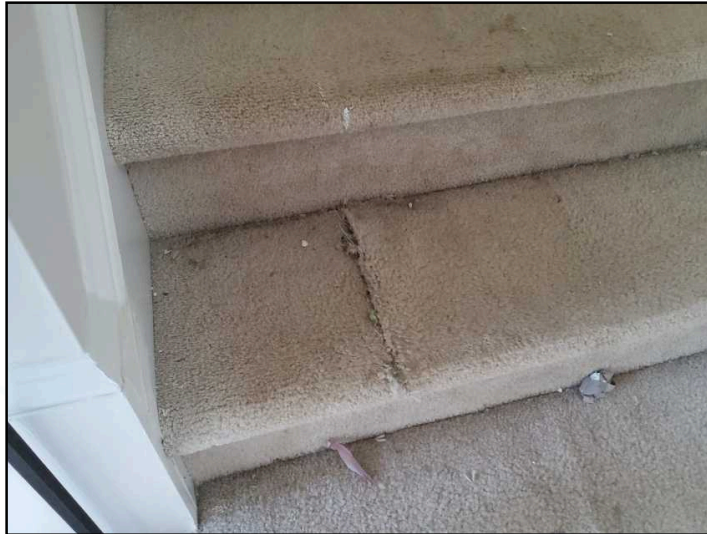
## 2. Interior Wall Conditions

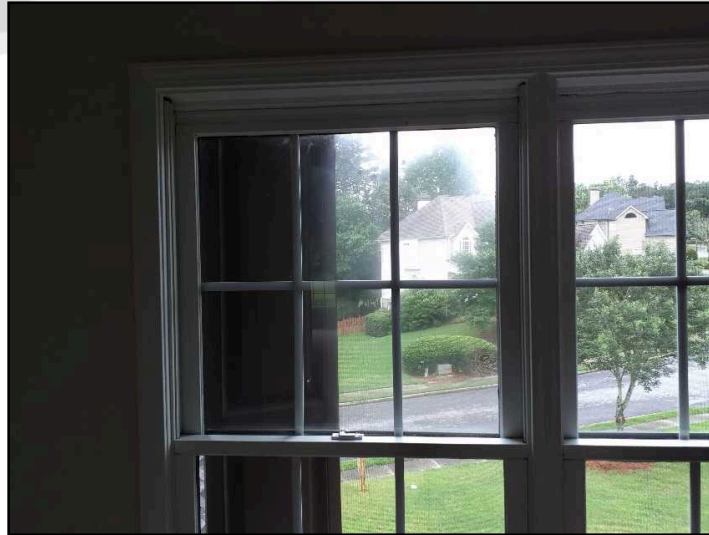
Thermal seal failure observed at window in the Upper Front right guest bedroom

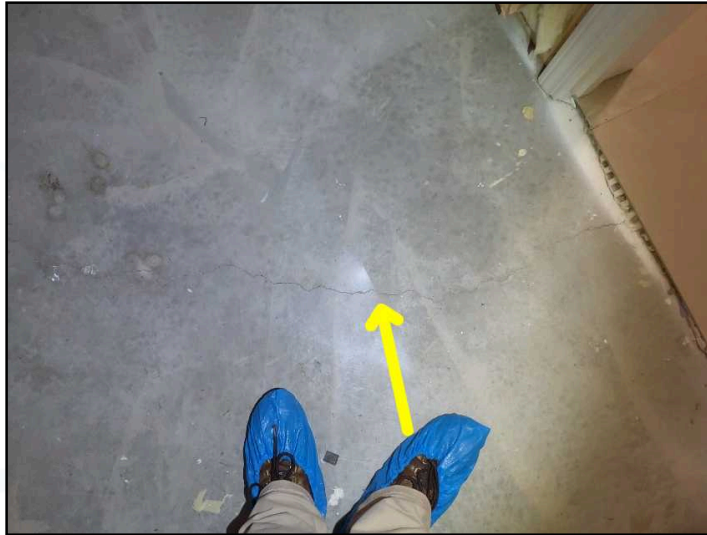
Settlement/shrinkage cracks were present on the concrete surface (<1/4 inch wide). Typically, these are from standard settlement, from admixtures or the composition of the concrete, or from weather conditions when the concrete was poured. Any references to cracks on basement or garage concrete slabs will need to be sealed with an appropriate material by a qualified person at a minimum, regardless of the crack's size. This will prevent the possibility of moisture/water infiltration rising through the crack(s) during periods of heavy rainfall. This material can then be monitored for new cracking which would indicate active movement/settlement.

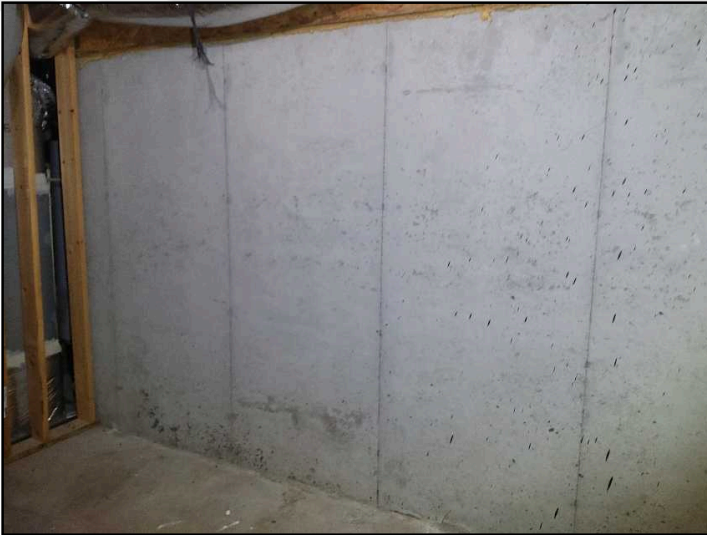
Foundation wall image

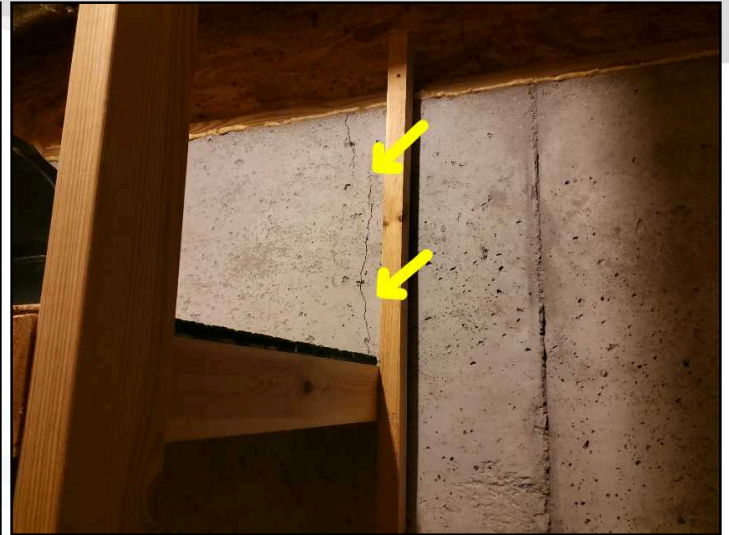
Common cracks observed. These should be sealed as needed and monitored for any future leaks or movement.

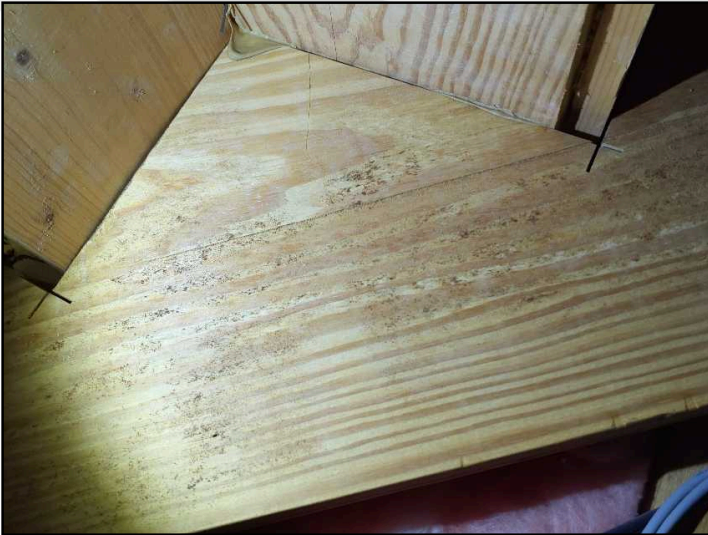
The inspector observed a substance resembling microbial fungal growth partially covering the sub floor structure and framing members in the basement below the staircase.

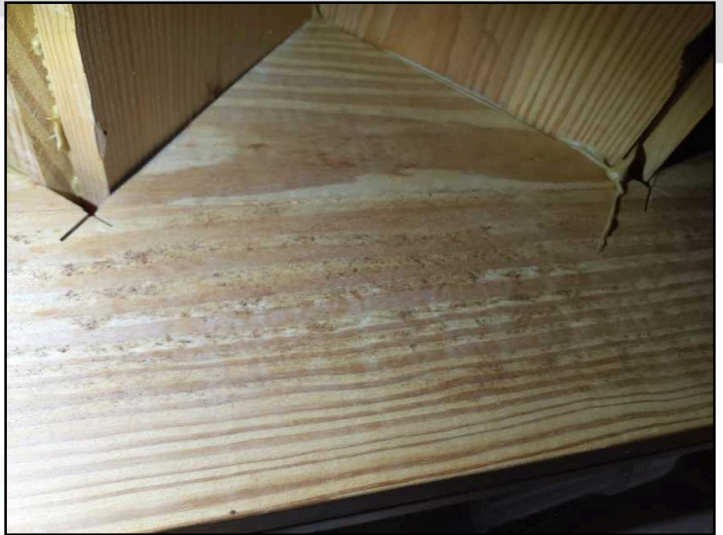
The inspector observed a substance resembling microbial fungal growth partially covering the sub floor structure and framing members in the basement below the staircase.

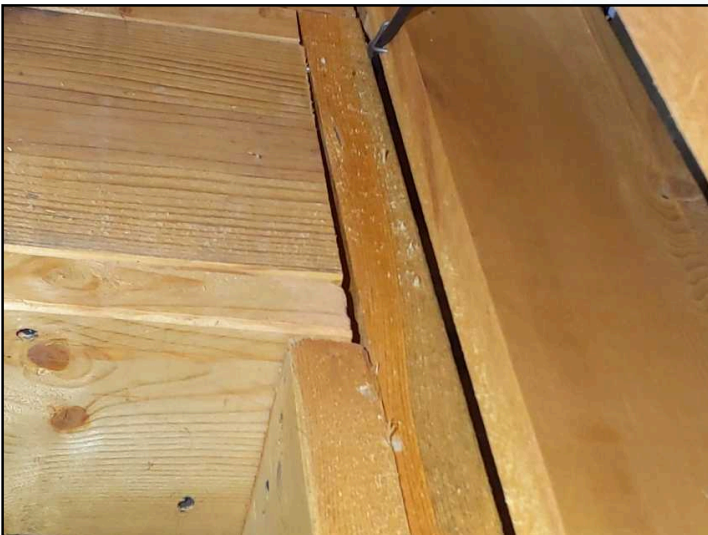
The inspector observed a substance resembling microbial fungal growth partially covering the sub floor structure and framing members in the basement below the staircase.

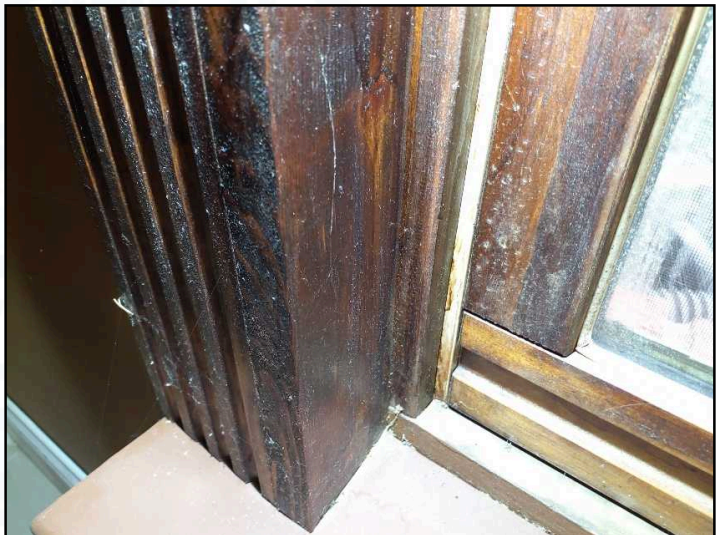
## 6. Basement Insulation

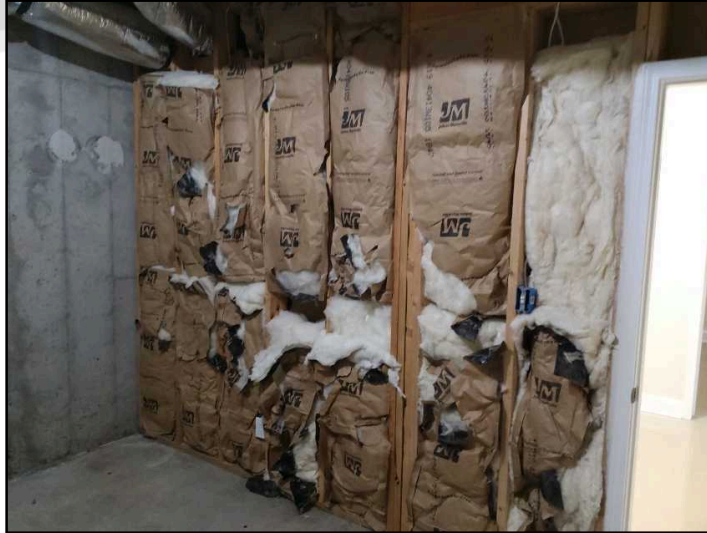
The insulation at the ceiling or walls of the basement has been installed backwards. The paper facing should be installed towards the conditioned side of the home. The paper portion is flammable and should not be left exposed.

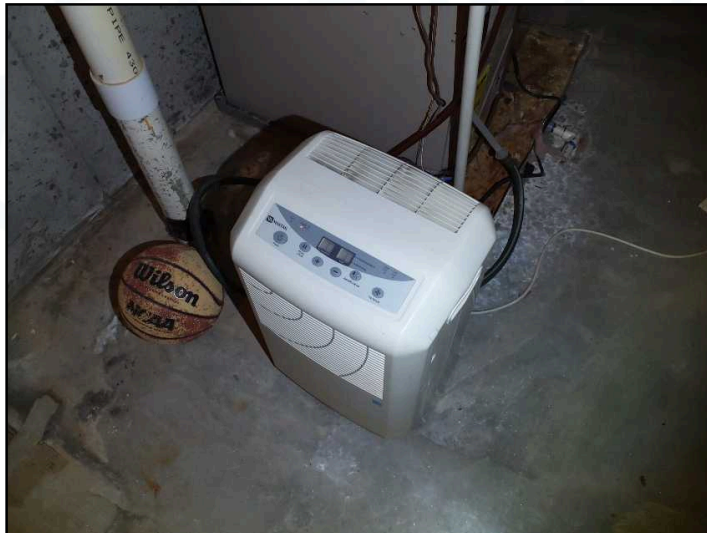
There is a dehumidifier running in the basement at the time of the inspection. This is a common way to reduce moisture in the air if the basement is not conditioned or if the AC does not run often enough.
