FINAL REPORT Water Quality & Conservation Grant FY21 Coronado Soil and Water Conservation District Restoration of Suela [Ciruela] Lateral Las Acequias de Placitas

PROJECT TITLE: Restoration of Suela [Ciruela] Lateral

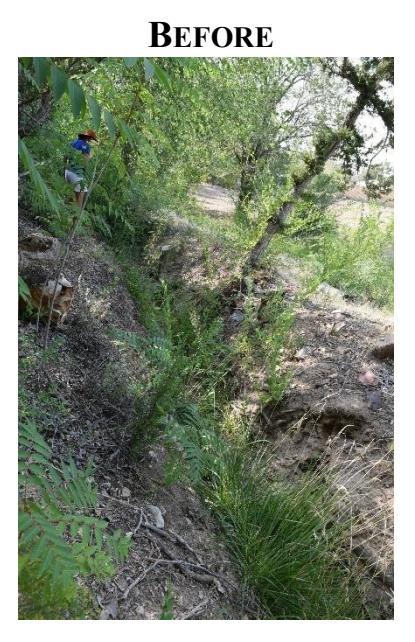
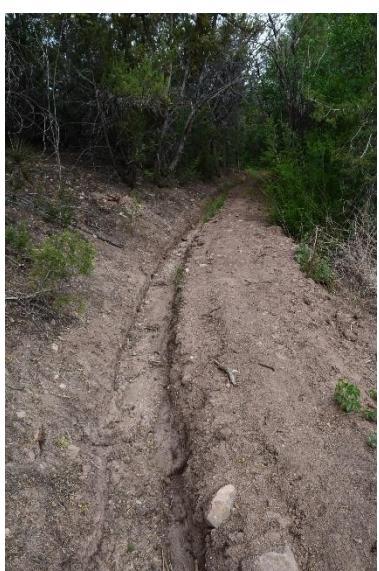
AFTER

The improvement of acequia efficiency and workability was a primary objective. Throughout 3,648 feet of the Suela [Ciruela] Lateral there were overgrown noxious weeds, invasive species, and hazardous stumps. These created an accessibility hazard, reduced workability, and caused excess water loss through transpiration. Their cumbersome removal has created a bank which is walkable and allows for more efficient water flow. To manage the acequia properly it is important for appropriate access of machinery. Removing the overgrowth and stumps allowed for both walkability and machine accessibility. Community volunteer labor was used to trim overgrowth, shovel silt and remove litter. Grant funds were used to rent chipper equipment, and four volunteers chipped for three days. A local arborist was hired to appropriately manage trees and chip wood.

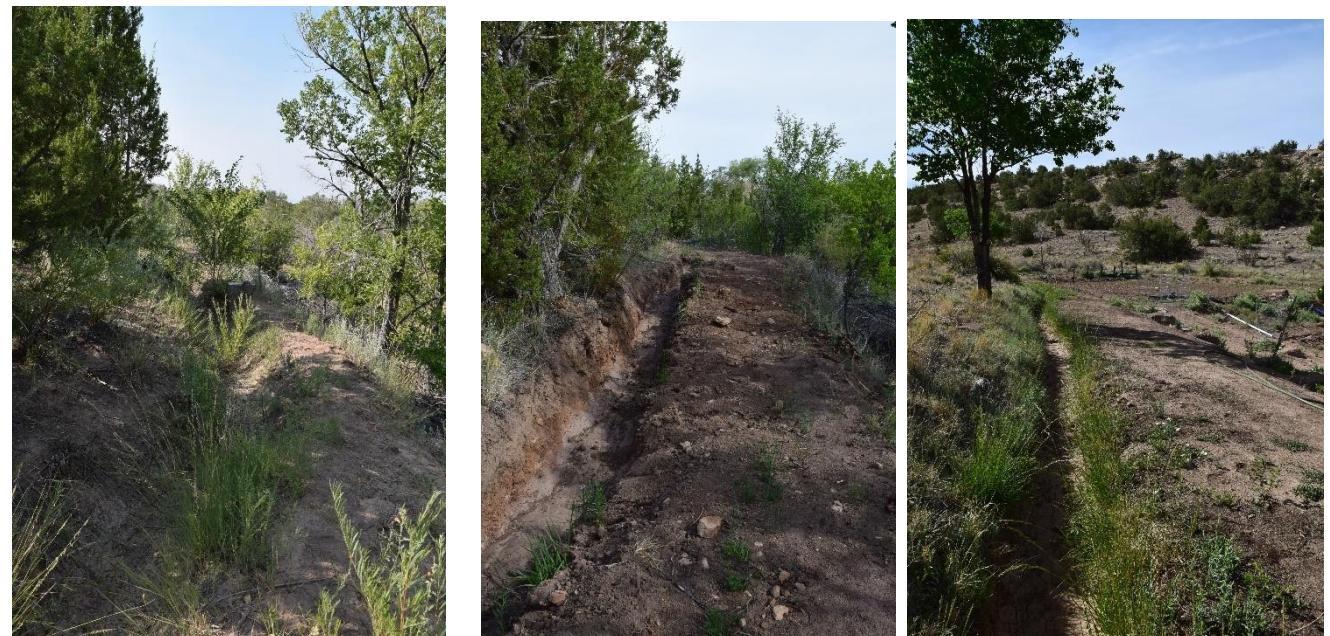
GATES RAMP

Traditional hand-dug ditch cleaning has led to a precarious bank and problematic heaps. Dirt work along the Suela [Ciruela] Lateral included realignment and leveling of the bank, which was necessary for safety, adequate walkability and machine access. The installation of gates at property lines has allowed property owner privacy while maintaining ditch access and workability for equipment. Two access ramps were created, one in the middle and one toward the end of the accequia to facilitate equipment access. Grant funds were used to rent a small tractor and the Mayordomo was the operator to level the bank.

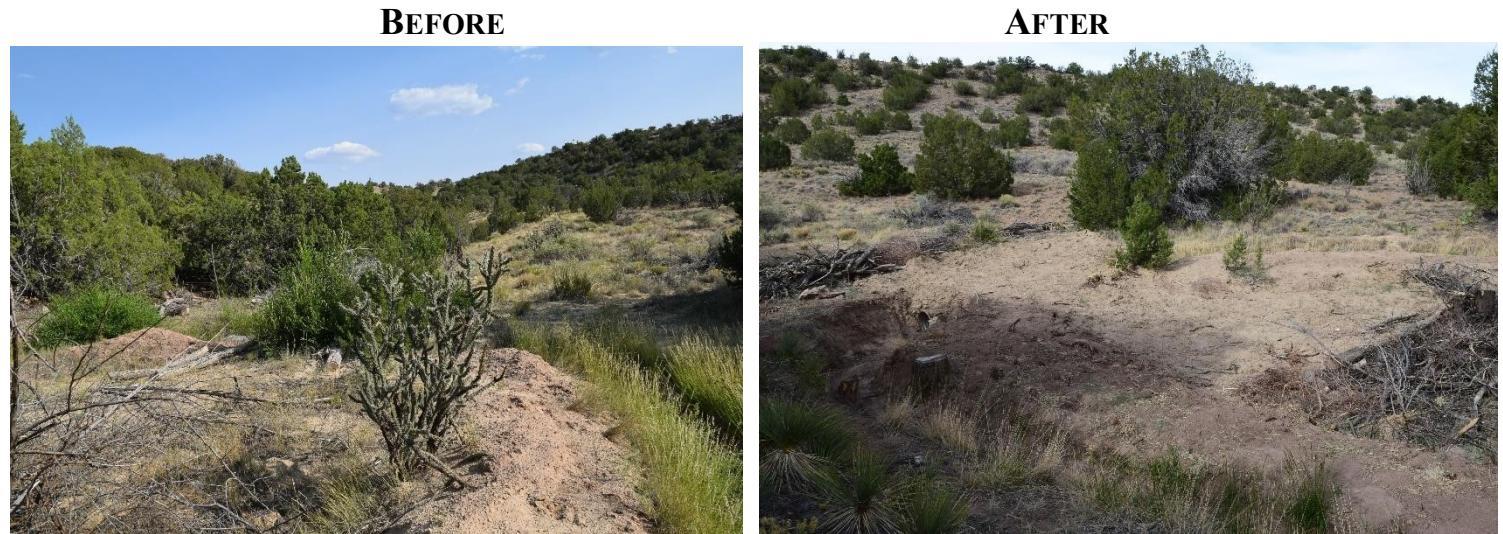
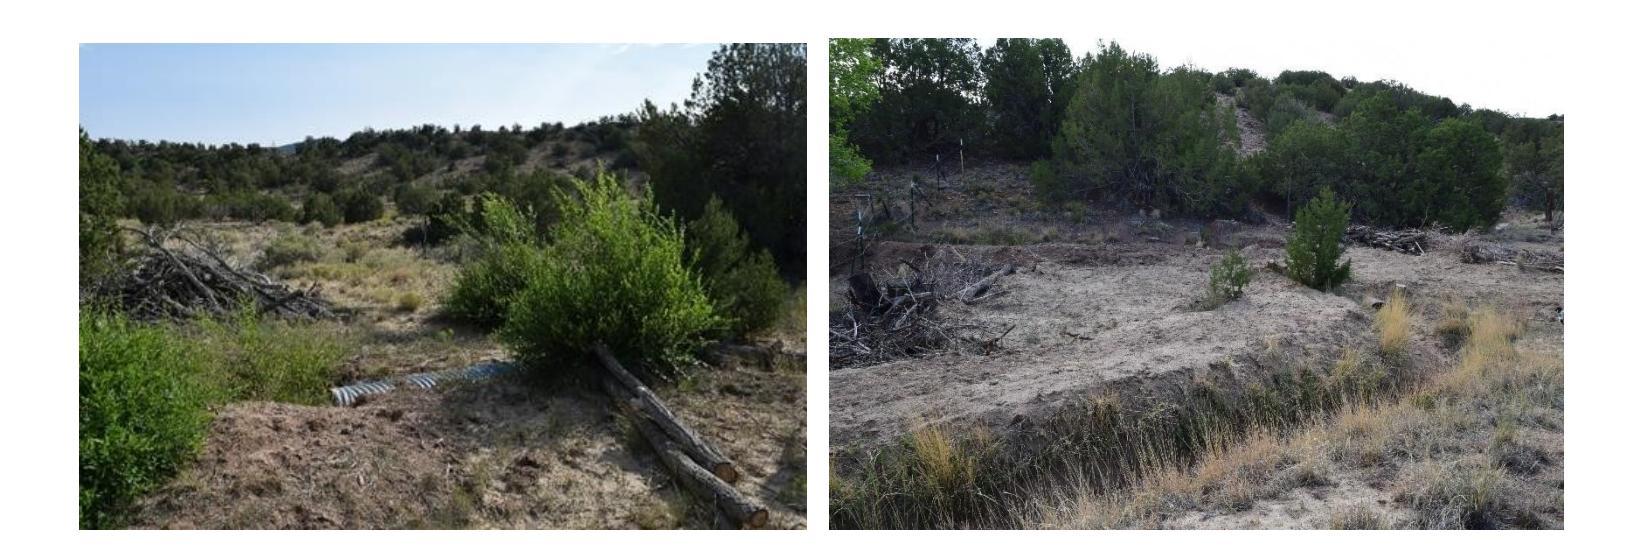
AFTER

Silt infiltration and clogging was a consistent problem. The installation of water breaks at arroyo crossings now controls the infiltration of sediment into the acequia. Equipment and an operator were used to create water breaks and upstream arroyo crossing for silt infiltration.

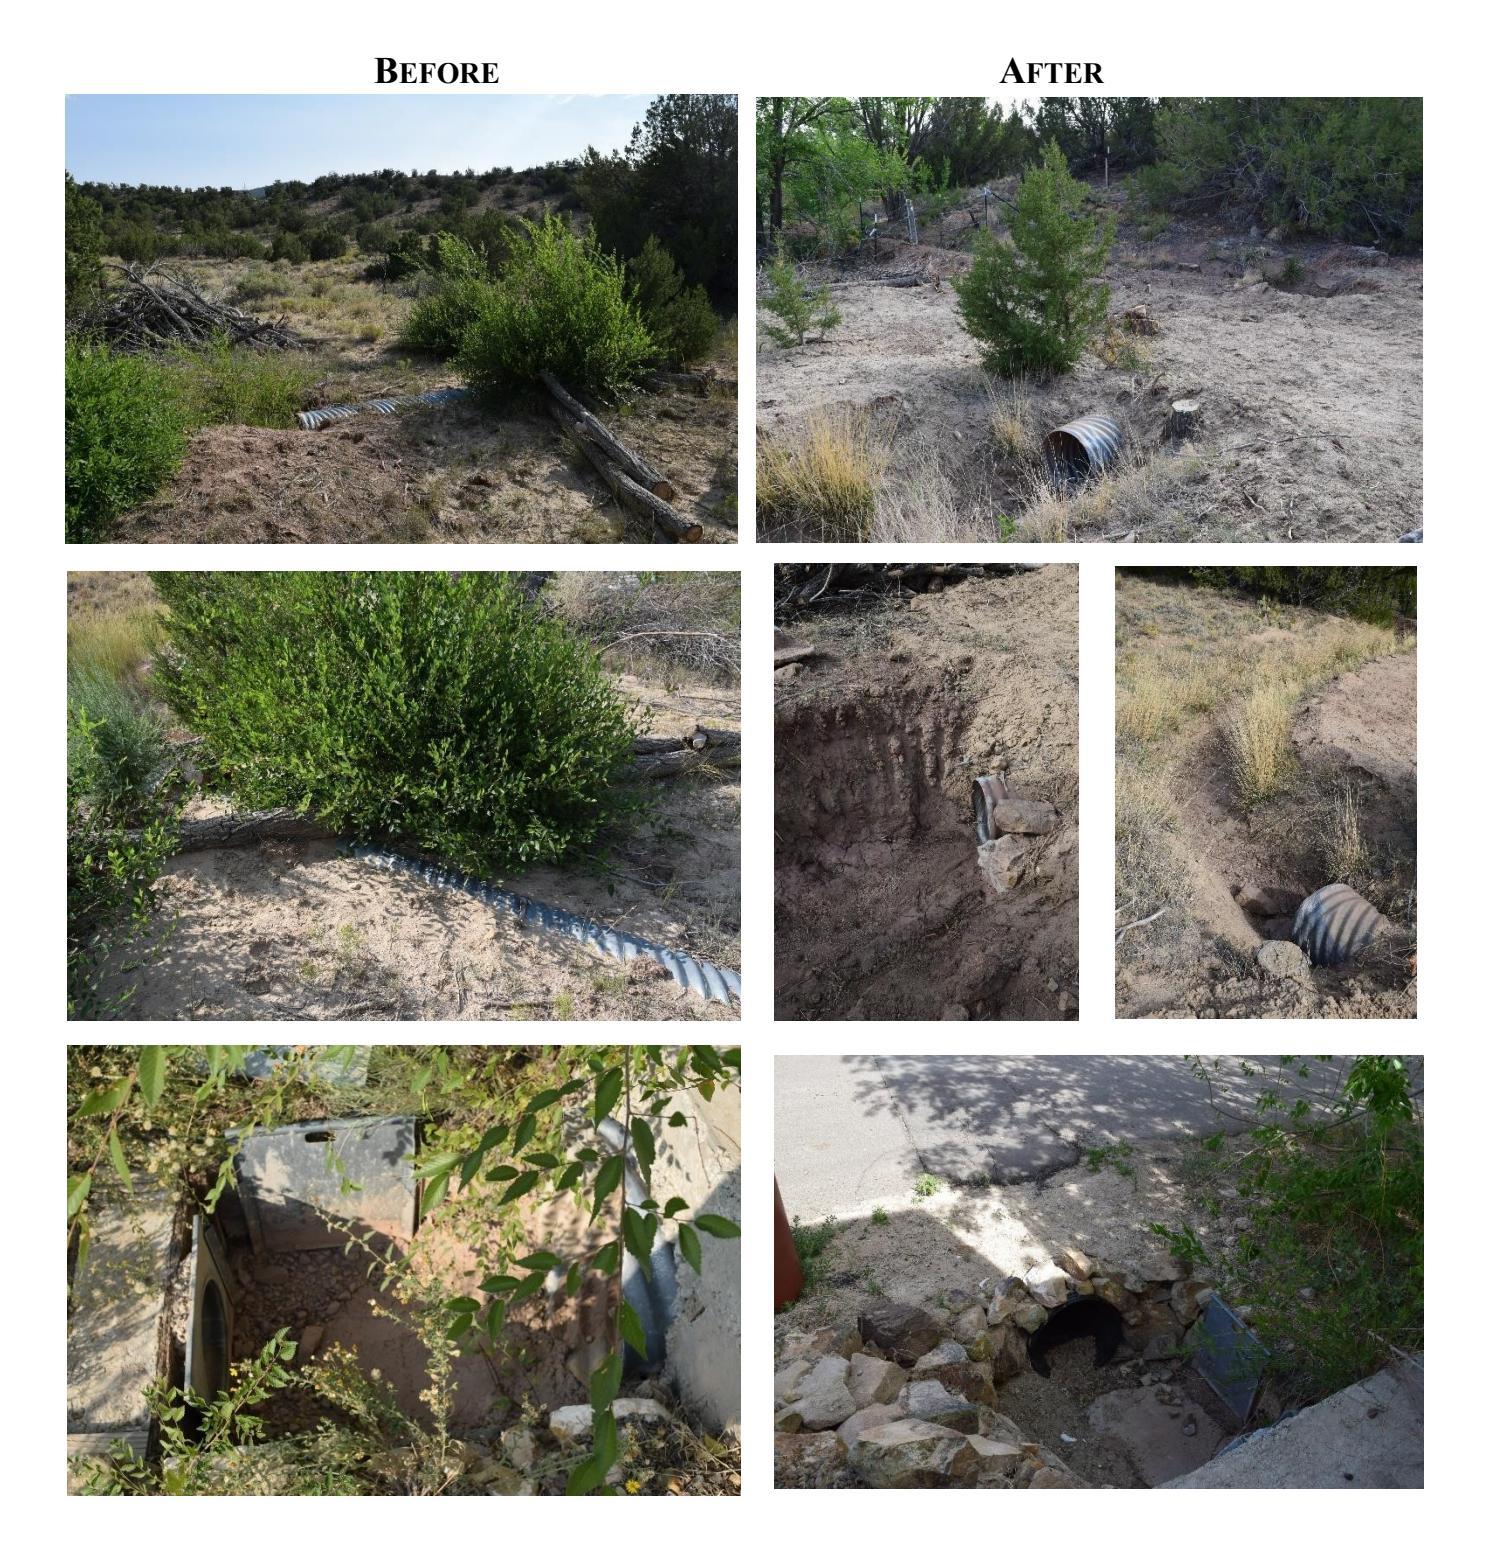
Culverts had been placed throughout the system ad hoc. Most were undersized, collapsed or missing. This made the acequia susceptible to silt infiltration and reduced head pressure. Of the six culverts in need of replacement, two were updated and reworked. These two culvert locations were critical for acequia operation and efficiency.

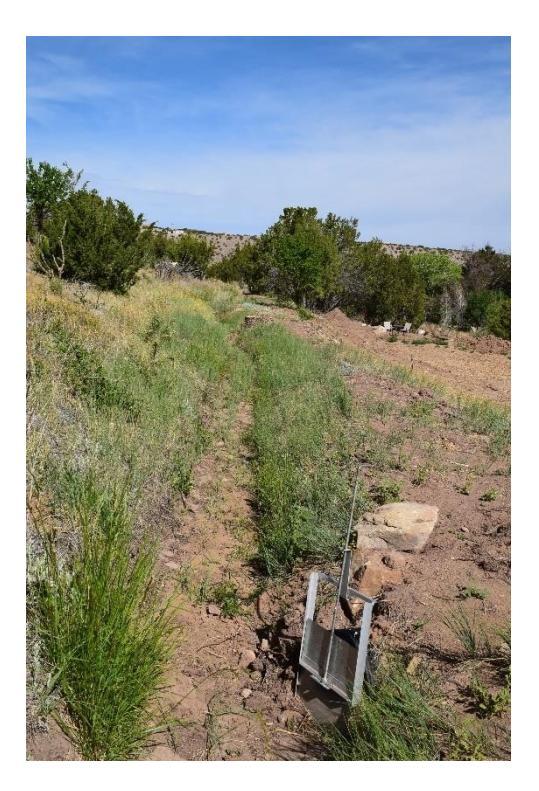
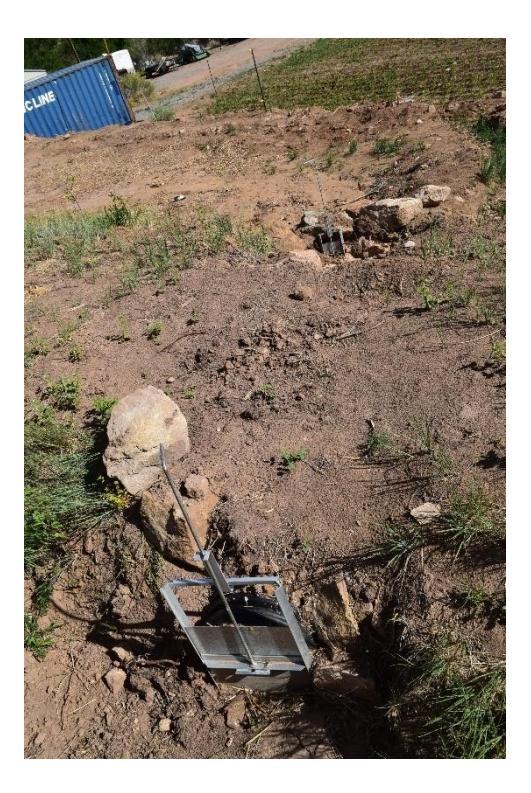
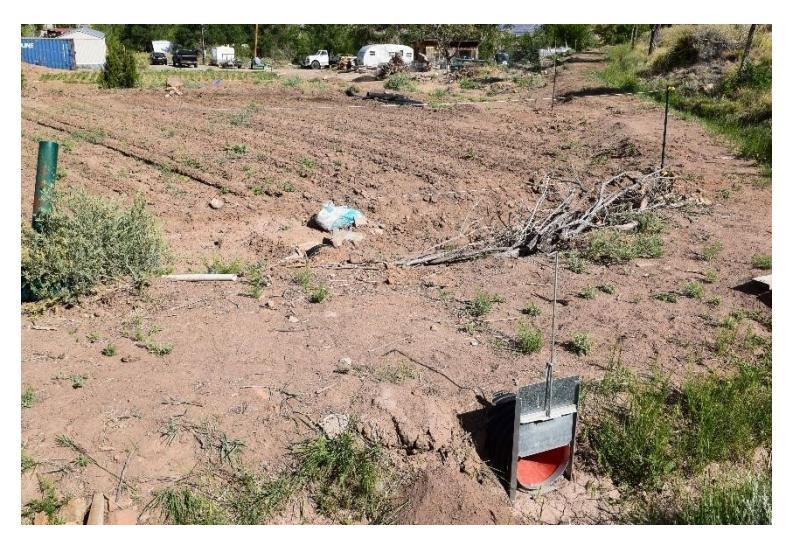
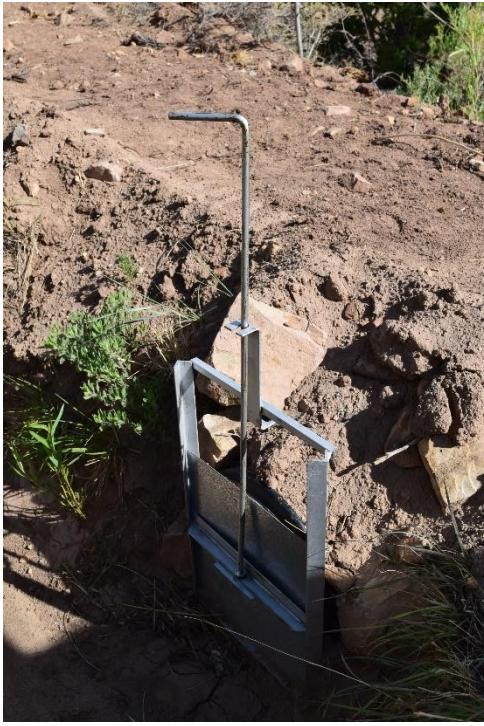
Old and leaking turnouts reduced head pressure and wasted water. The replacement of key turnouts has increased efficiency of the system, saving water and time.
