HANSON ENVIRONMENTAL

Contract Report: Eurasian Watermilfoil removal in Noxon Reservoir.

September 2014

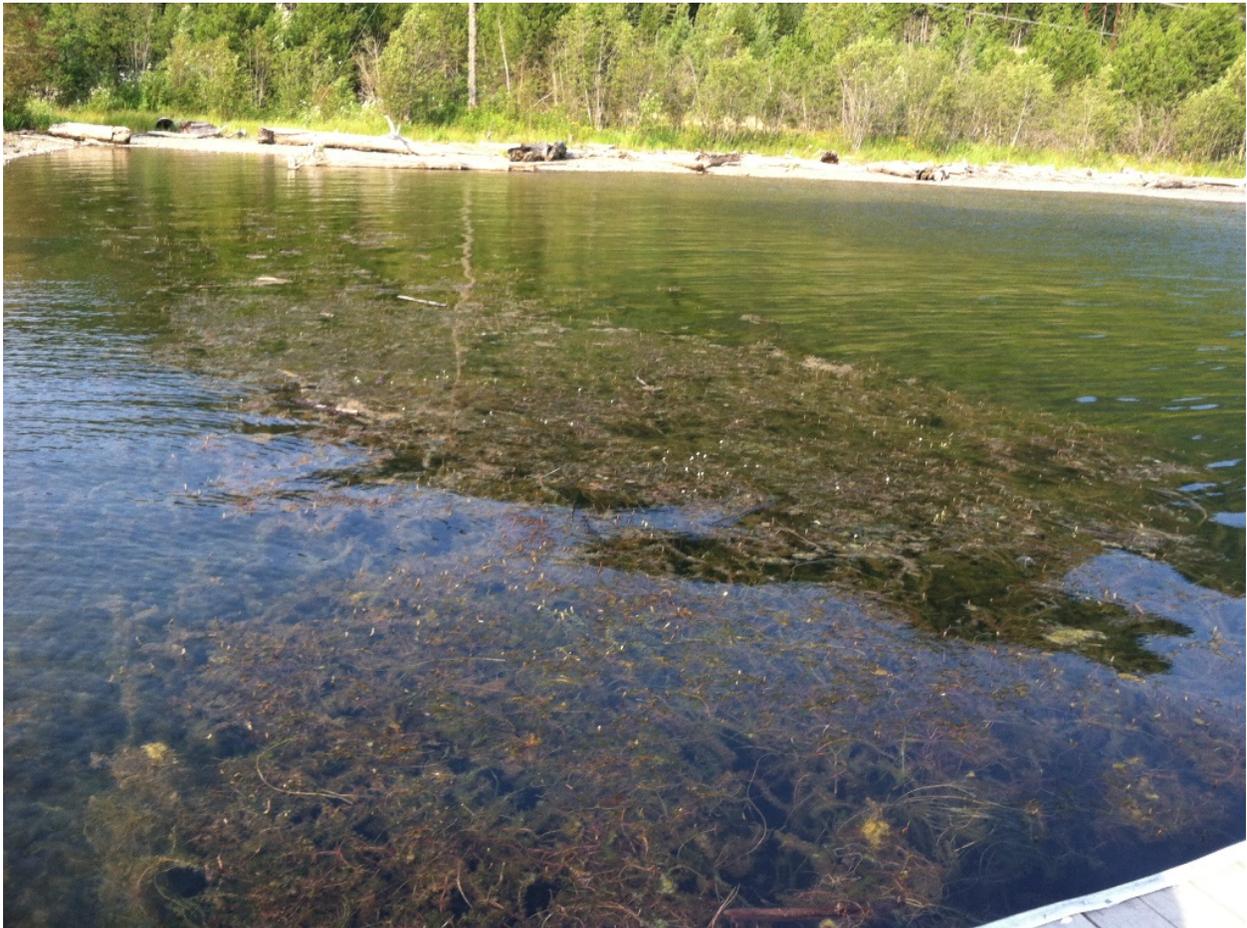
Diver dredge removal occurred August 1st through the 2nd. Plants were removed, stored overnight in bins and weighed. A total of 577 lbs of Eurasian Watermilfoil were removed from site N-11-14. 90% of the Eurasian Watermilfoil was removed from the area. Only a couple of Eurasian Watermilfoil plants occurred near the boat launch at site N-11-14 and were removed.

Eurasian Watermilfoil at site N-11-14

These sites and other boat launches should be monitored to ensure that watercraft do not pick up or displace Eurasian Watermilfoil as they launch. At N-11-14, there is a continuous strip of Eurasian Watermilfoil that continues along the shoreline. These plants would likely result in a rapid recolonization of the launch area due to their proximity and density. The site should either have an additional year of diver dredging or an application of a granular herbicide (due to small area) to provide control.

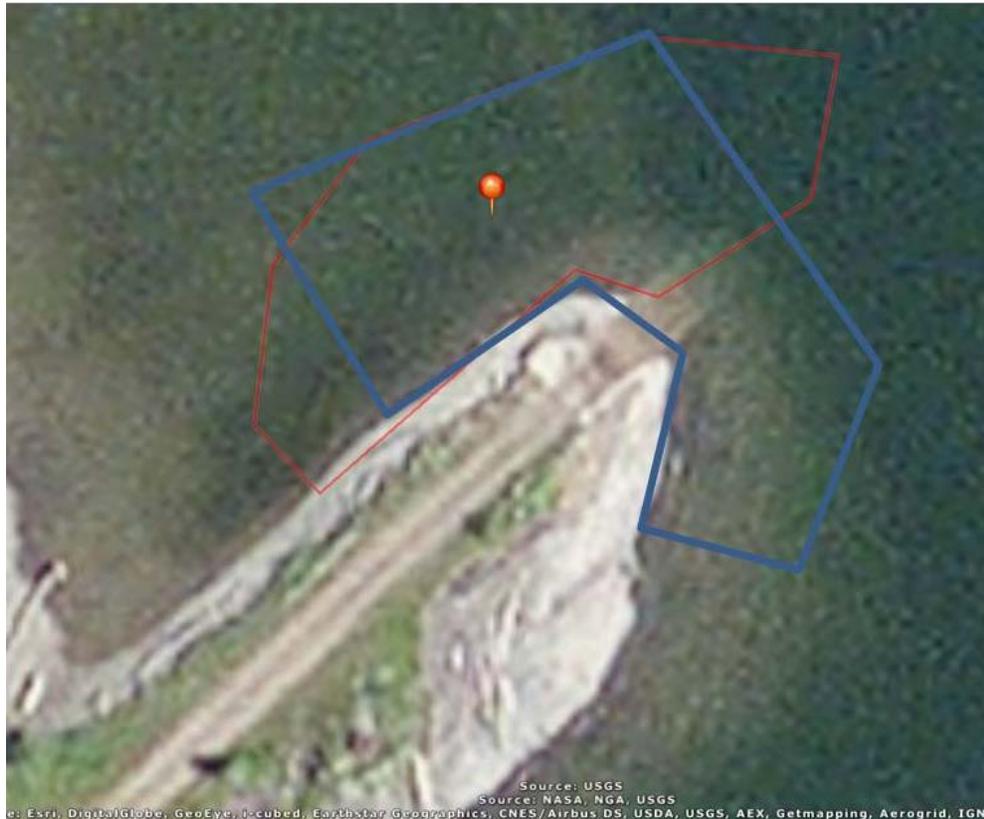
Eurasian Watermilfoil occurred in high densities outside of the identified N-11-14 plot area. The image below shows the outline of the plot area in red and the dredged area in blue. The photo doesn't show it but the dock sits to the left of the land area and the launch is at the very end. As the Eurasian watermilfoil was dense on both sides of the launch, removal took place to remove the Eurasian watermilfoil that could be moved around by boats.
