# **SANTA ROSA CREEK STEELHEAD HABITAT AND POPULATION SURVEY**

Prepared by:  
Jennifer Nelson, DFG  
Assisted by:  
Eileen Baglivio and Tim Kahles,  
CA Conservation Corps  
2005

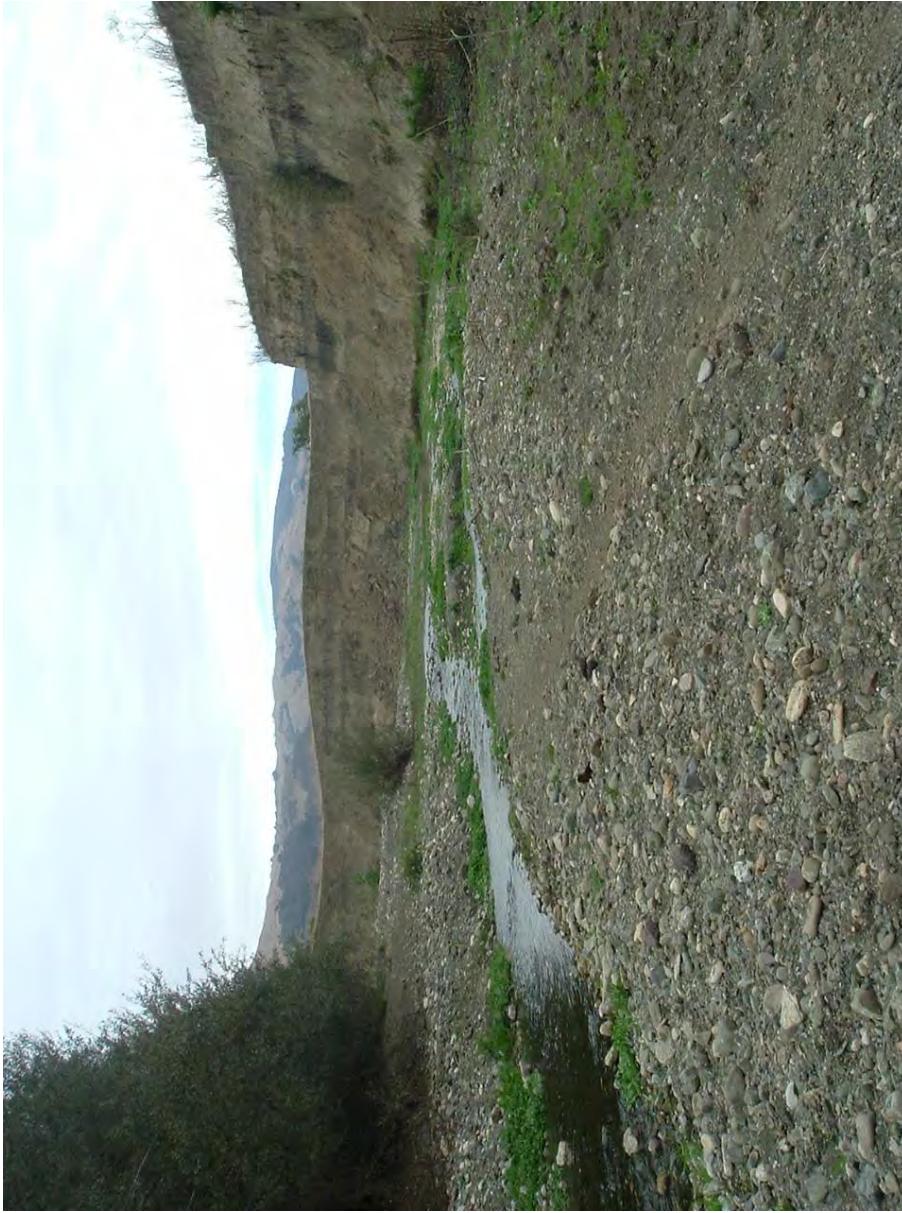
Descriptions and locations of stream bank erosion sites are in the Comments and Landmarks section.

Figure 11. One of several vertical denuded banks observed along Santa Rosa Creek, 2005.

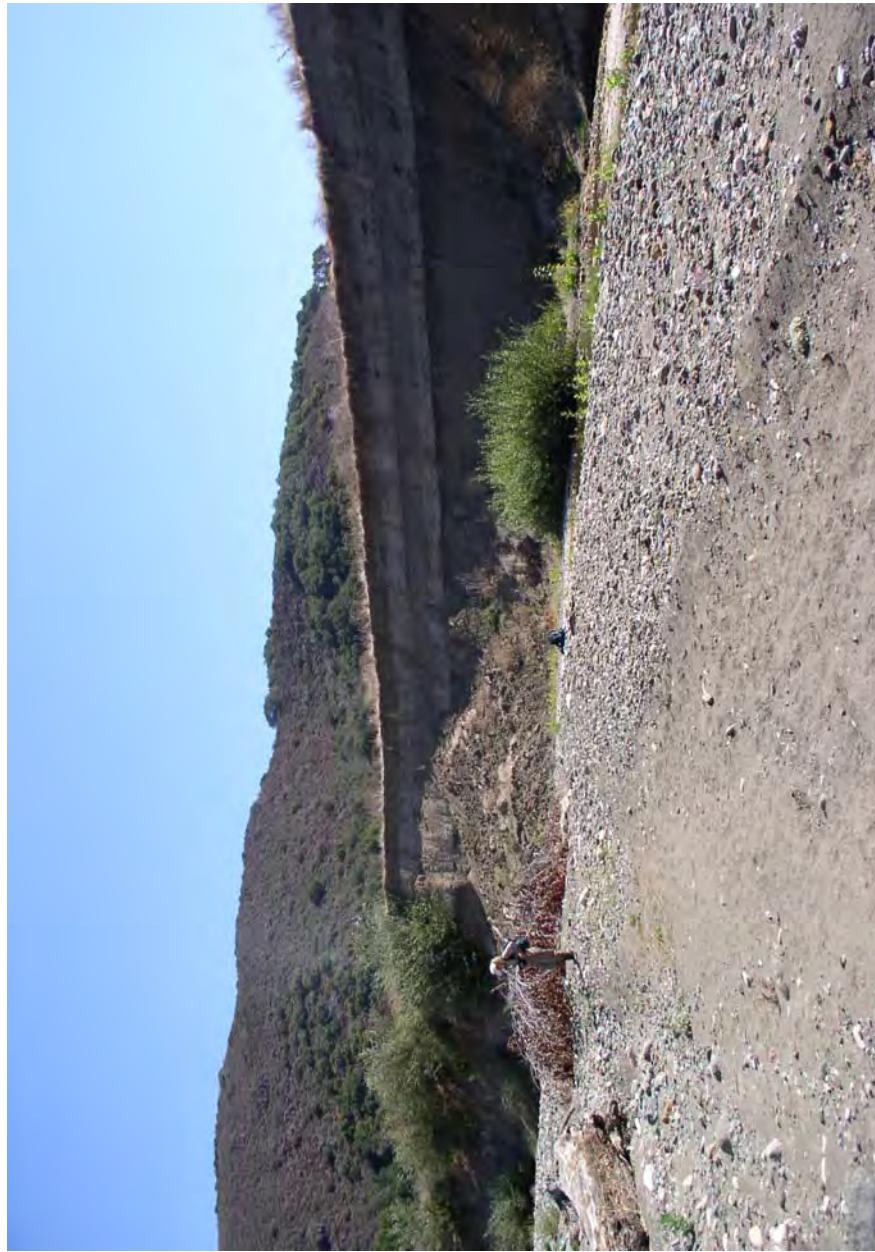
During the summer and fall months, stream flow at approximately stream mile 6.7 (unit 363) goes subsurface leaving a portion of Santa Rosa Creek dry for a part of the year. The dry unit was 2,625 feet long at the time of the survey (Sept. 21, 2005) although that distance and the length of the dry period may vary from year to year depending on the amount of rainfall the previous winter. The flood plain width in this section ranges from 250 to 350 feet with the potential wetted channel being 70 to 100 feet wide. These channel characteristics extend 3,304 feet upstream of the current dry channel. The stream banks throughout the dry reach and extending to stream mile 7.9 are 15 to 20 feet high, vertical, denuded, and are actively eroding in many areas (Figure 12). This section of dry creek severs the upper watershed from the lower watershed and can delay or prevent upstream migration of adult steelhead and downstream migration of smolts during drier years.

Figure 12. A portion of the dry section in Santa Rosa Creek, 2005.

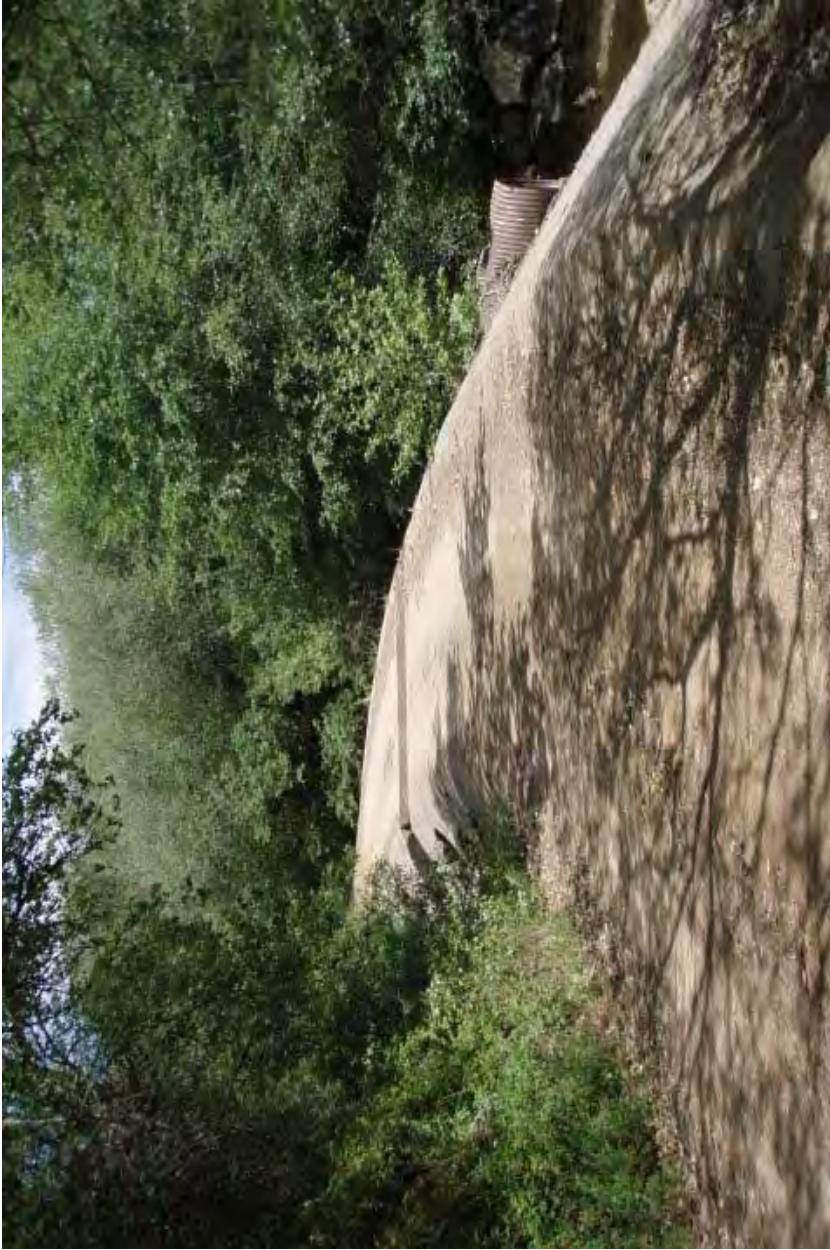
Another impediment and occasional barrier to upstream adult and juvenile migration is Ferrasci Road crossing located at stream mile 3.4 (N $35^{\circ} 24' 05.0''$  W $121^{\circ} 03' 55.3''$ ). The crossing is a 10 foot high concrete ford that spans the 45 foot wide channel at an angle and has three culverts and a fish ladder through the center (Figure 13). The culverts are 4 feet in diameter and are perched approximately five feet above the pool at the base of the structure (Figures 14 and 15). The fish ladder is 4 feet in width and the flow is run-like through the ladder during the low flow season. During high flow events, water flows completely over the structure (Figure 16).

Figure 13. Ferrasci Road crossing at stream mile 3.4.

#### **1) Remove Ferrasci Road (ford) crossing and replace with a bridge.**

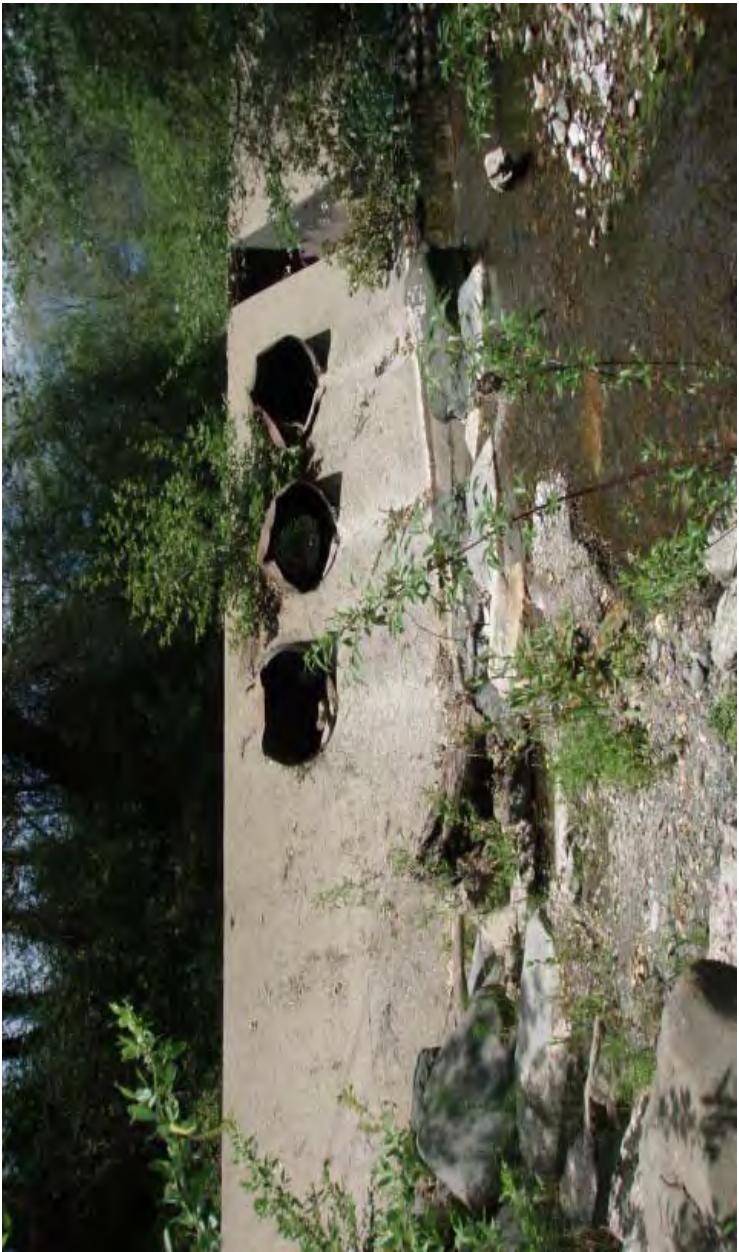
Figure 14. Looking upstream to Ferracci Road crossing, Santa Rosa Creek.

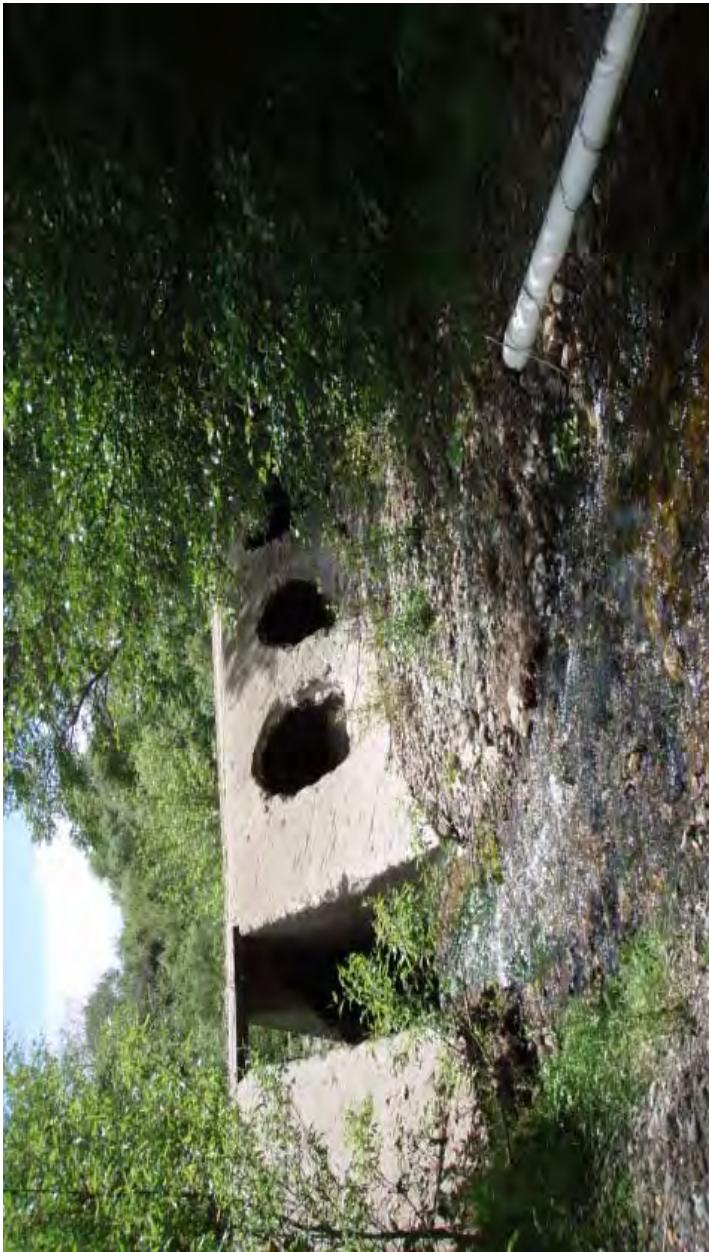
Figure 15. Looking downstream to Ferracci Road crossing, Santa Rosa Creek

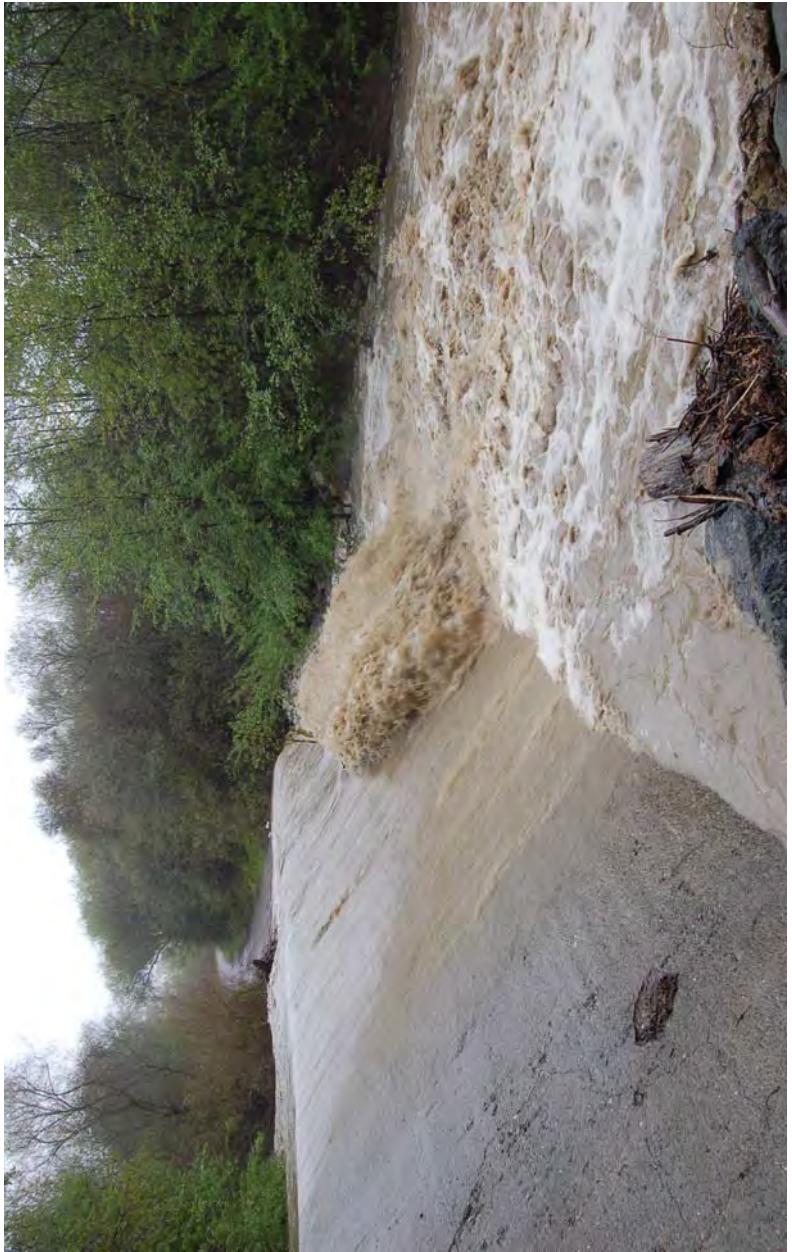
Figure 16. Ferrasci Road crossing during high flows in the spring of 2005.
