FAILURE ANALYSIS OF A WIND TURBINE GEARBOX

On December 27-30, 2010 and January 3-7, 2011, Robert Errichello and Jane Muller inspected one Jahnel-Kestermann (JAKE) gearbox at The Gear Works in Seattle, Washington. The root cause of the loss of oil is unknown and, therefore, not addressed in this report. In both instances, a temperature sensor on a high-speed pinion (HSP) bearing signaled a wind turbine shutdown. This report summarizes the results of the inspection of the gearbox and contains photographs of the failed components.

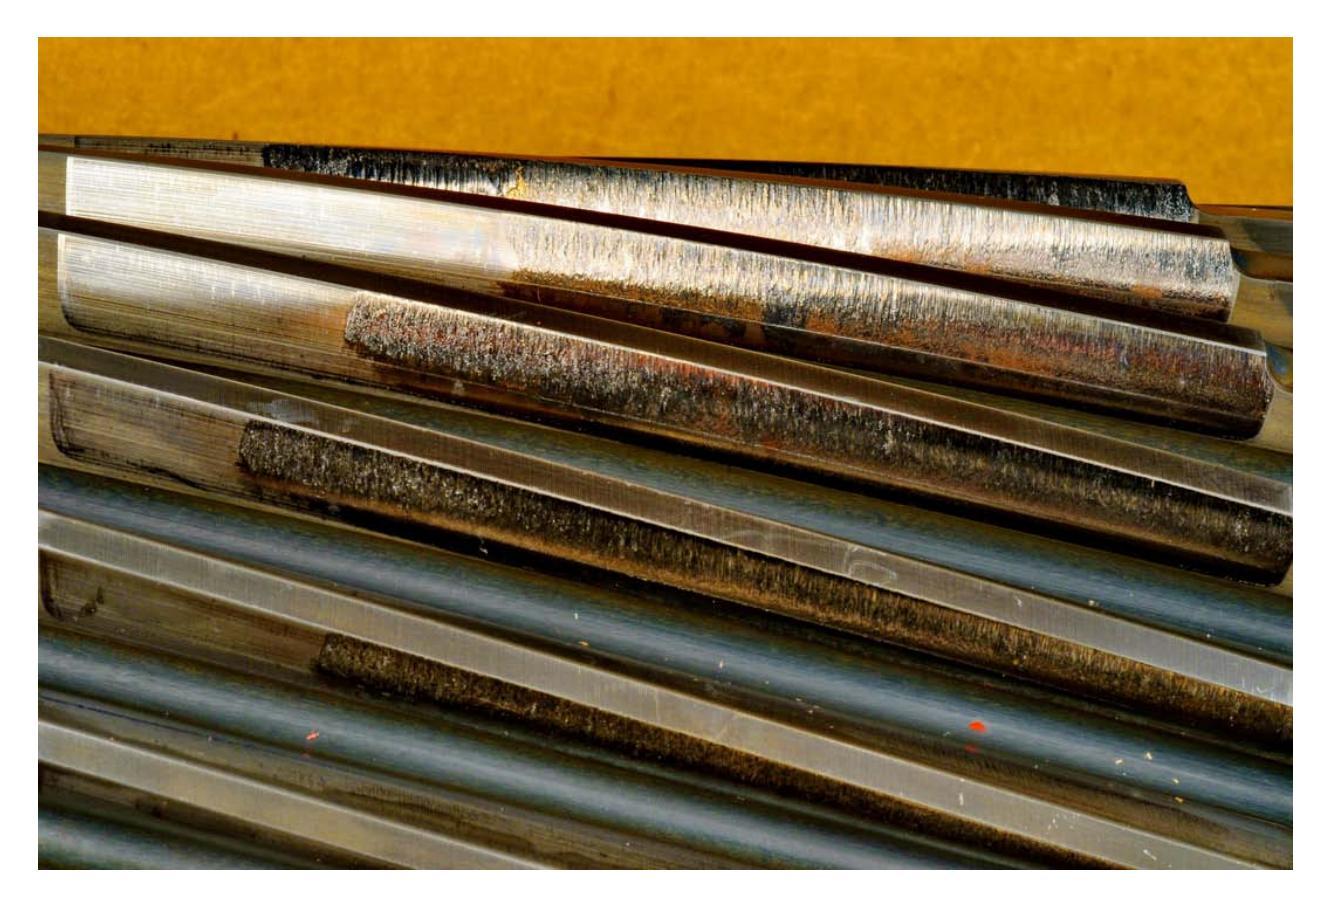
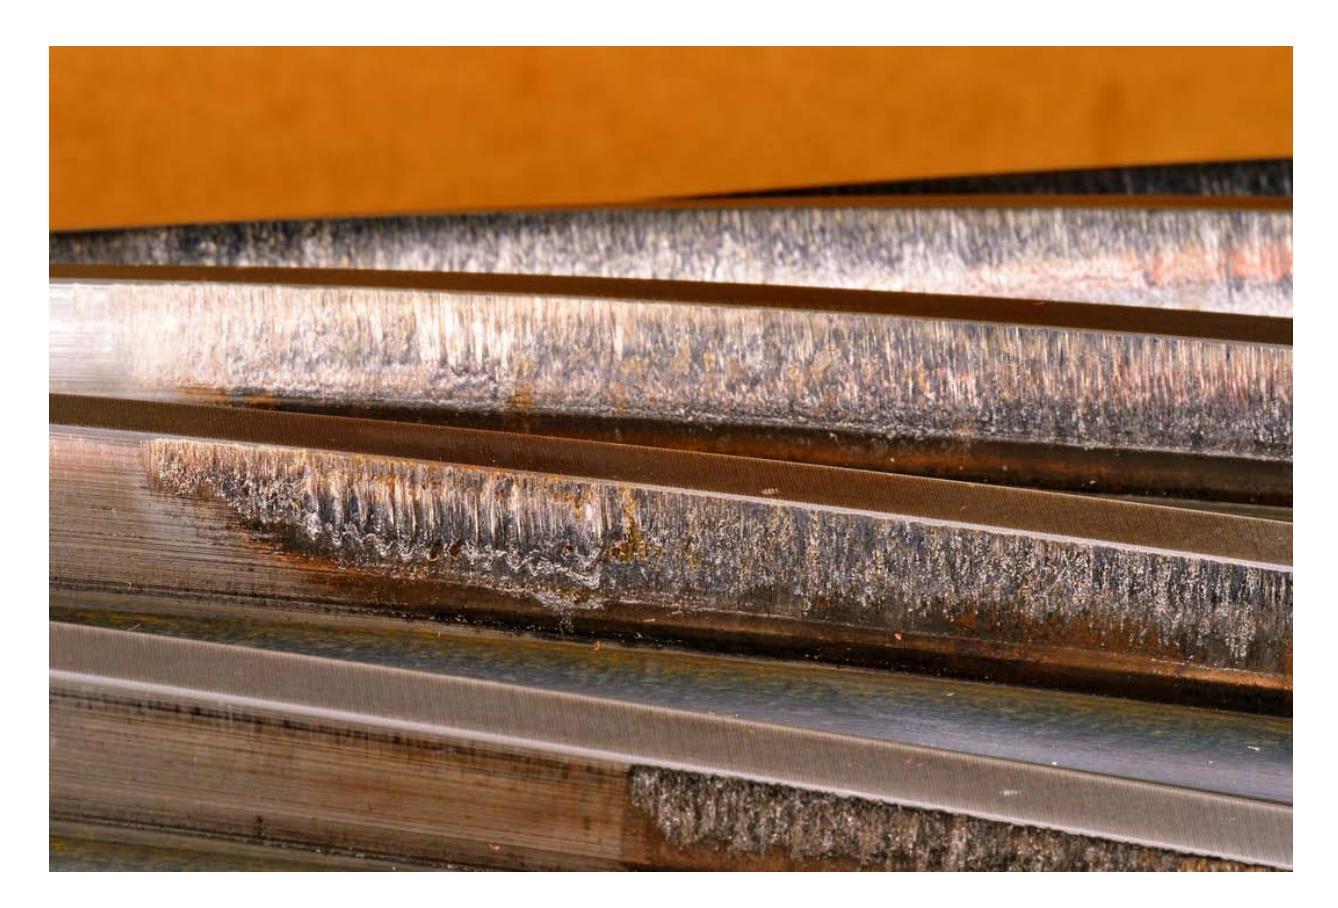
- 1. The primary failure mode of the HS gearset was severe scuffing. The root cause of the failure was probably lubricant starvation. The wear pattern indicates the HS gear mesh was misaligned causing a higher load at the rotor end of the teeth.

Figure No: 3 (NREL PIX 19860) Scale: 1.5X Component: HSP Failure mode: scuffing Failure mode severity: severe Description: Flanks have scuffing that is biased toward the rotor end of the pinion and varies from 65 to 105 mm wide in a sinusoidal pattern.

Figure No: 4 (NREL PIX 19861) Scale: 1.6X Component: HSP Failure mode: scuffing Failure mode severity: severe Description: Same as Figure 1 except closeup view.

Figures 3-6 show severe scuffing on the HS gearset. The scuffing is biased toward the rotor end of the pinion, indicating that the HS gear mesh was misaligned. Furthermore, the scuffing varied in a sinusoidal pattern around the pinion and gear, indicating that there was runout in the pinion, gear, or both. The misalignment could be caused by lead error in the pinion, gear, or both, or by inaccuracy in the gear housing bores. Therefore, the HSP, HSG, and gear housing bores should be inspected to determine the source of the misalignment of the HS gear mesh. Endplay in the HS bearings A1/A2 was within specified tolerance. Therefore, bearing internal clearance did not contribute significantly to the misalignment.

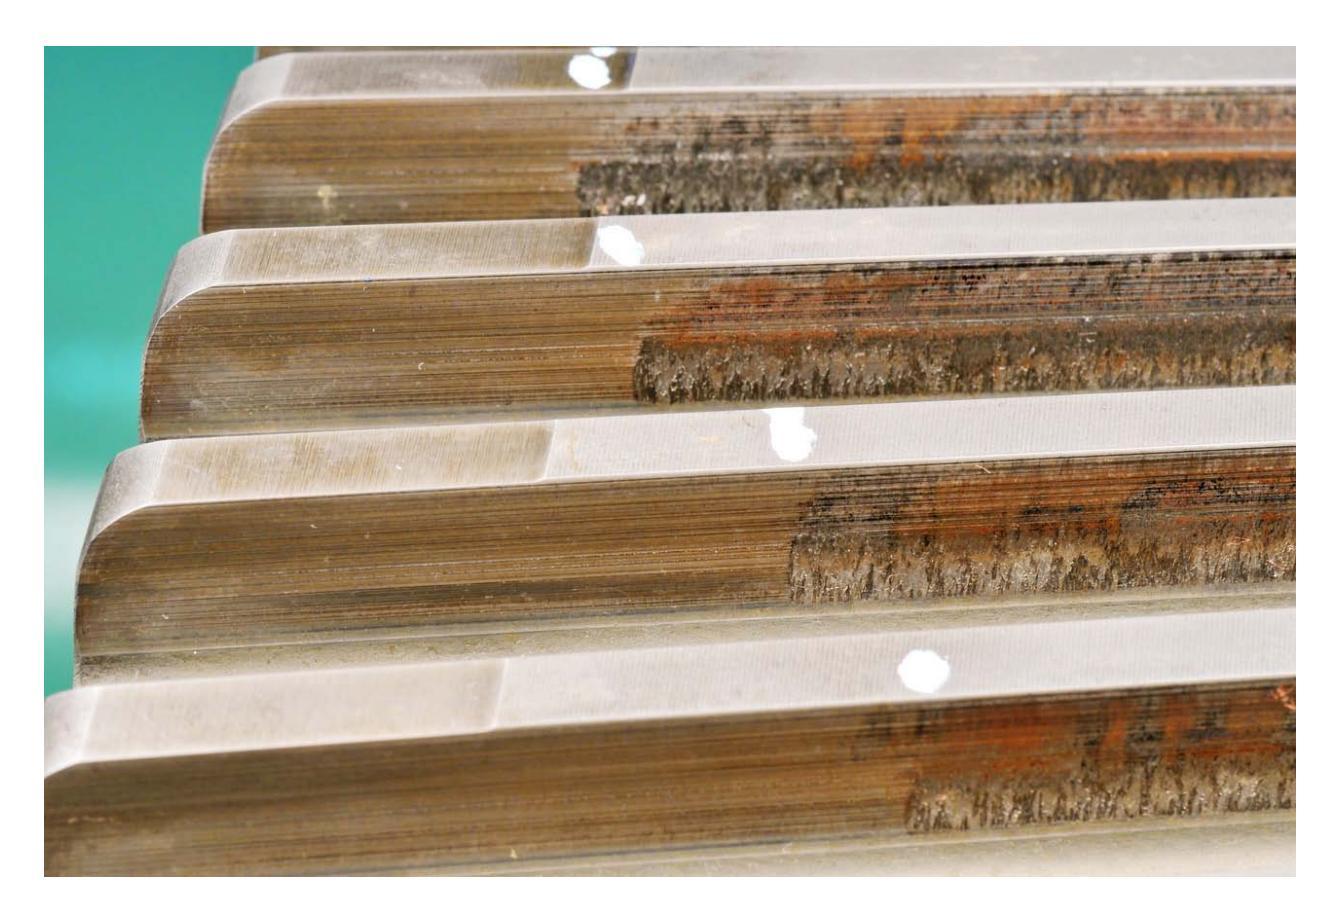
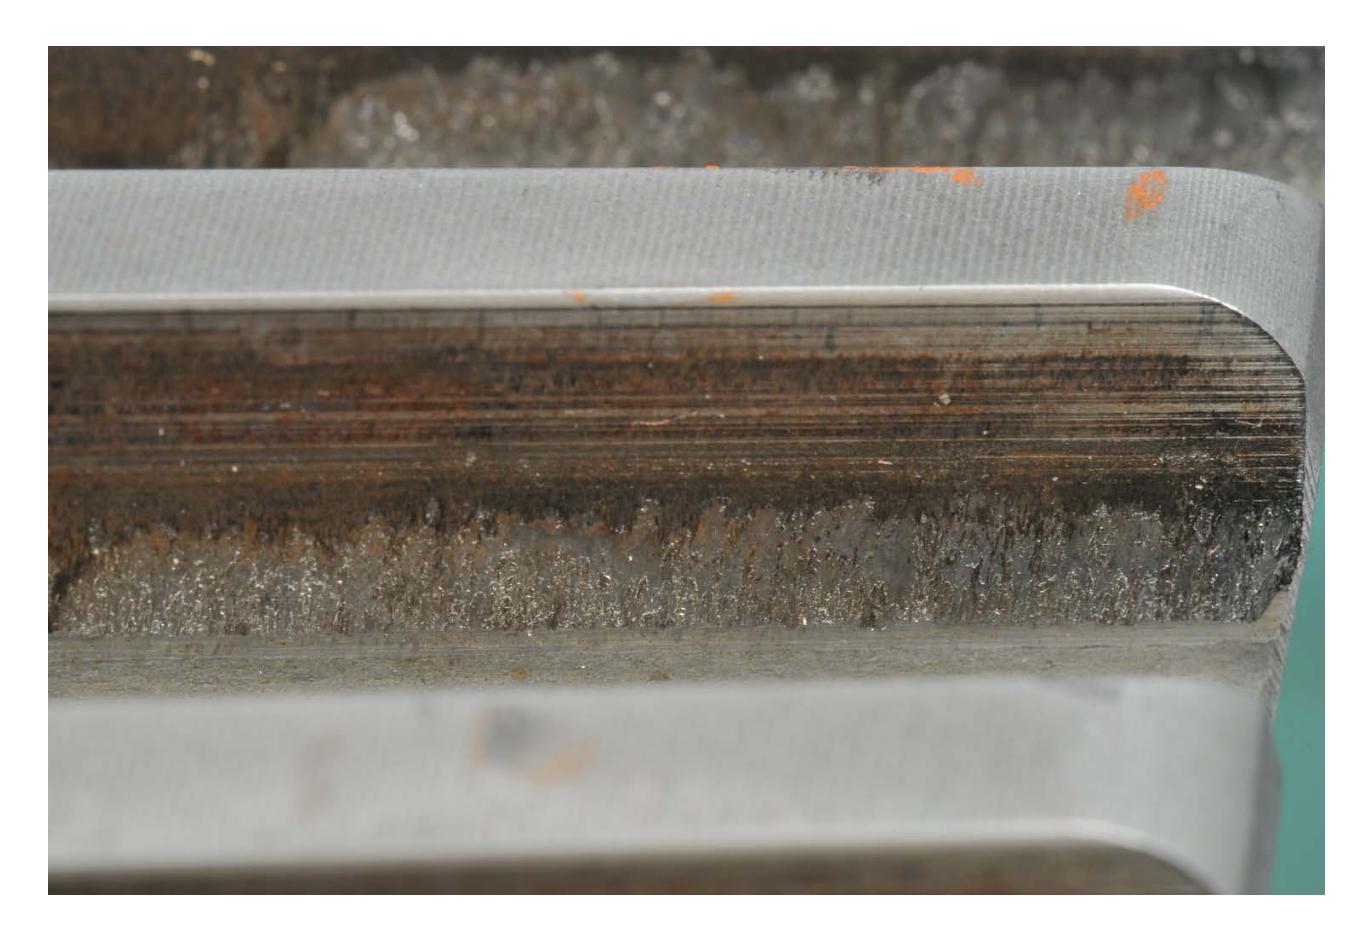
Figure No: 5 (NREL PIX 19871) Scale: 2.0X Component: HSG generator end Failure mode: scuffing Failure mode severity: severe Description: Flanks have scuffing that is biased toward the rotor end of the gear and varies from 65 to 105 mm wide in a sinusoidal pattern.

Figure No: 6 (NREL PIX 19872) Scale: 4.5X Component: HSG rotor end Failure mode: scuffing Failure mode severity: severe Description: Scuffing is concentrated in the dedenda and corresponds to the scuffing on the pinion addenda. Original grind marks are present in the addenda.

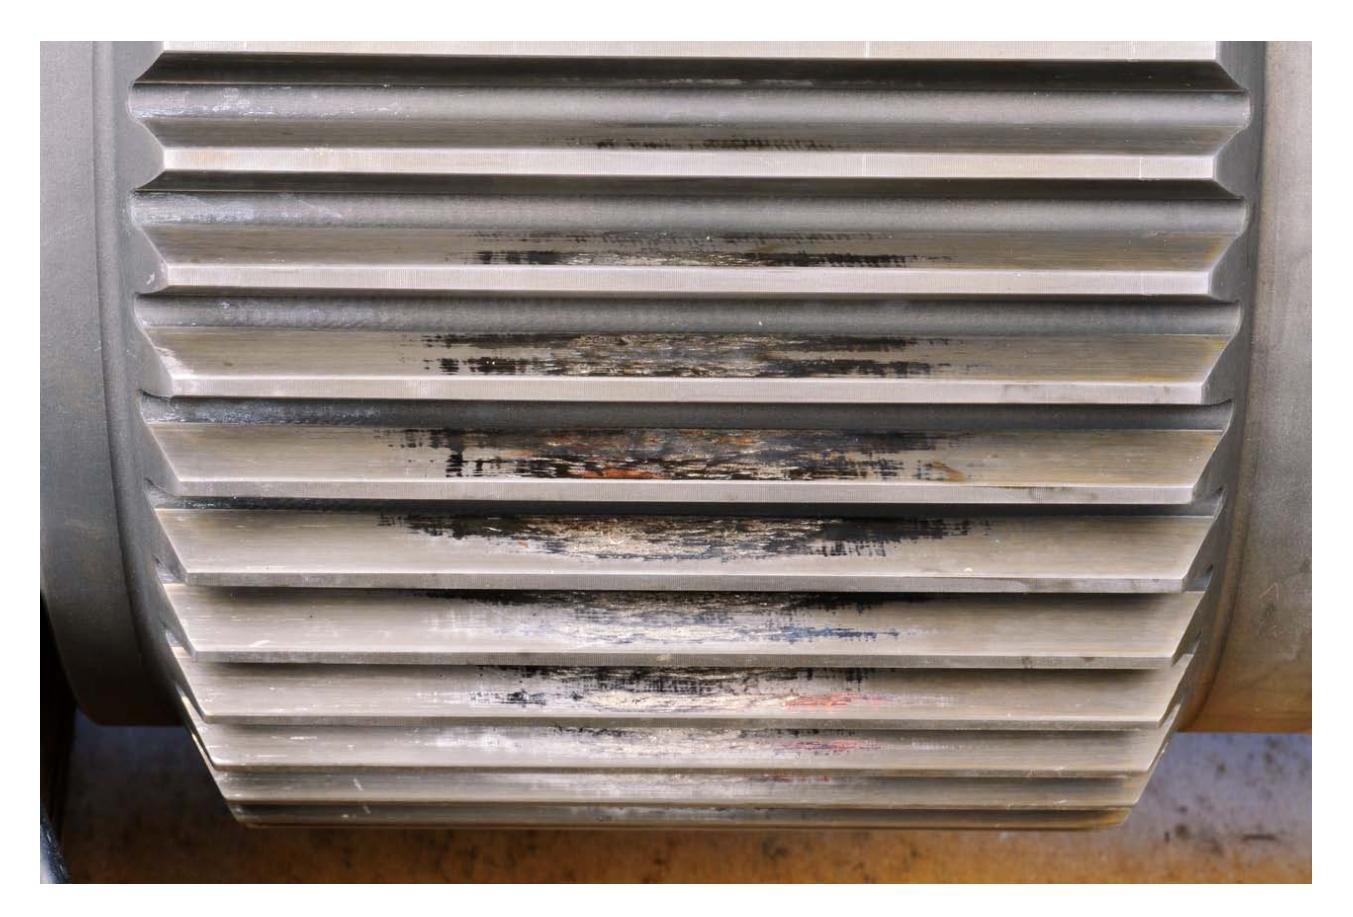
- 2. The primary failure mode of the sun spline was severe fretting corrosion. The root causes of the failure were probably lubricant starvation and poor load distribution (only about 50% of the teeth carried the load).

Figure No: 7 (NREL PIX 19852) Scale: 1.1X Component: sun spline Failure mode: fretting corrosion Failure mode severity: severe Description: Fretting corrosion is o

Description: Fretting corrosion is concentrated in the midface and is most severe at the high point of the lead crown. Tooth-to-tooth contact varies from no contact to heavy contact. Only about 50% of the teeth carried the load.

Figures 7-8 show severe fretting corrosion on the sun spline. The damage was centralized on the spline teeth, but varied in severity around the spline, with only about 50% of the teeth carrying the load. The load zones were about 180° apart, indicating that the external or internal spline was out of round. The accuracy of the internal spline is expected to be lower than the external spline because it was shaper cut. Cutting is less accurate than grinding, and the internal spline was nitrided, which imparts some distortion.

Because the external spline was carburized and ground, the internal spline was nitrided, and the spline was force-lubricated. It should have been resistant to fretting corrosion. Therefore, the root causes of the failure were probably lubricant starvation and poor load distribution.

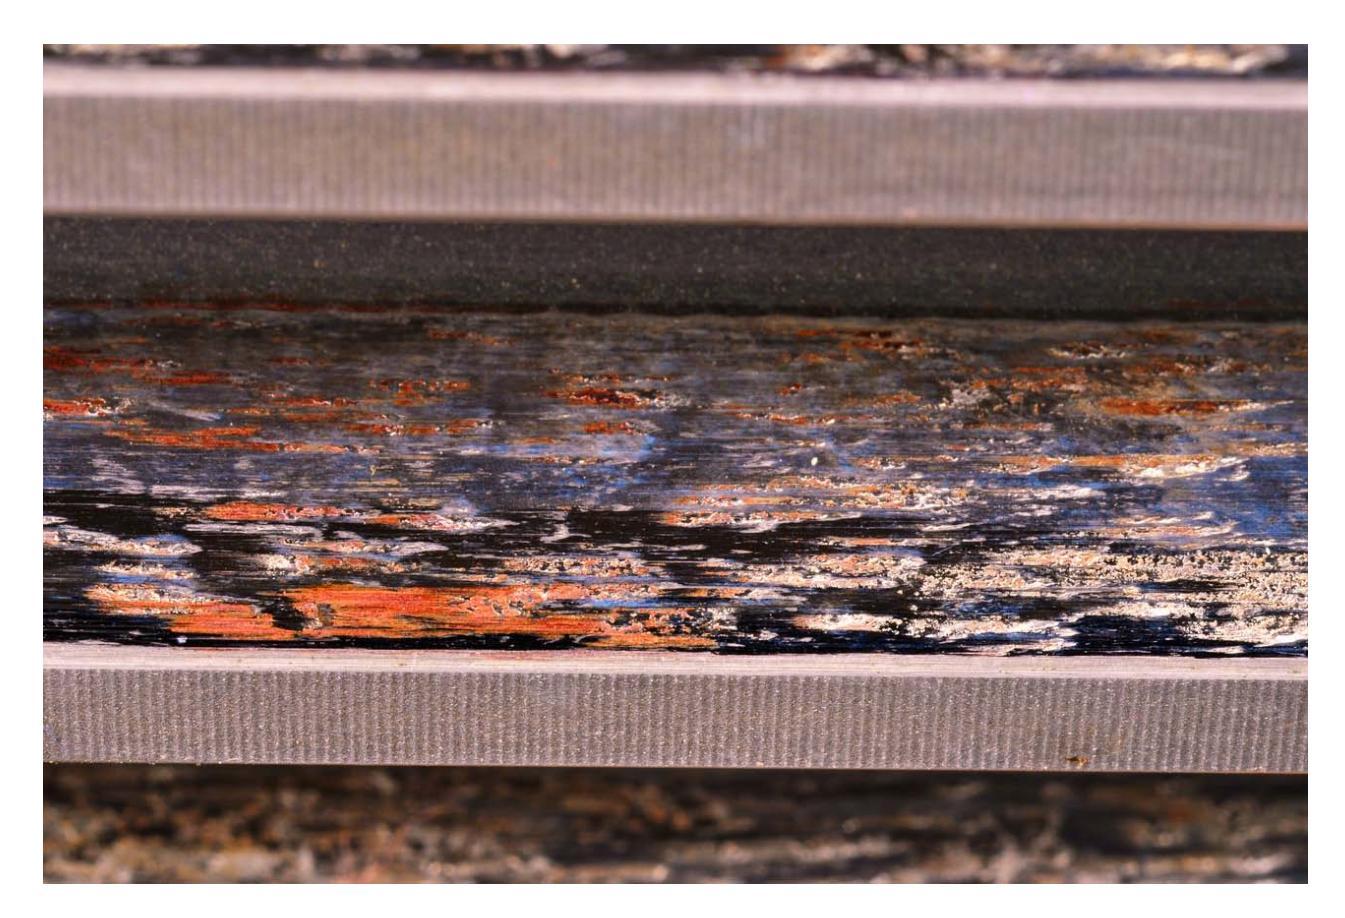
Figure No: 8 (NREL PIX 19853) Scale: 6.0X Component: sun spline Failure mode: fretting corrosion Failure mode severity: severe

Description: Closeup view of a tooth with severe fretting corrosion. Adhesion between the external sun spline and the hollow shaft internal spline transferred lumps of material from the hollow shaft. Axial sliding broke the welds and deformed the material in the axial direction. The red debris is hematite (Fe_2O_3). Hematite is a polishing agent that created polishing wear that surrounds the fretting damage.

Adhesion between the external sun spline and the hollow shaft internal spline transferred lumps of material from the hollow shaft. Axial sliding broke the welds and deformed the material in the axial direction. The red debris in Figure 8 is hematite (Fe_2O_3) . Hematite is a polishing agent and it created the polishing wear that surrounds the fretting damage.

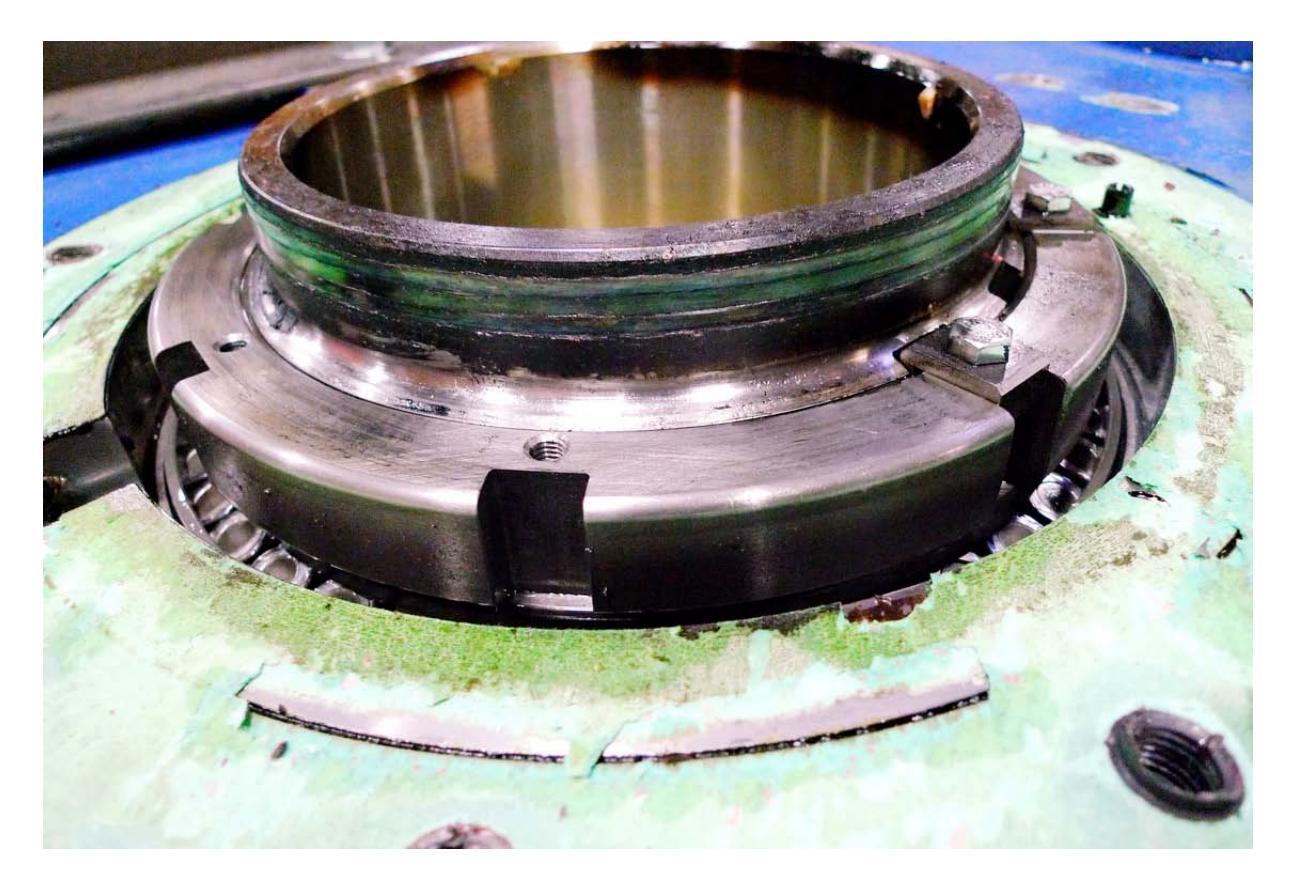
- 3. The primary failure mode of the "O"-ring/hollow shaft seal was severe scuffing and vaporization of the "O"-ring. The root cause of failure was excessive endplay in the TRB bearings E1/E2, which was caused by wear on the bearing locknut due to spinning of the IR of bearing E1.

Figure No: 9 (NREL PIX 19837) Scale: 0.45X Component: hollow shaft Failure mode: scuffing Failure mode severity: severe Description: View of the hollow s

Description: View of the hollow shaft extension that rubbed on the "O"-ring seal plate. The rubbing caused severe scuffing on the hollow shaft and "O"-ring seal plate. The "O"-ring vaporized. The green gasket is broken in many places indicating that it is brittle.

Figures 9-11 show severe scuffing on the hollow shaft and the "O"-ring seal plate. Excessive endplay in the TRB bearings E1/E2 caused the hollow shaft to rub on the "O"-ring plate resulting in severe scuffing on the hollow shaft and "O"-ring seal plate. The "O"-ring vaporized. Figures 12-13 show wear on the face of the bearing locknut. Abrasion removed 0.27 mm from the face of the locknut. The end face of bearing E1 IR also was worn, but to a much lesser degree than the locknut. Assuming the bearing endplay had been set to the specified endplay of 0.13 mm, the wear on the bearing locknut would have increased the endplay to 0.40 mm, which is consistent with the endplay of 0.41 mm measured during disassembly. Therefore, the root cause of the failure was excessive endplay in the TRB bearings E1/E2, which was caused by wear on the bearing locknut due to the spinning of the IR in bearing E1.

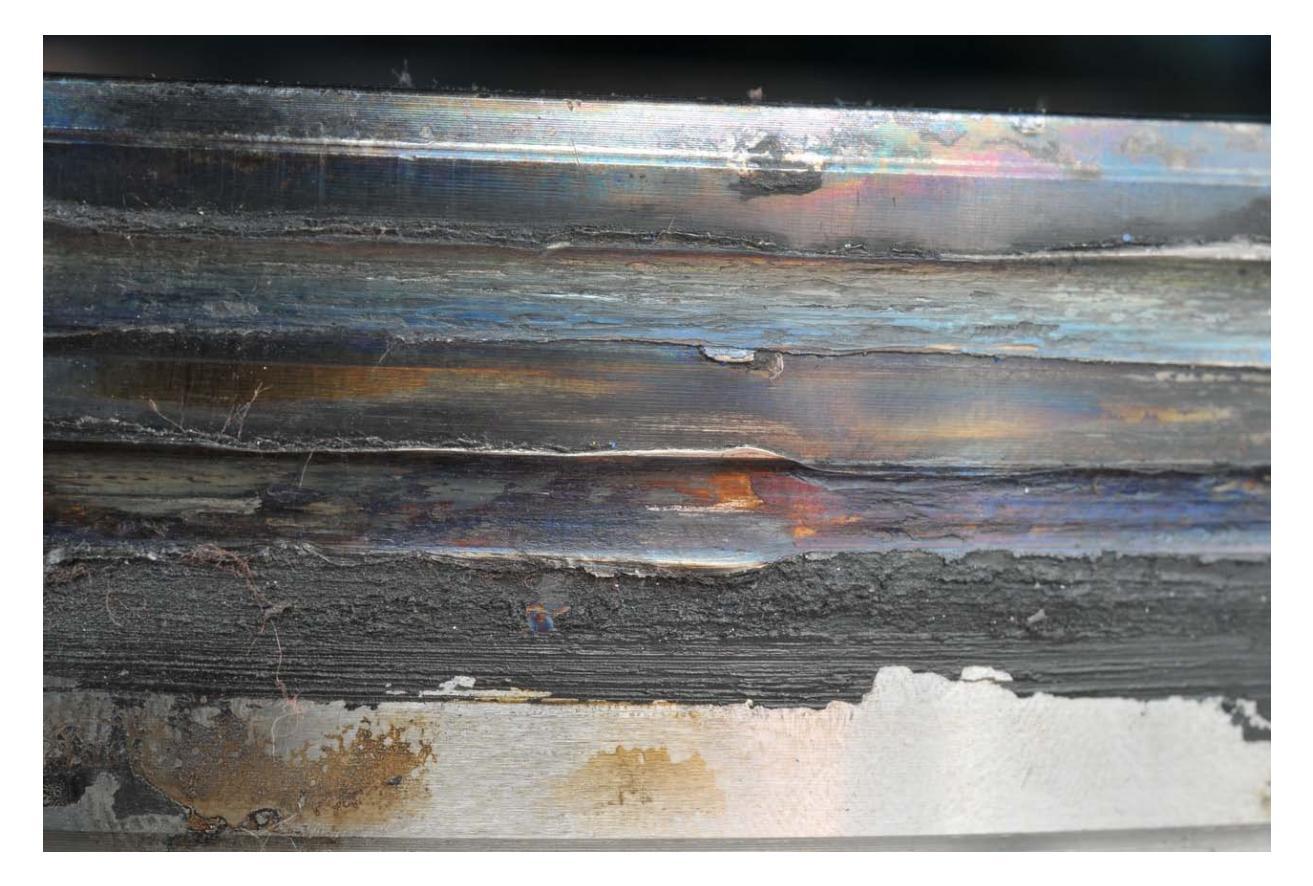
Figure No: 10 (NREL PIX 19875) Scale: 2.8X Component: hollow shaft Failure mode: scuffing Failure mode severity: severe Description: Closeup view of the hol

Description: Closeup view of the hollow shaft extension that rubbed on the "O"-ring seal plate. The scuffing wore two deep grooves into the hollow shaft. The black coating near the bottom of the photo is debris from the vaporized "O"-ring.

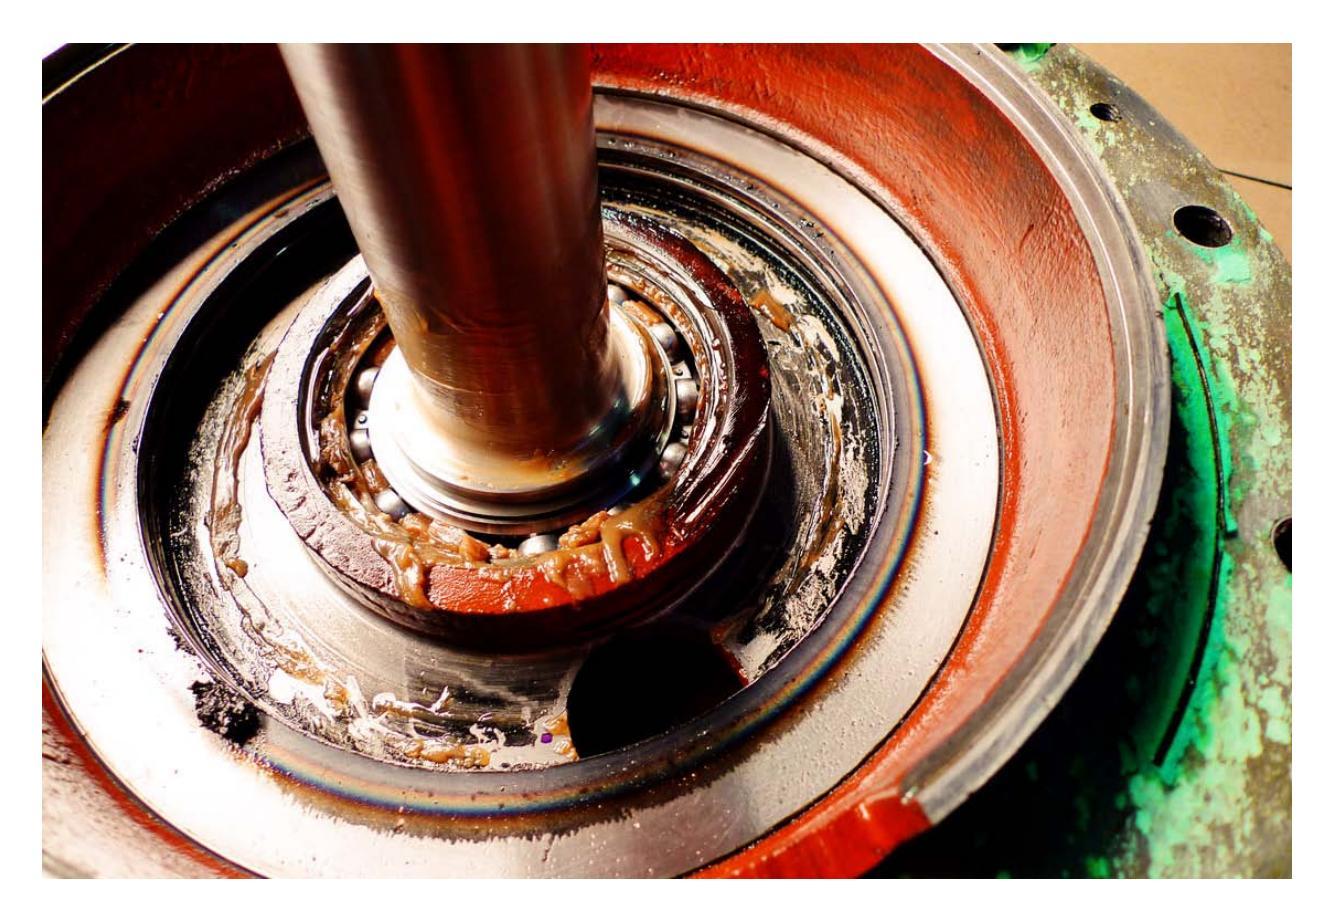
Figure No: 11 (NREL PIX 19838) Scale: 0.45X Component: "O"-ring seal plate Failure mode: scuffing Failure mode severity: severe

Description: View of the "O"-ring seal plate that rubbed on the hollow shaft. The rubbing caused severe scuffing on the hollow shaft and the "O"-ring seal plate. The "O"-ring vaporized. A lump of melted rubber adhered to the plate. The temper colors near the bore of the "O"-ring seal plate show that the temperature reached at least 700°F.

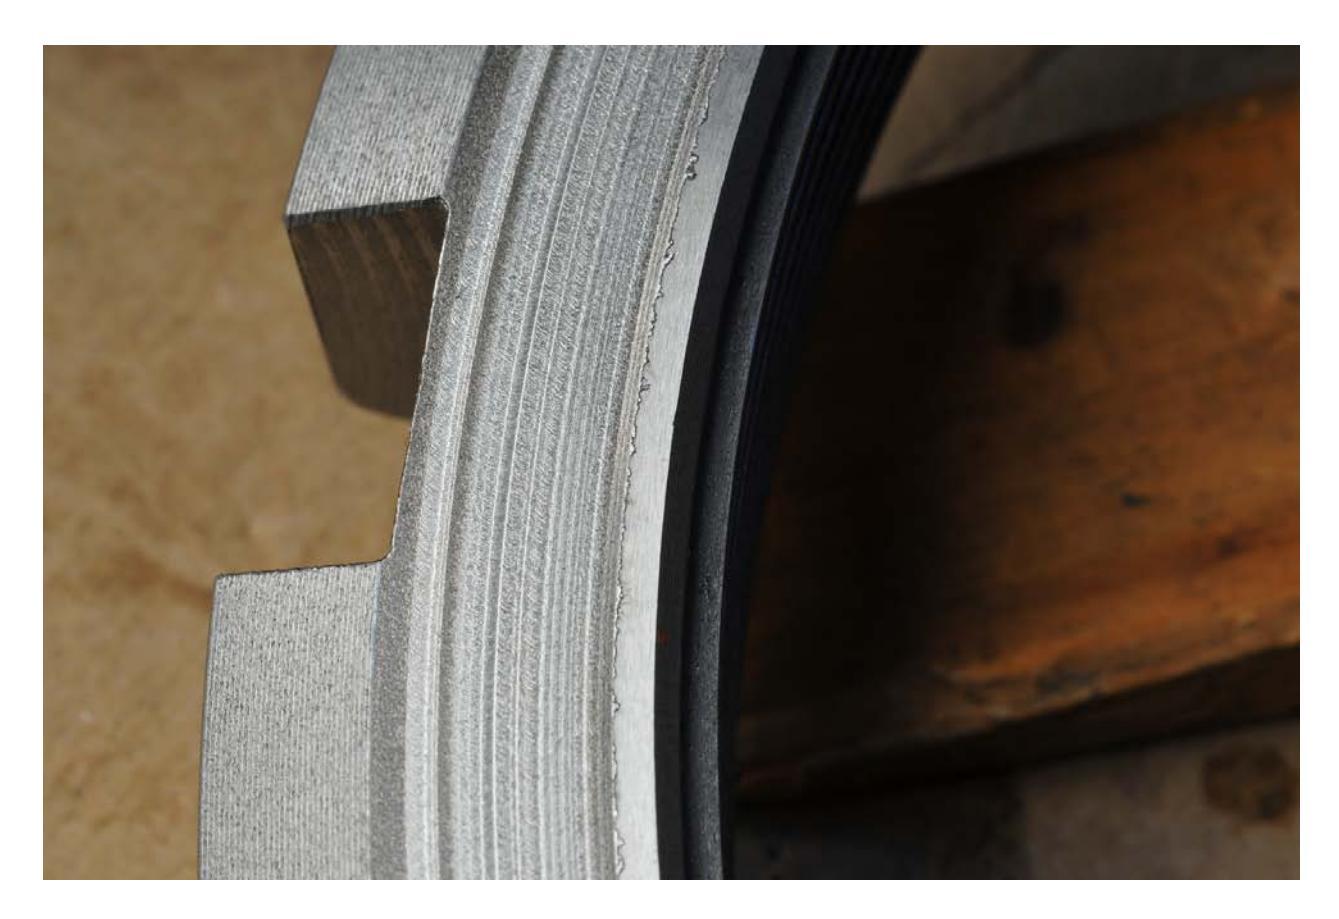
Figure No: 12 (NREL PIX 19874) Scale: 2.5X Component: bearing locknut for bearings E1/E2 Failure mode: abrasion Failure mode severity: severe Description: View of the face of the bearing locknut showing severe abrasive wear. Spinning of the IR of bearing E1 caused the bearing E1 IR to rub on the locknut.

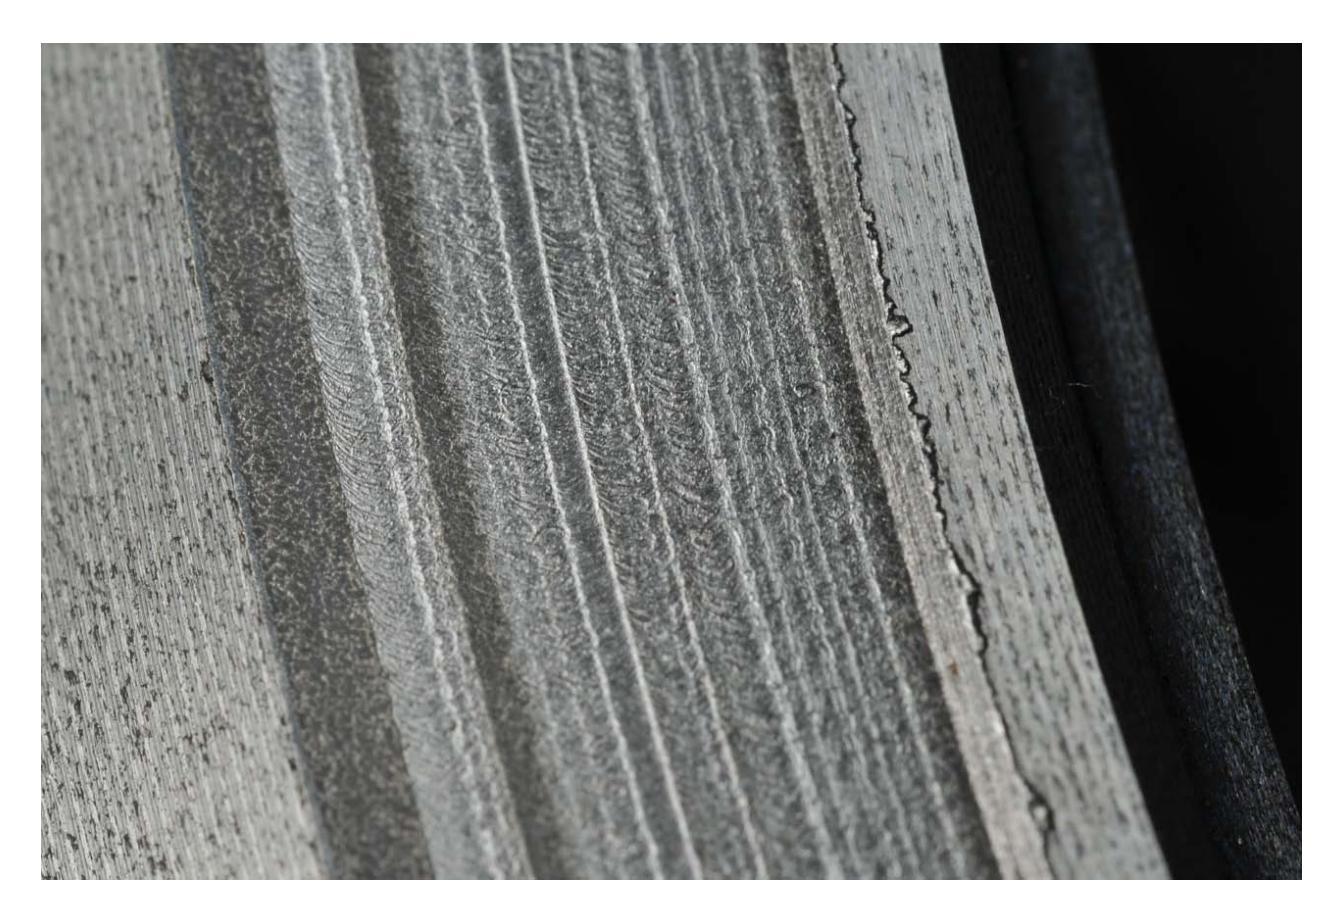
Figure No: 13 (NREL PIX 19873) Scale: 9.6X Component: bearing locknut for bearings E1/E2 Failure mode: abrasion Failure mode severity: severe Description: Closeup view of the face of the bearing locknut. Abrasion removed 0.27

mm from the face of the locknut. The end face of bearing E1 IR also was worn, but to a lesser degree than the locknut.

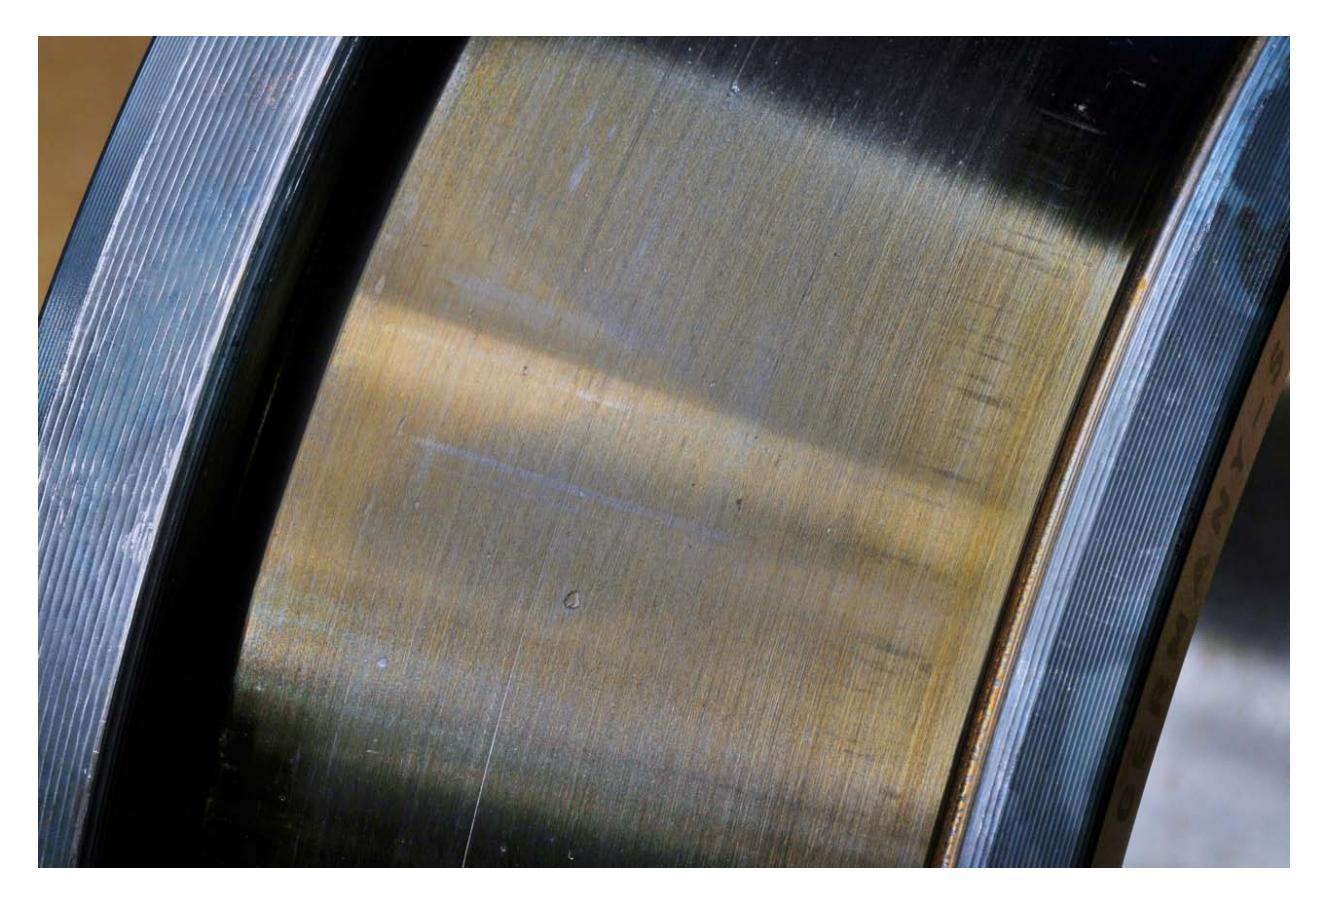
- 4. Bearing A1 overheated. Straw-yellow temper color indicates that the temperature reached about 400°F. The root cause of the overheating was probably lubricant starvation.

Figure No: 14 (NREL PIX 19858) Scale: 2.7X Component: bearing A1 IR Failure mode: overheating Failure mode severity: mild Description: Mild overheating created straw-yellow temper colors near each end of the IR raceway. The temper colors show that the temperature reached about 400°F.

Figures 14-15 show that the IR raceway and the rollers of bearing A1 had straw-yellow temper colors. This indicates that the temperature reached about 400°F. The root cause of the overheating was probably lubricant starvation.

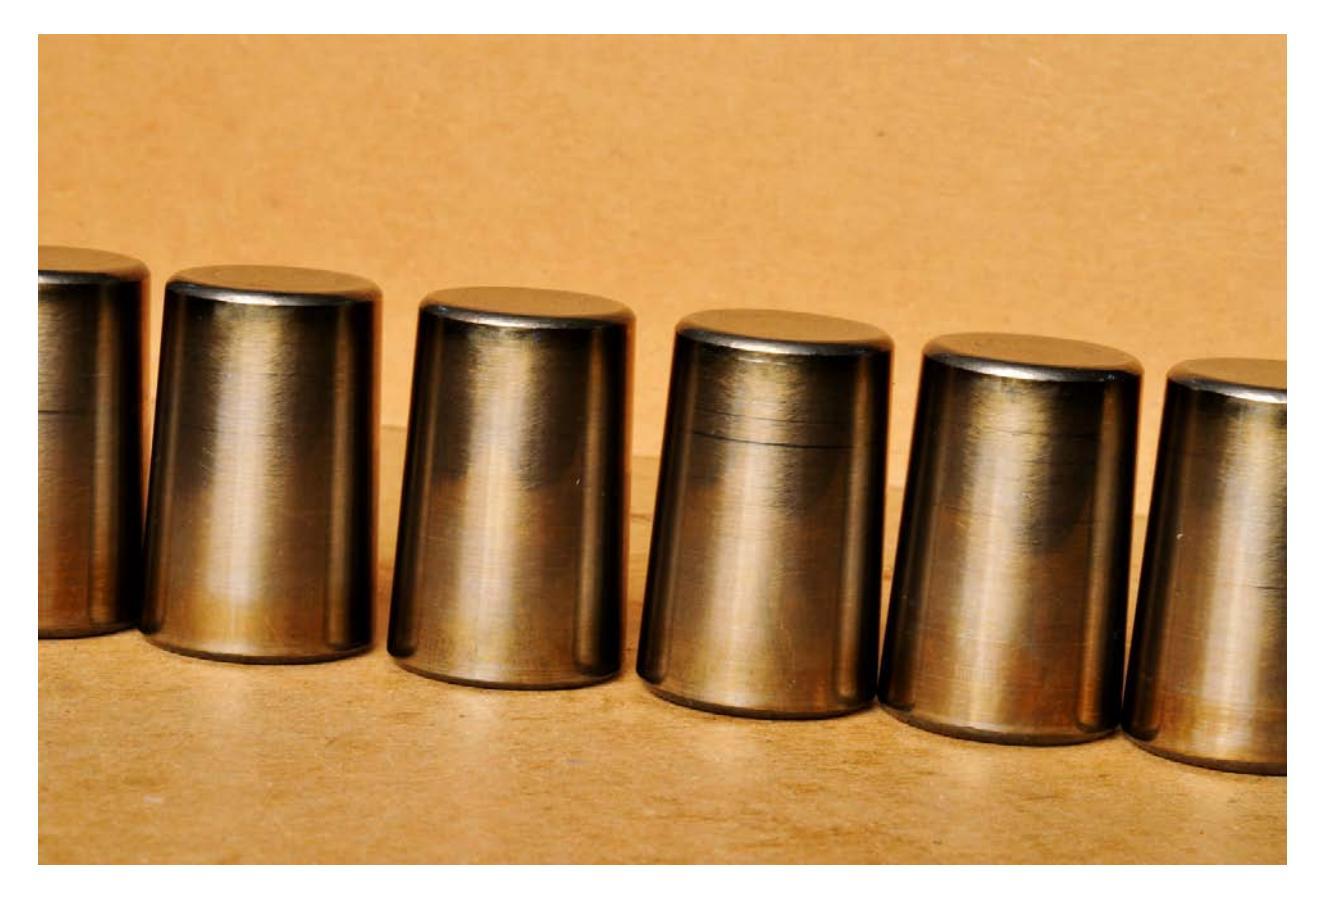
Figure No: 15 (NREL PIX 19859) Scale: 1.4X Component: bearing A1 rollers Failure mode: overheating Failure mode severity: mild Description: Mild overheating created s

Description: Mild overheating created straw-yellow temper colors near each end of the rollers. The temper colors show that the temperature reached about 400°F.

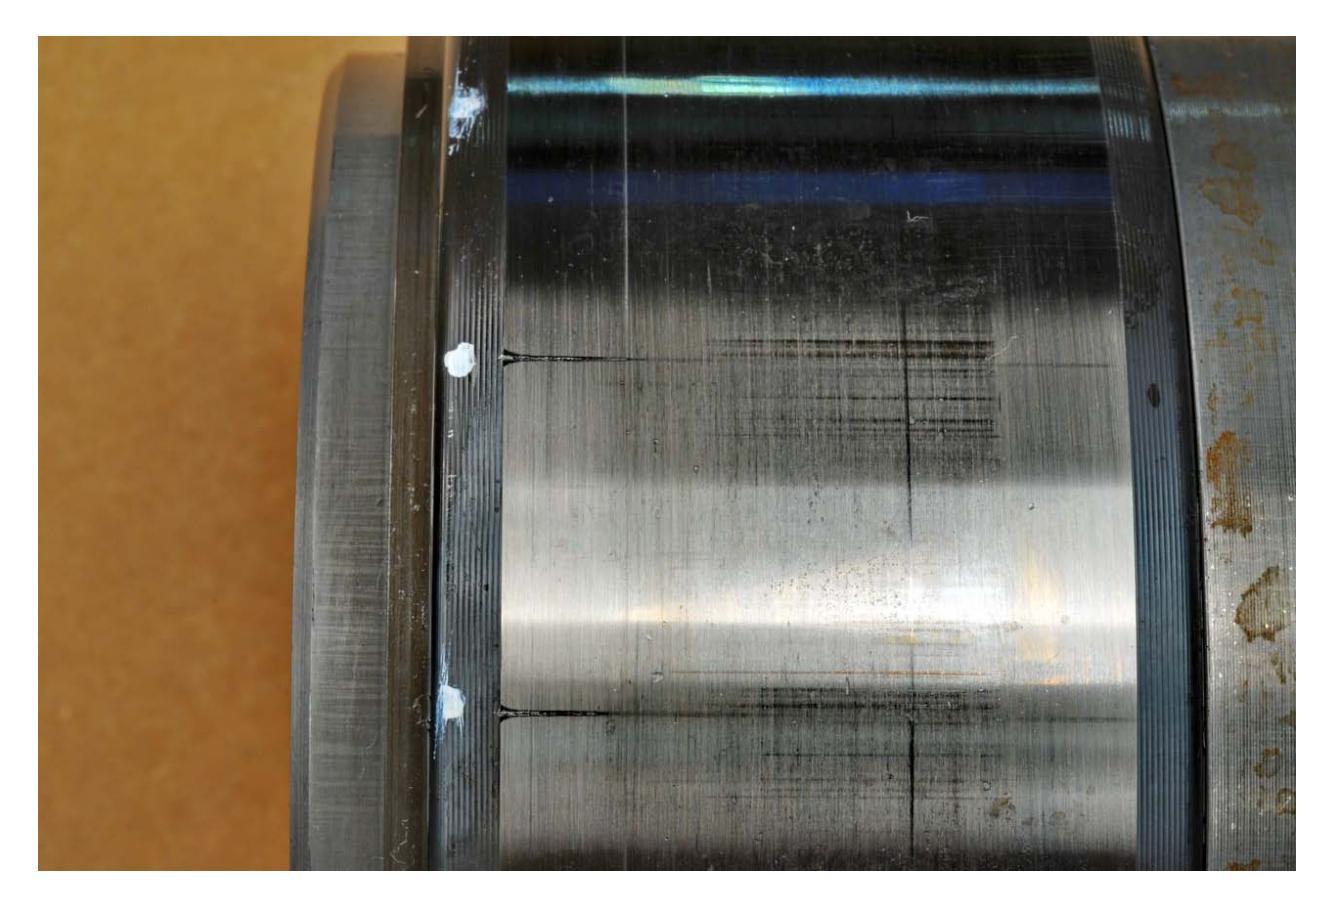
- 6. The IR of bearing D had assembly damage at the roller spacing caused by a cocking of the rollers during blind assembly.
- 7. The spacer for bearing C1/C2 ORs had assembly damage at the roller spacing caused by interference with the bearing rollers during assembly.

Figure No: 16 (NREL PIX 19864) Scale: 2.1X Component: bearing D IR Failure mode: assembly damage Failure mode severity: moderate Description: Three lines of plastic deformation and scuffing at the roller spacing indicate that the rollers cocked and jammed on the IR during assembly.

Figures 16-17 show assembly damage on the IR of bearing D. ANSI/AGMA/AWEA 6006-A03 [2], Figure 5, shows the root cause of the damage, which is due to forcing the assembly of the bearing when the rollers are cocked. It is a risk associated with blind assembly. Assembly damage often leads to macropitting and failure of the bearing. Therefore, the assembly procedure for bearing D should be revised as necessary to avoid assembly damage.

- 6. Review the assembly procedure for bearing D and revise as necessary to avoid assembly damage.
- 7. Revise the design of the spacer for bearings C1/C2 ORs to avoid assembly damage.

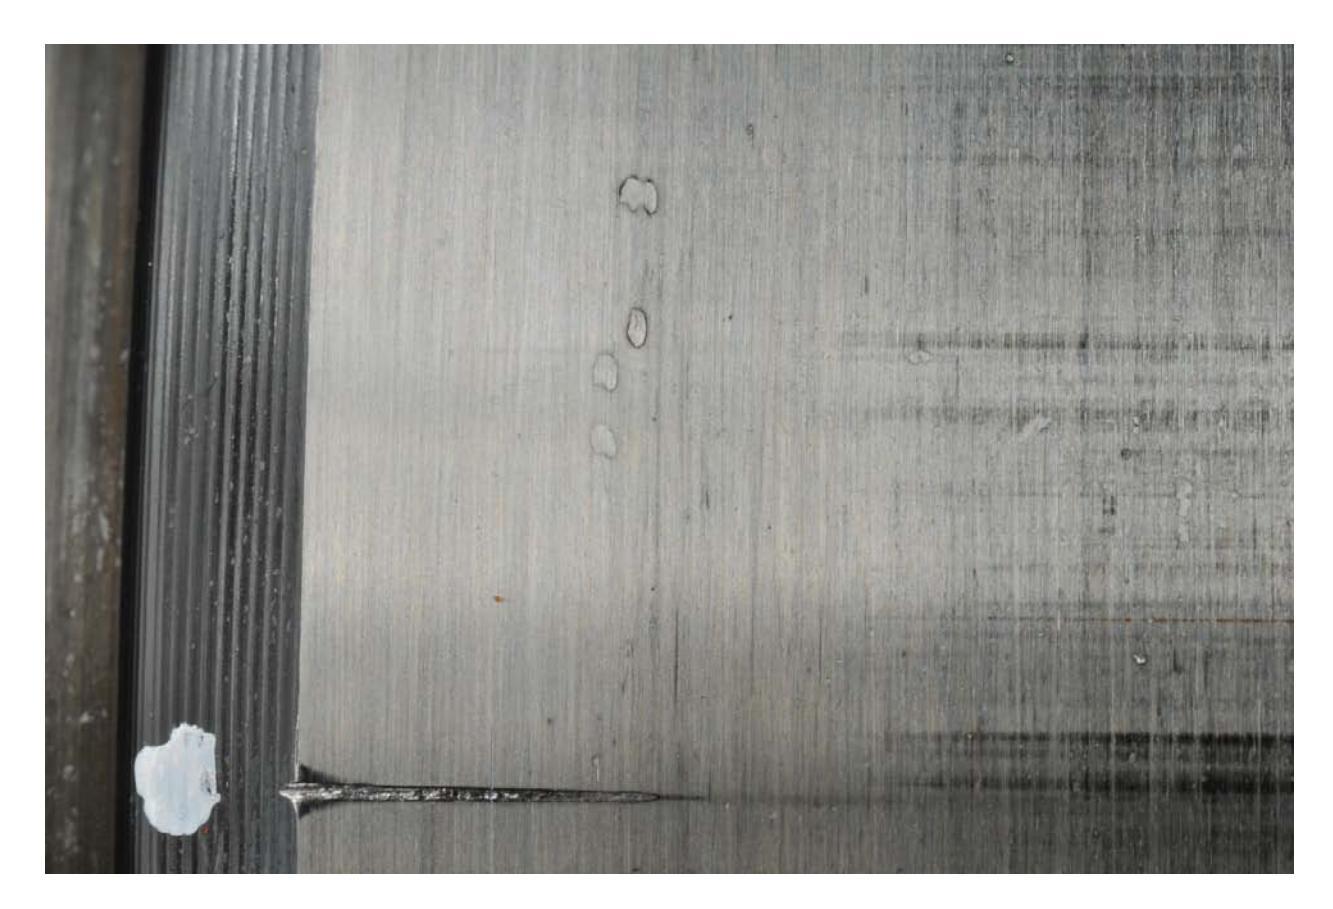
Figure No: 17 (NREL PIX 19865) Scale: 5.8X Component: bearing D IR Failure mode: assembly damage Failure mode severity: moderate Description: Closeup view of assembly damage. Debris dents and lines of false brinelling also are shown.

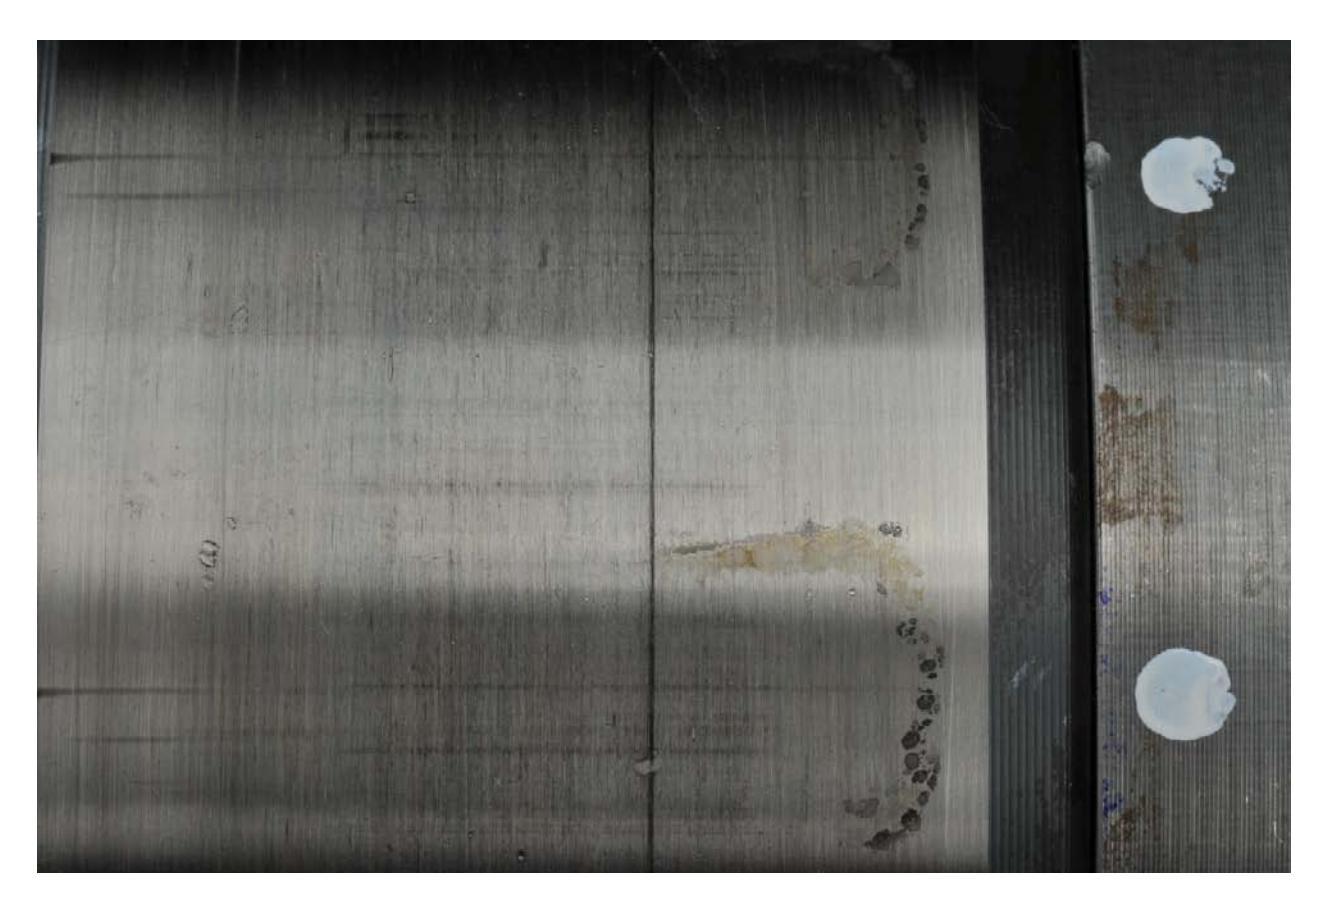
- 8. The IR of bearing D had corrosion at the roller spacing.
- 9. The sun spherical thrust rings had small patches of fretting corrosion. The root cause of the fretting corrosion was probably lubricant starvation due to malfunction of the bronze transfer ring.

Figure No: 18 (NREL PIX 19866) Scale: 3.2X Component: bearing D IR Failure mode: contact corrosion Failure mode severity: mild Description: Closeup view of contact corrosion at the roller spacing. Debris dents, false brinelling, and a circumferential line of abrasion also are shown.
