FAILURE ANALYSIS OF A WIND TURBINE GEARBOX

On December 27-30, 2010 and January 3-7, 2011, Robert Errichello and Jane Muller inspected one Jahnel-Kestermann (JAKE) gearbox at The Gear Works in Seattle, Washington. The root cause of the loss of oil is unknown and, therefore, not addressed in this report. In both instances, a temperature sensor on a high-speed pinion (HSP) bearing signaled a wind turbine shutdown. This report summarizes the results of the inspection of the gearbox and contains photographs of the failed components.

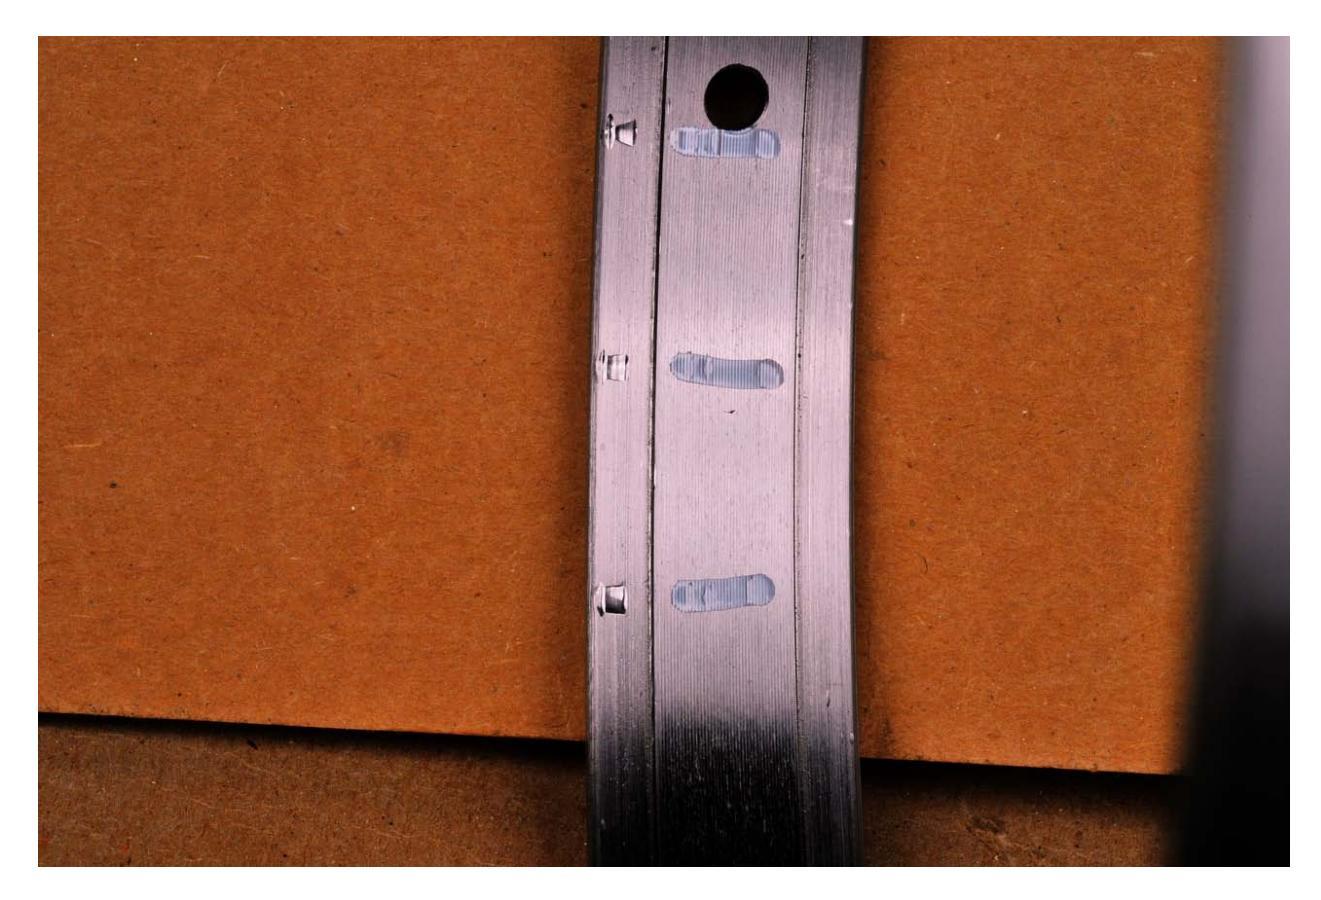
Figure No: 19 (NREL PIX 19867) Scale: 1.3X Component: bearing C1/C2 OR spacer Failure mode: assembly damage Failure mode severity: severe Description: Three lines of plastic deformation at roller spacing indicate that the rollers

of bearing C1 interfered with the spacer during assembly.

- 6. Review the assembly procedure for bearing D and revise as necessary to avoid assembly damage.
- 7. Revise the design of the spacer for bearings C1/C2 ORs to avoid assembly damage.

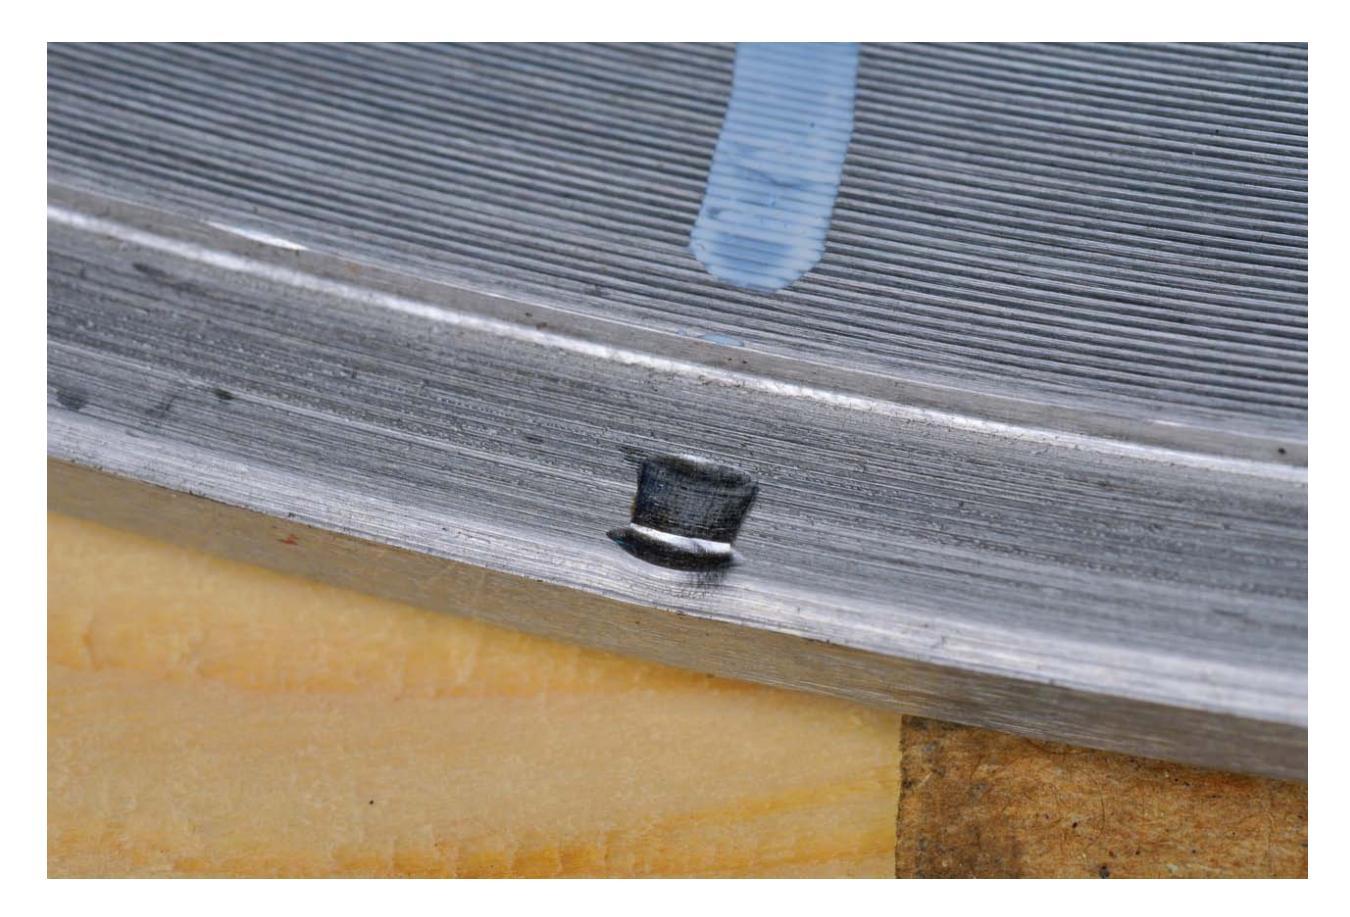
Figure No: 20 (NREL PIX 19868) Scale: 4.9X Component: bearing C1/C2 OR spacer Failure mode: assembly damage Failure mode severity: severe Description: Closeup of the dent in the bearing C1/C2 spacer. The dent caused a raised area on the end face of the spacer.

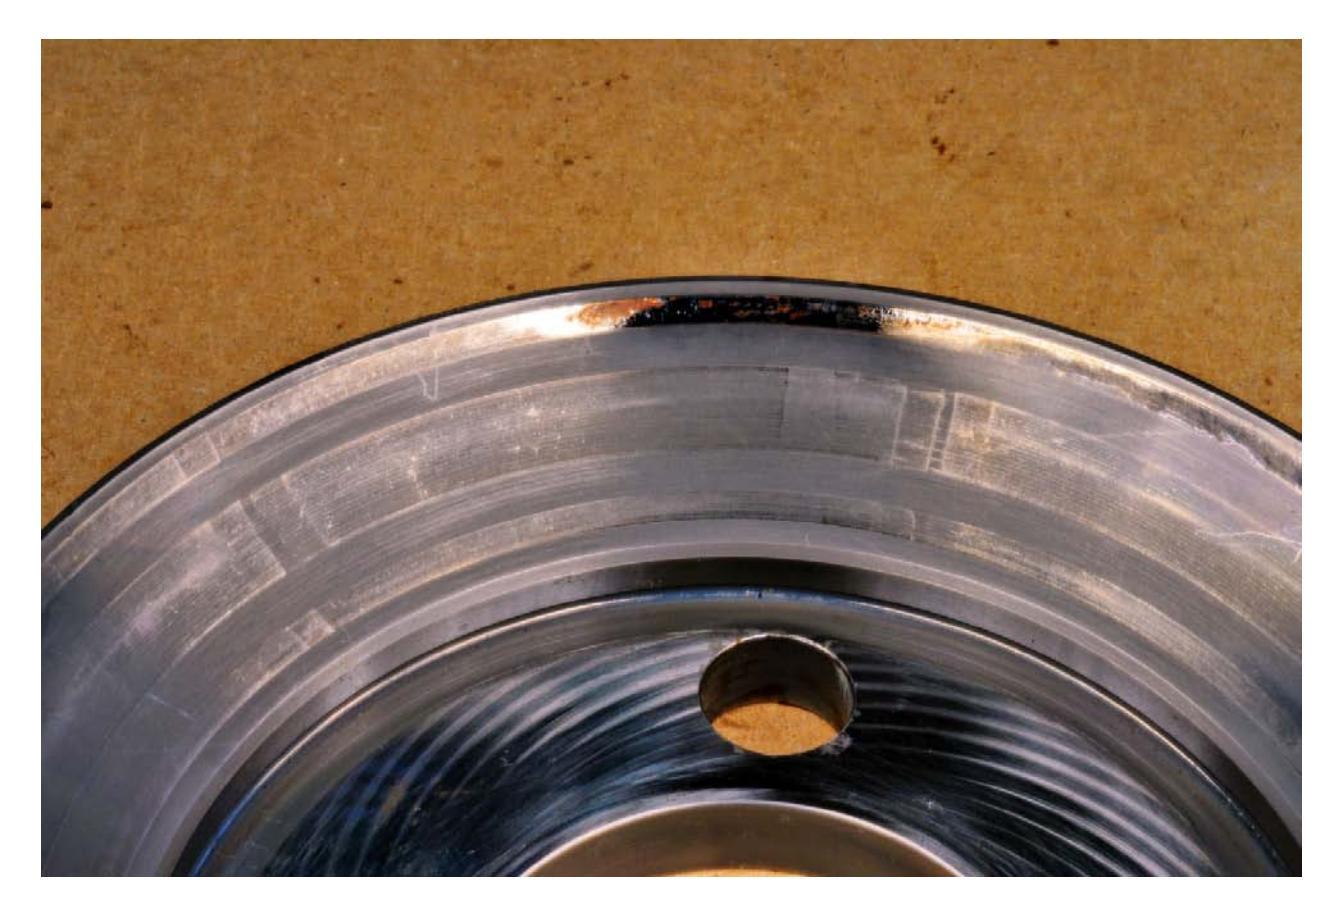
Figure No: 21 (NREL PIX 19846)
Scale: 1.0X
Component: sun upper spherical thrust ring
Failure mode: fretting corrosion
Failure mode severity: moderate
Description: Fretting corrosion occurred in a 60° sector near the outside diameter. The balance of the thrust surface had only mild wear.

- 8. Review the design of the lubrication system and revise as necessary to prevent ingress of moisture.
- 9. Review the design of the lubrication system to ensure adequate oil flow rate to the sun spherical thrust rings.

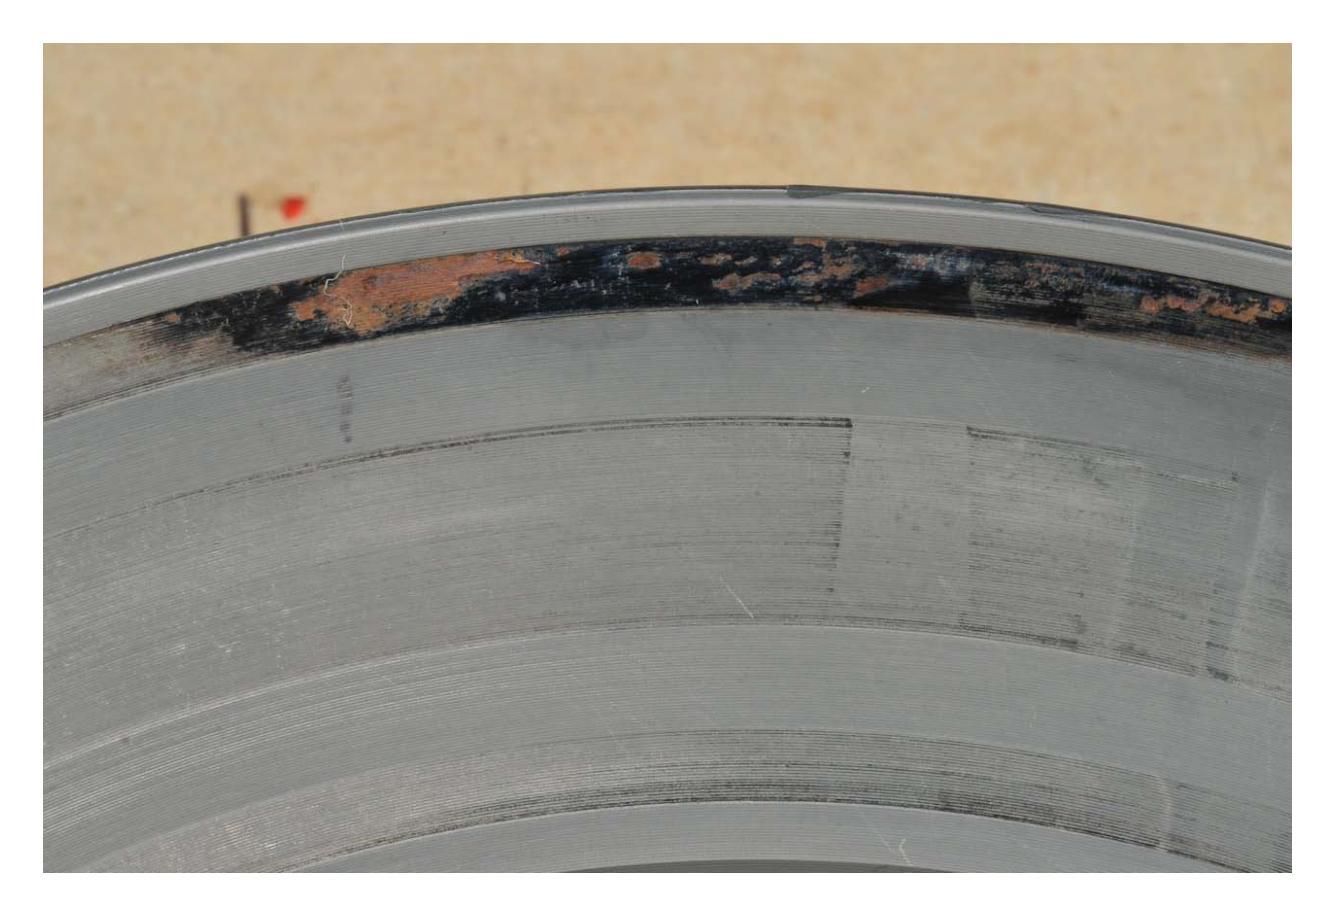
Figure No: 22 (NREL PIX 19847) Scale: 2.5X Component: sun upper spherical thrust ring Failure mode: fretting corrosion Failure mode severity: moderate Description: Closeup of fretting corrosion.

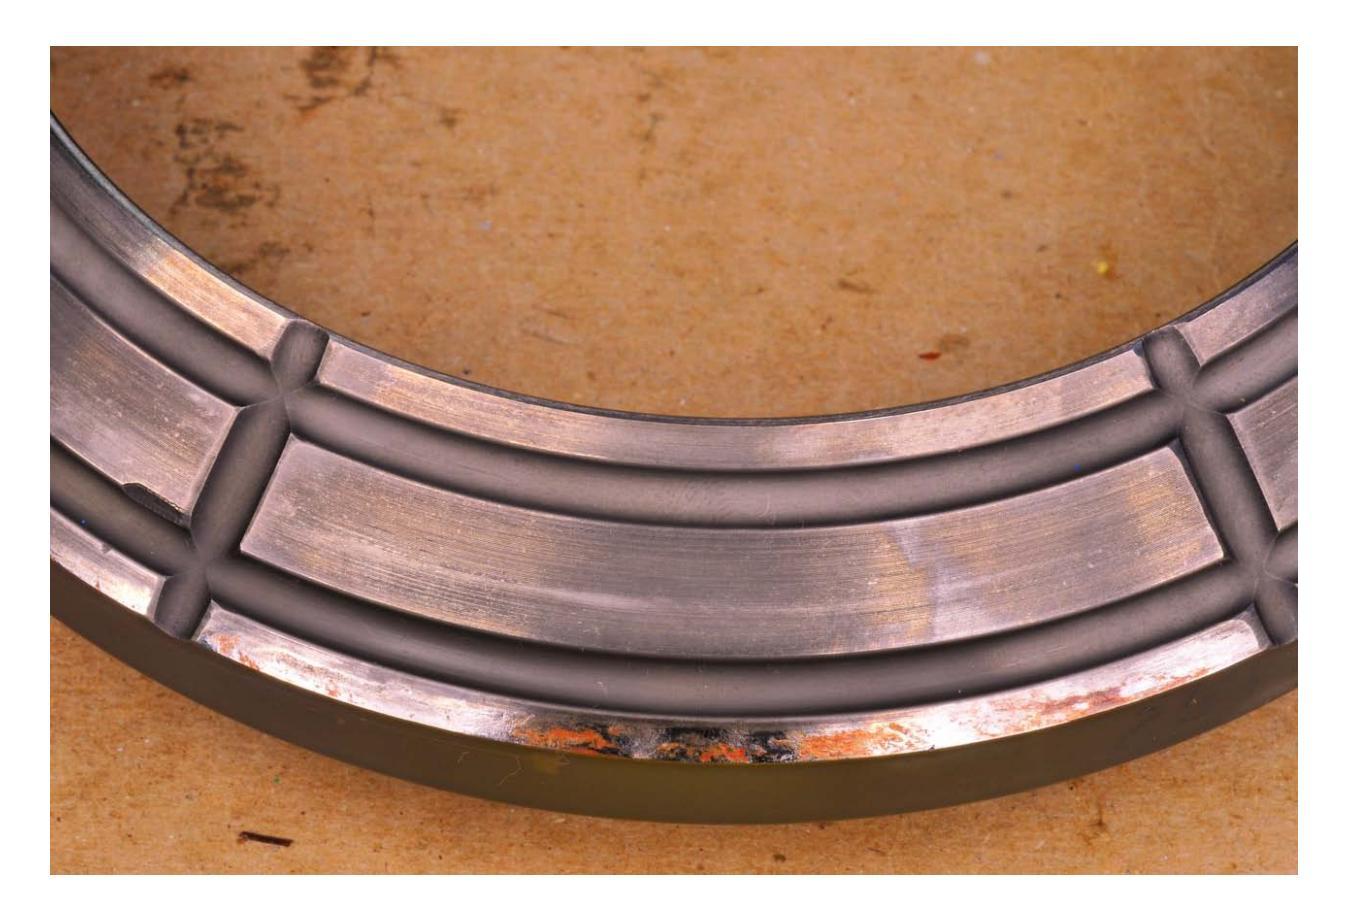
Figure No: 23 (NREL PIX 19848) Scale: 1.7X Component: sun lower spherical thrust ring Failure mode: fretting corrosion Failure mode severity: moderate Description: Fretting corrosion occurred in a 60° sector near the outside diameter. The balance of the thrust surface had only mild wear.

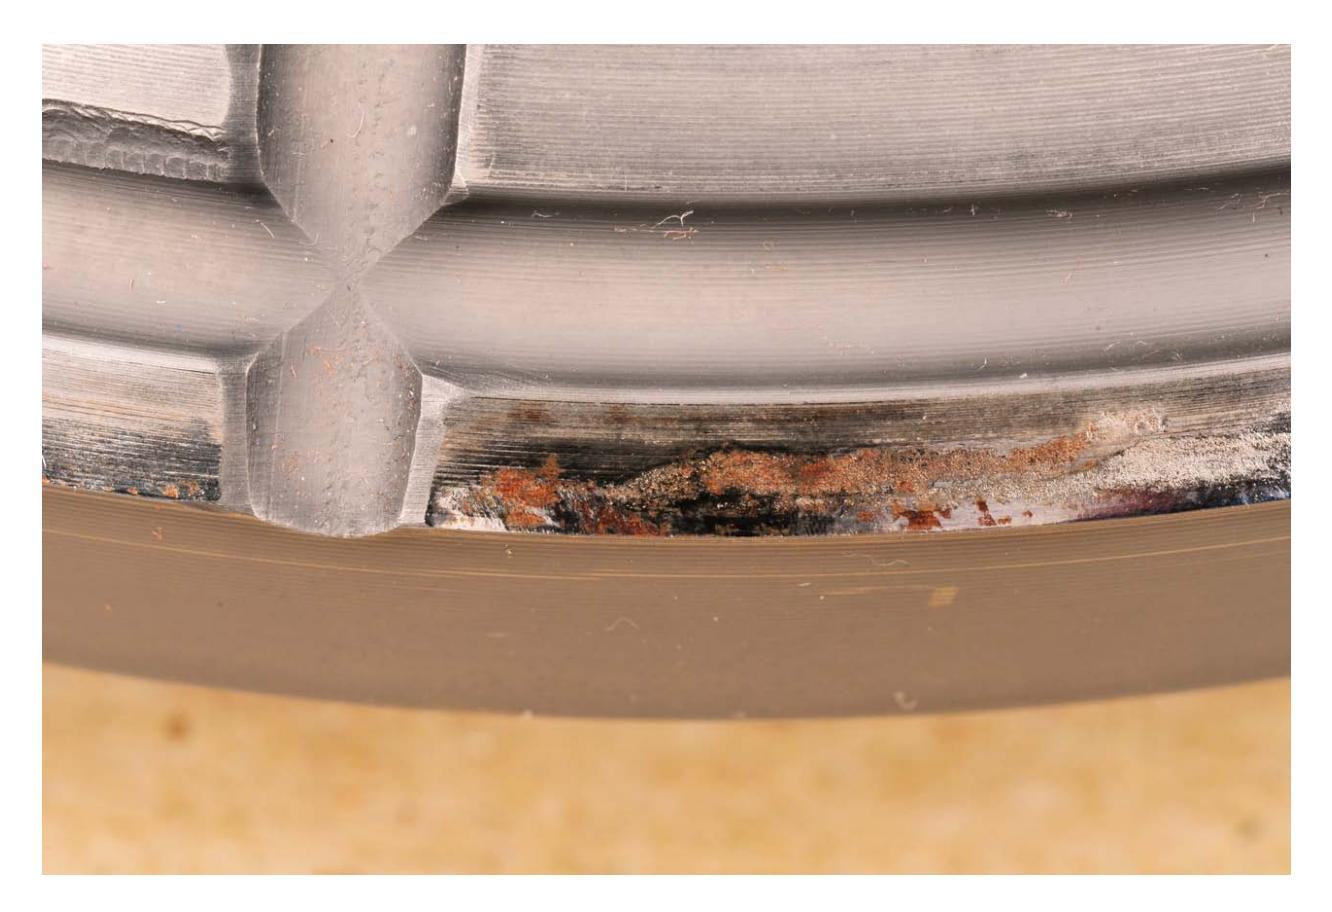
Figure No: 24 (NREL PIX 19849) Scale: 3.0X Component: sun lower spherical thrust ring Failure mode: fretting corrosion Failure mode severity: moderate Description: Closeup of fretting corrosion.

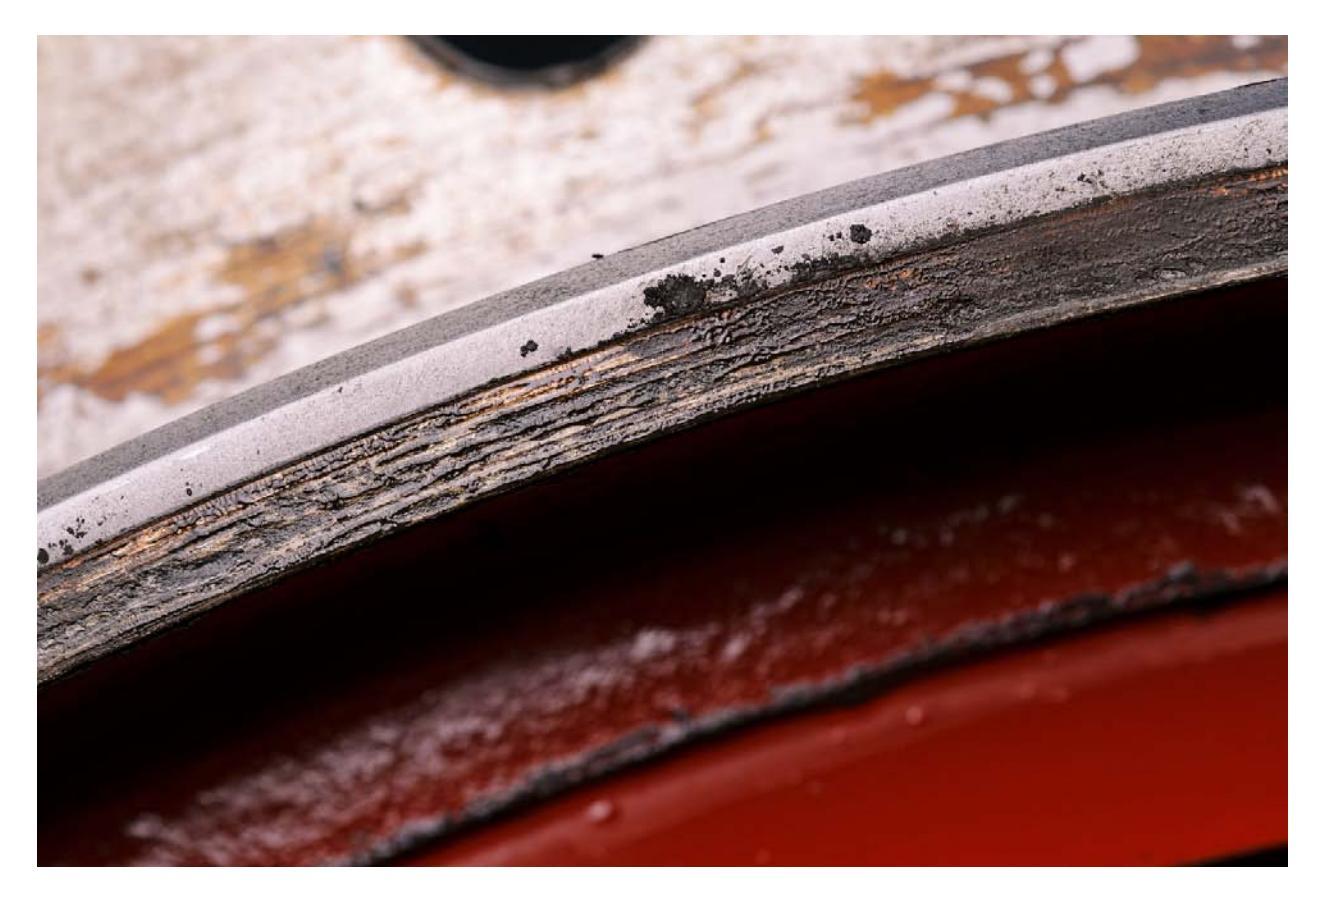
- 10. The interface between bearing H OR and the shoulder on bearing cap H had severe fretting corrosion. The root cause of the fretting corrosion was probably the loose fit of bearing H OR.

Figure No: 25 (NREL PIX 19839) Scale: 3.0X Component: bearing H retainer Failure mode: fretting corrosion Failure mode severity: severe Description: Closeup of fretting corro

Description: Closeup of fretting corrosion. Fretting corrosion occurred in a small sector on the face of the bearing H retainer thrust shoulder that locates bearing H OR.

- 10. Review the design of the fit of the OR of bearing H and the bearing cap for bearing H and revise as necessary to eliminate fretting corrosion at the interface between bearing H OR and the shoulder on bearing cap H.

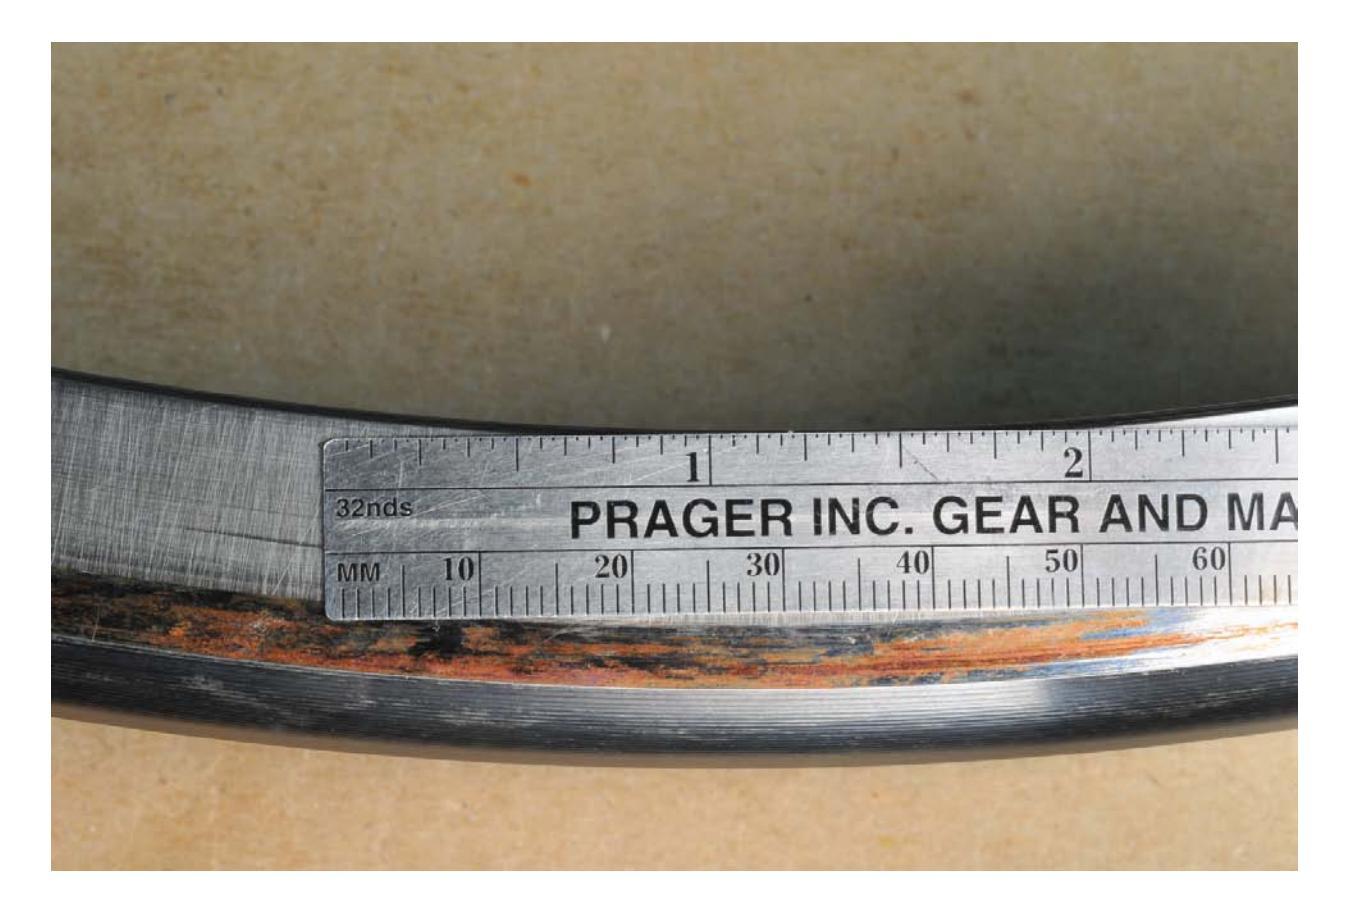
Figure No: 26 (NREL PIX 19843) Scale: 1.9X Component: bearing H OR Failure mode: fretting corrosion Failure mode severity: severe Description: Closeup of fretting corrosion. Fretting corrosion occurred in a small sector on the end face of bearing H OR.

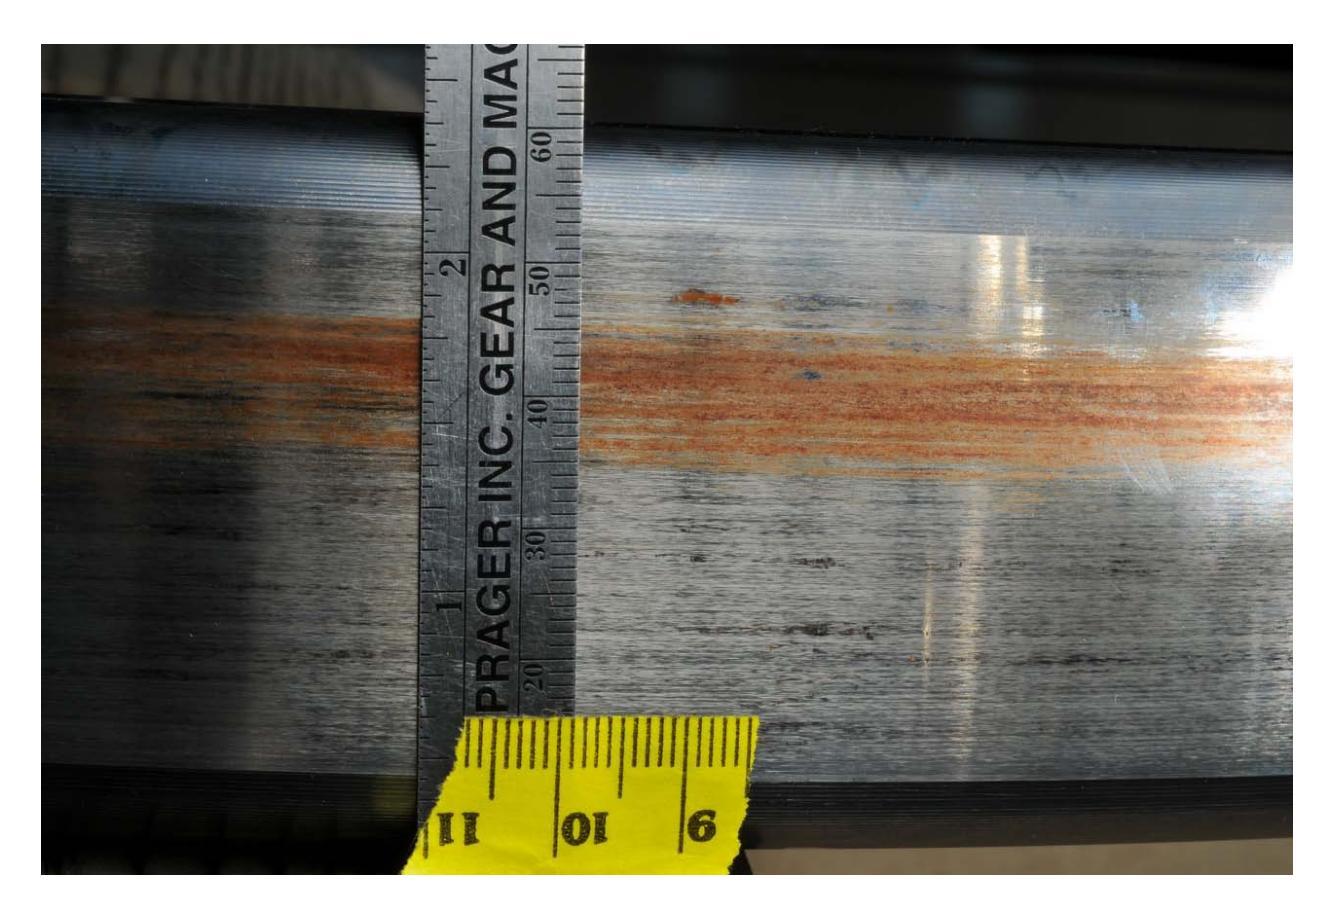
Figure No: 27 (NREL PIX 19844) Scale: 1.7X Component: bearing H OR Failure mode: fretting corrosion Failure mode severity: severe Description: Fretting corrosion occurred in a 140° sector on the outside diameter of bearing H OR.

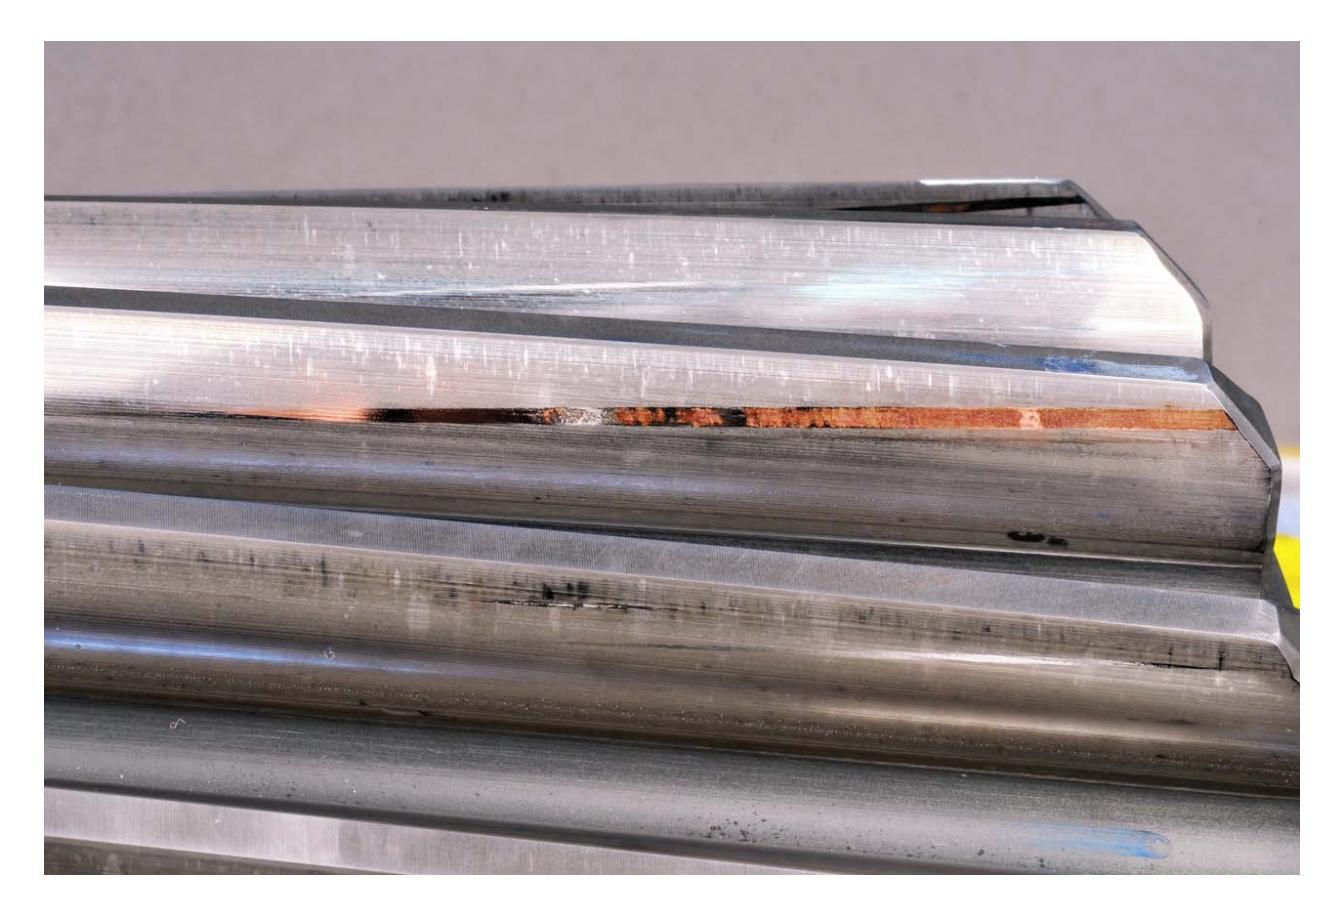
Figure No: 28 (NREL PIX 19850) Scale: 1.0X Component: sun pinion Failure mode: fretting corrosion Failure mode severity: severe Description: Fretting corrosion occurred along a line of contact.

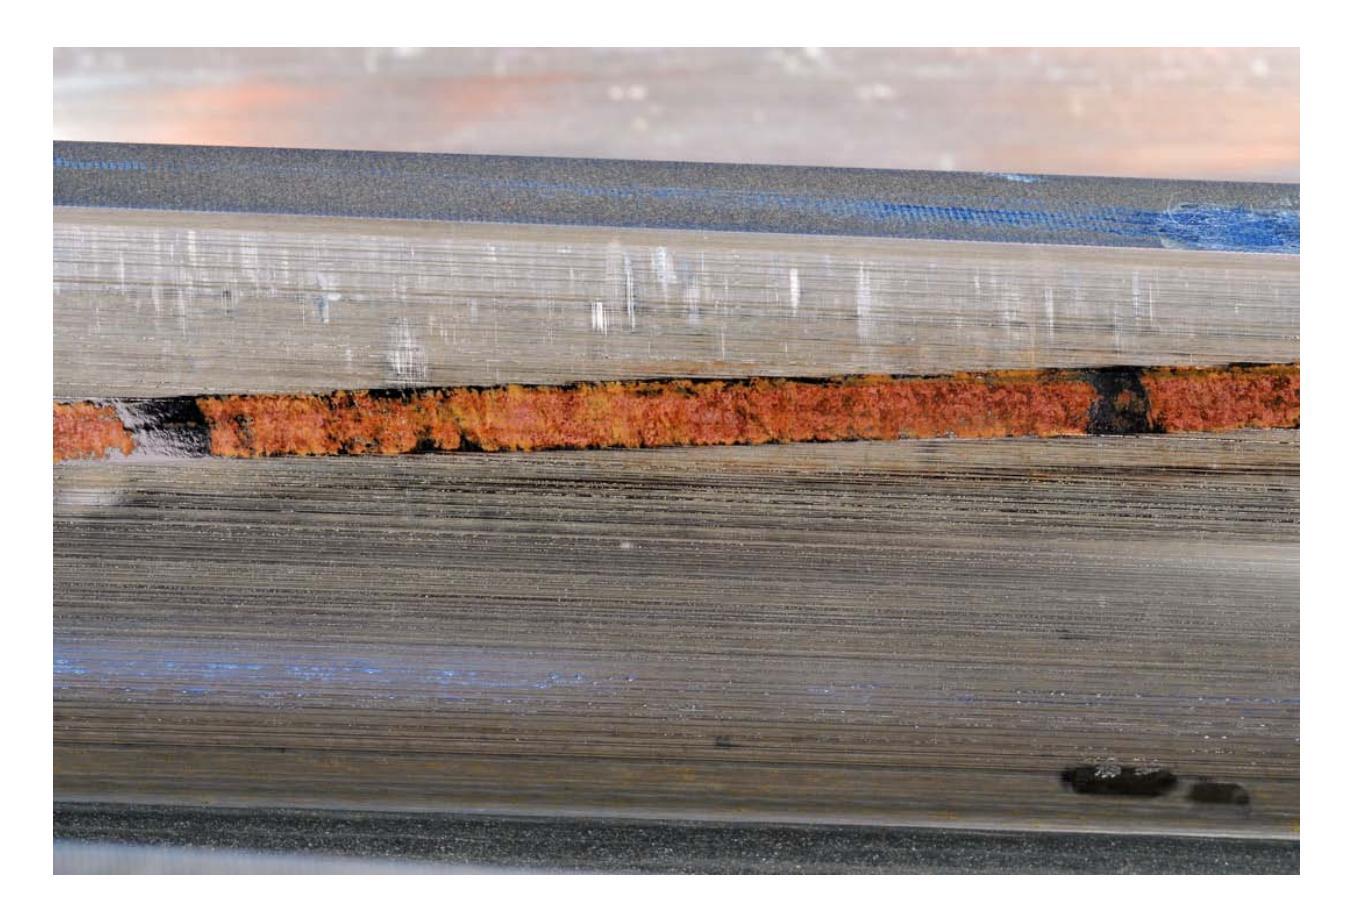
Figure No: 29 (NREL PIX 19851) Scale: 3.2X Component: sun pinion Failure mode: fretting corrosion Failure mode severity: severe Description: Closeup view of fretting corrosion.

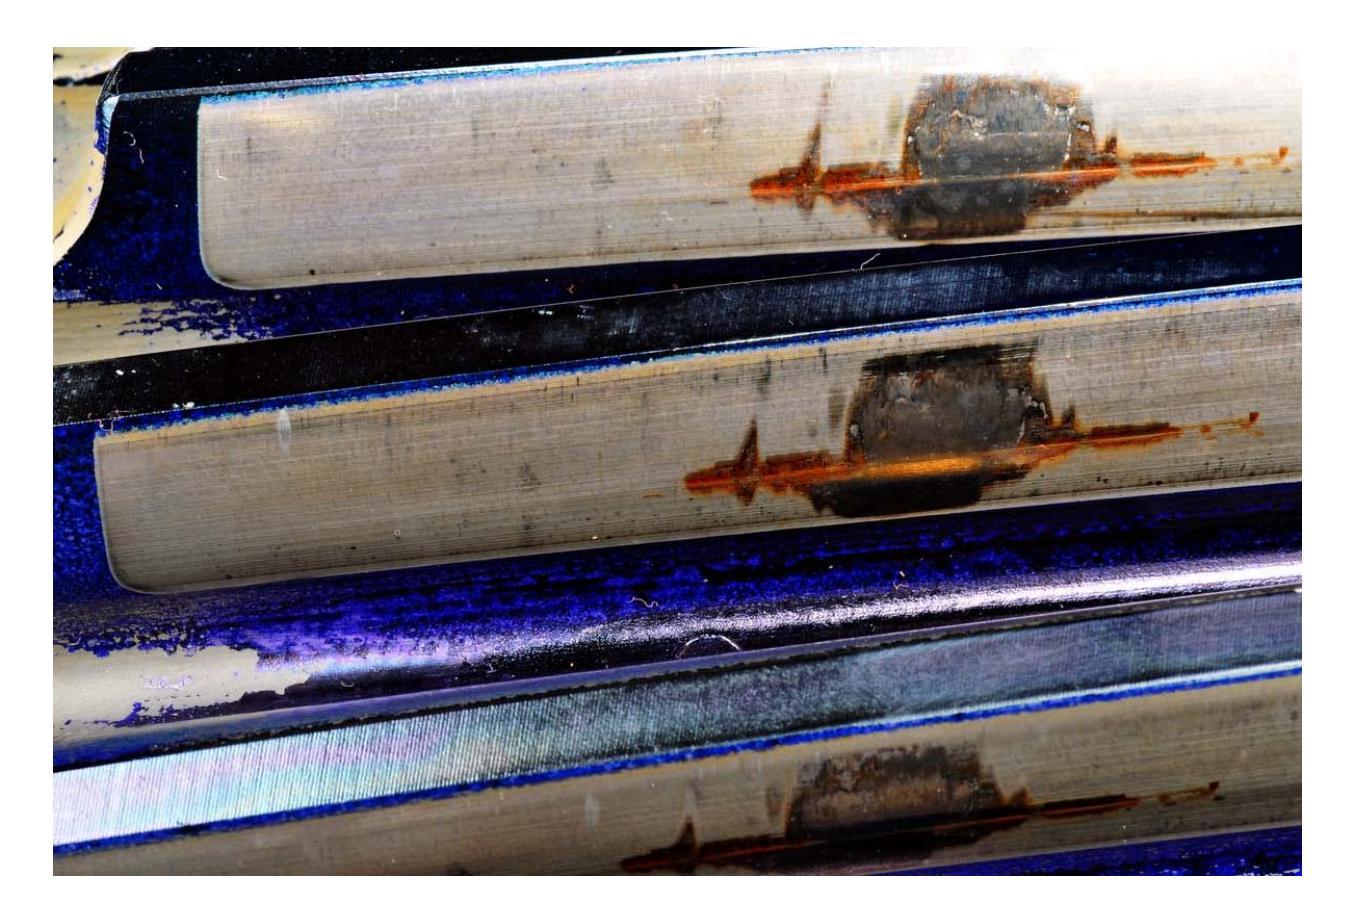
Figure No: 30 (NREL PIX 19862) Scale: 2.1X Component: INTP Failure mode 1: fretting corrosion Failure mode severity 1: severe Failure mode 2: polishing wear Failure mode severity 2: severe (local) Failure mode 3: scuffing Failure mode severity 3: severe (local) Description: Fretting corrosion, polishing, and scuffing. Damage was imprinted on all teeth because the gearset had a hunting gear ratio.

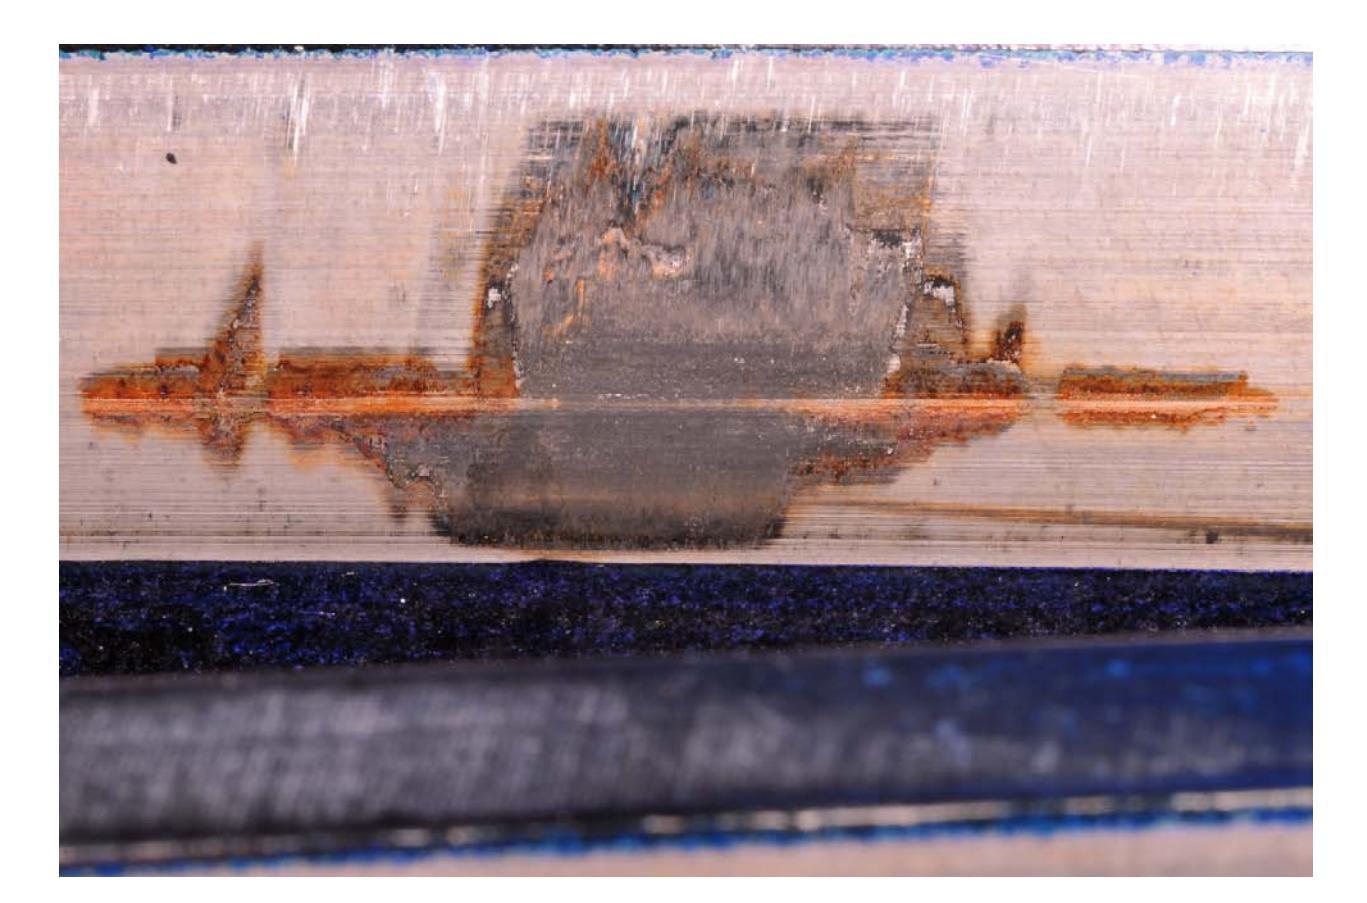
Figure No: 31 (NREL PIX 19863) Scale: 4.5X Component: INTP Failure mode 1: fretting corrosion Failure mode severity 1: severe Failure mode 2: polishing wear Failure mode severity 2: severe (local) Failure mode 3: scuffing Failure mode severity 3: severe (local) Description: Closeup view of the fretting corrosion, polishing, and scuffing.

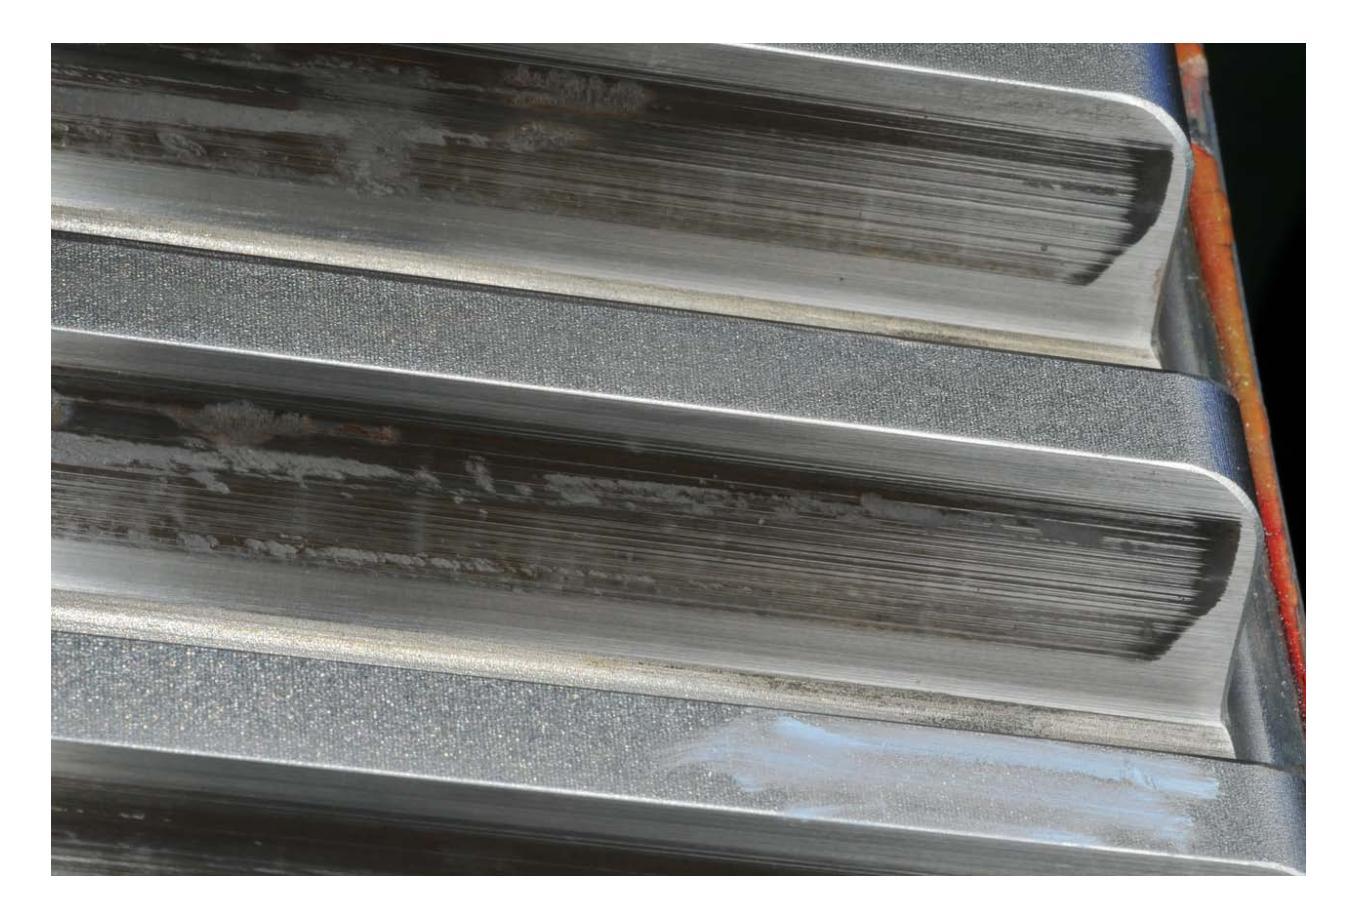
Figure No: 32 (NREL PIX 19854) Scale: 1.4X Component: ANN Failure mode 1: scuffing Failure mode severity 1: moderate (local) Failure mode 2: polishing Failure mode severity 2: moderate Description: Closeup view of polishing at the generator end of the teeth.

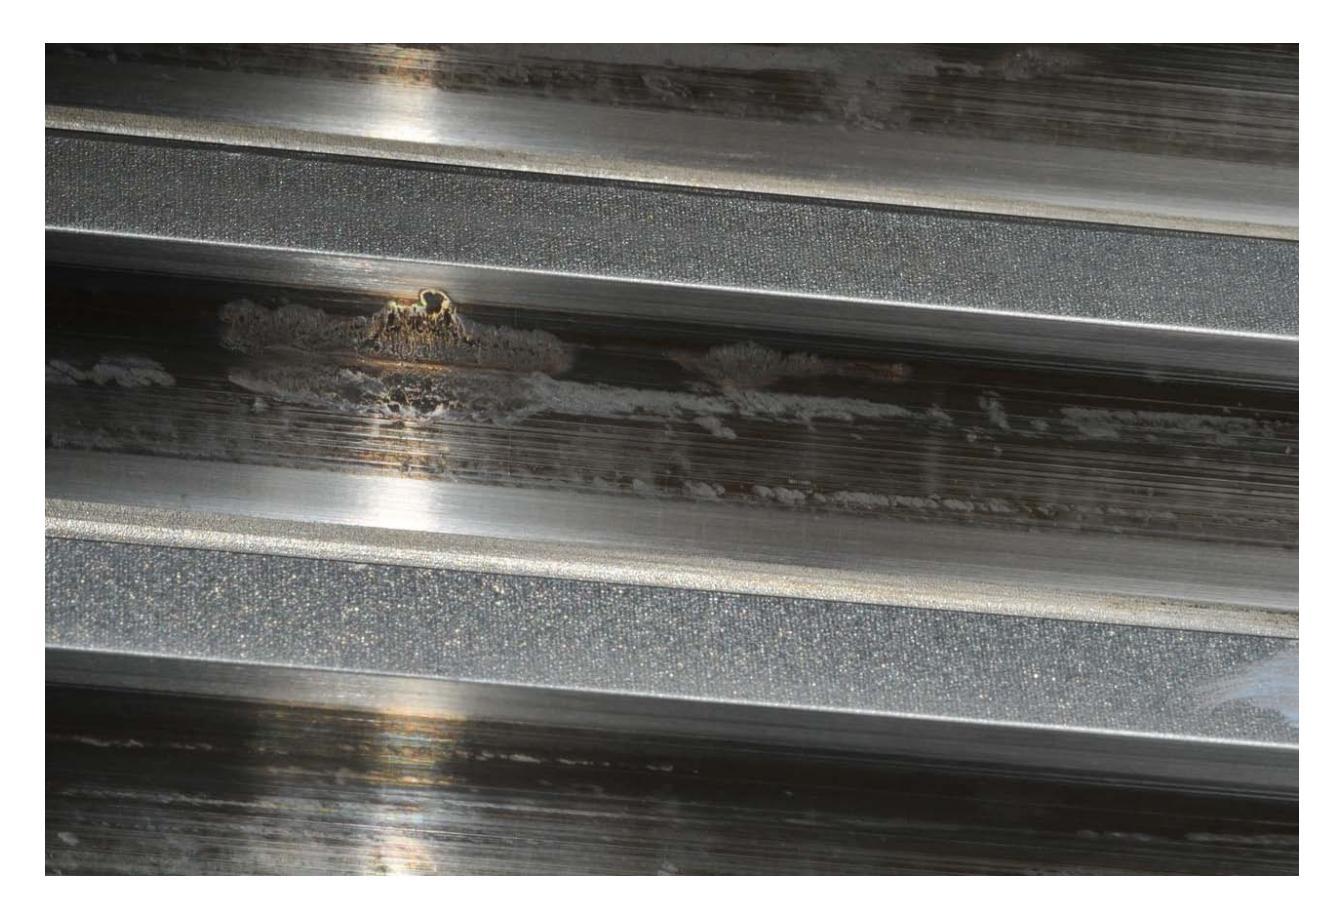
Figure No: 33 (NREL PIX 19855) Scale: 1.4X Component: ANN Failure mode 1: scuffing Failure mode severity 1: moderate (local) Failure mode 2: polishing Failure mode severity 2: moderate Description: Closeup view of scuffing near the midface of the teeth.

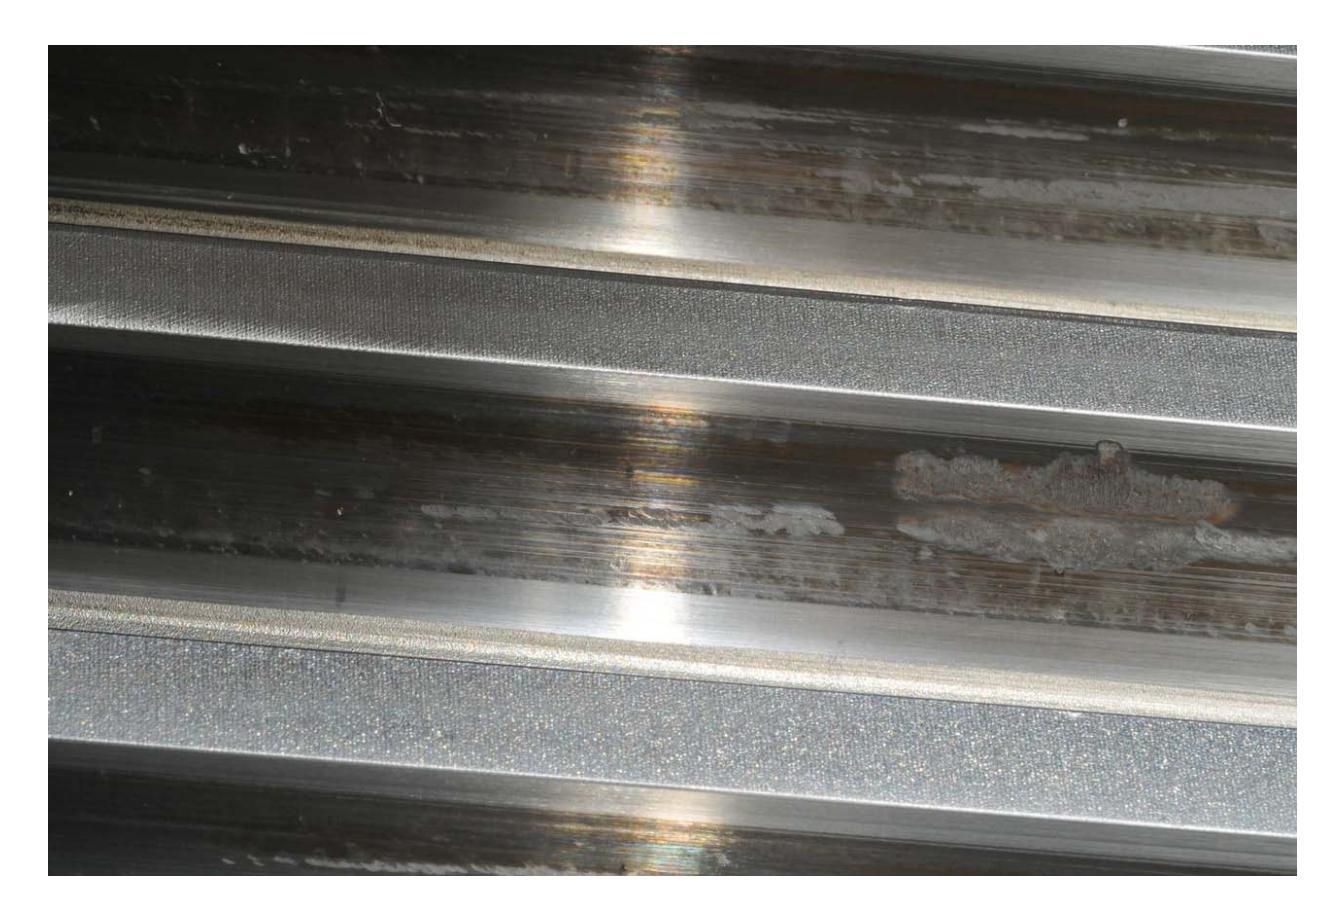
Figure No: 34 (NREL PIX 19856) Scale: 1.4X Component: ANN Failure mode 1: scuffing Failure mode severity 1: moderate (local) Failure mode 2: polishing Failure mode severity 2: moderate Description: Closeup view of scuffing near the midface of the teeth.

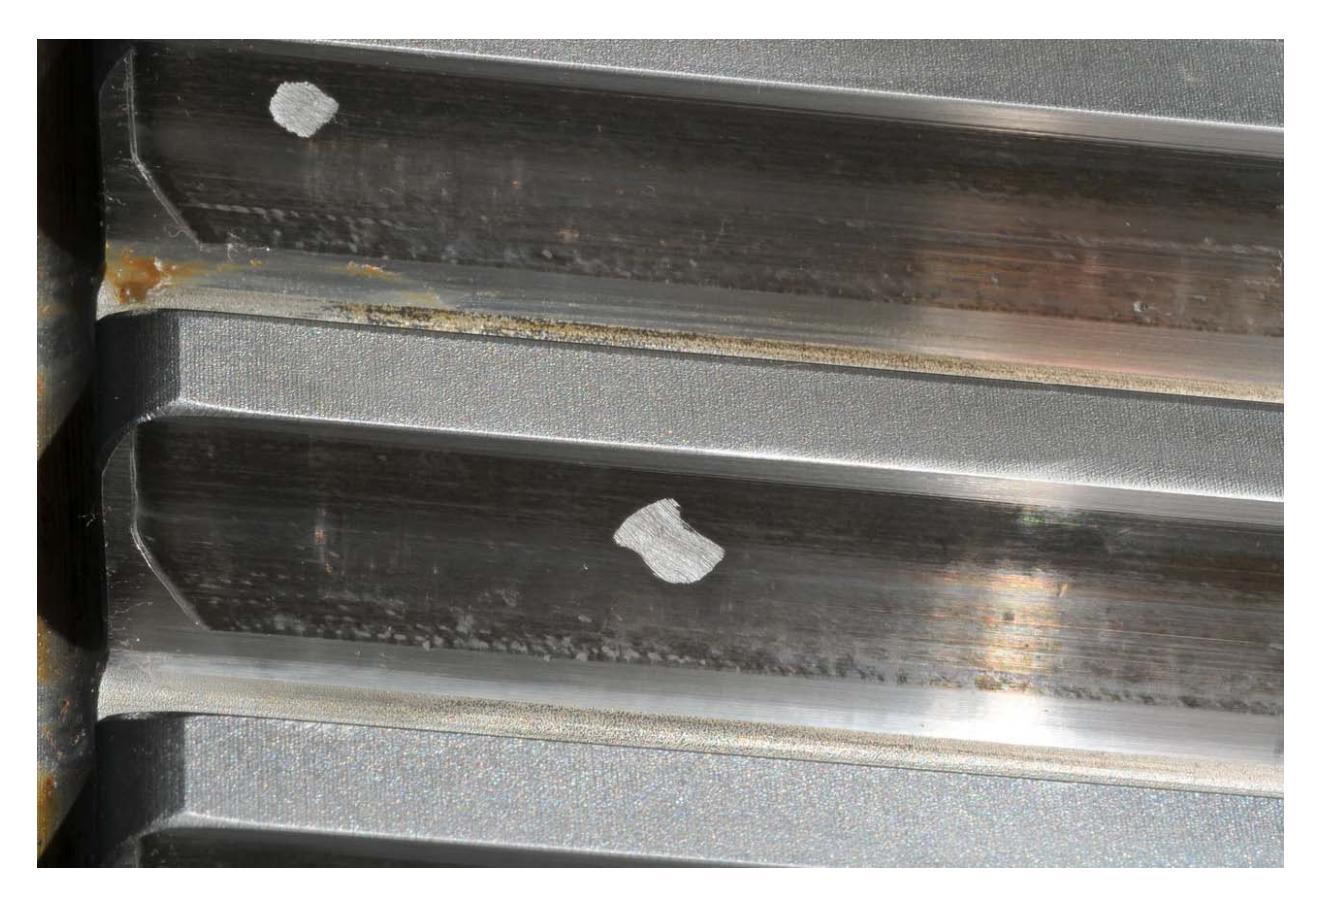
- 14. The annulus gear wear pattern indicated that the load distribution was heavier at the rotor end of the teeth.
- 15. The orientation of the annulus gear showed that it was assembled such that the load flanks had prior macropits that were hand dressed.

Figure No: 35 (NREL PIX 19857) Scale: 1.5X Component: ANN Failure mode 1: scuffing Failure mode severity 1: moderate (local) Failure mode 2: polishing Failure mode severity 2: severe

Description: Closeup view of severe polishing wear at the rotor end of the teeth. Two original, hand dressed macropits are shown. Polishing wear removed all traces of the grind marks and created a wear step at the end of the contact.

- 14. Review the lead modification for the planet and annulus and revise as necessary to improve load distribution on the planet/annulus gear mesh.
- 15. Replace the annulus gear with a new gear.
