FAILURE ANALYSIS OF A WIND TURBINE GEARBOX

On December 27-30, 2010 and January 3-7, 2011, Robert Errichello and Jane Muller inspected one Jahnel-Kestermann (JAKE) gearbox at The Gear Works in Seattle, Washington. The root cause of the loss of oil is unknown and, therefore, not addressed in this report. In both instances, a temperature sensor on a high-speed pinion (HSP) bearing signaled a wind turbine shutdown. This report summarizes the results of the inspection of the gearbox and contains photographs of the failed components.

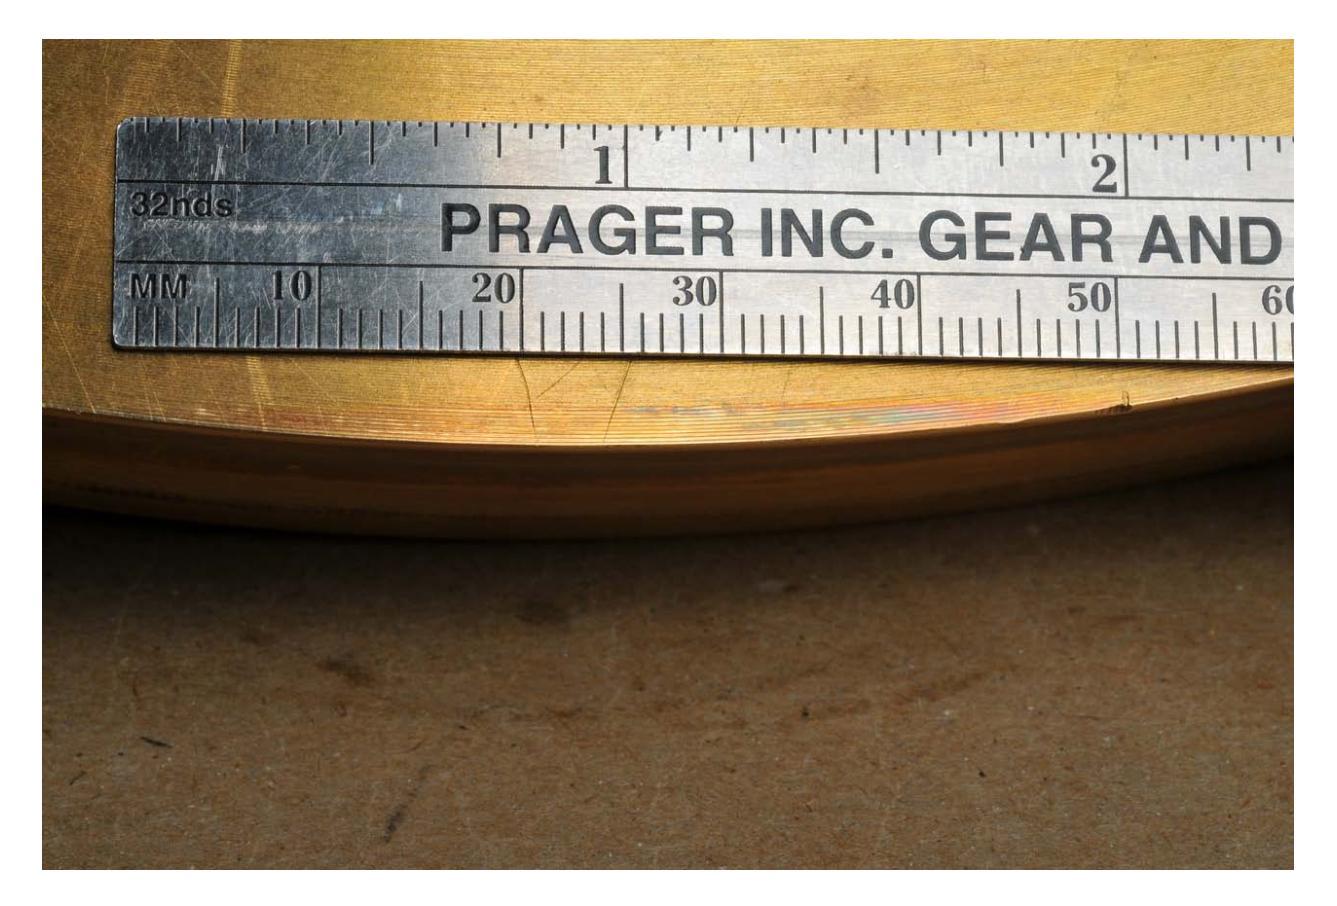
- 16. The oil transfer ring for the planet carrier was found cocked and jammed in the carrier. The wear pattern on its rubbing face showed it had only limited contact with the housing over a 50 mm sector. Hand pressure on the transfer ring showed that it was prone to jamming.

Figure No: 36 (NREL PIX 19840) Scale: 2.7X Component: oil transfer ring for carrier Failure mode: polishing Failure mode severity: mild (local) Description: Closeup view of polishing near the outside diameter of the rubbing face. The contact area was only about 50 mm long.

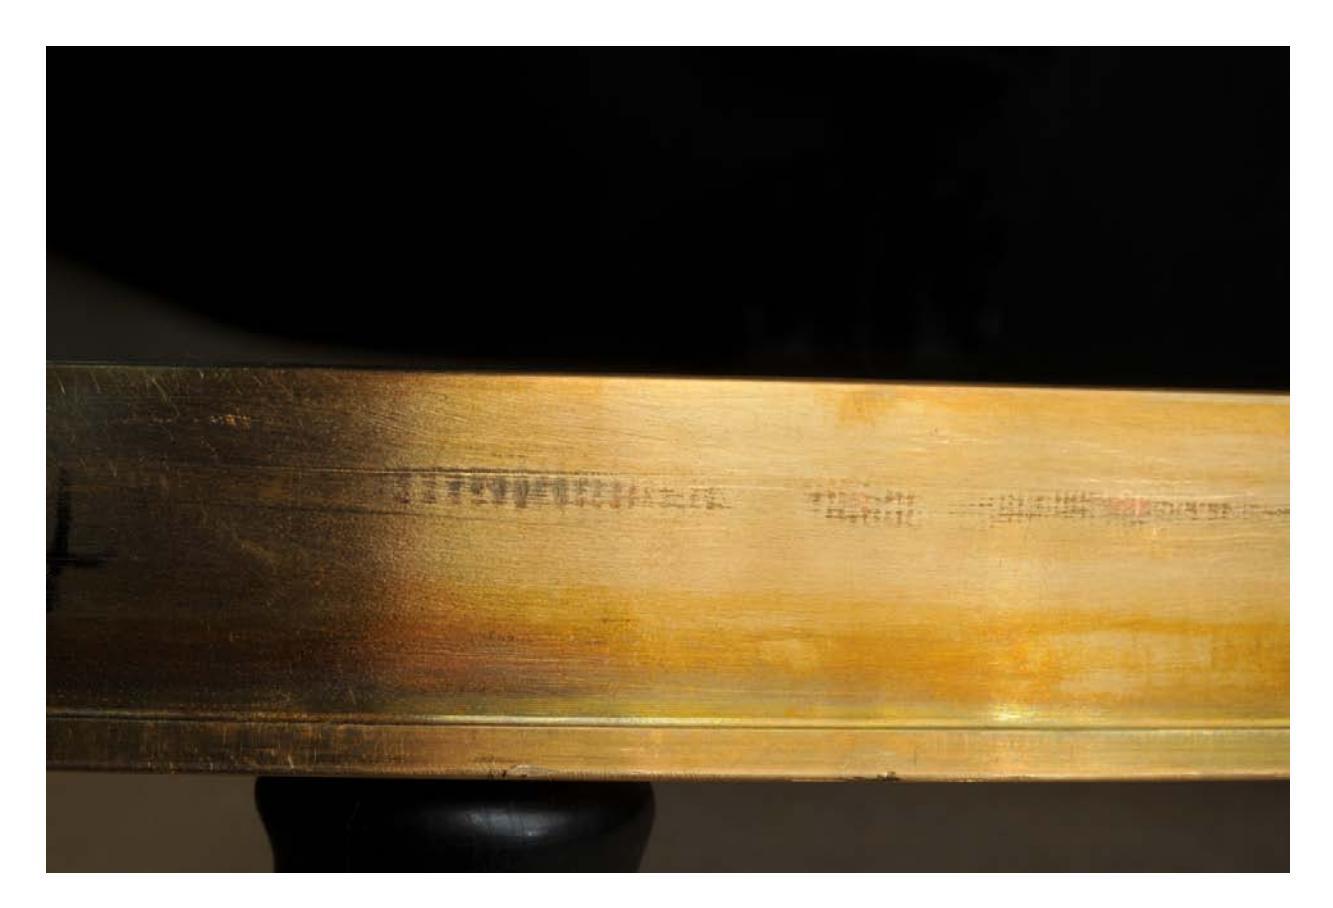
Figure No: 37 (NREL PIX 19841) Scale: 1.9X Component: oil transfer ring for carrier Failure mode: polishing Failure mode severity: mild (local) Description: Closeup view of polishing on the outside diameter. The marks occurred when the ring cocked and jammed.

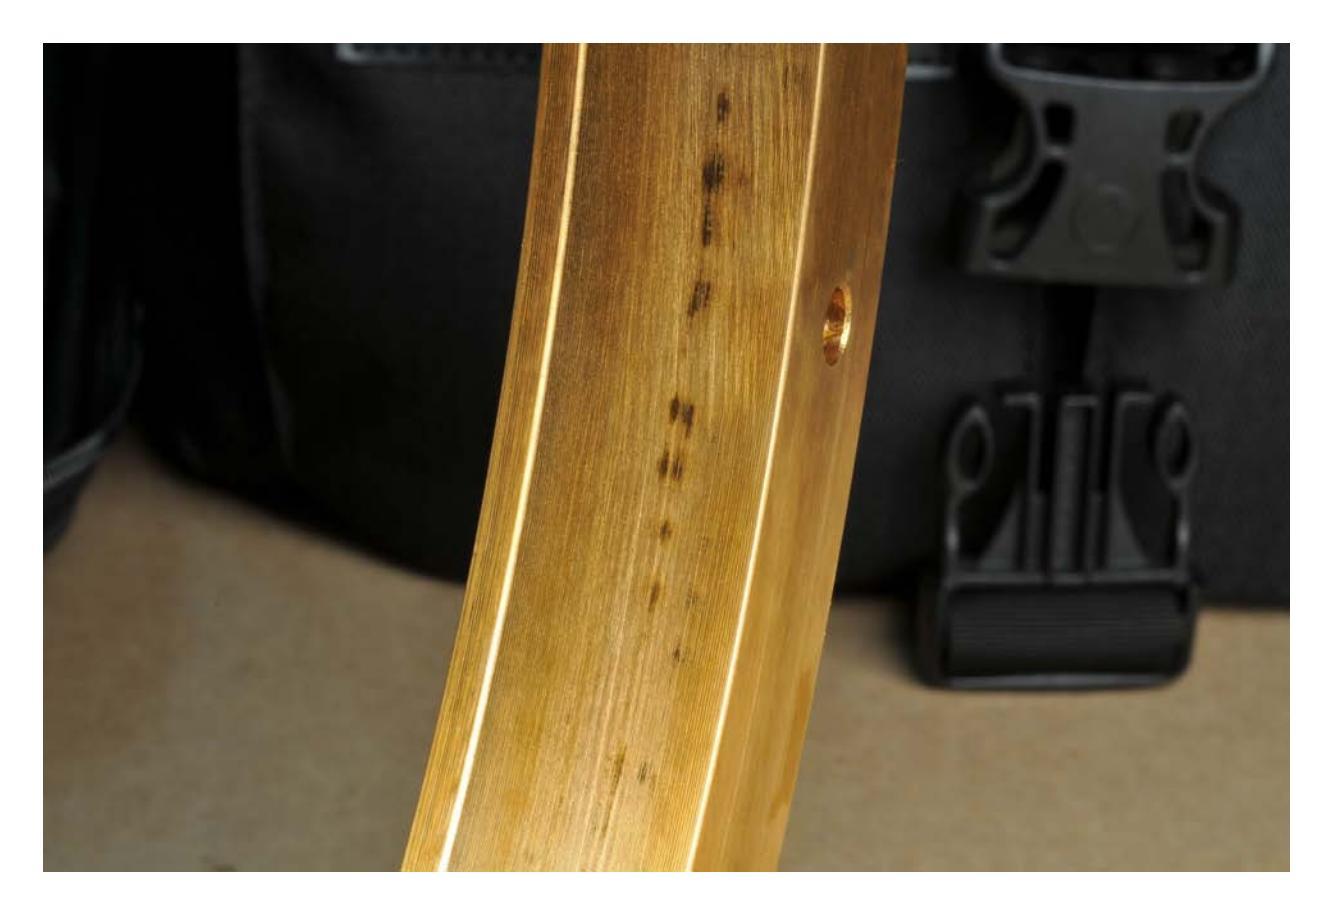
Figure No: 38 (NREL PIX 19842) Scale: 1.4X Component: oil transfer ring for carrier Failure mode: polishing Failure mode severity: mild (local) Description: Closeup view of polishing on the bore. The marks occurred when the ring cocked and jammed.

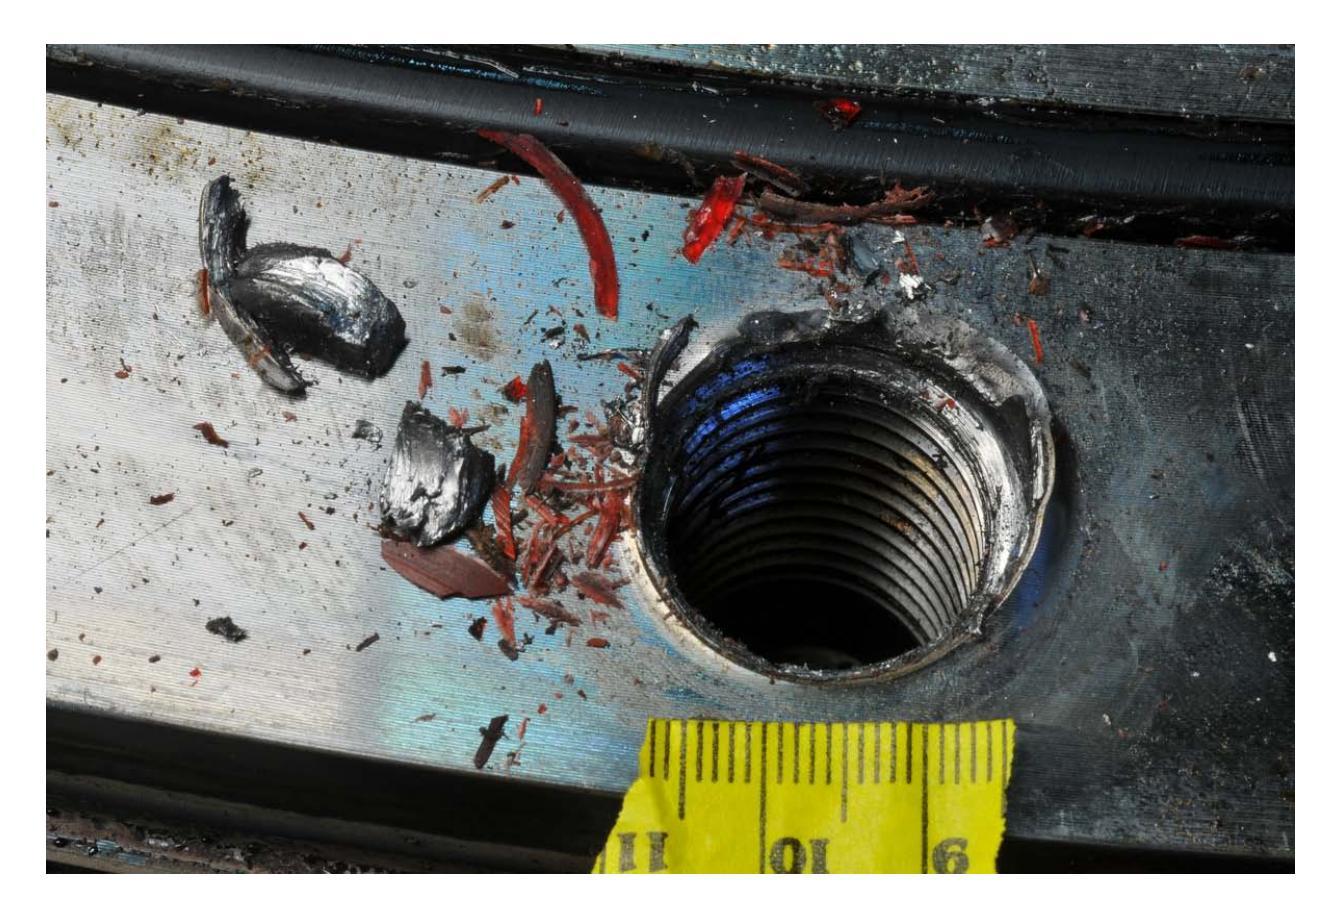
Figure No: 39 (NREL PIX 19845) Scale: 2,0X Component: ANN bolt hole Failure mode: plastic deformation Failure mode severity: severe Description: Closeup view of stripped thread. The failure occurred when the bolt jammed during removal.

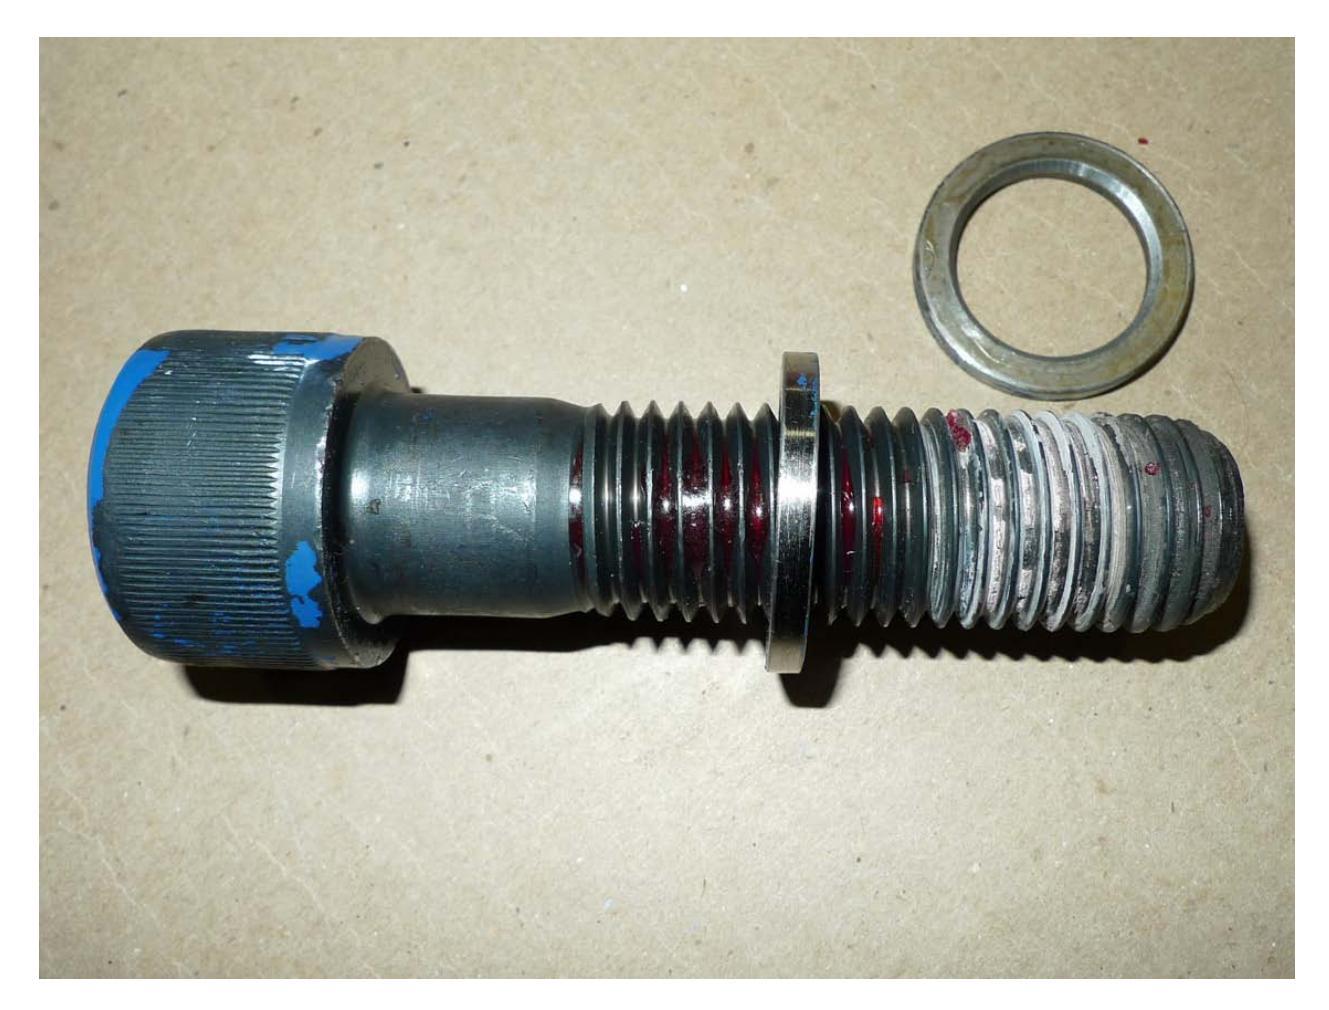
Figure No: 40 (NREL PIX 19836) Scale: 1.2X Component: ANN bolt washer Failure mode: none Failure mode severity: none Description: Closeup view of the bolt and washer. The washer outside diameter had been reduced by machining to a diameter about equal to the bolt shoulder.

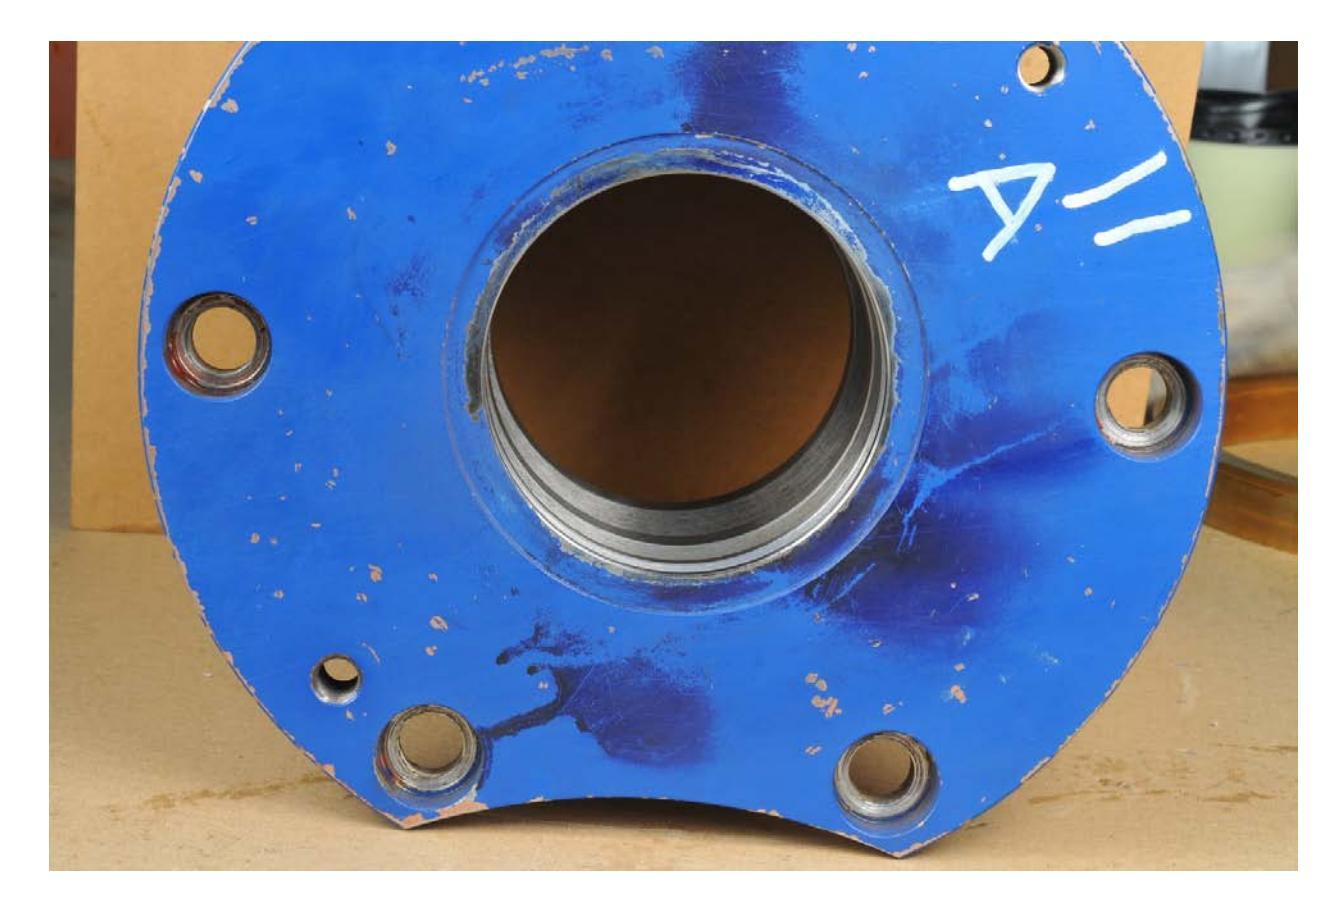
- 21. There was no external V-ring and no felt seal on the HS labyrinth. This allowed the gearbox to breathe through the labyrinth and ingest moisture and dust.

Figure No: 41 (NREL PIX 19869) Scale: 0.50X Component: bearing cap A Failure mode: none Failure mode severity: none Description: Closeup view of cap face. There was no V-ring and no wear track from a V-ring.

- 21. Add an external V-ring and felt seal to the HS labyrinth.
- 22. Add an external V-ring to the LS labyrinth.
- 23. Coat the bore and outside diameter of the carrier extension with rust preventative whenever the gearbox is disassembled from the rotor shaft.

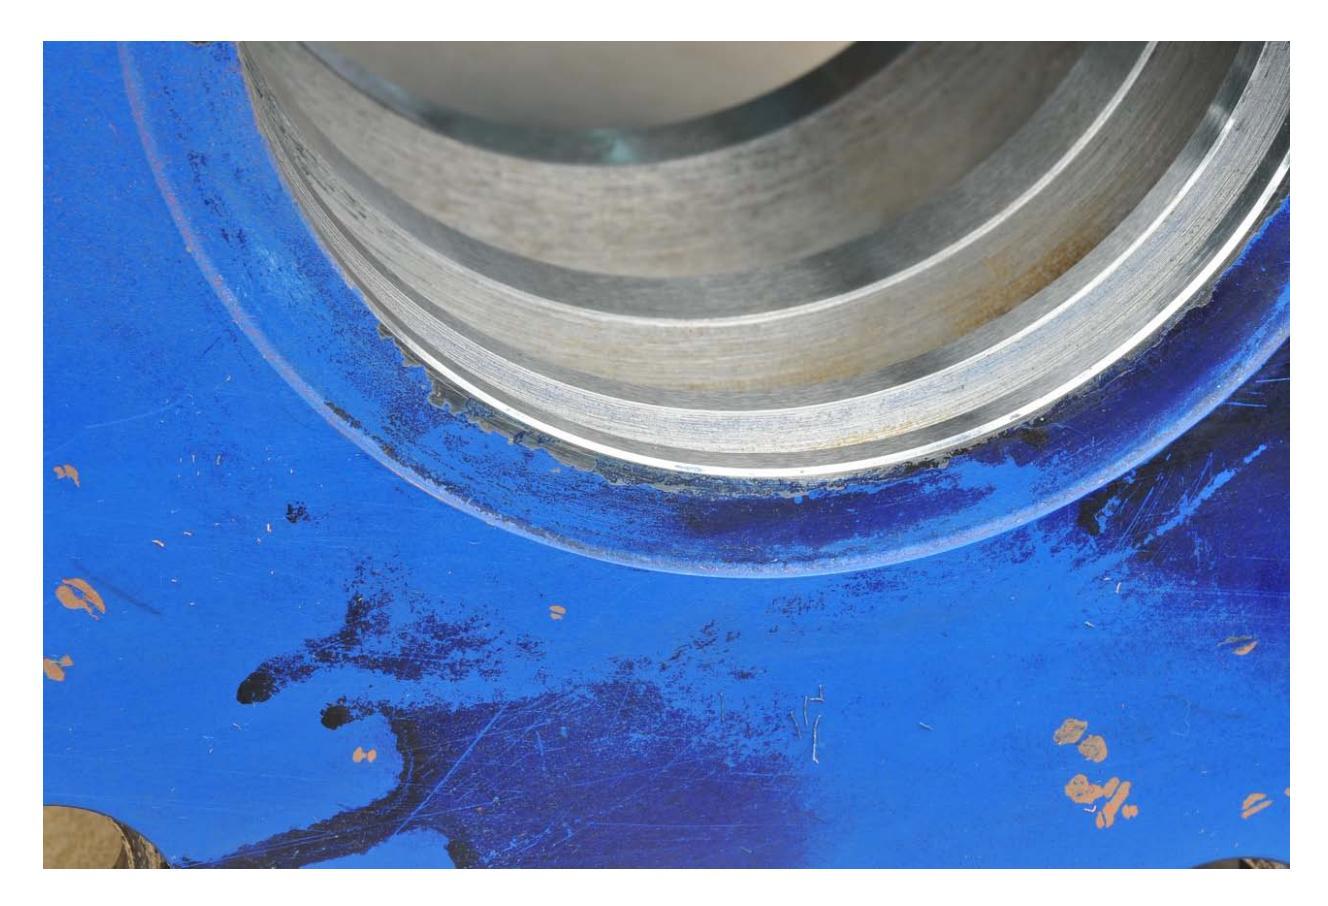
Figure No: 42 (NREL PIX 19870) Scale: 1.3X Component: bearing cap A Failure mode: none Failure mode severity: none Description: Closeup view of felt seal groove. There was no felt seal and no wear track on the HSP from a felt seal.

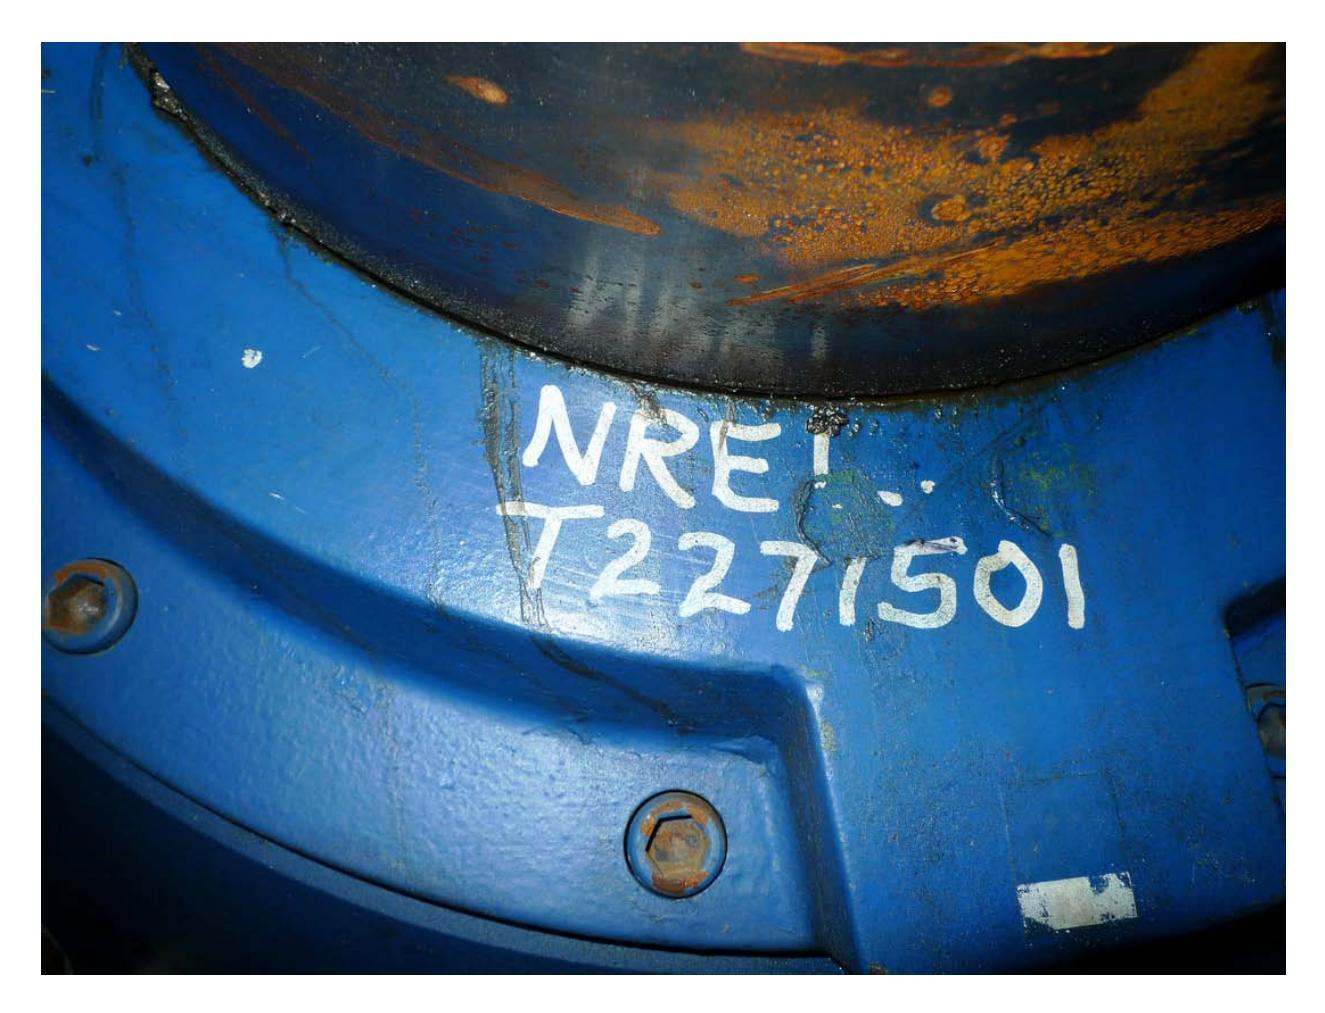
- 22. There was no external V-ring on the LS labyrinth. This allowed moisture and dust to enter the gearbox.
- 23. Rust was found on the carrier bore for the rotor shaft and on the OD fit for the shrink ring. These occurred because no rust preventative was applied when the gearbox was removed from the rotor shaft.

Figure No: 43 (NREL PIX 19835) Scale: 0.49X Component: bearing cap H Failure mode: none Failure mode severity: none

Description: Closeup view of cap face. There was no V-ring and no wear track from a V-ring. Oil on the cap face shows minor oil leaks. Rust is evident on the outside diameter of the carrier extension.
