EXXONMOBIL FACILITY BATON ROUGE, LA - 2016 ACCIDENT INVESTIGATION

Incident Date: November 22, 2016 4 Workers Injured No. 2016-02-I-LA The **U.S. Chemical Safety and Hazard Investigation Board** (CSB) is an independent Federal agency whose mission is to *drive chemical safety change through independent investigations to protect people and the environment*.

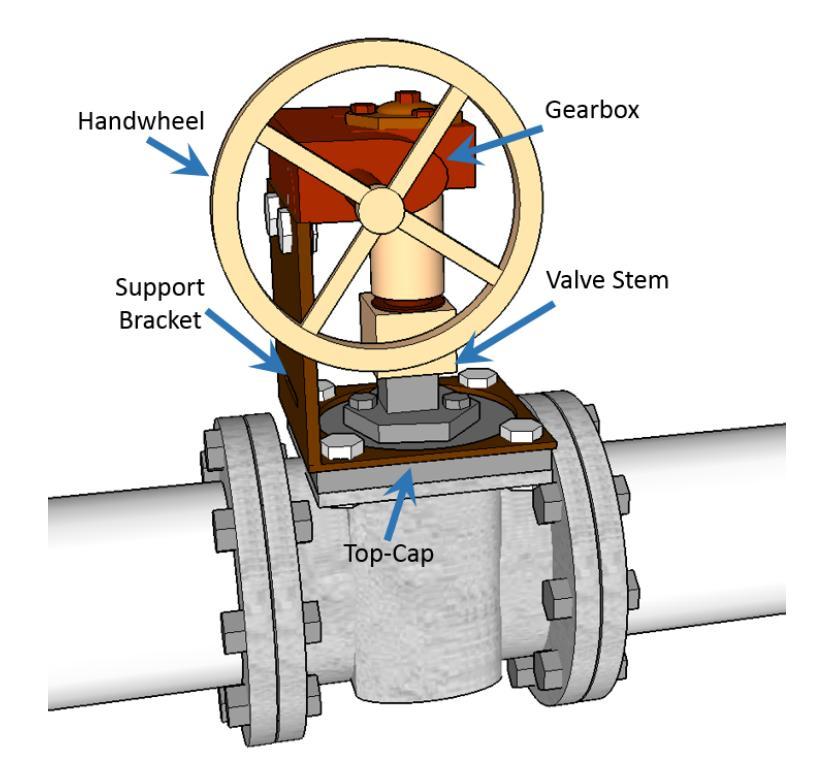
Infrequently used plug valves like this one are often operated manually. An operator turns a handwheel connected to a gearbox to open or close the valve.⁸ (Figure 2). The handwheel rotates gears to turn the valve stem into the open or closed position, and a support bracket attaches the gearbox to the valve body using bolts. On the afternoon of the incident, one of the operators attempted to open the plug valve to the spare pump using the handwheel attached to the valve. But the gearbox was not operating properly, and although the handwheel turned, the valve did not open.⁹

Figure 2. Illustration showing an alkylation unit plug valve with gearbox, valve stem, top-cap, support bracket, and handwheel similar to the one involved in the incident.

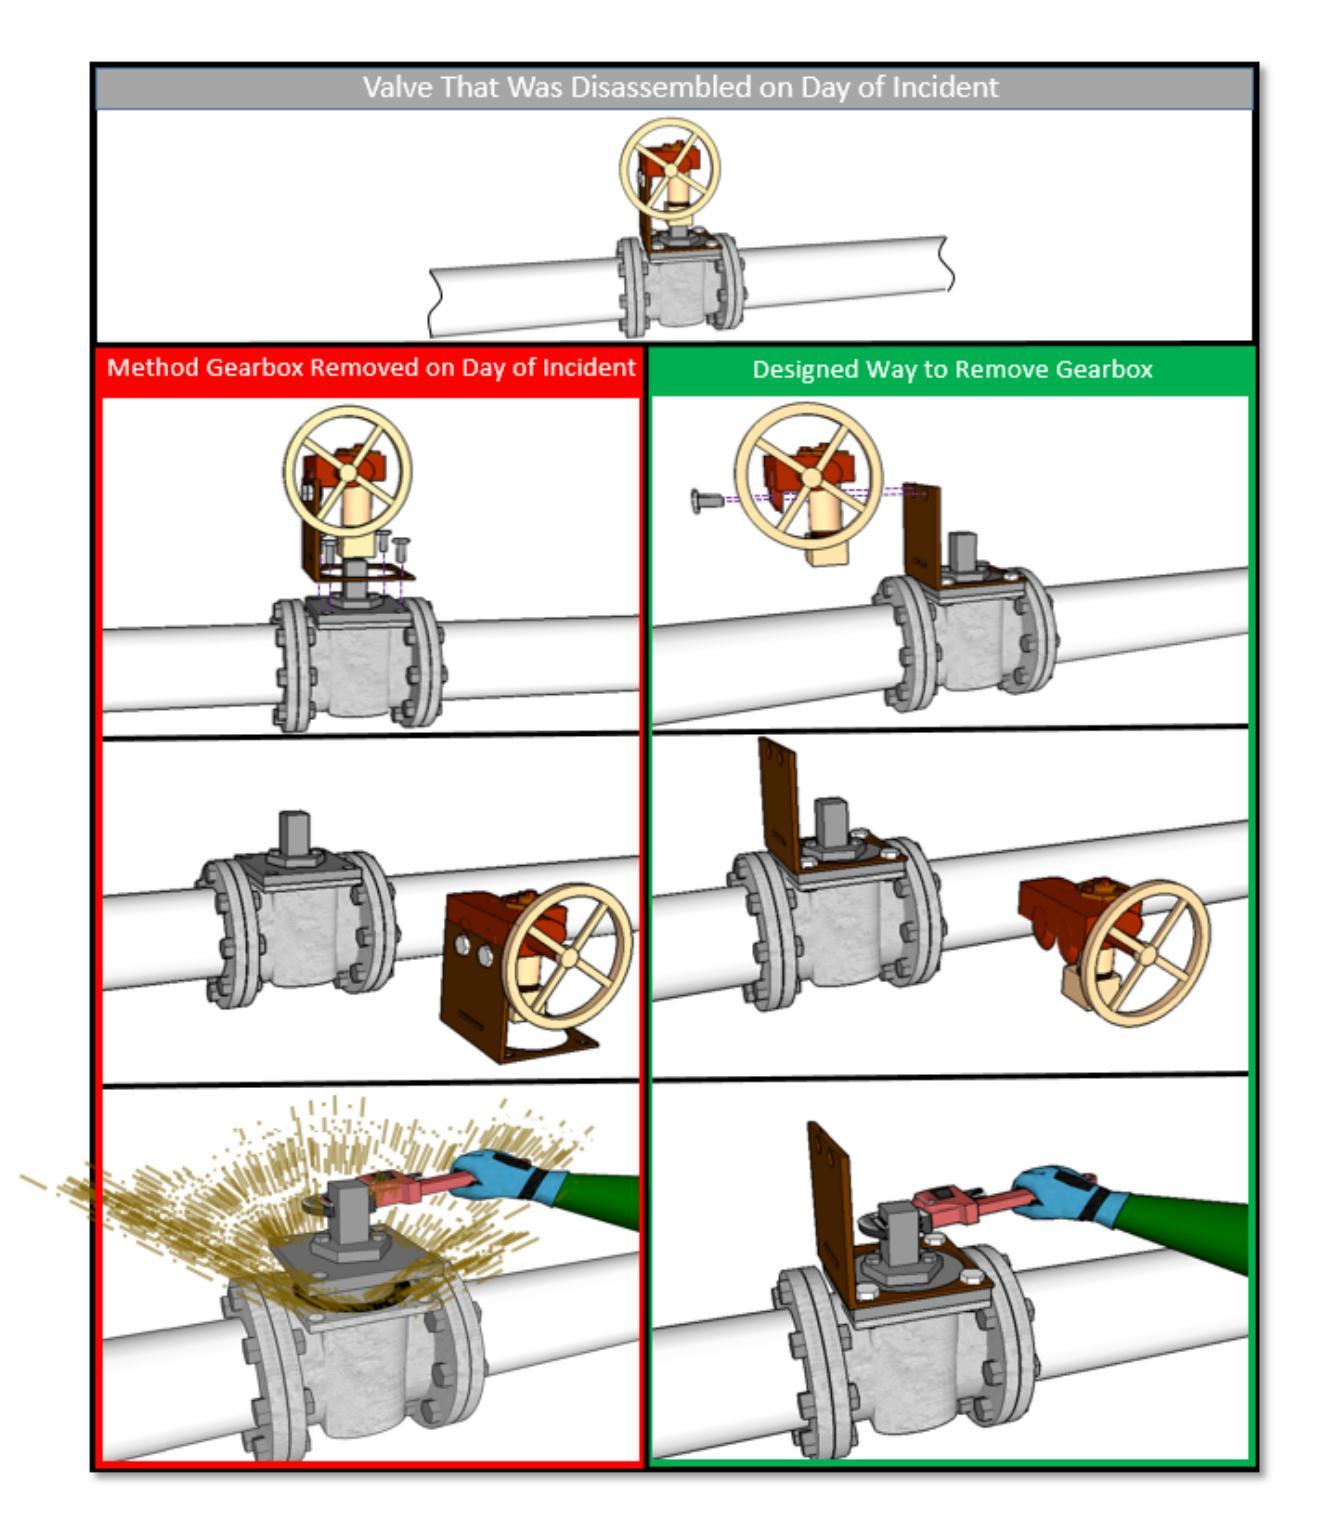
One of the operators removed the gearbox assembly so he could turn the valve stem with a pipe wrench to open the valve.¹⁰ Removing a malfunctioning gearbox from a plug valve is an accepted practice for alkylation unit operators.¹¹ To remove the gearbox, the operator removed the four vertical bolts that connected the gearbox support bracket to the valve body.¹² These four bolts, however, also secured the top-cap – a pressure-retaining component – to the valve body.¹³ The two horizontal bolts that could safely remove the gearbox from the support bracket remained in place. (Figure 3).

One of the operators then opened the valve by rotating the valve stem with a pipe wrench, while the other operator observed. With the four bolts removed from the top-cap, critical valve components were no longer held together. When the operator turned the valve stem, the plug valve loosened and came apart. Pressurized isobutane¹⁴ escaped from the valve body, forming a flammable white vapor cloud.

Figure 3. Gearbox removal. The left column illustrates how operators removed the plug valve gearbox on the day of the incident. It shows operators removed the entire support bracket. By design, removing the gearbox did not require removing the four vertical bolts that secured the pressure-retaining top-cap. The right column illustrates how the plug valve gearbox should be disassembled. The gearbox and handwheel could be disconnected from the support bracket by removing the two horizontal bolts on the side of the support bracket.

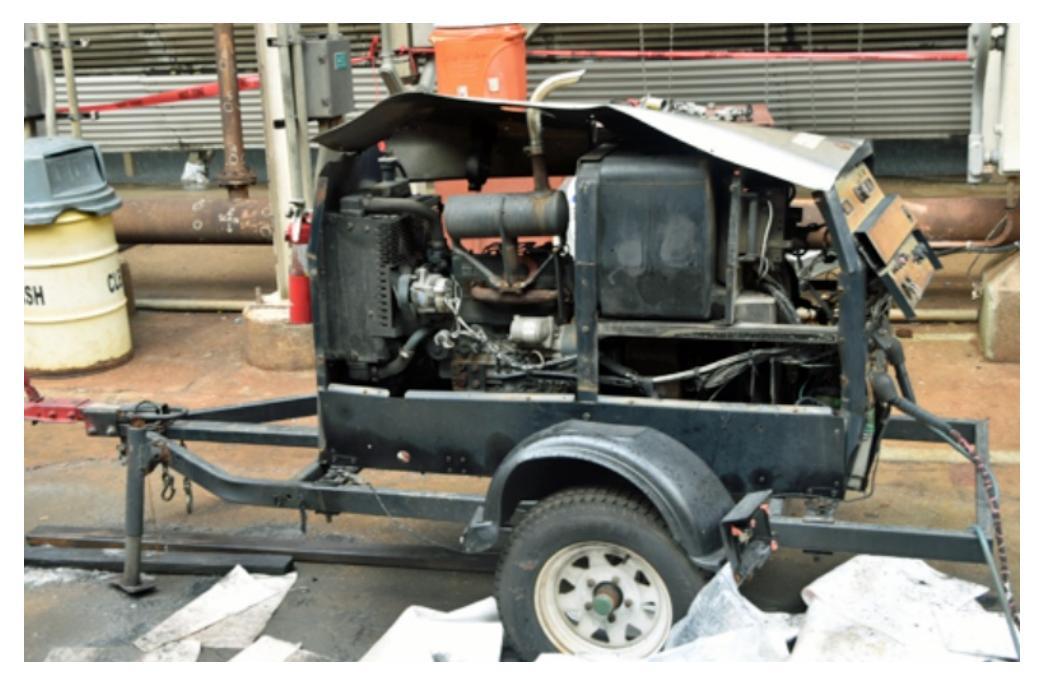
ExxonMobil estimated that 2,000 pounds of isobutane released into the atmosphere. Based on surveillance video, an energized welding machine located roughly 70 feet away likely ignited the vapor cloud. (Figure 4 and Figure 5). The resulting fire seriously injured one ExxonMobil employee and three contractors working in the vicinity of the release.¹⁵ Emergency responders isolated the release and extinguished the fire about 25 minutes after the initial ignition.

Figure 4. Welding machine that was the likely ignition source of the isobutane vapor cloud.

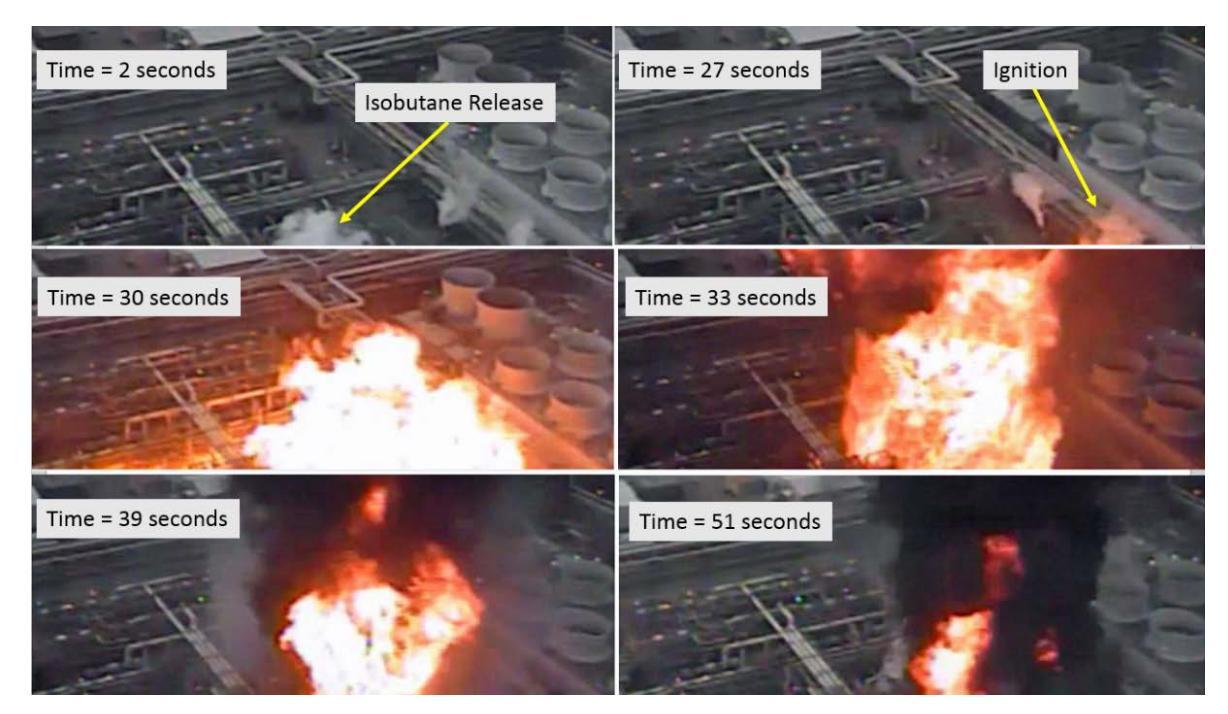
Figure 5. Sequence of events. Baton Rouge refinery security video clips showing the isobutane release and subsequent fire. This sequence does not show time zero – the first indication of the isobutane vapor cloud.

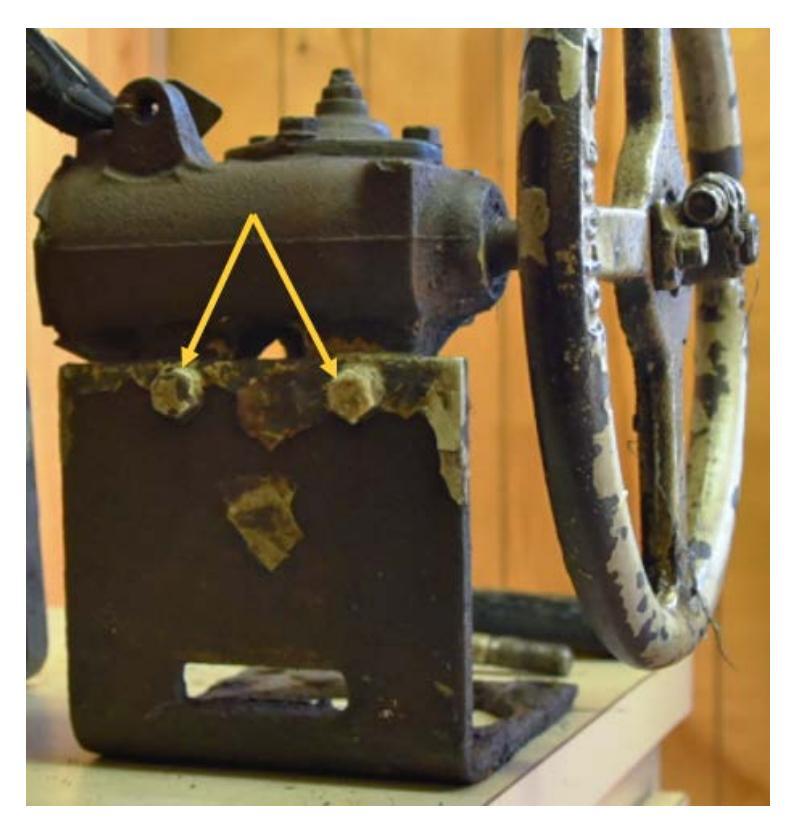
The gearbox involved in the incident conformed to this part of the standard because it *could* be removed without removing any pressure-retaining parts. The operator could have removed the two horizontal bolts that connect the support bracket directly to the gearbox, rather than the four vertical bolts that secure the support bracket to the pressure-retaining top-cap (as shown on the right side of Figure 3 and in Figure 6). But the operator did not remove these two horizontal bolts; instead, he removed the four vertical bolts, which he believed to be the correct bolts to remove.

Figure 6. Gearbox support bracket for the valve involved in the incident. The two horizontal bolts (yellow arrows) can be removed to take the gearbox off the support bracket and the valve without disturbing the top-cap bolts. By removing the gearbox in this manner, the pressure-retaining valve components are not disturbed.

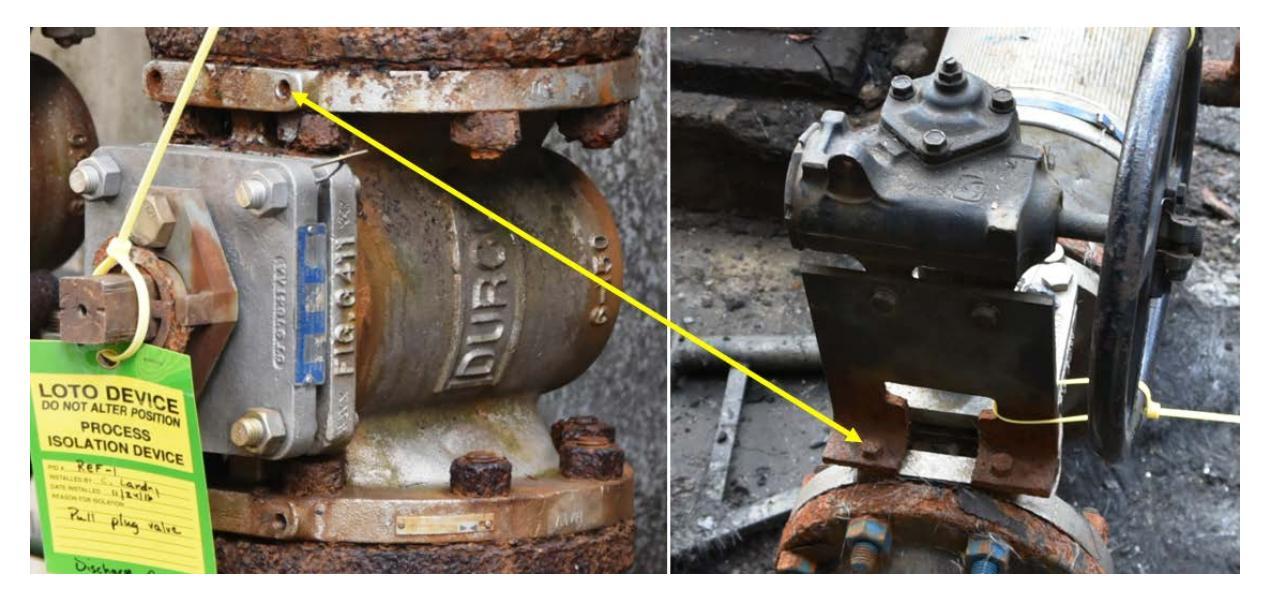
The CSB learned that the plug valve manufacturer (Durco) updated the plug valve design in 1984 so that the gearbox support bracket could be attached to the valve using different bolt connections than those that secure the pressure-retaining top-cap to the valve body. Approximately 97 percent of the plug valves located in the Baton Rouge refinery's alkylation unit are the more recent Durco plug valve design, which secures the gearbox assembly to the valve body flanges. (Figure 7 and Figure 8). With this improved design, the gearbox support bracket is unlikely to connect to the pressure-retaining top-cap, which can help prevent future incidents.

Figure 7. The improved plug valve design includes an additional four gearbox support bracket holes separate from the pressure-retaining top-cap (located on the valve body flanges) as seen at the yellow arrows. The photo on the right shows a gearbox support bracket attached to the valve body flange for a valve that was not involved in the incident. The photo on the left shows a different plug valve in the alkylation unit with its gearbox removed.

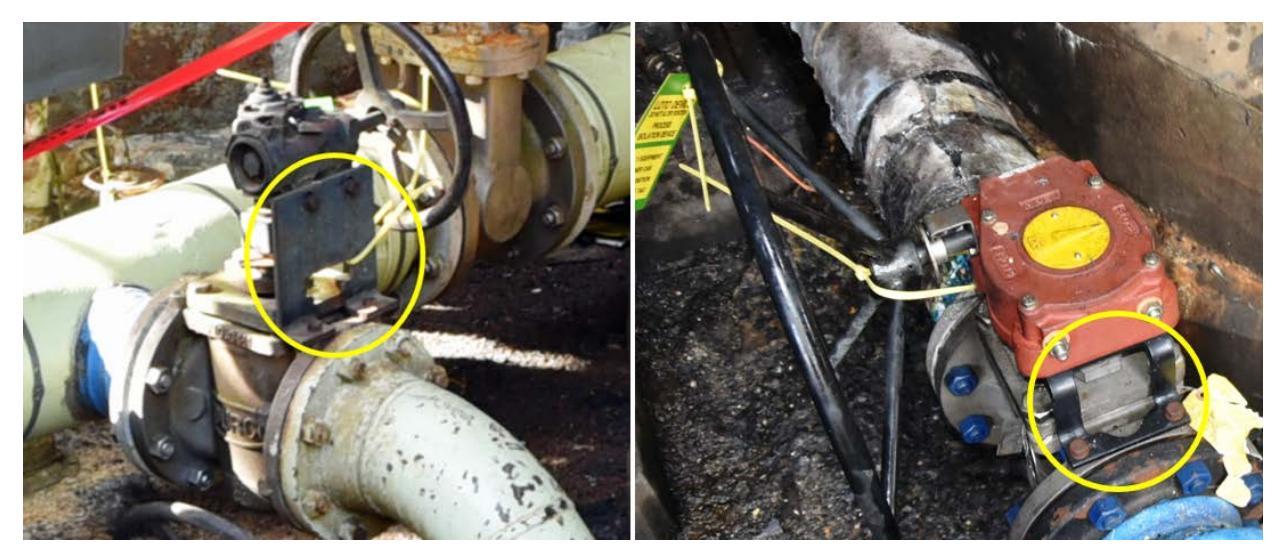
Figure 8. Two of several designs of gearbox support brackets (yellow circles) used at the Baton Rouge refinery. These specific brackets attach to the valve body flange – they are not among the approximately three percent of valves in the alkylation unit that attach the gearbox support bracket using the same four vertical bolts that secure the pressure-retaining top-cap.

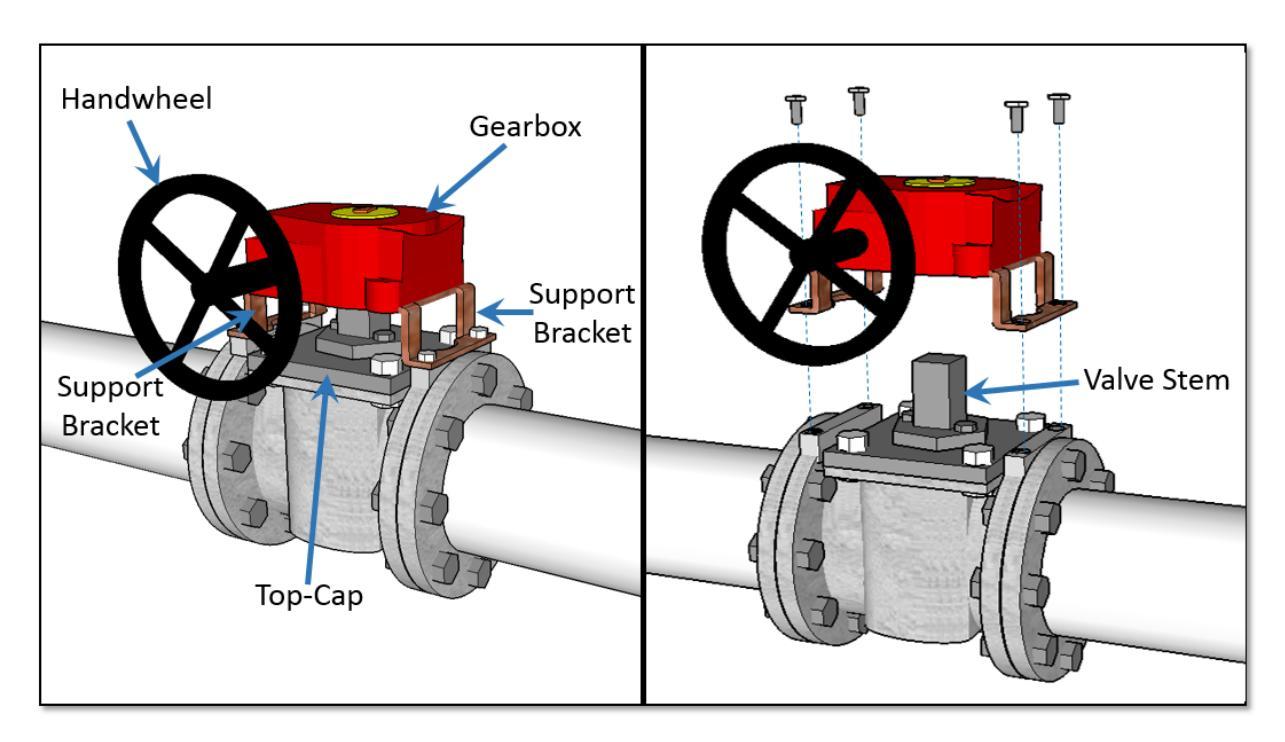
The newer plug valve more broadly used in the alkylation unit is a better design. The redesign addressed the potential to have a chemical release when removing the gearbox assembly. The valve designers provided four additional connection points to secure the gearbox support brackets and these attachment locations are not pressure-retaining components. (Figure 9). With the newer and improved valve design, if a worker completely removes the gearbox and its support bracket(s), a chemical release cannot occur.

Figure 9. The post-1984 plug valve design, showing how one type of gearbox connects to all four dedicated attachment points on the valve flanges that are not pressure-retaining parts.

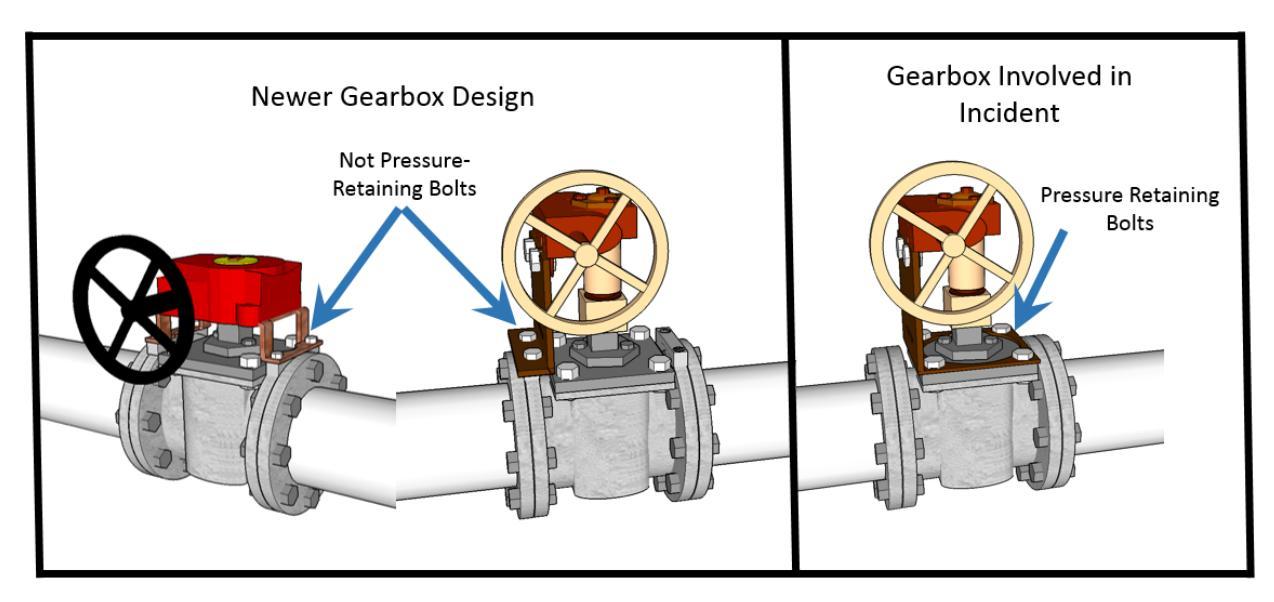
The location of the bolts on the newer valve design may have also contributed to the operator removing pressure-retaining bolts. On the newer design, the bolts connecting the support bracket to the valve are vertical, and are usually removed in order to remove the gearbox and handwheel. In describing how to remove a gearbox from this type of plug valve, an alkylation unit operator explained, "I would only have to pull those [vertical] bolts right there and the whole thing would come off." Although another operator recognized that there were two different ways to remove the plug valve gearbox, there was not a preferred method. While looking at a photo of a plug valve to explain how to remove the gearbox, the operator said either the horizontal or the vertical bolts could be removed.

For the less common, older valve design, the vertical bolts were the pressure-retaining bolts and should not be removed; instead, the horizontal bolts should be removed to disassemble the gearbox and handwheel safely. (Figure 9 and Figure 10). It could appear as though these critical vertical bolts had to be removed to take the inoperable gearbox off the valve. Although other bolts allowed for gearbox removal without touching the critical pressure-retaining bolts, this design can lead to potentially catastrophic consequences. The CSB concludes that poor equipment design was a significant factor that led to this incident.

Figure 10. Comparison of newer gearbox attachment designs, which are among the approximately 97 percent of the gearboxes in the alkylation unit, and the gearbox involved in the incident. Importantly, the improved valve design connects the gearbox support bracket to dedicated connection points on the valve flange as shown in the left illustration.
