BS5837 2012 Tree Information Oakfield, Llantarnam – Proposed Footpath/Cycleway Construction

Torfaen County Borough Council
Llantarnum Playing Fields and Industrial
Park.

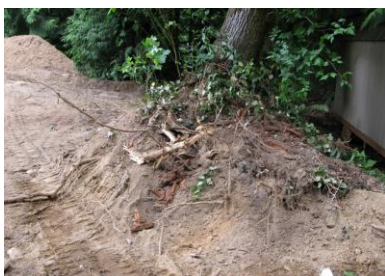
This photo shows a combination of damage. The roots have been severed or damaged in such a way that stability has been lost and this tree was felled. If the same damage had not led to an immediate tree failure the tree would have been sent into an irreversible spiral of decline.

The loss of roots will have caused a lack of structural support, loss of moisture take up, loss of oxygen take up and a means of the tree storing energy as starch within root structures. This type of root damage causes a slow decline in tree foliage known as crown die back.

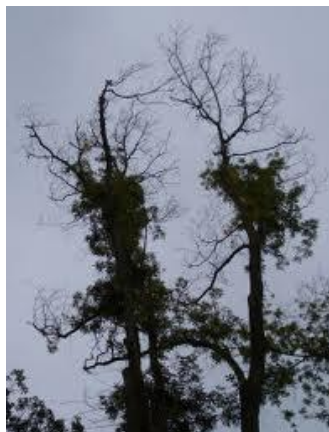
The picture to the right shows the years after the completion of a development site. Operators will often mention how they have driven over them. This is what happens.

die back of foliage several years after the completion of a development site. Machine operators have dug roots or happened once they leave

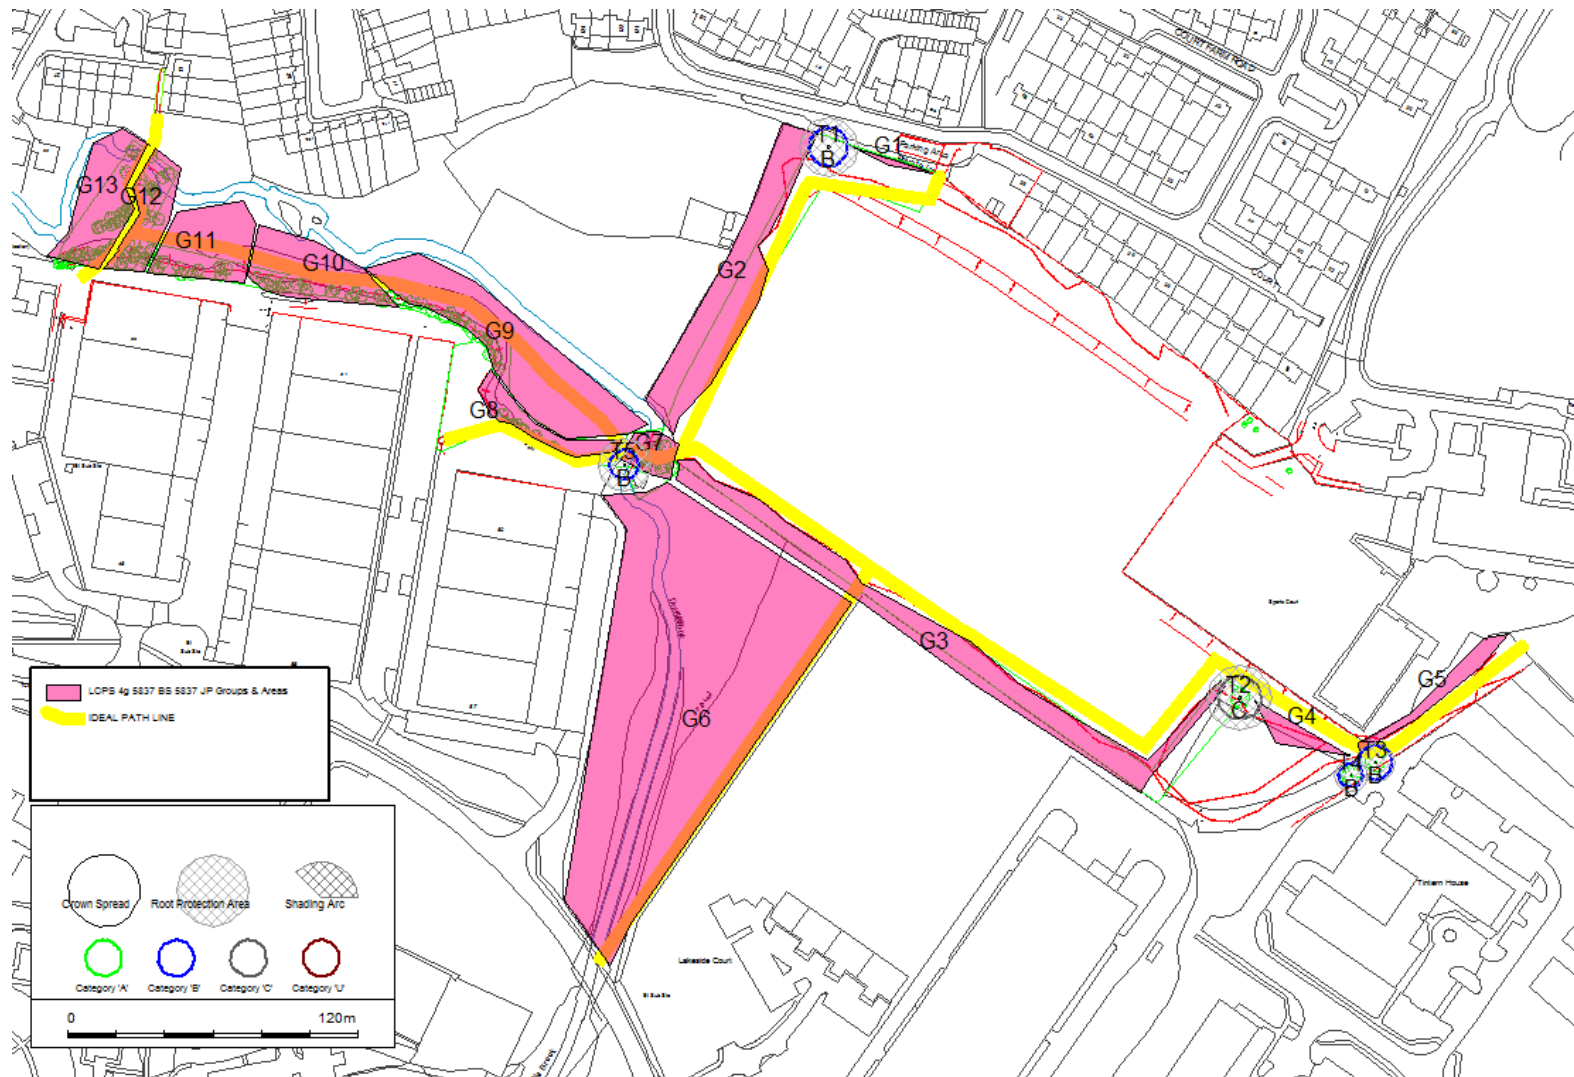
Site Plan screen grab – please see scale pdf plan also

In general the project is a reasonably straightforward from a tree perspective. There are areas where trees do not feature in path construction or design but in some areas trees will be an issue due to theoretical root spread beyond tree drip lines and into path construction areas. Trees close to or on the path line will certainly be an issue, both from rooting areas and also hazard trees proximity to work areas and the final paths.

1. Extensive ash trees with ash die back (*Hymenoschyphus fraxineus*). These will require removal – in places this helps the project a lot but it will be costly. It’s a lot of work.
2. Most of the individual trees marked on this plan also need work. Dead wood, die-back, stem decay are all issues. This will also need resolving before work starts on the path.
3. There will be a need for many metres of no dig path construction. I would propose Cellweb (or similar) as the type to be used. You will also need to find a contractor who is used to working with this product and near trees.
