Bayview Condominium Association, Inc.
2025 Annual Budget Report

Bayview Condominium Association

Millbrae, CA

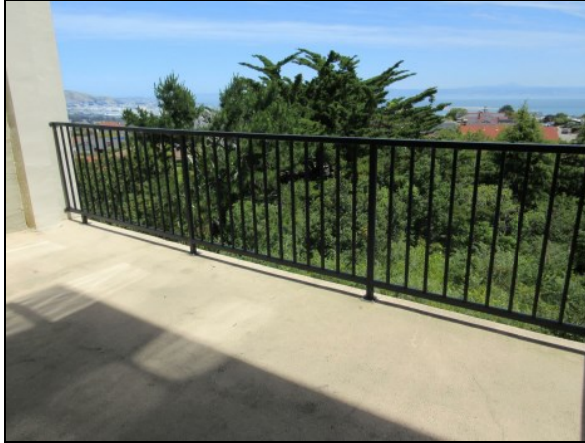
Comp #: 105 Balconies - Repair Allowance**Quantity: Approx 5,250 GSF**

History: Unit #219 balcony repairs done in 2024.

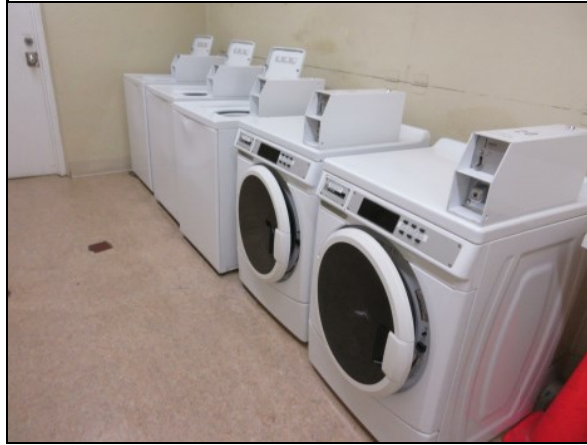
Comments: Washers and dryers appear intact and functional. Funding for replacement of the washer and dryer units at the interval below.

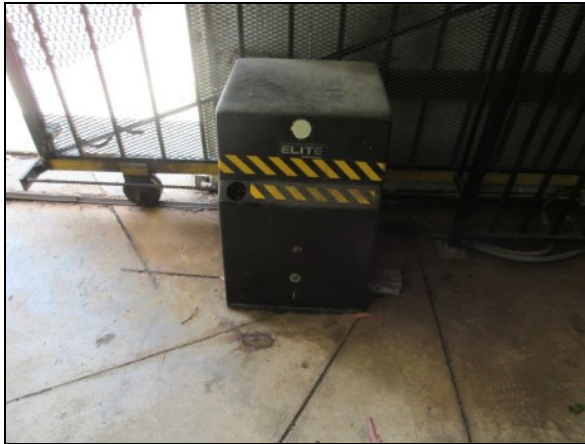
Comments: This is the Vallejo Drive Elite gate operator with model #SL3000UL. Gate operator continues to function but due to its age, anticipate the need for replacement in the near future.
