PROPOSED BATTERY STORAGE FACILITY,
NEWBURN HAUGH, NEWCASTLE-UPONTYNE

STAGE 1 GEO-ENVIRONMENTAL ASSESSMENT

R3127-R01-v4

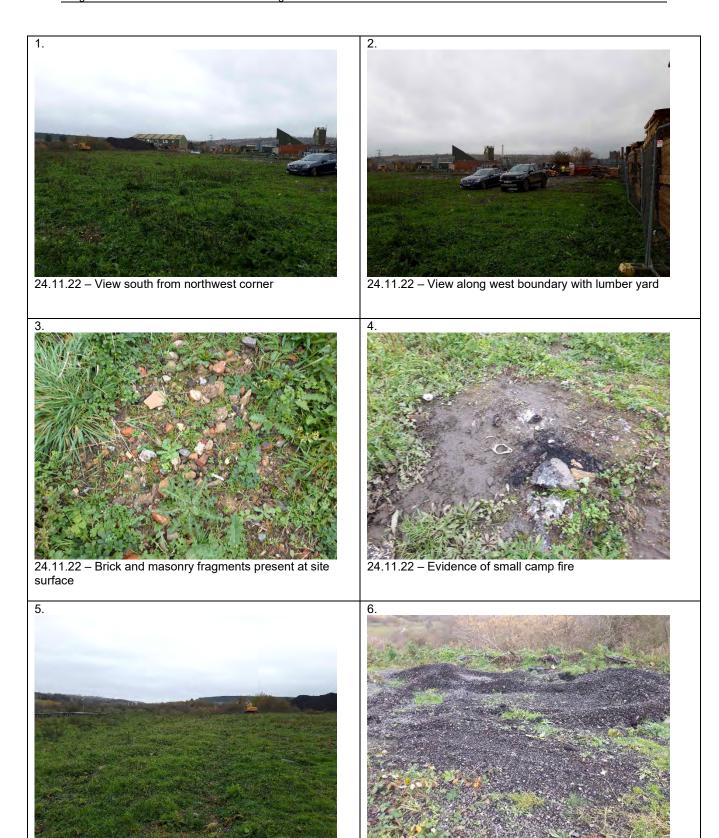
24.11.22 - View along northern boundary

24.11.22 - Poorly spread gravel in northwest corner of site
