# IMPROVING COOLANT FLOW

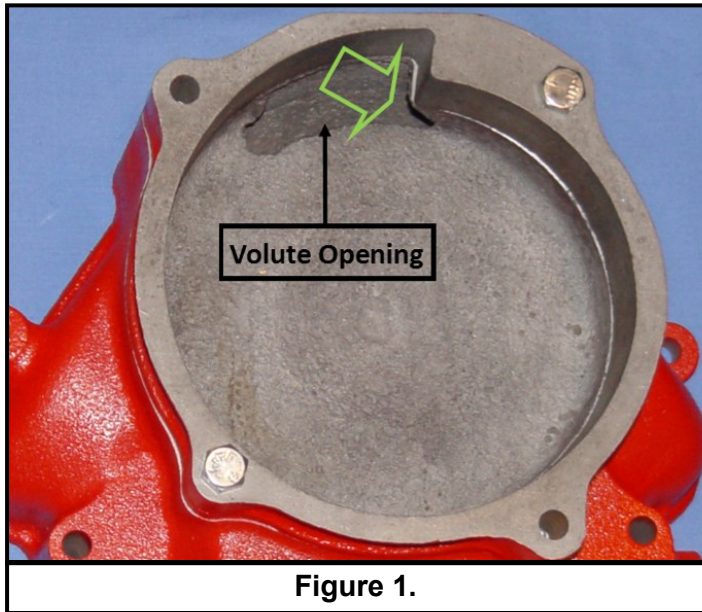
Figure 1 shows the alignment of the inner surface of an OEM (Original Equipment Manufacturer) water pump spacer and the timing chain cover's water pump well. These two components define the chamber in which the water pump impeller operates. The impeller accelerates the coolant in a clockwise flow, and centrifugal force keeps the fastest moving coolant to the outer circumference of the chamber. The green arrow shows the desired coolant flow back into the volute opening.

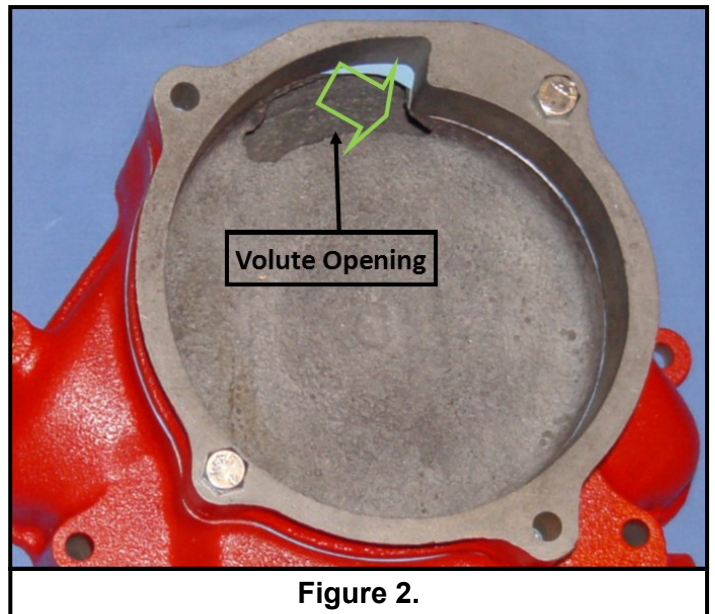
Figure 2 again shows the alignment of the spacer and timing chain cover, but with a standard Y-Block water pump gasket installed between them. The gasket is light blue and a portion of it is visible. Unfortunately, this visible part of the gasket presents an obstacle to the desired coolant flow. And this obstruction is at the most critical point in the coolant flow into the volute opening and ultimately to the engine's water jacket. The good news is this is easily corrected with a trim knife. This obstruction occurs when a standard Y-Block water pump gasket is used between either the OEM or an aftermarket spacer and the timing chain cover. If you are going to use one of these gaskets, it should be trimmed to align with the interior surface of the spacer.

And the location of this obstruction is significant. It blocks the corner of the chamber offset where the highest velocity coolant has just perpendicularly impacted the offset portion of the interior surface of the spacer. While the gasket currently installed between your spacer and timing chain cover is probably presenting an obstruction, I will leave the decision to remove the water pump to install a proper gasket or not to the reader. I would suggest that any time the water pump is removed, it should be reinstalled with a proper gasket.

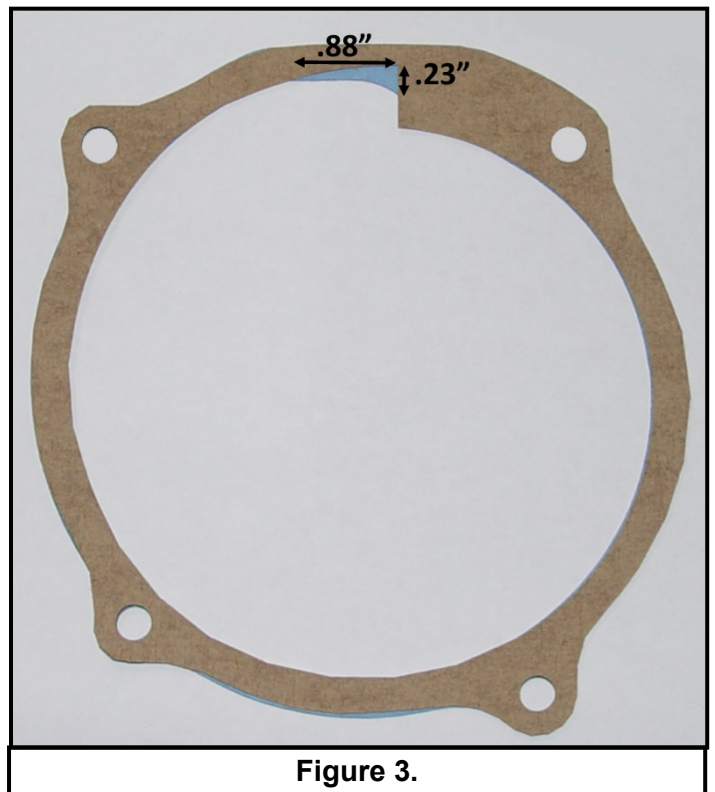
Figure 3 shows a gasket properly cut for the spacer to timing chain cover mating. It is positioned on top of a standard Y-Block water pump gasket to illustrate the location, size, and shape of the obstruction. As you can see, the is gasket obstruction is just

under a quarter of an inch wide and tapers off to zero over a span of just over three-quarters of an inch.

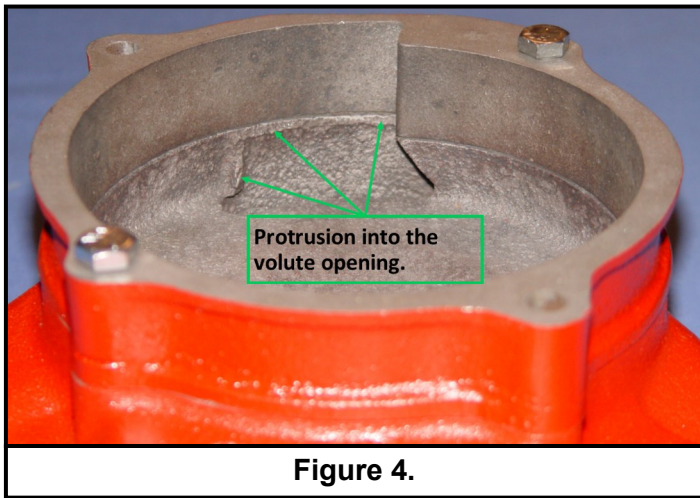
**Figure 4.**

The second potential issue is not as likely to exist in your Y-Block and results from a “bad” break at the Cleveland Foundry. Upon close inspection of the volute opening in the timing chain cover, it appears in the manufacturing process, part of the casting was broken away to make the volute opening. And unfortunately, not all breaks remove the same amount of the casting.

Figure 4 shows a timing chain cover with an example of a casting protrusion into the volute opening. Because of the location of the volute opening when the timing chain cover is installed, a casting protrusion is not something you would observe unless you were specifically looking for it.

I had removed and reinstalled my water pump and various spacers several times during flow testing and never saw the protrusion. After I became aware of this potential problem, I removed the water pump just to check. I found a protrusion close in size to the one pictured in figure 4. I used an angle drill with a 1½ inch sanding drum with number 80 abrasive to remove the biggest part of the protrusion, then stepped down to 1 inch, ¾ inch, and finally a ½ inch drum to get as close to the offset as possible. Cast iron is relatively soft, so check your progress fre-

quently during grinding. Finally, the water jacket will need to be thoroughly flushed to remove all grinding debris.

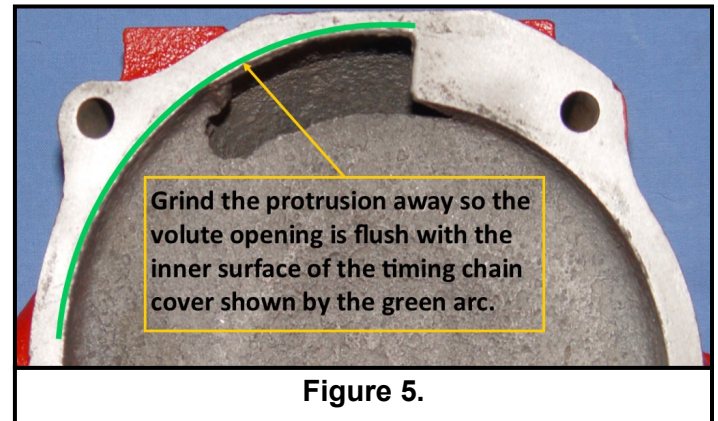
**Figure 5.**

Figure 5 shows the inner surface of the timing chain cover with which the volute opening should be flush.

Because this issue has only recently come to light, most of us have no idea if the timing chain cover on our car got a good break or bad break when it was manufactured 60 plus years ago. I suggest you make a note to check it the next time the water pump is removed.
