IMPROVING COOLANT FLOW

This article discusses two potential issues that may hurt the coolant flow in your Thunderbird's engine temperature control system. The first issue is the gasket installed between the water pump spacer and the timing chain cover.

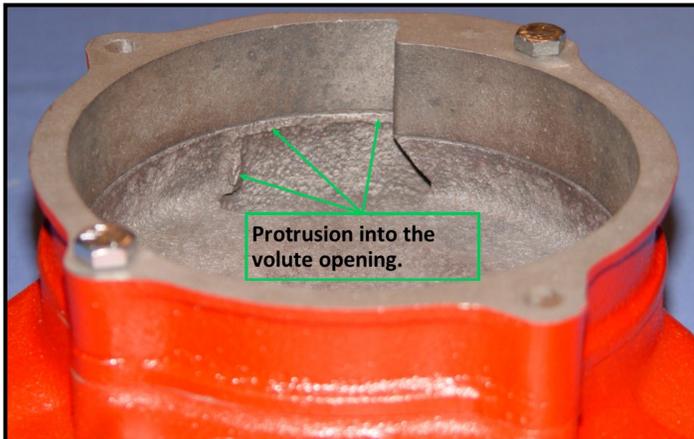
The second potential issue is not as likely to exist in your Y-Block and results from a "bad" break at the Cleveland Foundry. It appears that part of the timing chain cover casting was broken away in the manufacturing process to form the volute opening. Unfortunately, some of the breaks were not as clean as intended and resulted in some of the casting protruding into the volute opening. Figure 4 shows a timing

chain cover with an example of a casting protrusion into the volute opening. With the timing chain cover installed on the engine, a casting protrusion is not something you would see unless you were specifically looking for it.

I had removed and reinstalled my water pump several times with various spacers during flow testing and never saw the protrusion. After I became aware of this potential problem, I removed the water pump to check and found a protrusion close in size to the one pictured in Figure 4.

An angle drill with a 1/2 inch rotary file as shown in Figure 5 is an excellent tool to grind the protrusion away.

7771619. After the grinding is complete, the water jacket must be thoroughly flushed to remove all grinding debris.

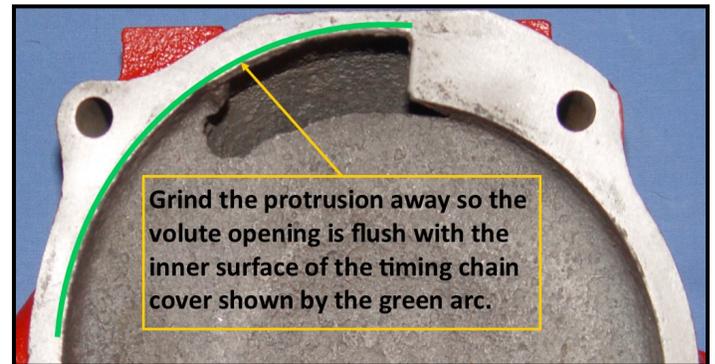
Figure 6.

Figure 6 shows the inner surface of the timing chain cover with which the volute opening should be flush.

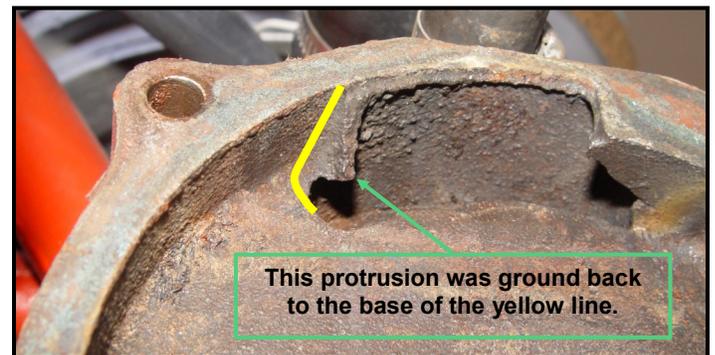
Figure 7.

The protrusion shown in Figure 7 is the worst I have seen to date and had gone unnoticed for over 60 years. Because this issue has only recently come to light, most of us have no idea how clean the break on our timing chain cover is. I suggest you make a note to check the next time you remove the water pump. Also, there is no better time to check for and remove any protrusion that exists than when the timing chain cover is uninstalled. So don't miss this opportunity when you are rebuilding your engine.
