IMPROVING COOLANT FLOW

This article discusses two potential issues that may hurt the coolant flow in your Thunderbird's engine temperature control system. The first issue is the gasket installed between the water pump spacer and the timing chain cover.

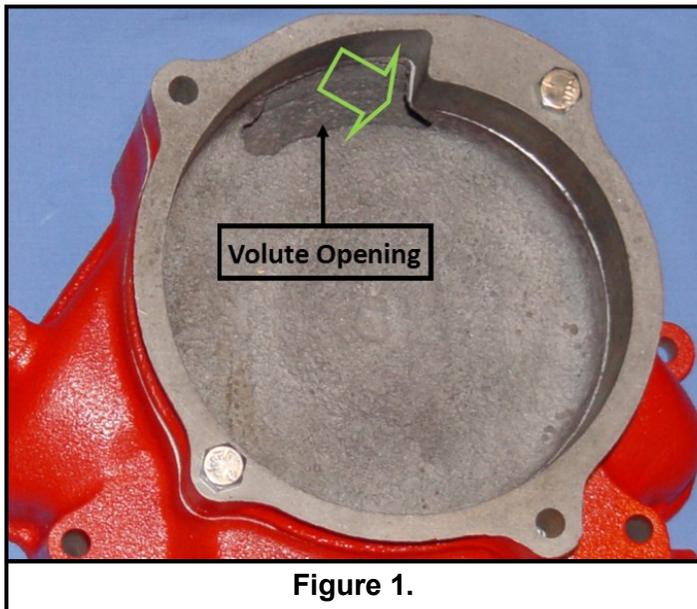
Figure 1 shows the alignment of the inner surface of an OEM (Original Equipment Manufacturer) water pump spacer and the timing chain cover's water pump well. These two components define the chamber in which the water pump impeller operates. The impeller accelerates the coolant in a clockwise flow, and centrifugal force keeps the fastest moving coolant to the outer circumference of the chamber. The green arrow shows the desired coolant flow back into the volute opening.

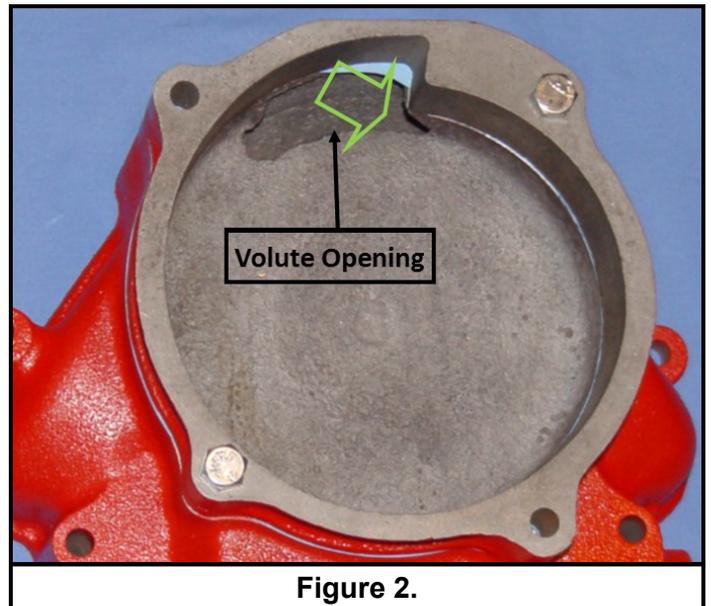
Figure 2 again shows the alignment of the spacer and timing chain cover, but with a standard Y-Block water pump gasket installed between them. The gasket is light blue and a portion of it is visible. Unfortunately, this visible part of the gasket presents an obstacle to the desired coolant flow. And this obstruction is at the most critical point in the coolant flow into the volute opening and ultimately to the engine's water jacket. The good news is this is easily corrected with a trim knife. This obstruction occurs when a standard Y-Block water pump gasket is used between either the OEM or an aftermarket spacer and the timing chain cover. If you are going to use one of these gaskets, it should be trimmed to align with the interior surface of the spacer.

While the gasket currently installed between your spacer and timing chain cover is probably presenting an obstruction, I will leave the decision to remove the water pump to install a proper gasket or not to the reader. I would suggest that any time the water pump is removed, it should be reinstalled with a proper gasket.

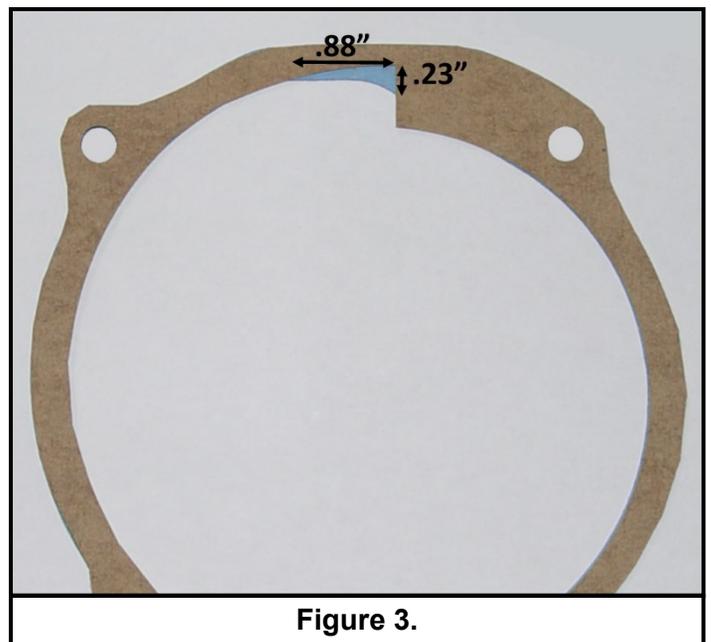
Figure 3 shows a gasket properly cut for the spacer to timing chain cover mating. It is positioned on top of a standard Y-Block water pump gasket to illustrate the location, size, and shape of the obstruction. As you can see, the is gasket obstruction is just under a quarter of an inch wide and tapers off to zero over a span of just over three-quarters of an inch.

And the location of this obstruction is significant. It blocks the corner of the chamber offset where the
(Continued on page 2)

highest velocity coolant has just perpendicularly impacted the offset portion of the interior surface of the spacer.

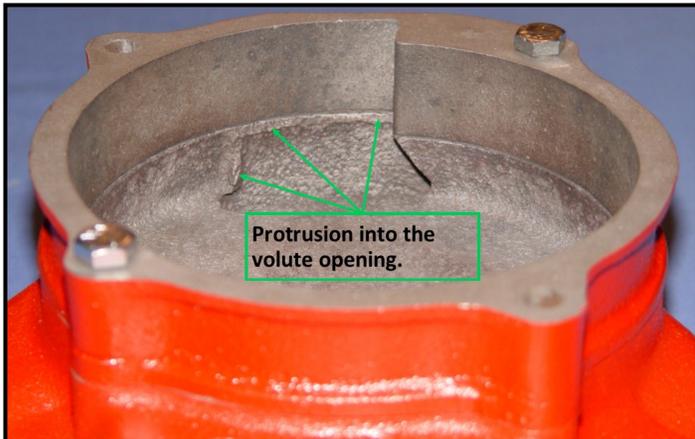
The second potential issue is not as likely to exist in your Y-Block and results from a "bad" break at the Cleveland Foundry. It appears that part of the timing chain cover casting was broken away in the manufacturing process to form the volute opening. Unfortunately, some of the breaks were not as clean as intended and resulted in some of the casting protruding into the volute opening. Figure 4 shows a timing

chain cover with an example of a casting protrusion into the volute opening. With the timing chain cover installed on the engine, a casting protrusion is not something you would see unless you were specifically looking for it.

I had removed and reinstalled my water pump several times with various spacers during flow testing and never saw the protrusion. After I became aware of this potential problem, I removed the water pump to check and found a protrusion close in size to the one pictured in Figure 4.

An angle drill with a 1/2 inch rotary file as shown in Figure 5 is an excellent tool to grind the protrusion away.

7771619. After the grinding is complete, the water jacket must be thoroughly flushed to remove all grinding debris.

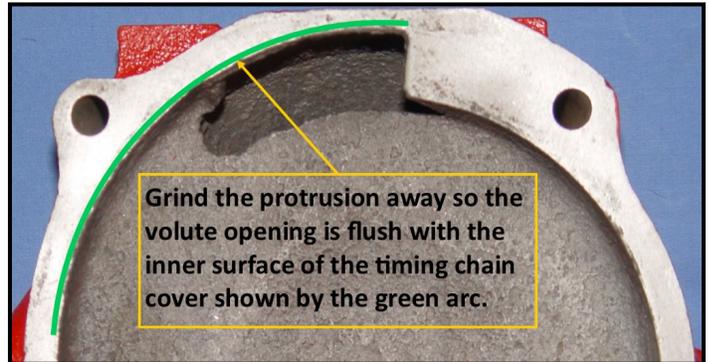
Figure 6.

Figure 6 shows the inner surface of the timing chain cover with which the volute opening should be flush.

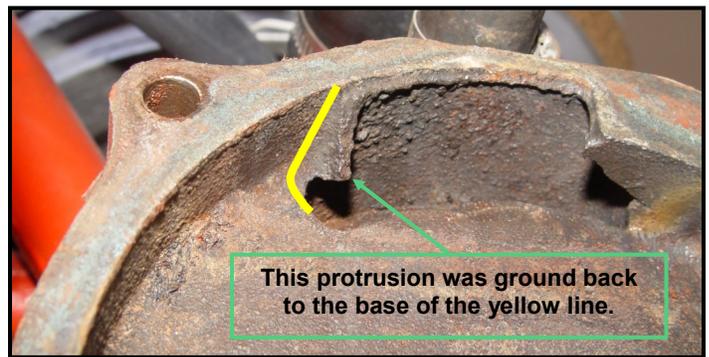
Figure 7.

The protrusion shown in Figure 7 is the worst I have seen to date and had gone unnoticed for over 60 years. Because this issue has only recently come to light, most of us have no idea how clean the break on our timing chain cover is. I suggest you make a note to check the next time you remove the water pump. Also, there is no better time to check for and remove any protrusion that exists than when the timing chain cover is uninstalled. So don't miss this opportunity when you are rebuilding your engine.
