How To: Automatic Transmission Indicator Pin Replacement

PRNDL

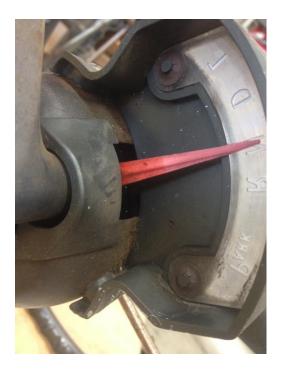
Vintage Chevy Vans (VCV) equipped with an automatic transmission remains a popular option. The 1967-70 second generation vans(2nd gens) from 1967-70 have a red indicator pin (pin) which points to the PRNDL housing (PRNDL) on the steering column. The tip of this "plastic" pin becomes worn from contact with the PRNDL. The pin will scratch the housing and the tip of the pin wears and eventually breaks and falls off.

The PRNDL will also crack and eventually break off near where the screws hold it to the column. This is due to the PRNDL being smaller in diameter than the steering column.

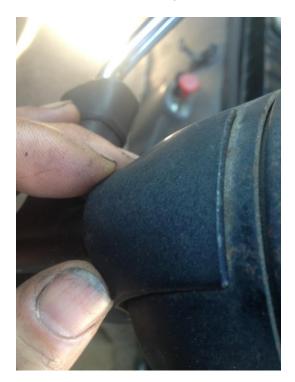
Pic below shows the small plastic dust cover below the PRNDL.

This small plastic piece helps keep dirt out of the upper shift housing. If this is damaged when removing, it may not be able to be reused. Then there would be a much greater chance that you will have problems with this repair in the long run as the dirt will gradually collect. That is why this small part should be carefully removed. I have included many pics so that you have the greatest chance of removing and reinstalling it without damage. A little care at this point can go a long way. If this piece is damaged or missing, you may have to cover that area with something like tape.

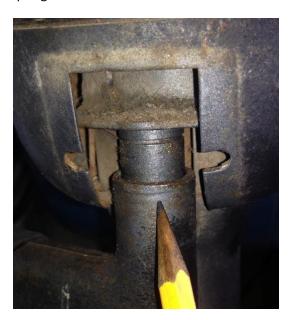
Below pic shows the dust cover removed. Note the lack of spring or groove cut in shifter housing for the spring. This identifies this column as from a manual transmission equipped van.

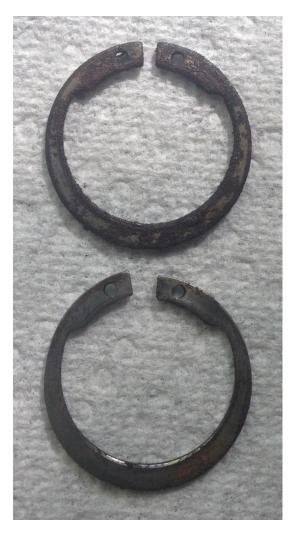
The snap ring that holds the pin in place should be checked for distortion. The snap ring on the bottom is out of round and will not properly retain the pin. It should be replaced.

This pic below shows the pin and snap ring in place on a shaft removed from the column. The poorly fitting snap ring leaves a gap that will cause problems. You want to avoid the gap seen in this pic. If the original snap ring doesn't fit well, it should be replaced. I found 9/16" snap rings at ACE Hardware that was similar and would work. The original is always best but if it is tweaked, replace it.

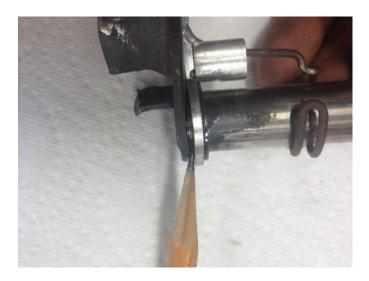
Below pic shows the pin not quite in place for several reasons;

An improperly cleaned shaft or bent shaft retainer ears can prevent the pin from laying flat and the snap ring will not be riding properly in groove. The pencil is pointing to a gap that was caused from removing the piece from the column. It is not likely to happen on most columns but the snap ring fit should be checked.

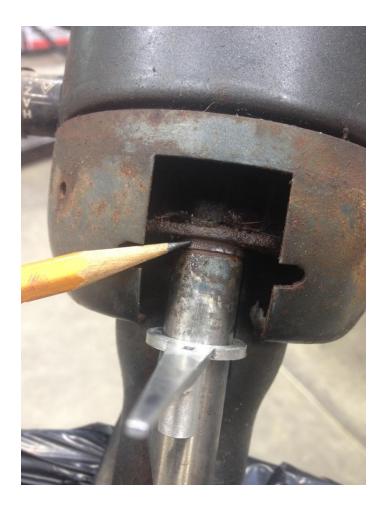
The replacement pin is a tight fit and final sizing should be completed on the column you are building. Before final placement, be sure the shaft is free from rust and other buildup. This area should be cleaned and smooth before final pin fitting. This is where the pin must rotate freely. The pencil is pointing to the area that should be carefully inspected. This is where the pointer will ride back and forth. Below that is the snap ring groove.

One way to clean this area is to use a strip of sandpaper behind the shaft.
