DFFM Site Visit Report

Site Visit Date: 04/19/2024

<u>Org. Name</u>	<u>Contact Name</u>	<u>Phone</u>	<u>Email</u>
Pinetop Country Club Village (PCCV)	Robin Faison	480-213-3261	PCCV.Secretary@gmail.com

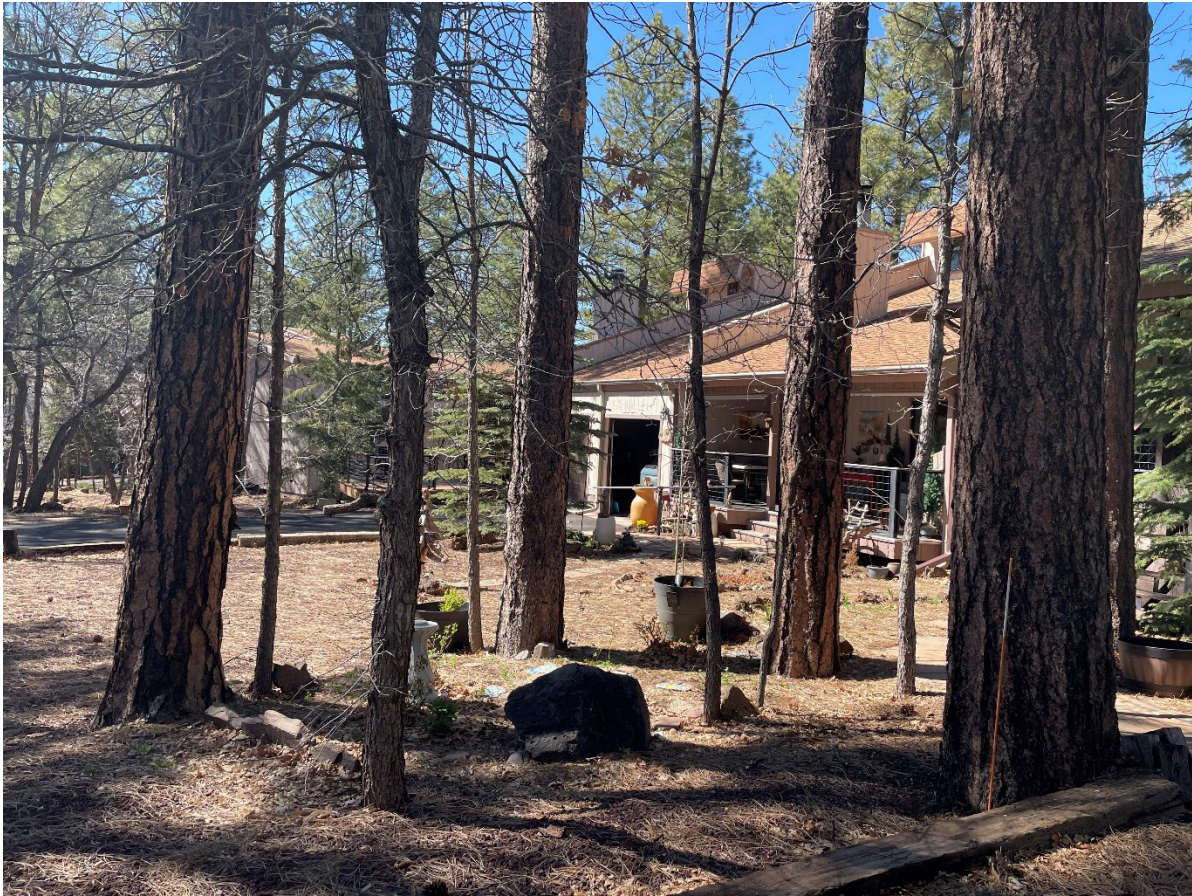
Image 1: Stand conditions at the Pinetop Country Club Village (PCCV)

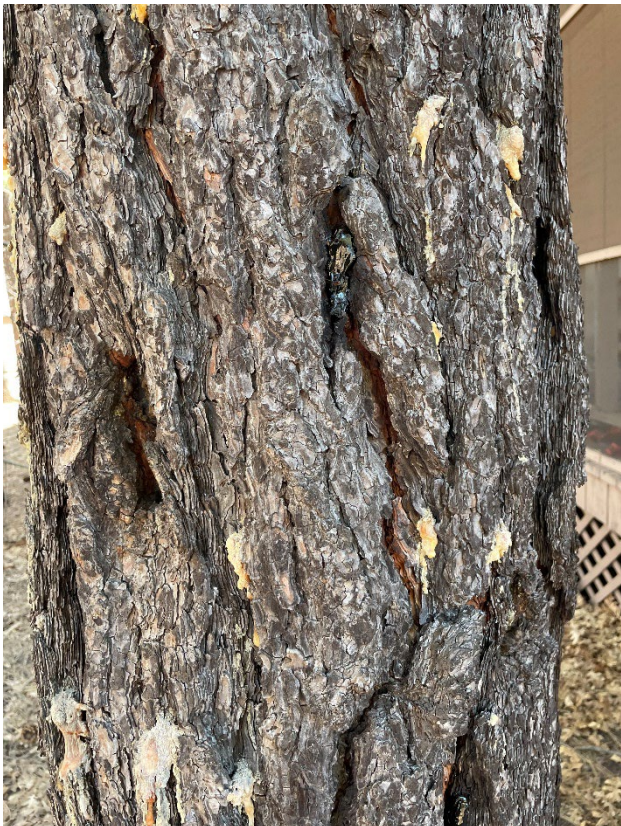
Image 2 (Left): Older unsuccessful bark beetle attacked tree on the PCCV property. **Image 3 (Right):** Hazard tree near structure on PCCV with a large amount of included bark.

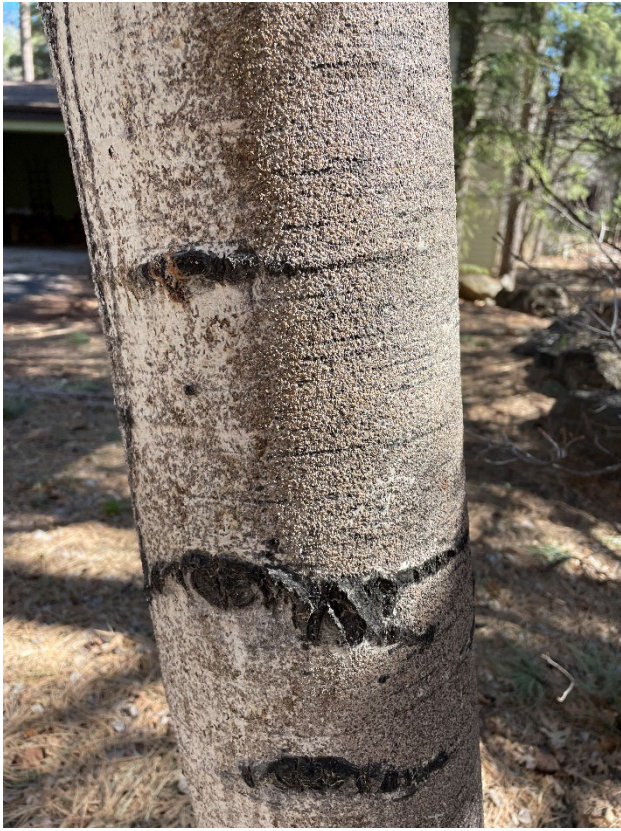
Image 4 (Left): Aspen oyster shell scale (OSS) present on an aspen located on the PCCV property. **Image 5 (Right):** Overview of aspen with oyster shell scale on the PCCV property.
