GEOLOGIC HAZARDS ASSESSMENT

**GENESEE PROPERTIES, INC.
SOCIETY TURN PARCEL
HIGHWAY 145
SAN MIGUEL COUNTY, COLORADO**

June 15, 2020

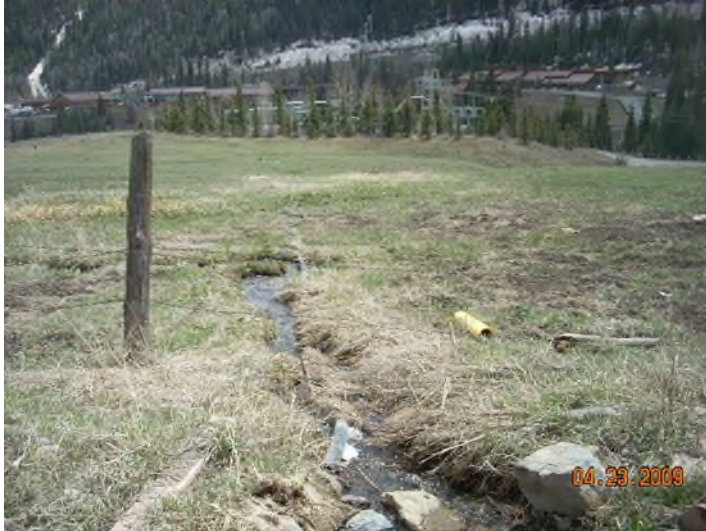
Photo 10. This is a view to the south at the irrigation ditch shown on Map 2 that enters PA1. The source of this water is from Remine Creek that is conveyed through a culvert under Highway 145, which is behind the photographer. There are no wetlands associated with this man-made irrigation ditch.

Groundwater can be problematic as it weakens foundation soils, creates hydraulic pressure, and can seep into the interior of structures if foundation components are not properly waterproofed and drained. At the toe of the slopes, saturated soil conditions also can contribute to unstable slope conditions. Consequently, management of surface and subsurface water is very important for long-term performance of foundation components and the preservation of slope stability. Although not observed during the Feasibility Geotechnical Investigation performed by DOWL in July 2019, site-specific geotechnical investigations should be conducted to determine if groundwater is present at a building site prior to development. Potential groundwater hazard can be mitigated by careful site grading and drainage plans that control surface and groundwater drainage, avoidance through reasonable setbacks, and the design of elements that are waterproofed and capable of resisting hydraulic forces, if necessary.

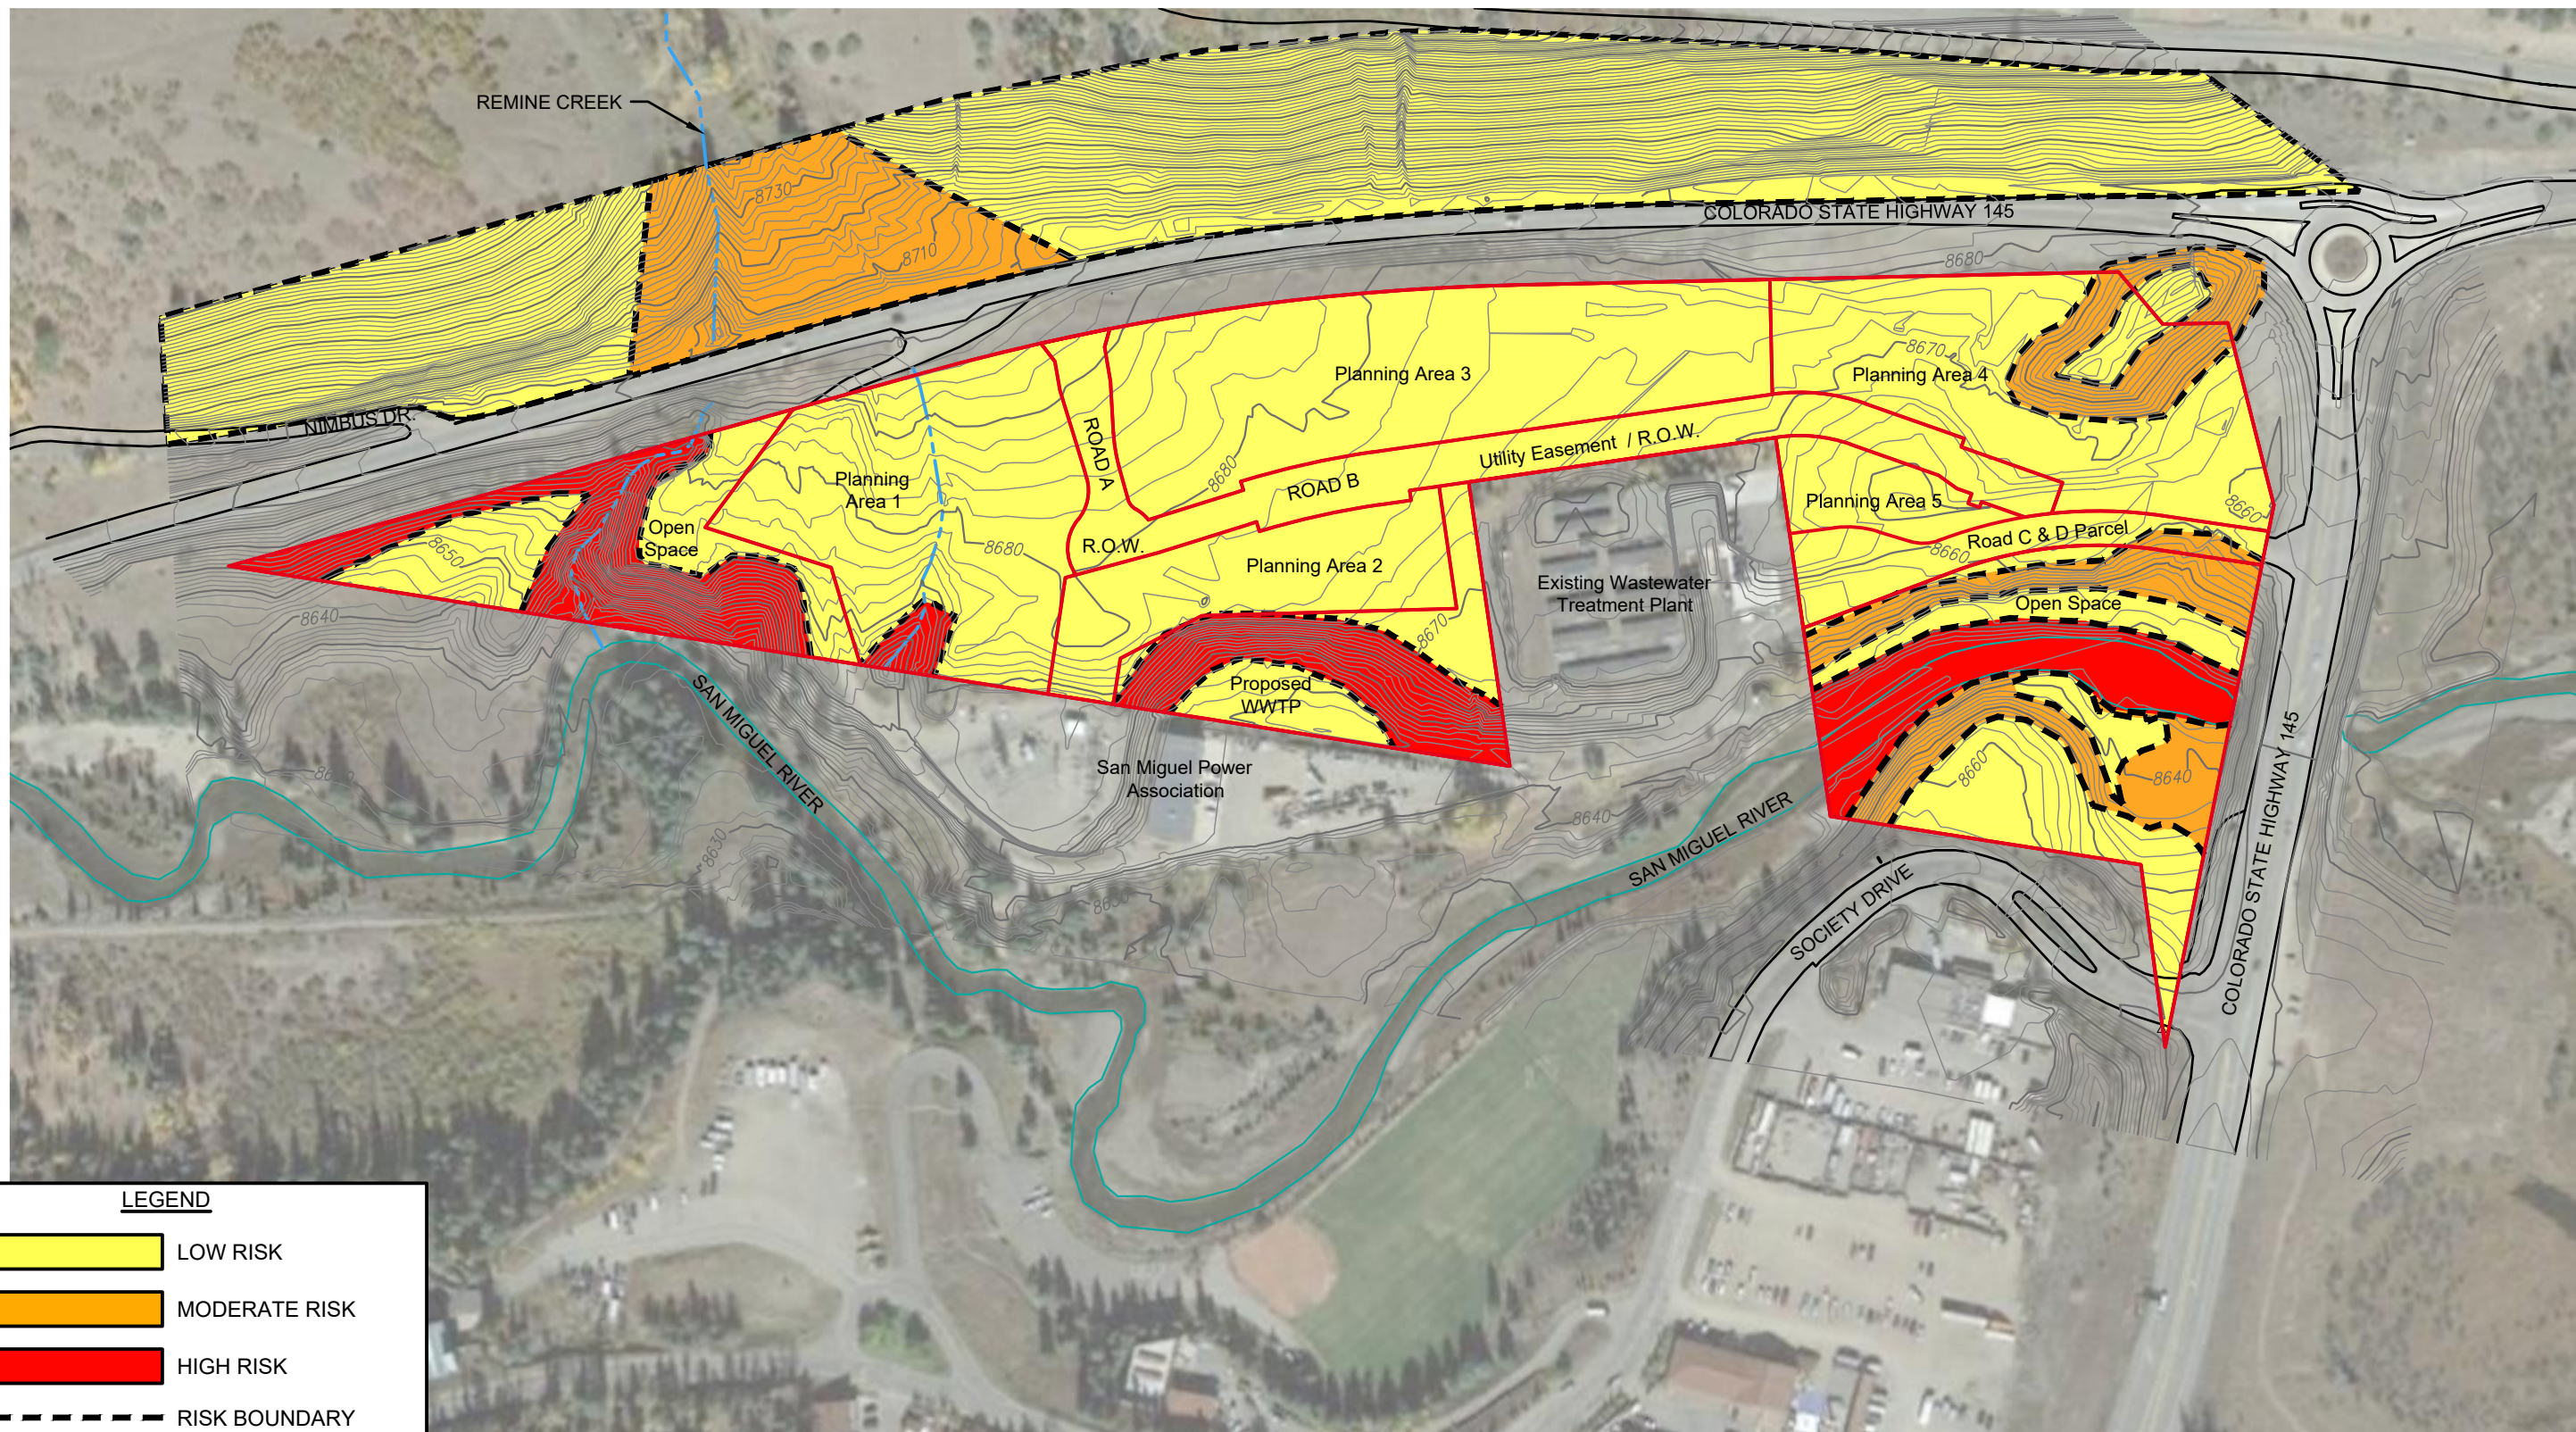
MAP 10

High risk areas (shown in red on Map 10), have one or more geologic hazards that severely limits development. Generally, an area designated with "high" risk should be avoided. However, with appropriate mitigation measures and careful placement of building sites and roadways,

Areas of high risk due to flooding along the San Miguel River have been avoided in the development plan. However, there is some high risk due to PUS slopes associated with the steep banks of unconsolidated alluvial material along the San Miguel River, Remine Creek, and the relic cut bank scarp on the south side of PA2. These areas will need slope stability analyses tailored to intended uses and degree of site disturbance. Mitigation, if necessary, may include one or more of the following: shoring methods (reinforced slopes, soil nails, retaining walls, etc.), deep foundation systems, setbacks to avoid disturbing the edge of slope, and drainage improvements. Controlling drainage in areas of high risk also is important for maintaining slope stability on these steep slopes.
