Mill Pond Salt Marsh Restoration Alternatives Assessment Technical Memorandum

Town of Truro
Truro, MA

June 2022

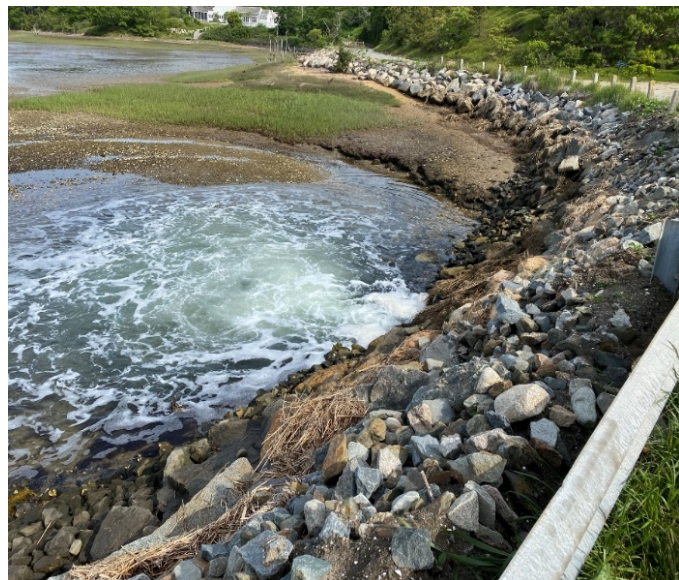
Figure 2 — Downstream Culvert Outlet and Stone Armor Slope Protection (Facing North)

The downstream face of the embankment is currently in poor condition as exhibited by displaced slope protection and debris build up around the culvert discharge point. The Town of Truro completes maintenance on the embankment annually to restore displaced riprap and repair areas of erosion. In addition, a scour hole is positioned at the discharge area at the beginning of the Mill Pond Channel.

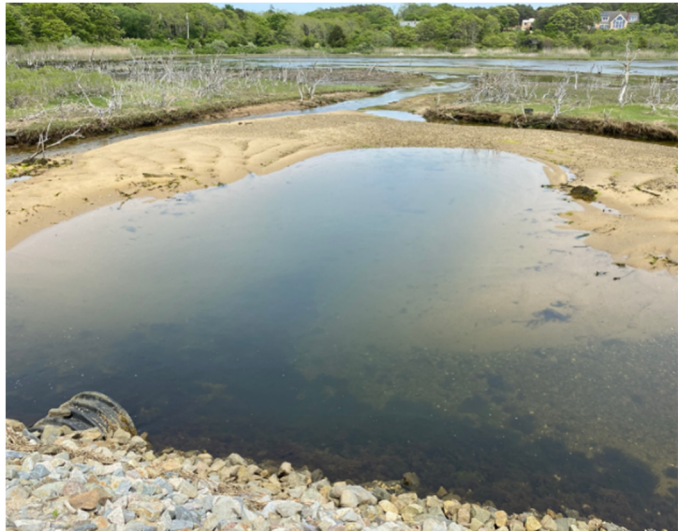
The upstream end of the CPP projects from the earthen causeway supporting MPR, which is partially covered by stone armor protection over and adjacent to the culvert. Indications of a tidal restriction near the culvert's end include a scour hole with an intertidal island formed by shoaled

Figure 3 — Upstream Culvert Outlet, Scour hole and Shoaled Sediment (facing east)

sediment, a significant tidal lag and muting, poor drainage during inland precipitation events, and bank erosion adjacent to the culvert.

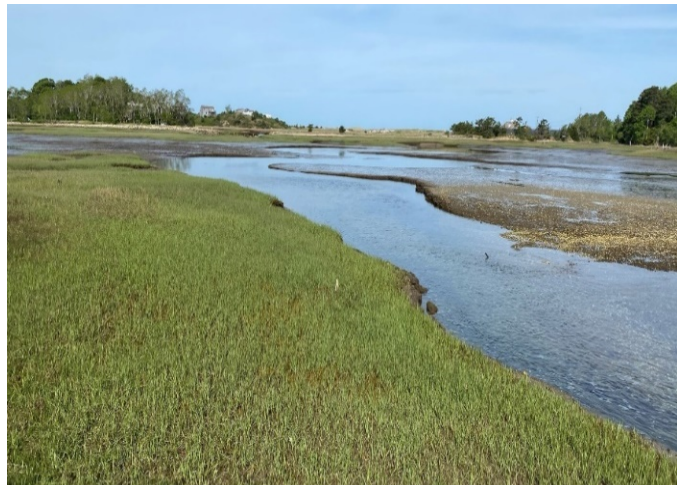
Figure 4 — Downstream Tidal Channel and Abutting Salt Marsh (facing west)

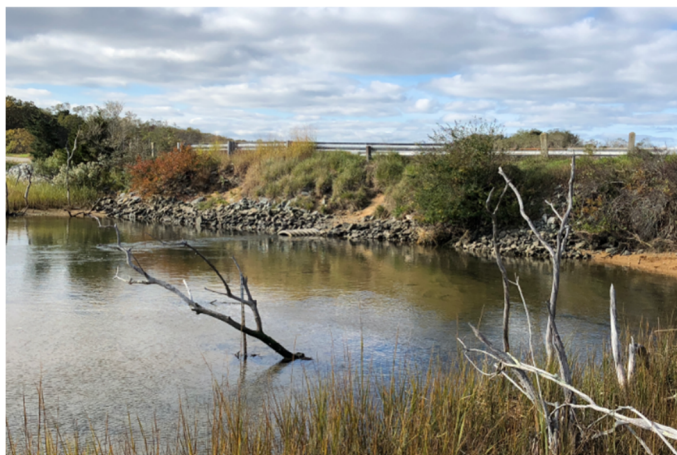
Figure 5 — Upstream Culvert Outlet and Stone Armor Slope Protection (facing south)

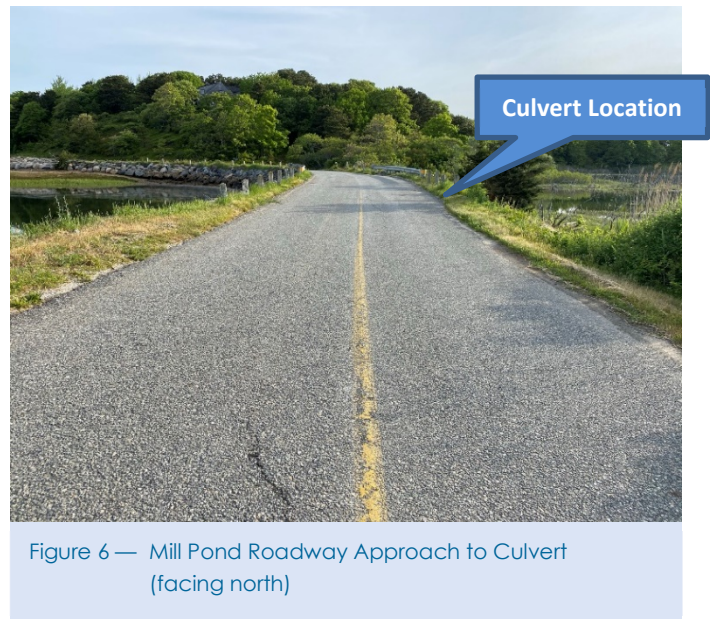
Embankment slopes behind the guardrails exhibit signs of erosion and steepening, providing inadequate lateral support to the guardrail system, as indicated by leaning posts supporting the horizontal rail on the roadway's southbound (western) travel lane. Concrete posts are positioned beyond the ends of the metal beam guardrails in both directions at an approximate 8 foot spacing.

Survey measurements along the roadway's centerline profile on both sides of the culvert indicate low points approximately 80 feet north and 115 feet south of the culvert (0.1 feet and 0.65 feet lower, respectively, than the roadway elevation at the culvert). The roadway is pitched to the upstream (east) slope in proximity to the culvert, with a small section south of the culvert nearly flat.
