# COLORADO GEOLOGICAL SURVEY

**Subject: Gold Hill Mesa Filing No. 11,  
Final Plat-AR FP 19-00201; and Development Plan-AR DP 19-00198;  
City of Colorado Springs, El Paso County, CO; CGS Unique No. EP-19-0132**

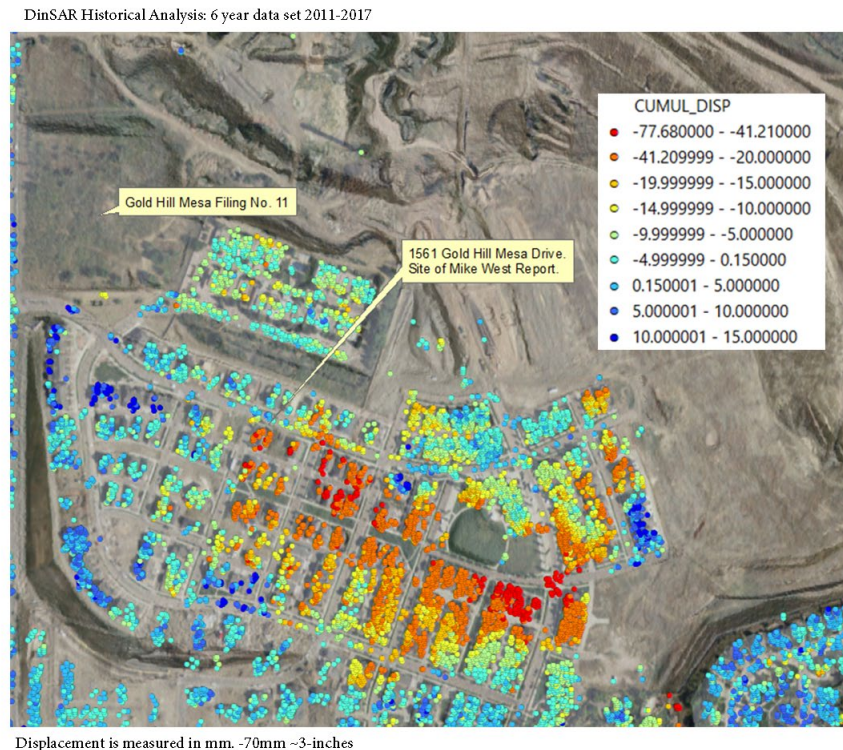
Following concerns raised by the city and local residents CGS commissioned this type of satellite study for Gold Hill Mesa. The study was performed on a stack of 162 images covering the period from June 24<sup>th</sup>, 2011 to October 14<sup>th</sup>, 2017. This work shows 3-inches of cumulative vertical settlement around the area of concern in the Mike West reports. This area generally corresponds with some of the deep, saturated slime deposits outlined in the reports. The cumulative movement recorded in the Satellite study is shown in the following figure. (The data is collected on fixed points associated with houses, streets, etc., so no points are in the undeveloped areas. The movement is relative movement and may not be exact at specific locations.)

Three-inches of movement can result in cracking of walls, floors, and hard finishes such as tile or rock. Doors and windows can stop operating properly and floors can become uneven. We observed external and internal evidence of structural distress on each floor and throughout the subject house of the Mike West reports at the time of our visit. This included cracks; in the concrete basement floor, around doors and window openings, along ceiling panels and within exterior finishes. The first floor above basement level was noticeably out-of-level throughout the house. Additionally, evidence of differential movement was observed in the street and sidewalk adjacent to the structure.

The geotechnical reports on file for Gold Hill Mesa do not fully characterize the slimes versus the sands, but typically treat the mill tailings as a relatively homogenous unit. The area of greatest measured settlement as depicted in the DinSAR image corresponds to deep saturated slimes beneath tailing sands. Borings historically drilled in this area tend to be shallow and not drilled to bedrock. Minimal or no sampling and testing of the slimes was done.

**CGS cannot recommend approval of Filing No. 11 until: the underlying mill tailings are fully characterized in terms of fines versus sands both laterally and vertically; sampling and testing is completed of the fines and saturated fines, to their full depth; settlement calculations are performed for the actual materials located beneath Filing No. 11; a liquefaction analysis for the entire Gold Hill Mesa is conducted.**
