RESERVE STUDY UPDATE

MEADOWLAKE VILLAGE HOMEOWNERS' ASSOCIATION

Baytown, Texas, 77521

On-site Inspection performed August 14, 2023 Submitted January 13, 2025

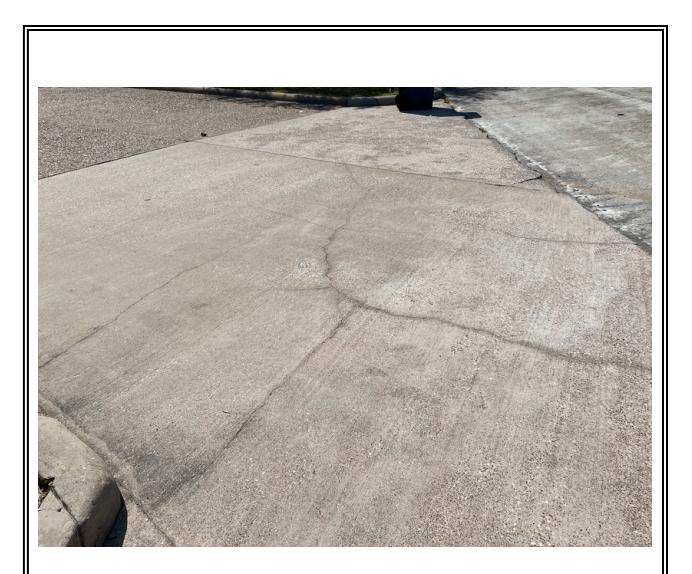
- Concrete pavement in the drive areas at the Community Center is in good condition. While the concrete has spalled in small localized areas, it is generally performing as intended with no significant deficiencies. We anticipate small repairs, maintenance, and crack sealing will be required as the pavement ages and we have budgeted for this activity to occur every ten (10) years.

Description: Site - View of the concrete pavement in the drive aisle in front of the community center

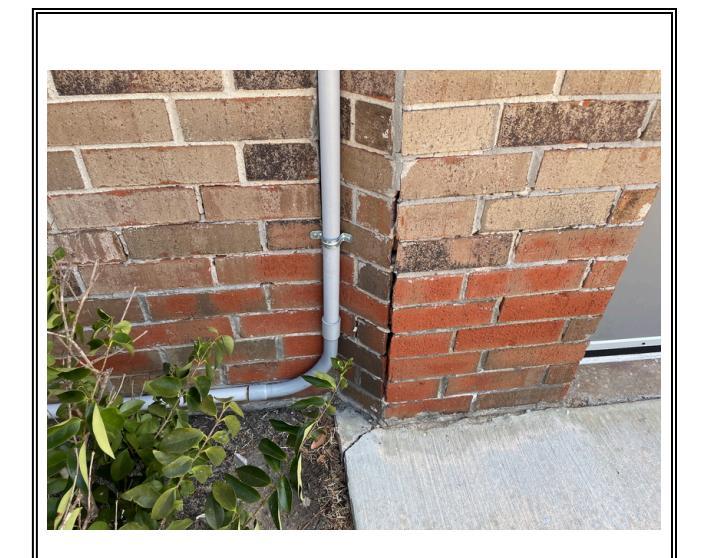
Description: Building Exterior - Portions of the exterior brick veneer wall need to be repaired (1 of 2)

- The clubhouse structure appears to be in good condition. We noted no patterns of cracking in the brick veneer, abnormal cracks in concrete grade beams, floor unevenness or damaged framing that would indicate a structural deficiency.
- The exterior service doors are in good condition and have recently been replaced. The overhead rolling doors are in good condition.
- The roof on the community center building is in good condition. It is our understanding that the roof was replaced in 2014. A metal roof has a nominal life expectancy of 40+ years. We anticipate roof replacement at the end of the 30 year term.
- The exterior brick is generally in good condition, with a few exceptions. We observed spalling mortar at a few isolated locations that will require repair. We have allocated funds for periodic masonry repair in the short term.

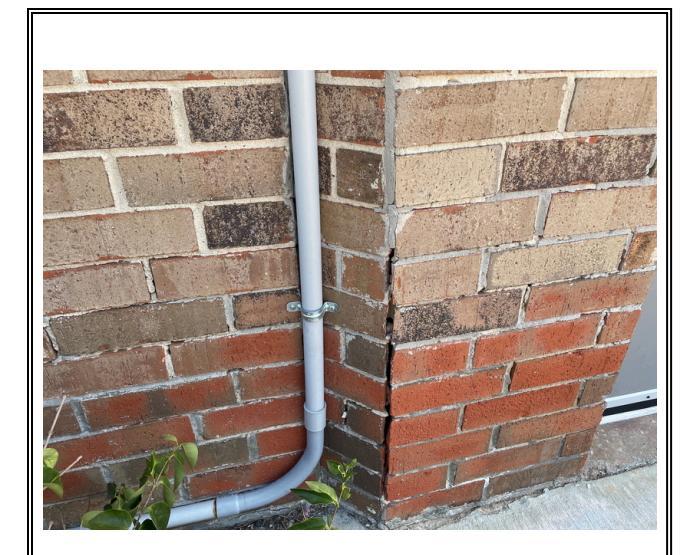
Photo Number 9

Building Exterior - Portions of the exterior brick veneer wall need to be repaired (2 of 2)

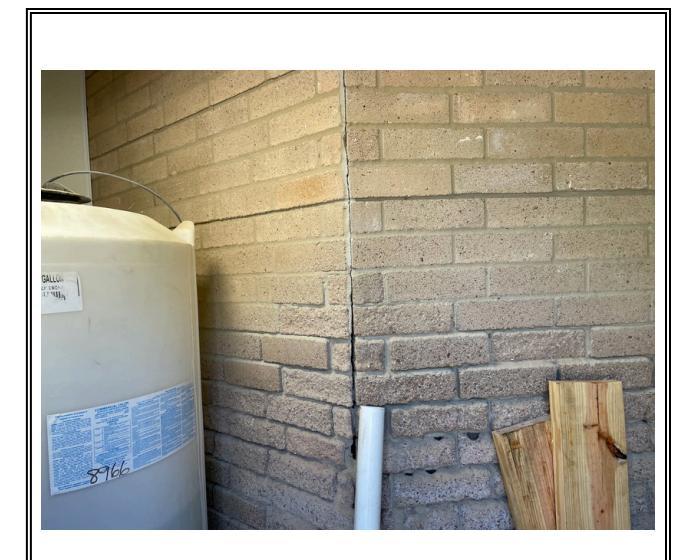
Photo Number 10

Building Interior - Portions of the interior brick veneer wall need to be repaired

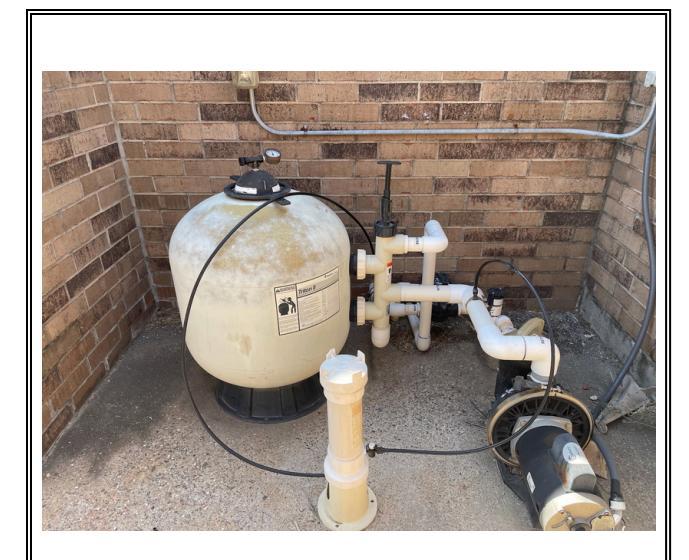
Photo Number 21

Description: Mechanical - Typical view of the filter and pump for the wading pool

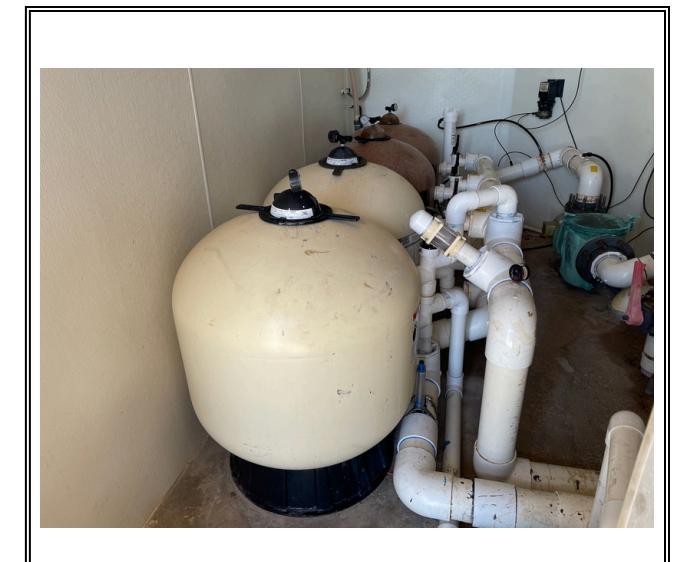
Photo Number 22

- The large pool and wading pool water filtration equipment appears to be in generally good condition. While we saw no apparent issues with the operation or performance of the units, funds have been allocated for their periodic replacement. Based on the age of the equipment, we anticipate its replacement in the short term.

Description: Mechanical - Typical view of the filters and pumps for the main pool

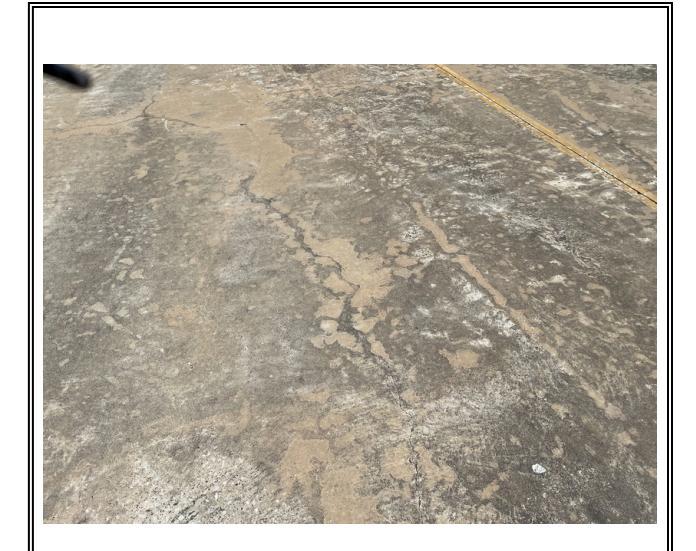
Photo Number 30

Description: Amenities - Concrete court pavement has cracks in the surface (typical)

- The tennis court lighting has been upgraded to LED lights. Funds have been allocated in the report for ongoing replacement of the lights.
- The community basketball court appears to be serviceable. Funds have been allocated to replace the court at the end of its useful life.

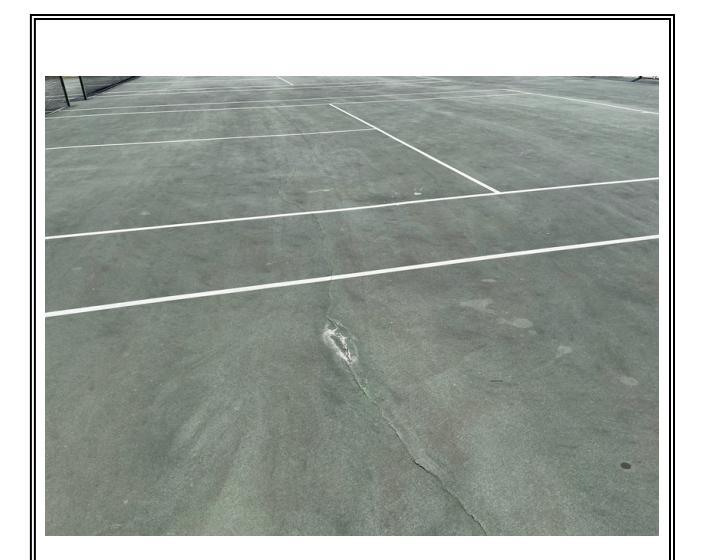
- The tennis courts were in average condition. For continued enjoyment of a quality playing surface, these areas should be re-surfaced every eight to ten years. Variations in the amount of use will cause how often the court is re-surfaced to vary. Funds have also been allocated for the periodic repair and resurfacing of the courts at ten year intervals.

Description: Amenities - View of the tennis court surface and lighting

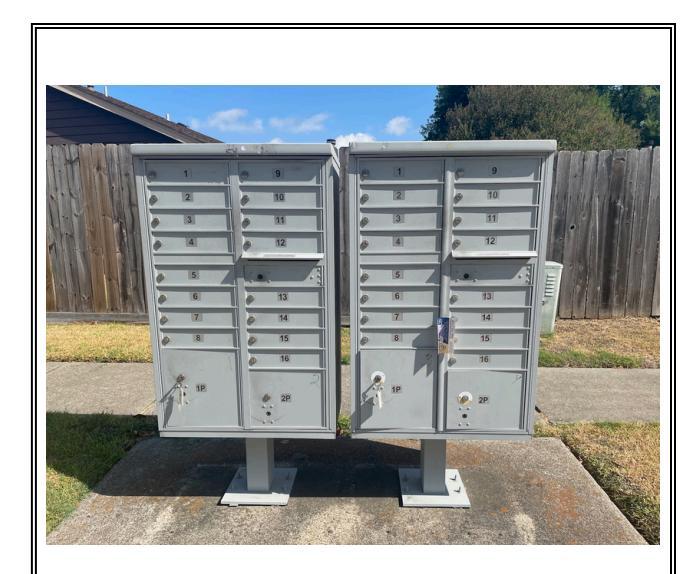
Description: Amenities - Mailboxes throughout the neighborhood are scheduled for periodic painting to improve aesthetics
