Nuggets of Gold

- Troubleshooting Tips For diagnosing vibration problems
- Balancing
- Alignment
- Motors
- Pumps
- Signal Processing Considerations
- DC Drives

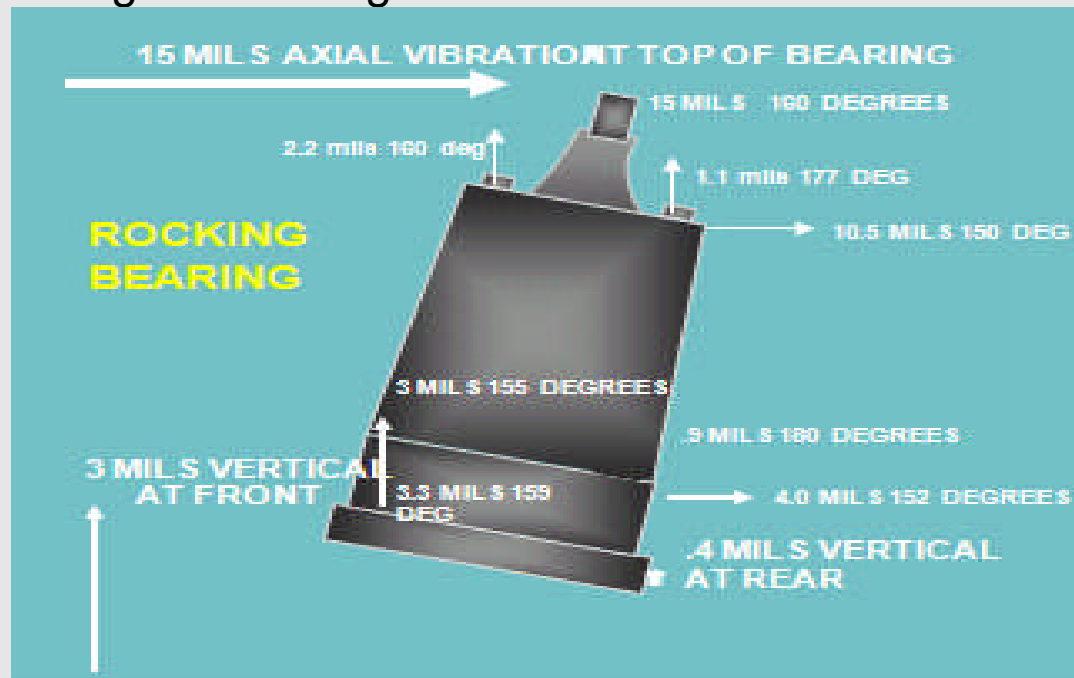
Case History 1- The phase on a turbine bearing was identical in the vertical and axial directions with the axial vibration being very high. It was discovered that one of the hold down bolts was broken off beneath the surface of the concrete allowing the bearing to rock.

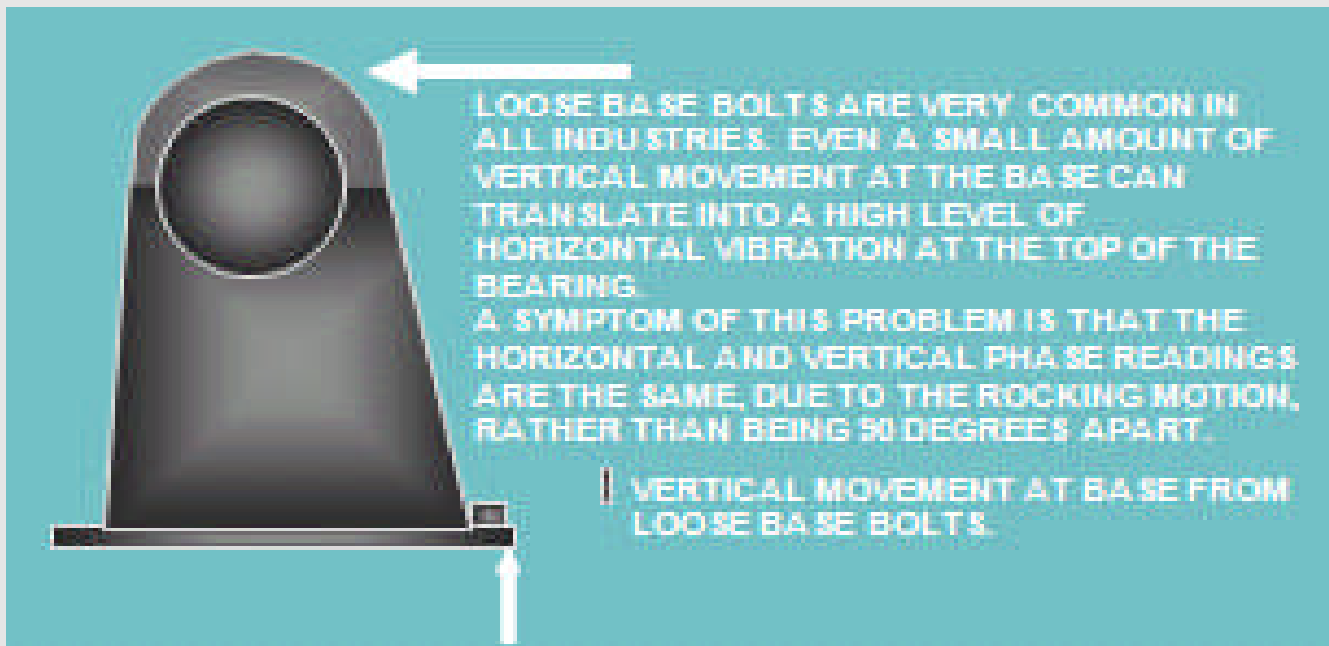
Case 2- On a large fan, the horizontal and vertical vibration phase angles were identical. The base bolts were loose allowing the bearing to rock. The maintenance manager did not believe it so a cup of water was poured on the base next to the bearing. When the water alternately shot out from between the bearing housing and the base plate, he agreed to have the bolts tightened. The horizontal vibration dropped from 12 mils to less than 2 mils.

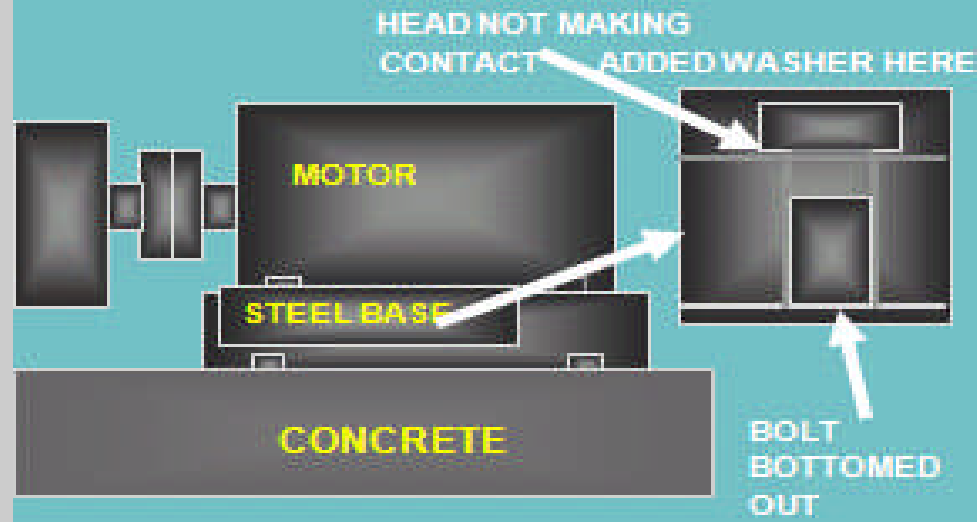
CASE 3- A power plant had spent \$30000 on a mill motor trying to get the vibration levels reduced. The rotor had been balanced several times, but the amplitude was still high.

MOTOR VIBRATION WAS 8 MILS. BOLT WAS TIGHT BUT NOT MAKING CONTACT. WHEN WASHER WAS ADDED, VIBRATION DROPPED TO BELOW 1 MIL.

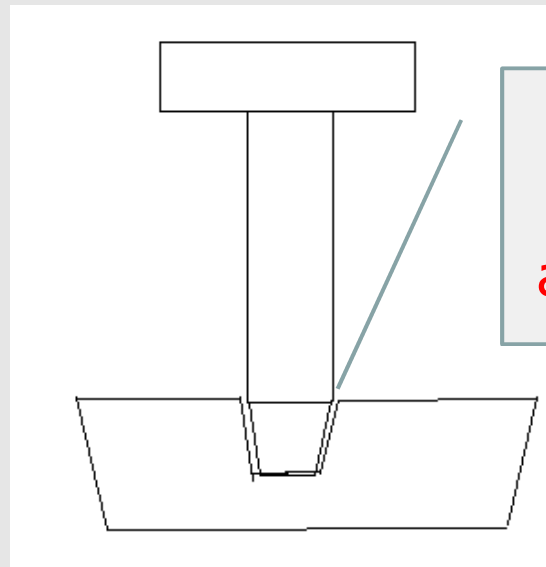
8: When balancing a rotor and the phase suddenly shifts 180 degrees, then this is a sign that the rotor may be loose. Case History- While balancing a large centrifuge, with a strobe light the vibration vector changed from 3 mils at a given phase angle to approximately that amount 180 degrees out. The change was instantaneous. It was discovered upon examination that the tapered fit of the shaft and bowl assembly was loose.

**Loose fit
between bowl
and drive shaft**

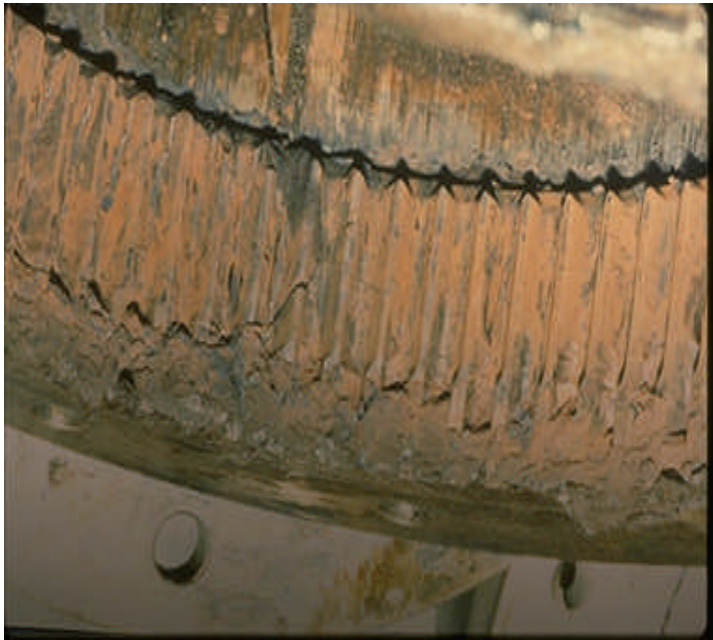
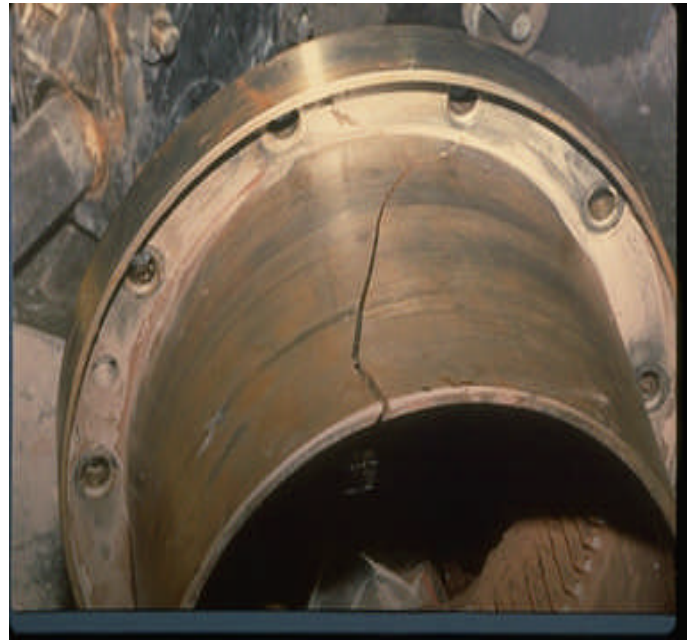
. Case 2- Two boiler feed pumps were having vibration problems and wearing out their gear couplings. When dynamic alignment was performed between the turbines and pumps, it was discovered that when vacuum was pulled on the turbines that they dropped .020" relative to the pumps.

COUPLINGS BEING DESTROYED ON STEAM
GENERATOR FEED PUMP AT NUCLEAR
STATION

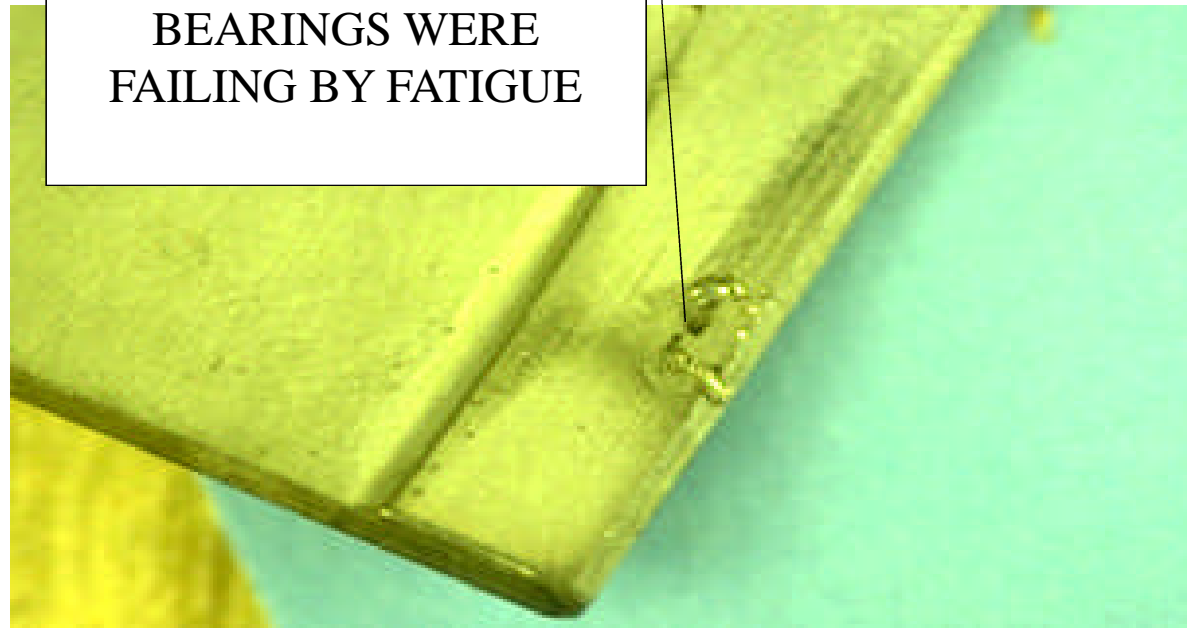
UPPER HALF OF BEARINGS WERE FAILING BY FATIGUE

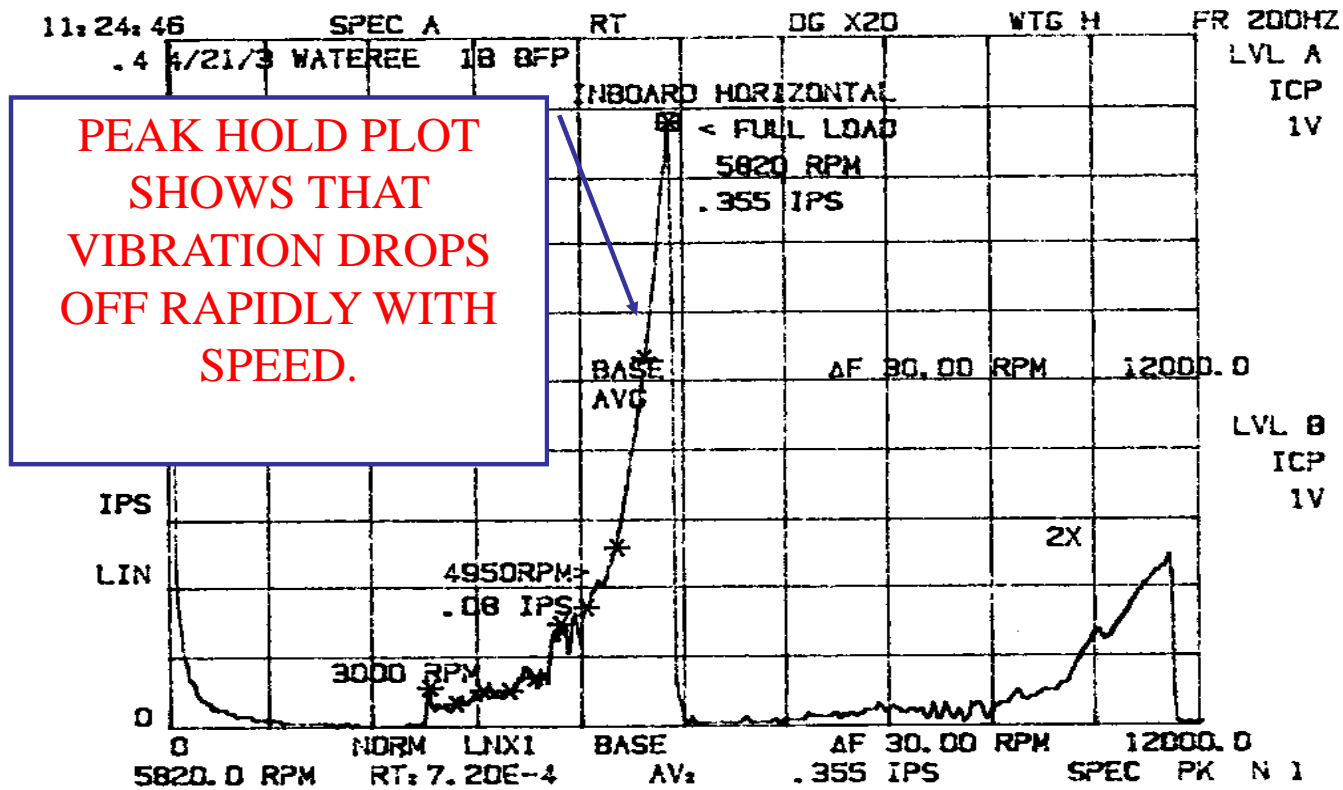
Case History- A large feed pump had a history of operating well after it was overhauled with new seals, but after time the running speed vibration would increase. A system was set up to monitor the amplitude and phase as the pump was brought to speed. It was discovered that after the seals experienced wear that the pump was operating just below a rotor critical speed.

TEST RESULTS

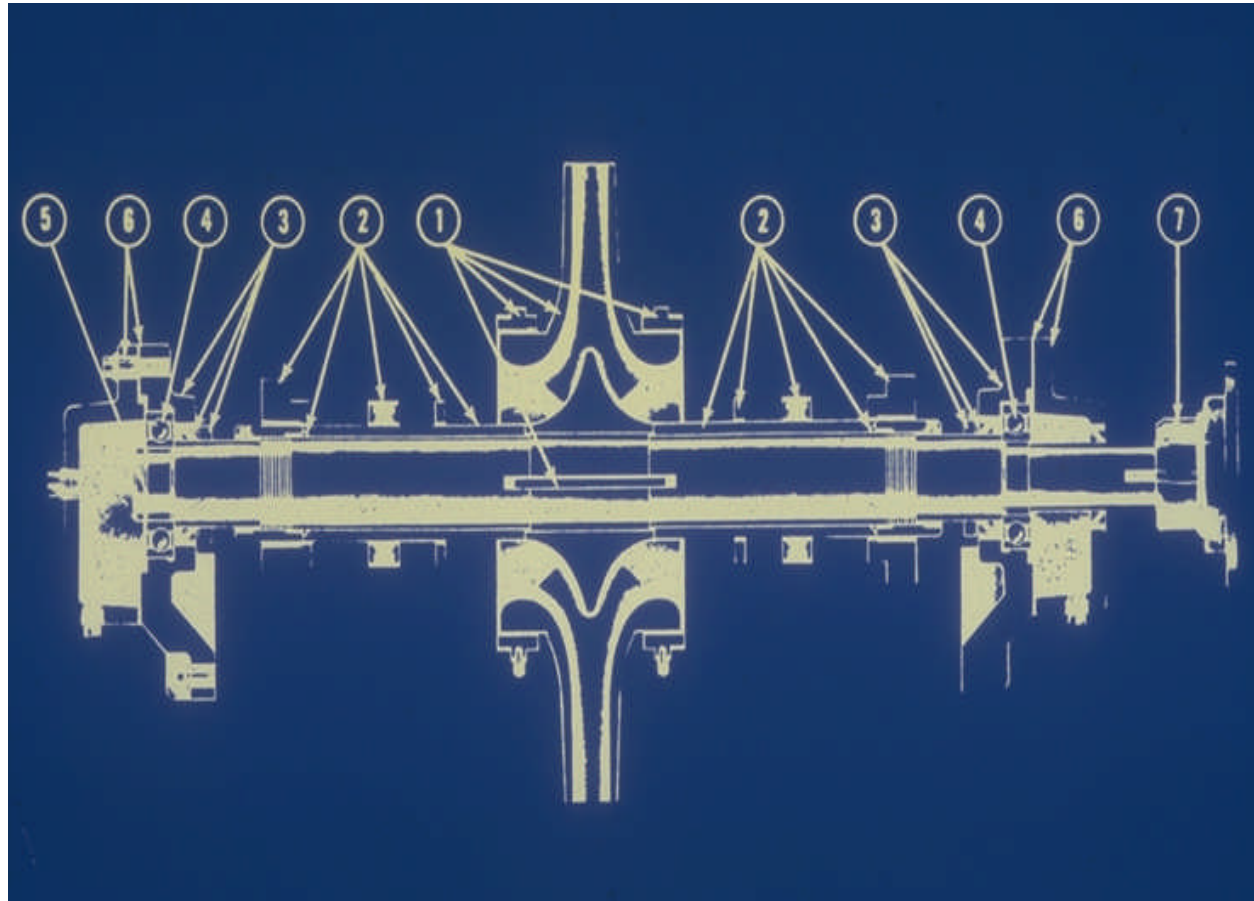
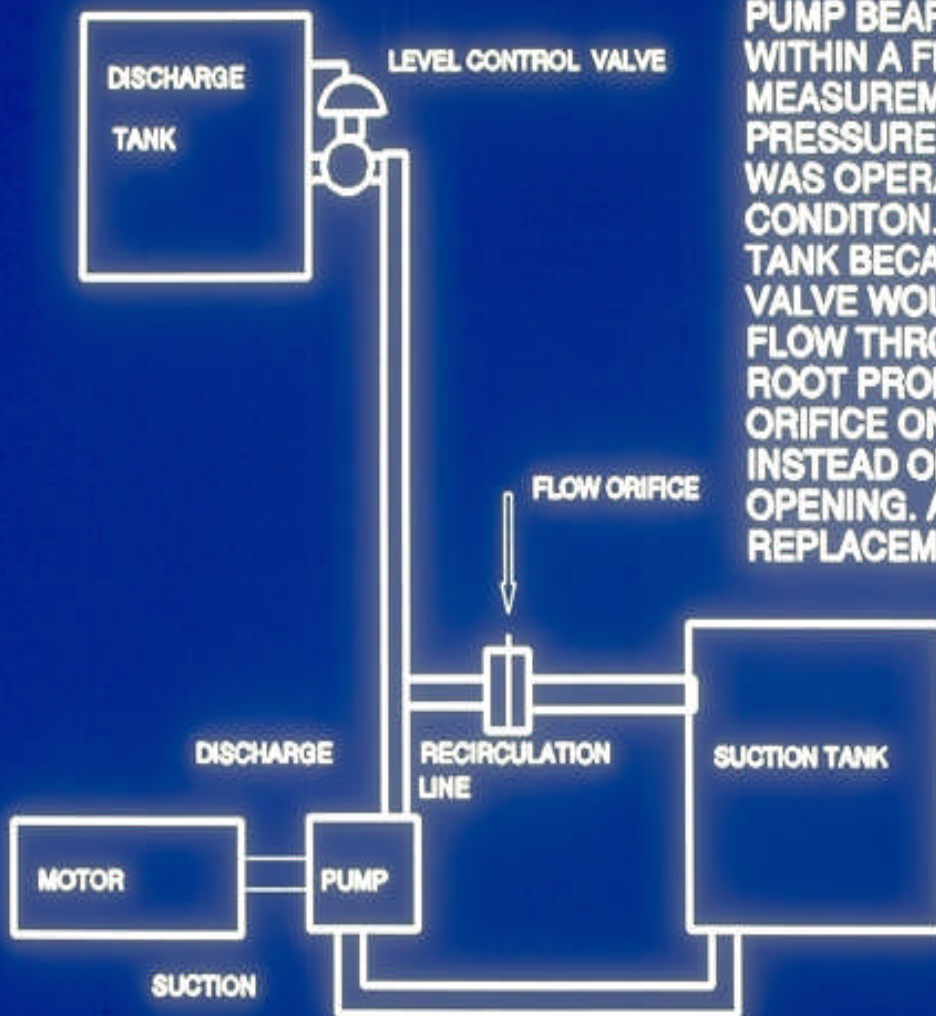
3: When analyzing pumps, measure the suction pressure, the discharge pressure, calculate the total developed head then look at the pump head curve before doing anything else. Case History 1- Three identical pumps were operating side by side. One of the pumps was failing bearings every few weeks. A study of the suction and discharge pressure showed that the pump was operating at near shut off head conditions. The problem was that during recirculation conditions, the flow was way too small due to the presence of a one inch orifice plate instead of the required three inch orifice plate. Replacement of the orifice plate solved the bearing failure problem.

PUMP BEARINGS WERE FAILING WITHIN A FEW WEEKS. MEASUREMENT OF DISCHARGE PRESSURE SHOWED THAT PUMP WAS OPERATING IN DEAD HEAD CONDITON. WHEN DISCHARGE TANK BECAME FULL, CONTROL VALVE WOULD SHUT, FORCING FLOW THROUGH ORIFICE. THE ROOT PROBLEM WAS THAT THE ORIFICE ONLY HAD A 1" OPENING INSTEAD OF THE DESIGNED 3" OPENING. AFTER ORIFICE REPLACEMENT, FAILURES ENDED.

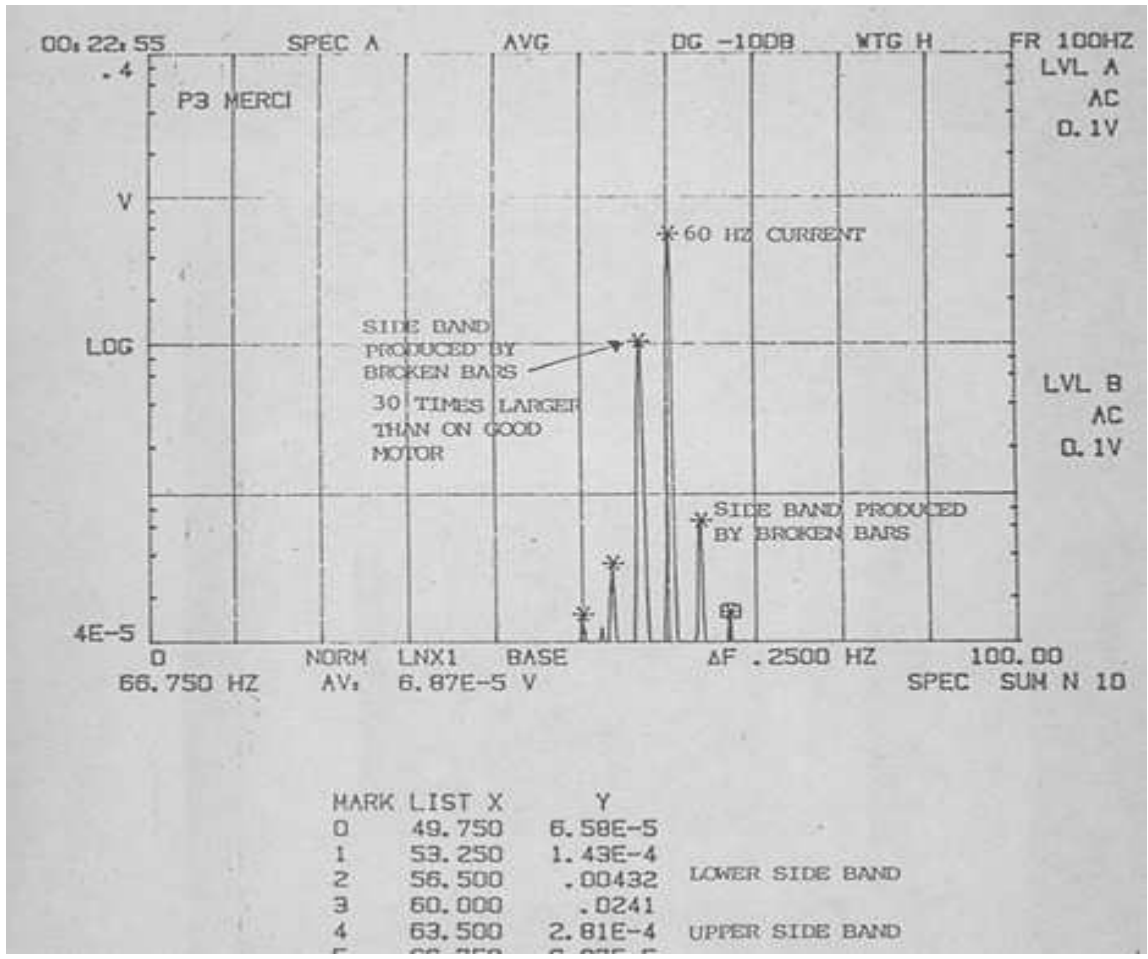
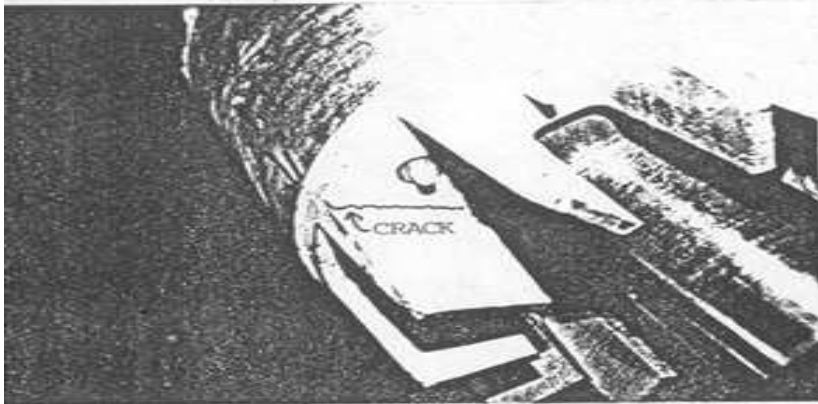
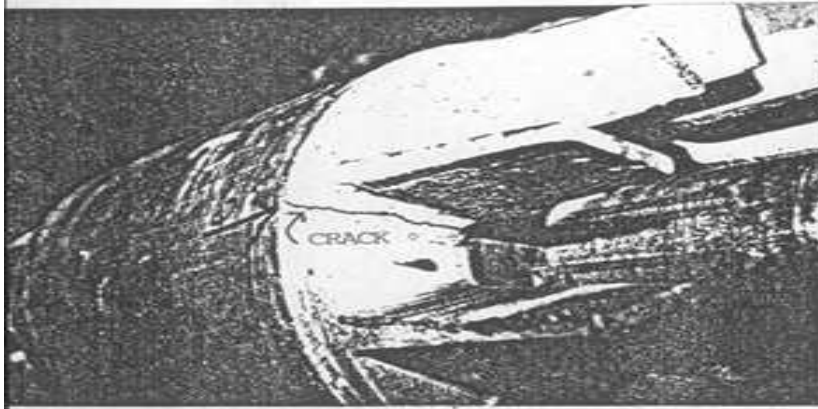
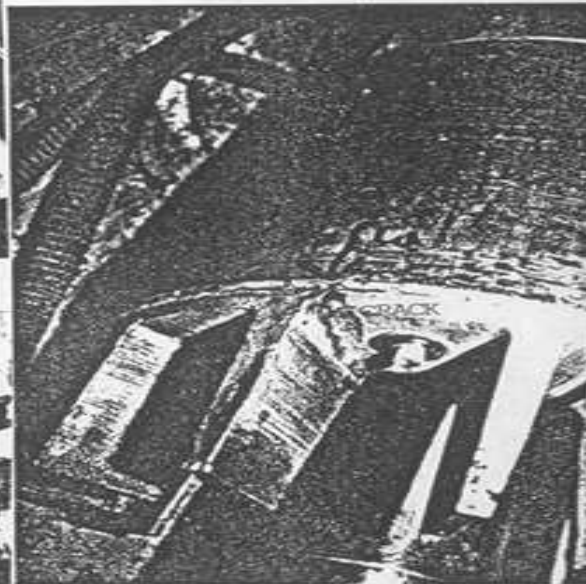
THIS FIGURE SHOWS THE MODULATION OF THE CURRENT GOING TO THE P-3 MERCO MOTOR. FOR A HEALTHY MOTOR, THE CURRENT WILL FLOW STEADILLY. WHEN BROKEN BARS ARE PRESENT, THE IMPEDENCE VARIES AS THE MAGNETIC POLES GO PAST THE BROKEN BARS. THIS CAUSES THE VARIATIONS IN MOTOR CURRENT. THE POLES PASS AT THE RATE OF THE NUMBER OF POLES TIMES THE SLIP FREQUENCY.

PHOTOGRAPHS OF DAMAGE
TO P-3 MERCO MOTOR ROTOR

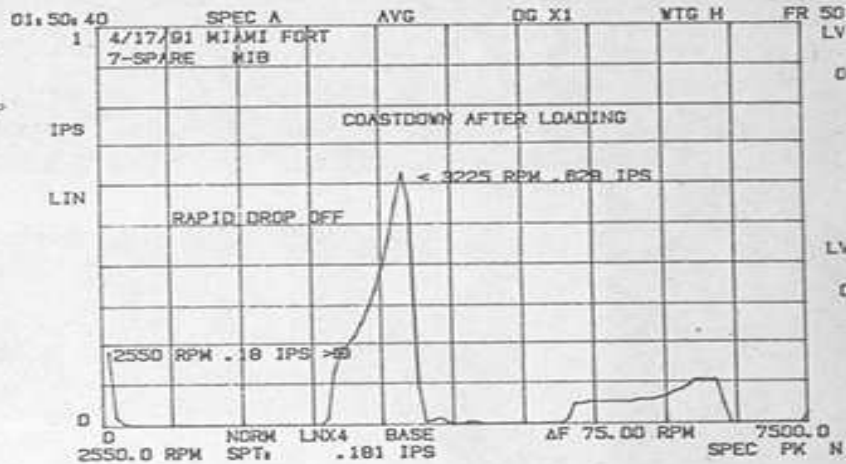
FIGURE 3
COAST DOWN PLOT IN PEAK
HOLD SHOWING THE RAPID DROP
OFF OF VIBRATION. THIS
INDICATES THAT THE ROTOR
MAY BE OPERATING NEAR A
NATURAL FREQUENCY.

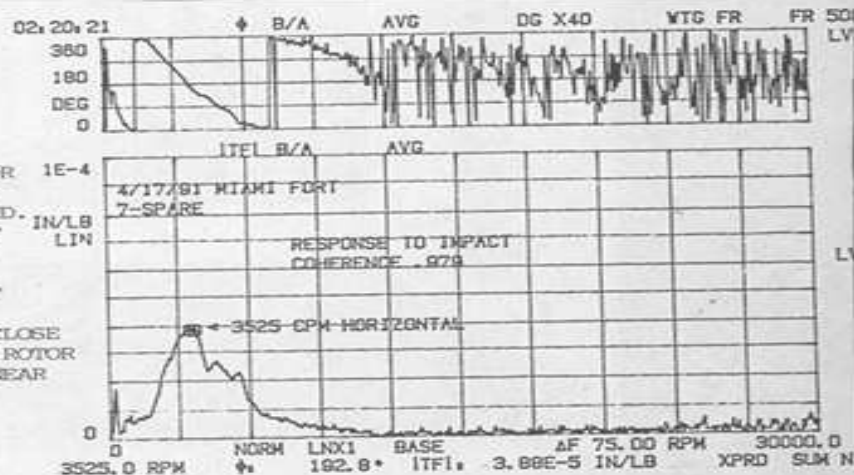
FIGURE 4
FREQUENCY RESPONSE PLOT
THIS PLOT SHOWS THE
RESPONSE OF THE MOTOR ROTOR
TO AN IMPACT. A 3525 CPM
NATURAL FREQUENCY WAS FOUND.
THIS WOULD CHANGE SOMEWHAT
WITH THE ROTOR SPINNING
IN ITS BEARINGS DUE TO
GYROSCOPICS AND THE EFFECT
OF THE BEARING OIL FILM.
IT IS NONE THE LESS VERY CLOSE
TO OPERATING SPEED SO THE ROTOR
IS UNDOUBTEDLY OPERATING NEAR
ITS FIRST BENDING MODE.

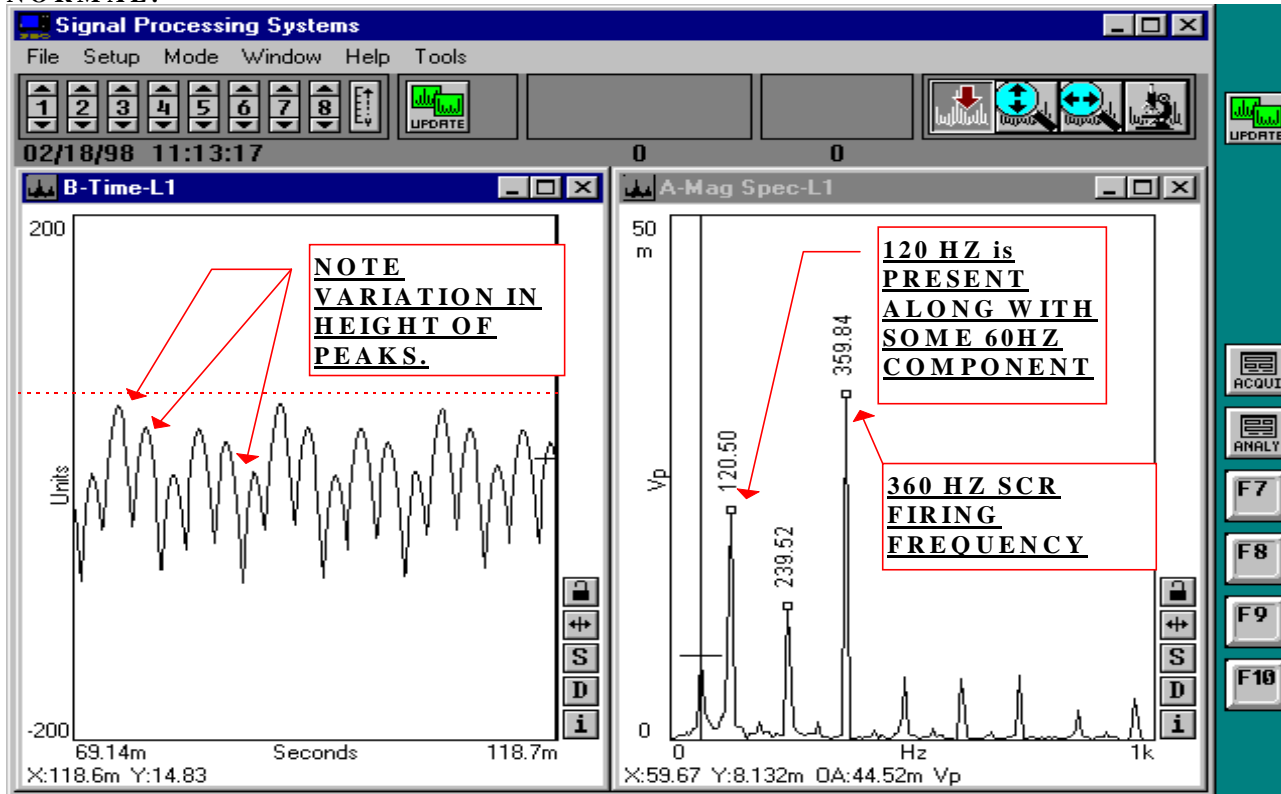
FEBRUARY 18, 1998
VISY FAN PUMP DRIVE
250 AMP LOAD

WHEN SCR'S WERE REPLACED, THE WAVEFORM AND SPECTRUM RETURNED TO NORMAL.

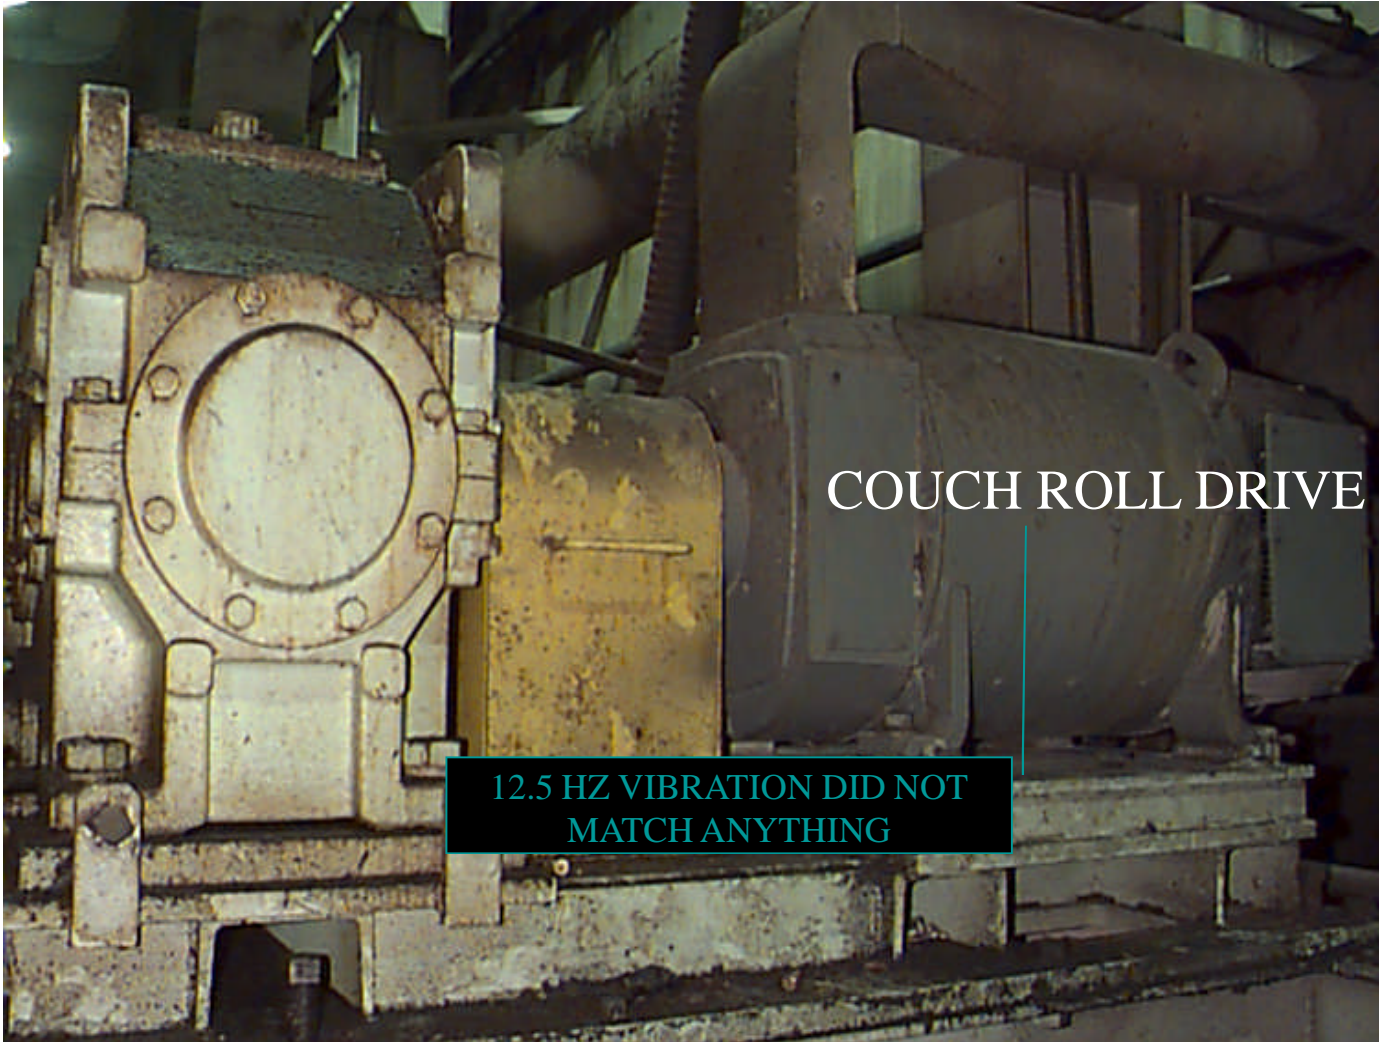
COUCH ROLL DRIVE

3: DC MOTORS- Unknown frequencies in the spectrum of the current going to a DC drive can originate from other mechanical equipment in the drive train. Case History- The current on a couch roll of a paper machine had an unknown component in its spectrum. It turned out to be the vane pass frequency of the fan pump located several yards away in the basement. The fan pump was causing pressure pulsations in the head box that caused the paper to be deposited in varying thicknesses. As the thicker material passed over the vacuum rolls, this caused the tension to increase which changed the tangential force on the couch roll which in turn caused the current draw to the couch roll to modulate at that rate.

12.5 HZ VIBRATION DID NOT
MATCH ANYTHING

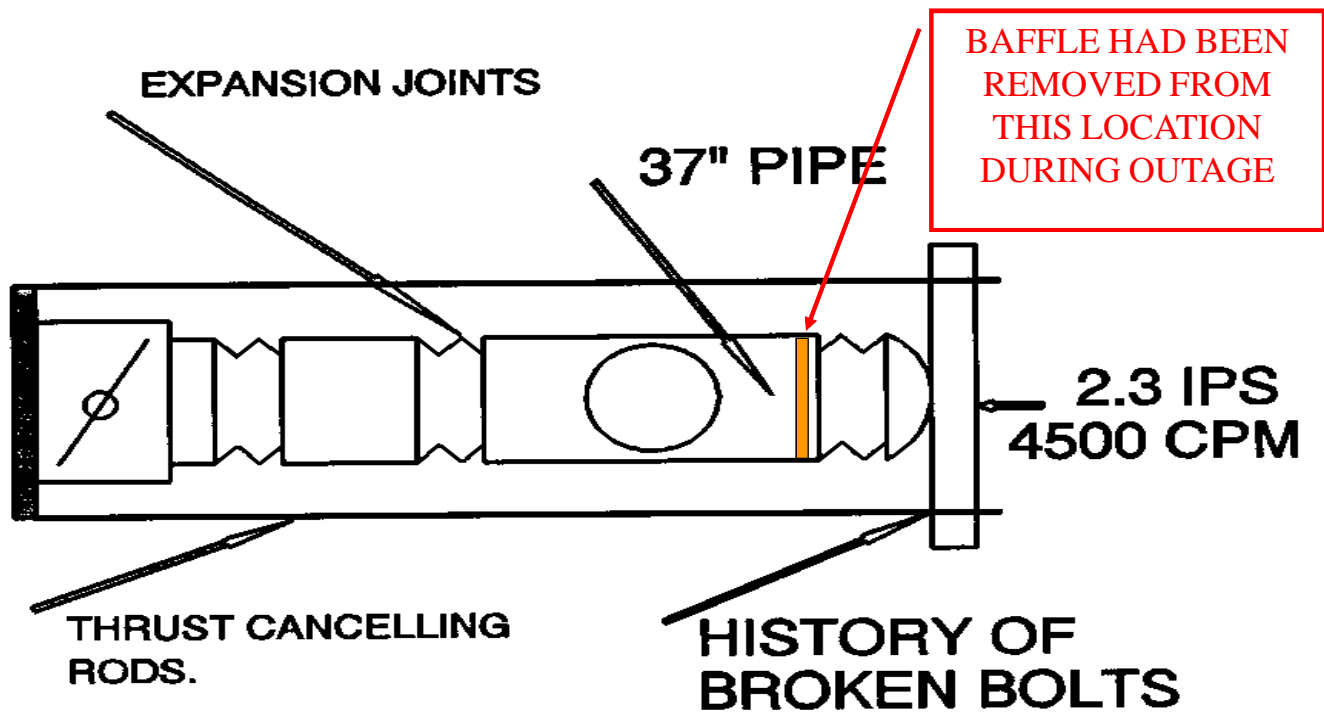
MISSING COMPONENT

- A 37" pipe has an area of 1075 square inches.
- Stiffness of bolts is EA/L
- Partially closed butterfly valve was generating broad band noise that caused pipe to resonate.
- Missing baffle allowed pressure pulsations to move end cap.

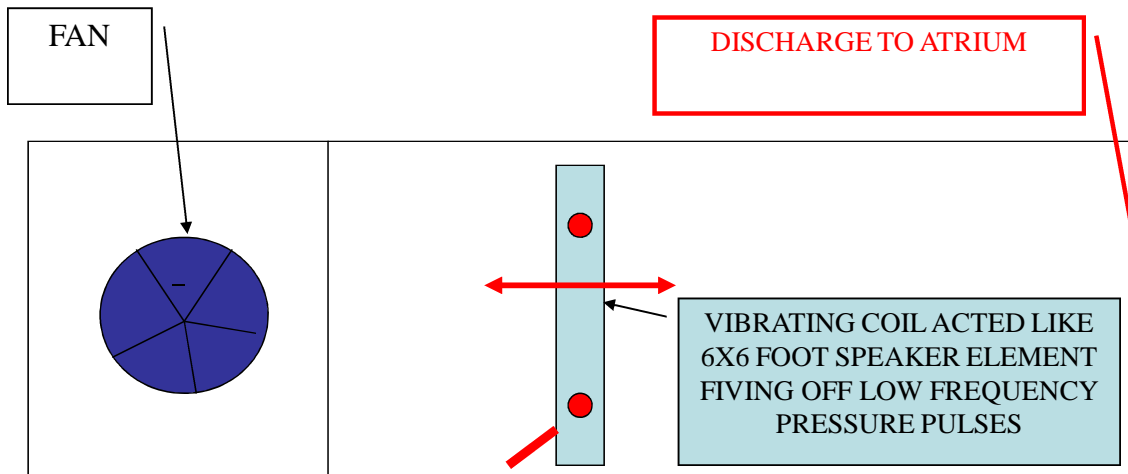
LOOSE COIL

COIL WAS SUPPORTED BY ONLY SUPPLY AND RETURN PIPE. NATURAL FREQUENCY 240 CPM.
