## **HYDROGEOLOGIC EVALUATION**

# RITNER HIGHWAY WAREHOUSES 3485 RITNER HIGHWAY NEWVILLE, CUMBERLAND COUNTY, PENNSYLVANIA

ECS PROJECT NO. 47:20270

**DECEMBER 9, 2024**

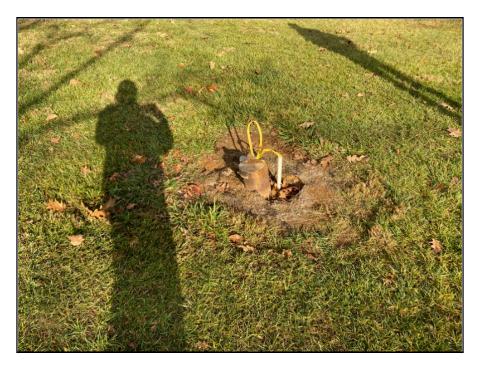
1 - Unused well at 3497 Ritner Highway.

- If the monitoring and supply wells are no longer to be used at the property, they should be properly abandoned in accordance with PA DCNR and PADEP guidance.
- The existing sinkholes observed on the western boundary of the site should be repaired under the guidance of ECS's Geotechnical Engineer.

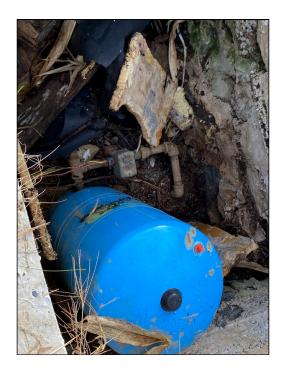
2 - Inaccessible well at the vacant farmstead house.

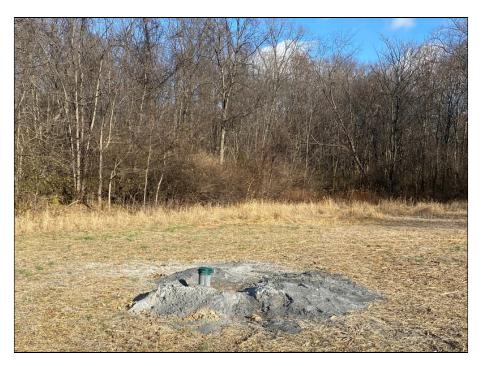
Brown silt and clay was encountered from ground surface to 10 feet bgs. Weathered limestone was encountered from 10 feet to 15 feet bgs. Limestone was encountered with from 15 to 150 feet bgs. No water-bearing zones were encountered the following weathered zones and fractures were encountered:

- A softer, weathered zone from 30 to 35 feet bgs,
- A soft zone from 75 to 78 feet bgs
- A fracture or void from 88 to 89 feet bgs, quick drop in rods
- A fracture or void at 104 feet bgs.

At the end of drilling, the driller flushed out the hole with water and removed the water with compressed air. The well was completed with a stickup cover and bolted cap. No water was in the boring immediately after drilling but a few inches of water was encountered in the well after an hour wait. After an overnight wait, water had risen to a depth of 85 feet below the top of casing and was continuing to rise. Groundwater monitoring is discussed in Section 8.0.

3 - Monitoring well PZ01.
