# Stormwater Construction Site Inspection Report

Rattlesnake Creek Substation and T-line

CWS-201802602

16 Aug 2018 10:53 AM

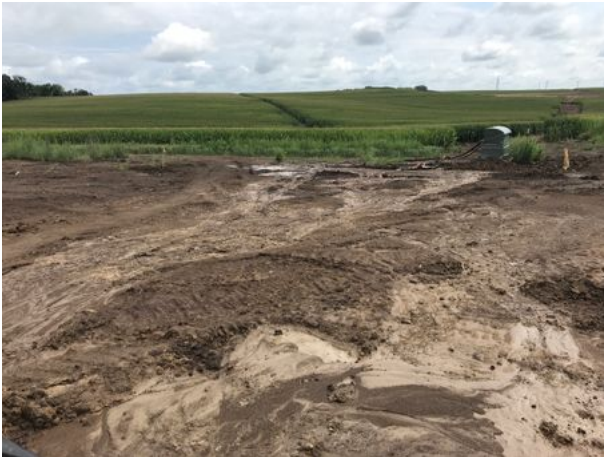
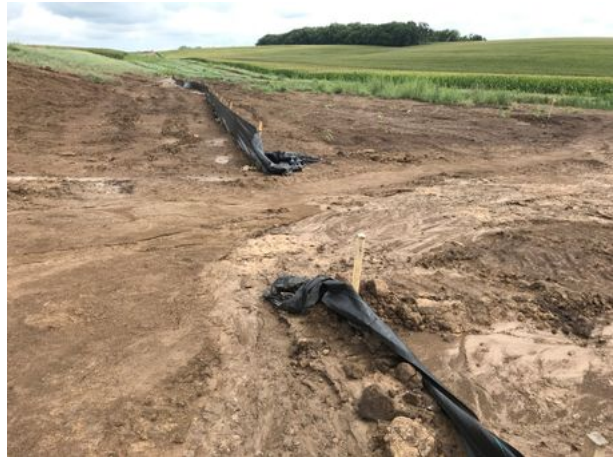
| Question | Response | Details |
|--|---|---|
| Describe | Water escaped on the east side of the substation through an opening in the silt fence that Mortenson cut to trench. | |
