Lead-Based Paint Inspection And Risk Assessment Report

Inks Dam National Fish Hatchery Quarters 66 Route 2 Burnet, TX 78611 (512) 793 2474

11 September 2000

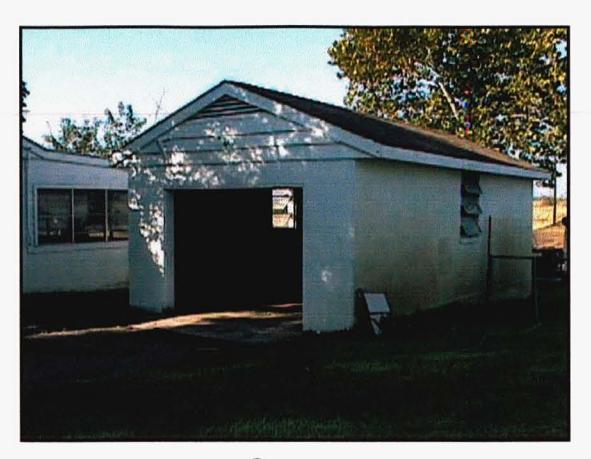
1. The exterior white paint on the overhead garage door was rated to be in "unsatisfactory" condition, and contains more than 10ft² of LBP. Based on the age and condition of the door, it will be cost effective to replace the door. The Garage Doorjambs should be chemically stripped and repainted. Comments in Part IV, Para. B, concerning exterior white paint are germane, but do not represent a lead "hazard".

b. The exterior white paint on the overhead garage door was rated to be in "unsatisfactory" condition, and contains more than 10ft² of LBP. Based on the age and condition of the door, it will be cost effective to replace the door. The LBP on the Garage doorjambs should be chemically stripped and the jambs then primed and repainted.

- 2. Repair of Jambs and Replacement Cost for the Garage Door—Hazard #1:
 - **b.** Cost estimate to replace the Garage Door is \$600.00. Cost estimate to repair the Garage doorjambs is \$200.

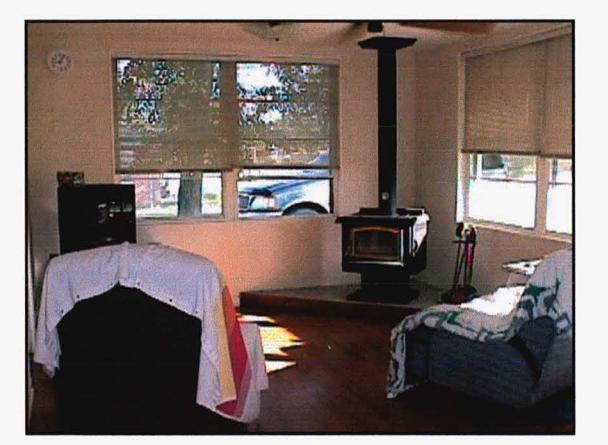
NOT A LEAD HAZARD—The ceramic tiles on the Utility Room floor and Full Bathtub surround, contain low quantities of lead in their glazes. The ceramic tile on the Living Room Hearth, however, contains significant lead in the glazing. (The reader's attention is invited to see lines **452**, 467, and 472, column #9 of the Preliminary XRF Report).

However, it is your **iS²e Risk Assessor's** opinion, in consultation with the Region VI EPA toxic waste coordinator, Mr. Jeff Robinson, that these tiles currently <u>do not present any LBP "hazard"</u>.

In order to repair any chipped or damaged tiles in the future, these should first by washed with warm, soapy water, rinsed and dried. The homeowner using epoxy-resin-paint may then repair the damaged portion of the tile. This will re-seal the lead within the glaze.
