Subject	Preliminary Roost Assessment (Commentary)
Site Name	Harlech Court, Bute Terrace, Cardiff, CF10 2FE
Title / Description	Commentary on PRA
Client	The Draycott Group
Clients Ref	
CEC Ltd Ref

Subject Commentary on a Preliminary Roost Assessment of Harlech
Court Assessment in Respect of Bats

Date 19.06.2024

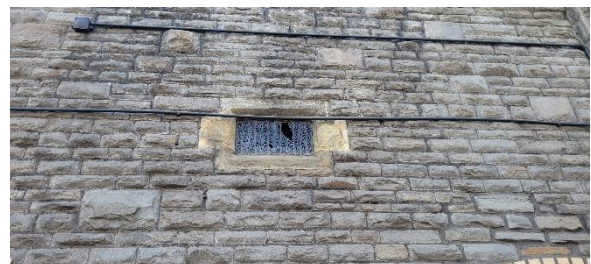
Plate 6 – ventilation grill on Porters front elevation

The presence of a hole in the metallic grill over a ventilation screen in the front of the Porters façade could indeed provide a roost access point; however, during the May 2024 site visit, access was possible to the internal areas of the building where it was observed that the grill fronts an (either steel or aluminium) air conditioning duct, unsuitable for use by bats. Bute Terrace is also a well-lit and busy four lane road opposite a road junction.

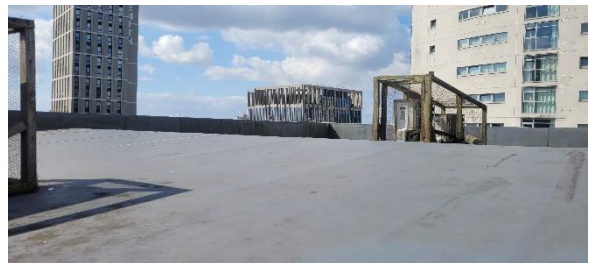
Plate 14 – flat roof of multi-storey building

The ground floor of the multi storey building is built of concrete (Plates 10 – 12) and is integrated into the building behind the Porters façade. Internally, the multi-storey building is given over to classrooms and offices (Plate 13), mostly all now disused or used for general storage. A number are still used for education / teaching purposes. All windows are intact. The flat roof (Plate 14) is open and exposed and in a generally good state of repair.

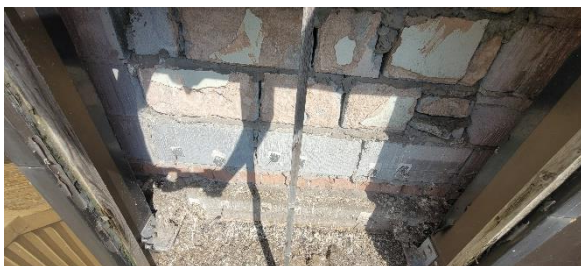
Plate 15 – Missing panel on south elevation

The external glass cladding shows signs of damage and repair. One panel is missing (Plate 15); others are boarded over with plywood sheets.

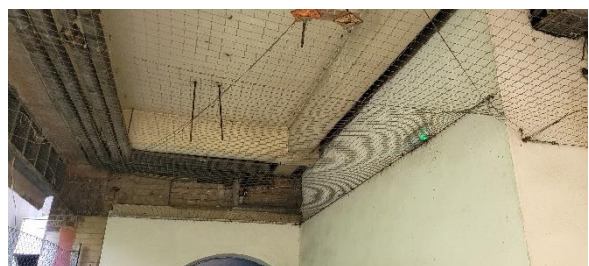
Plate 18 - Anti-bird netting

- Bird netting - the rear elevations of the building below the podium parking level are netted (Plate 18) to prevent birds accessing potential roosting locations on the building. While bats are small enough to fly through the holes in such nets, it is more likely that they would be caught and tangled in them.

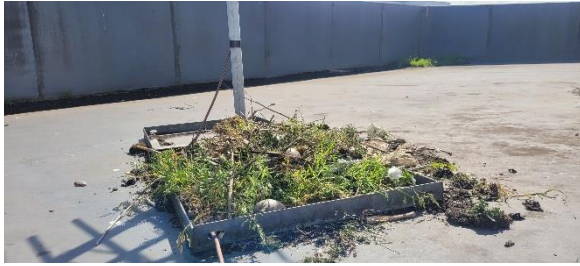
Plate 19 – gulls nest on flat roof

- Predators – gulls are known to predate bats. The presence of large numbers of gulls were observed in the vicinity of Harlech Court. Gull nests were observed on the roof of the multi-storey section of the building (Plate 19) and within the wall cavities around the missing glass panel on the building's southern elevation. The presence of an outdoor bar and dining area would have only encouraged their presence. The numbers of such predators would likely discourage bats from using the area.
