F59 MY20 & newer Steering Wheel & Connectors

Horn Pad Removal

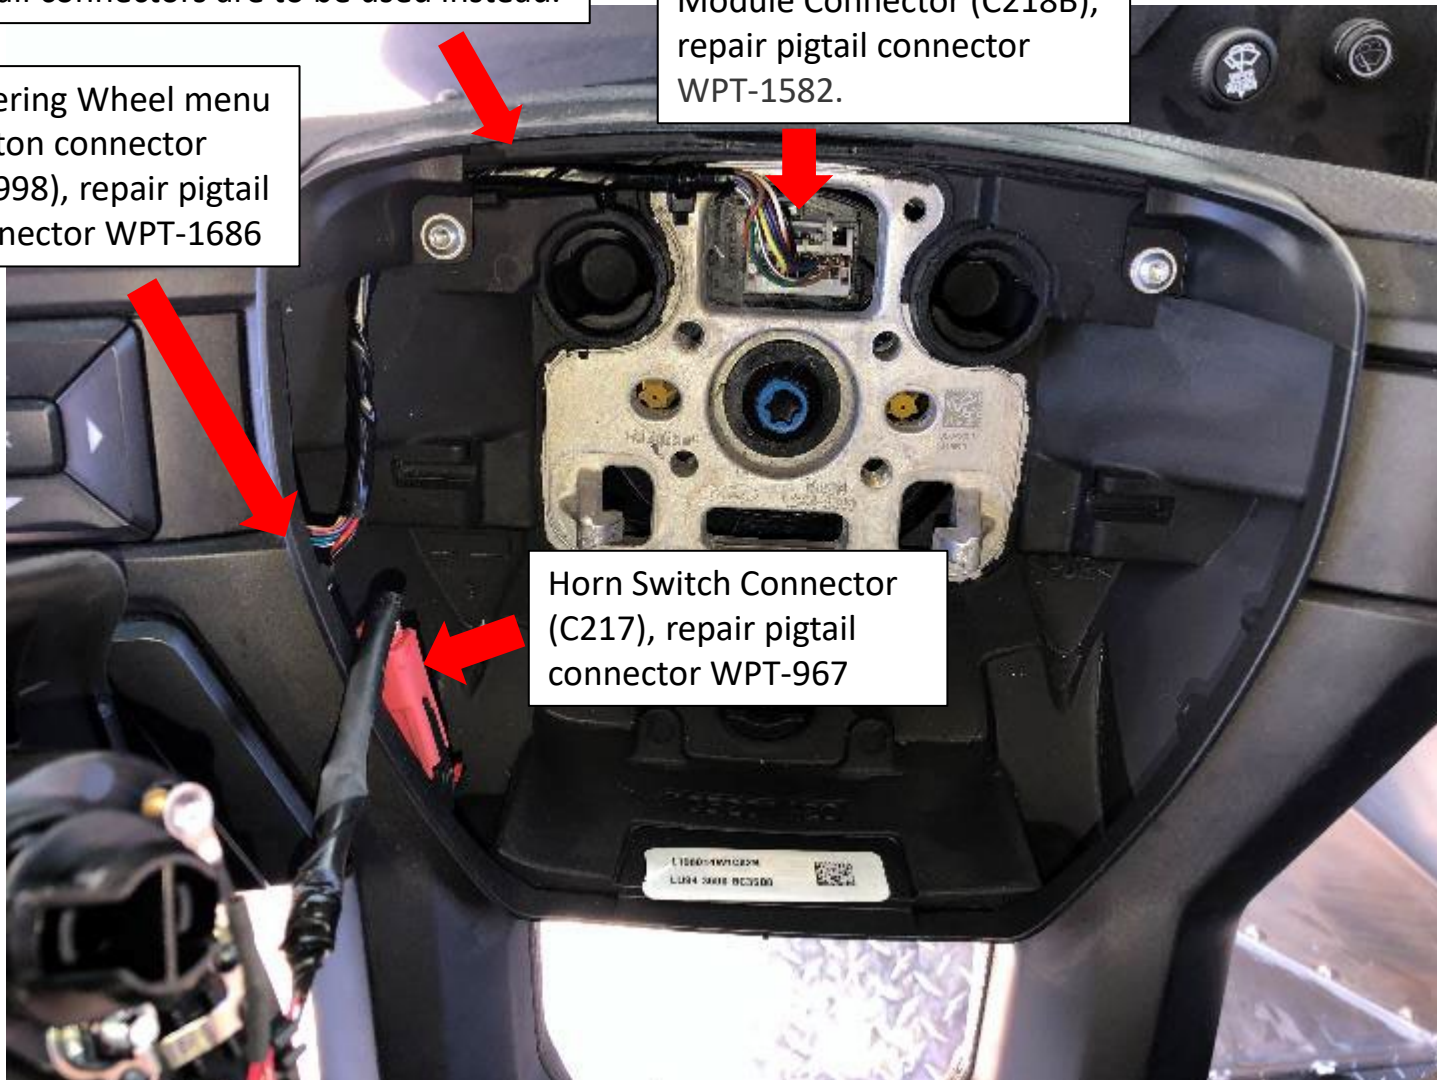
Horn connection

Horn Switch Connector (C217), repair pigtail connector WPT-967

The wiring harness inside the wheel is not available as a service part. The repair pigtail connectors are to be used instead.

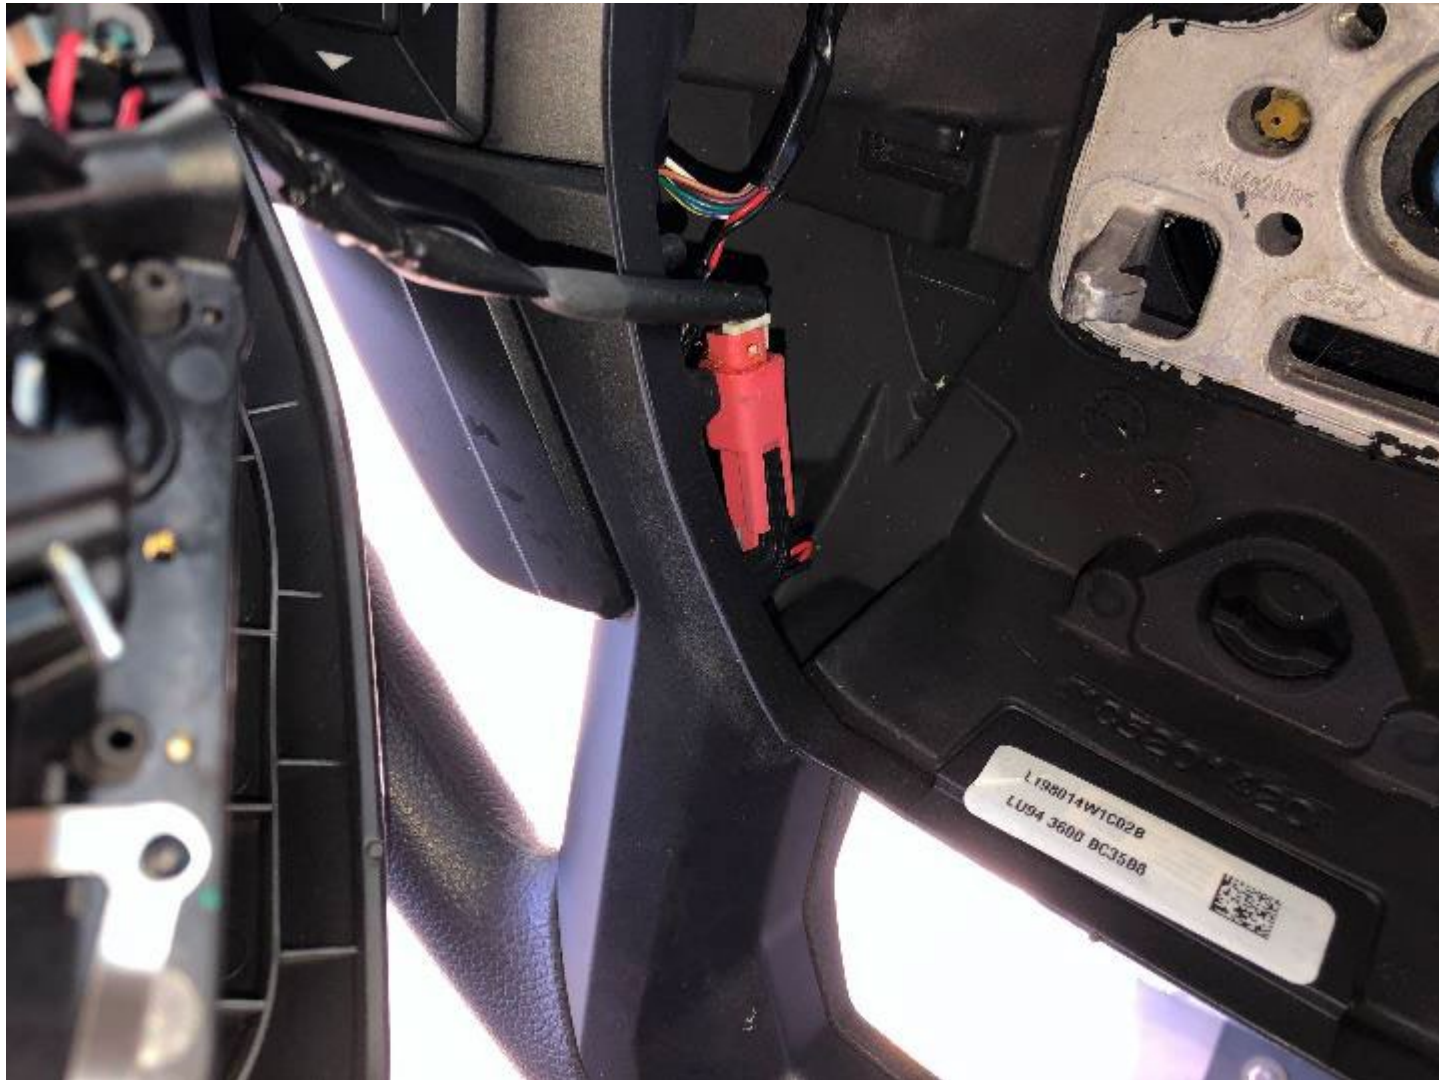
Steering Wheel Menu Button Connector

Steering Wheel menu button connector (C2998), repair pigtail connector WPT-1686

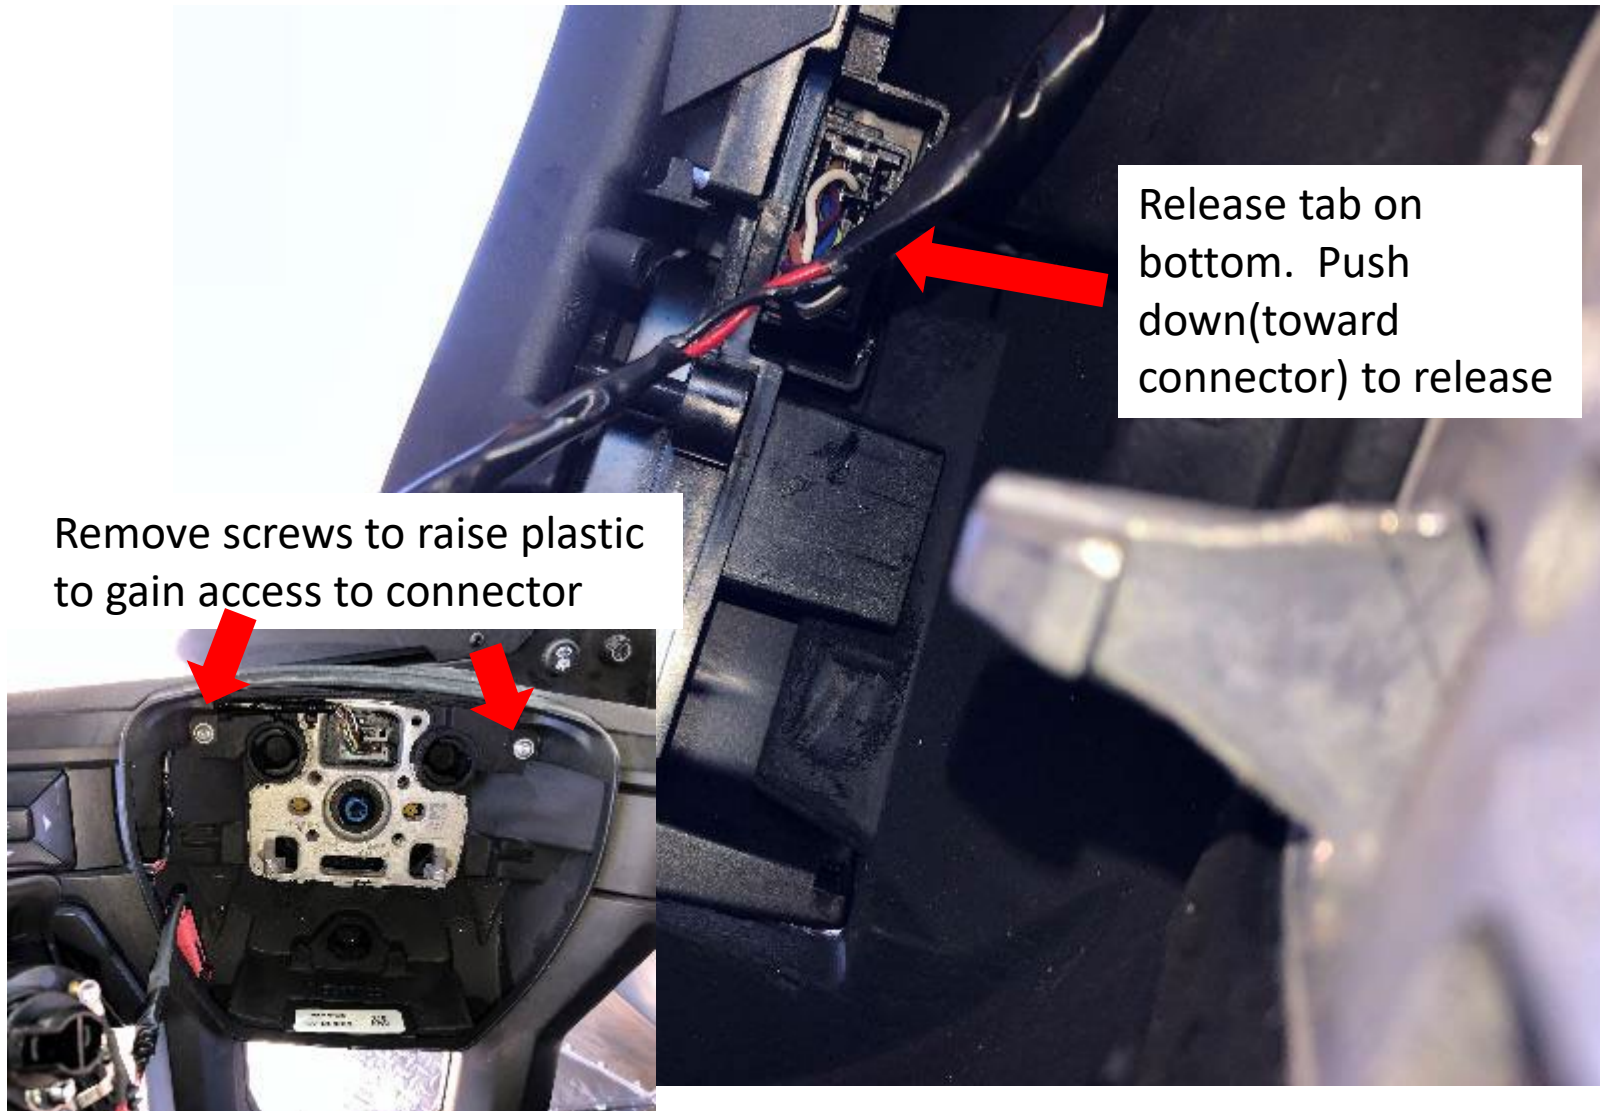
Steering Column Control Module Connector (C218B), repair pigtail connector WPT-1582.
