PROPERTY INSPECTION REPORT

**Donald D'Angelo
Big Bear Home Inspectors**

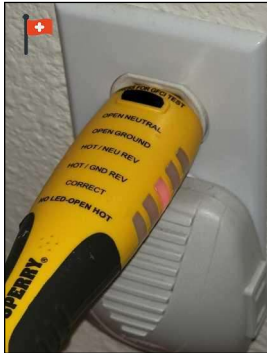
Living Room -Reversed polarity, hot and neutral reversed and other terms used for electric receptacles are usually easily corrected by minor wiring adjustments at the specified item. When these conditions are noted in this report, a licensed electrician should be consulted for repairs/replacement as needed to ensure safety.

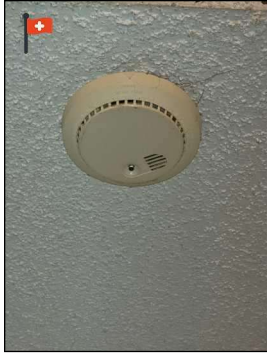
Hallway--Old detectors. Smoke detectors last 6-10 years. Recommend replacing.

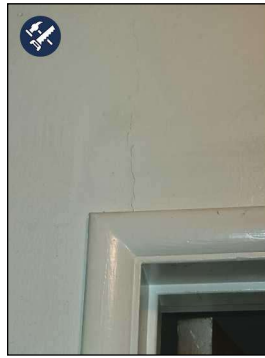
Hallway--Settlement Crack Observed

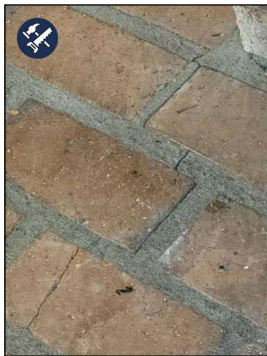
Living Room--Cracked or Deteriorated Mortar Observed in Hearth

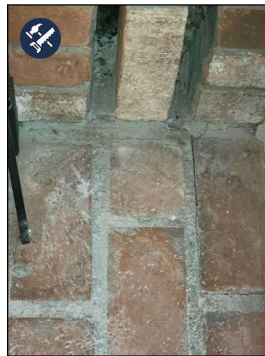
Living Room--Cracked or Deteriorated Mortar Observed in Hearth

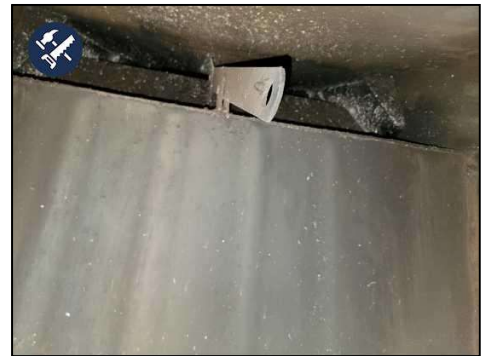
Living Room--Flue Damper is Stuck Open

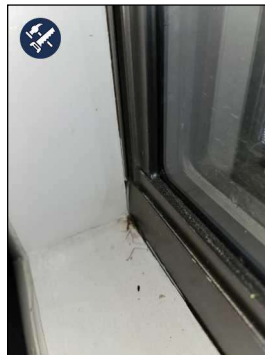
Living Room--Cracked Seal Observed around Window Framing

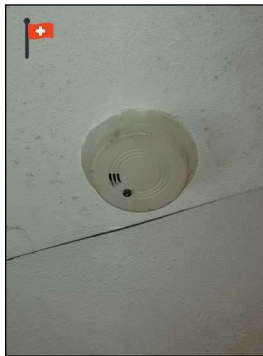
Master Bedroom#1--Replace all old not functioning smoke/ fire detectors with new hard wired detectors or make sure batteries are good.

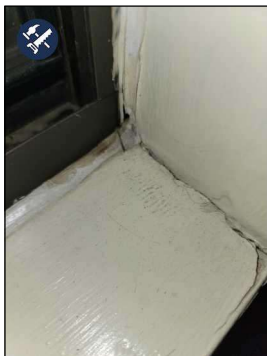
Bedroom#3--Cracked Seal Observed around Window Framing

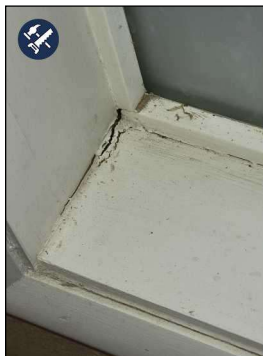
Master Bedroom#1--Deterioration noted due to contact with moisture, repairs needed.

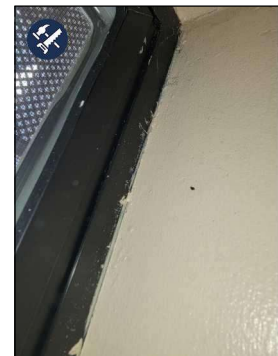
Master Bedroom#1--Cracked Seal Observed around Window Framing

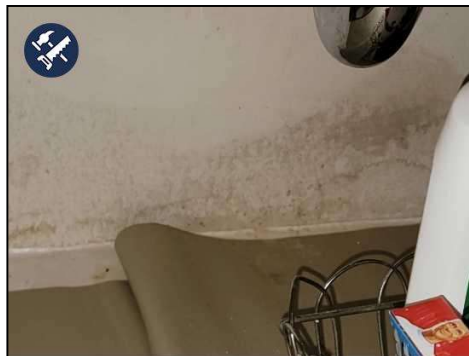
Bathroom#2--There appears to be water damage under sink. This tested dry at the time of the inspection, but monitor for any further intrusion.

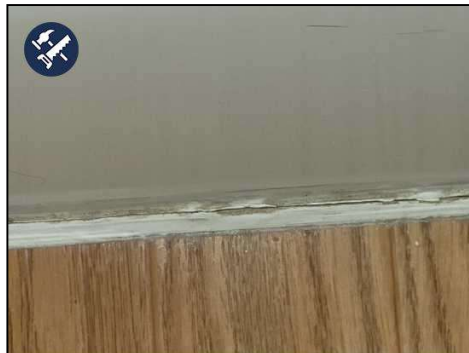
Master Bathroom#1--Recommend caulking at the tub and shower areas

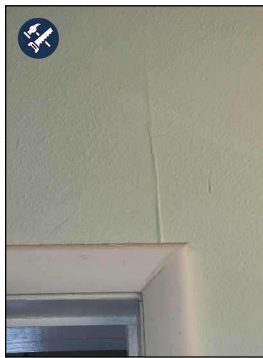
Master Bathroom#1--Small cracking in the wall finish is noted. This is probably caused by the joint compound (spackle) drying too quickly during application.

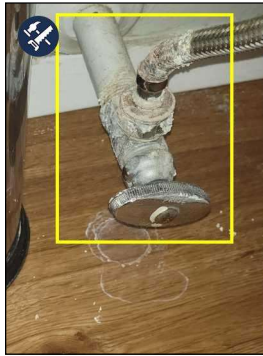
Bathroom#2--Excessive corrosion on water shutoff valve. Valve could leak at any time or may not work properly when used. Recommend further evaluation by licensed plumbing professional.

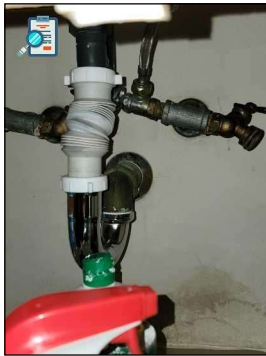
Bathroom#2--Flex drain observed, these are subject to frequent clogging.

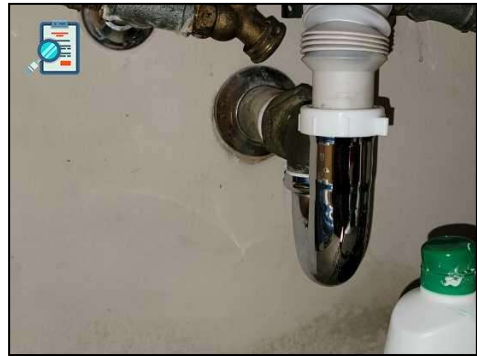
Bathroom#2--Older style metal traps noted. Buyer is cautioned that these traps can leak at any time due to corrosion.

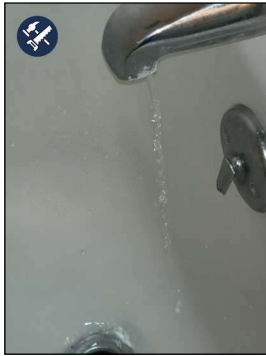
Bathroom#2--Shower diverter does not fully engage.

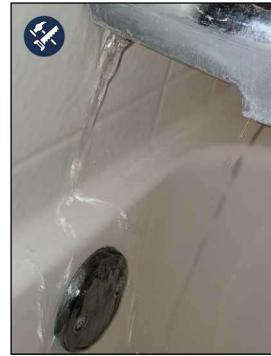
Master Bathroom#1--Tub Spout leaks while operating

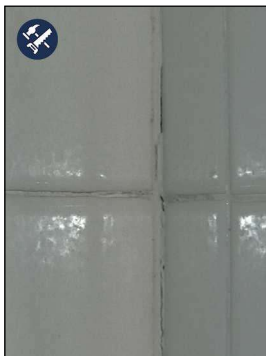
Bathroom#2--Missing/damaged grout observed, suggest regrouting as necessary.

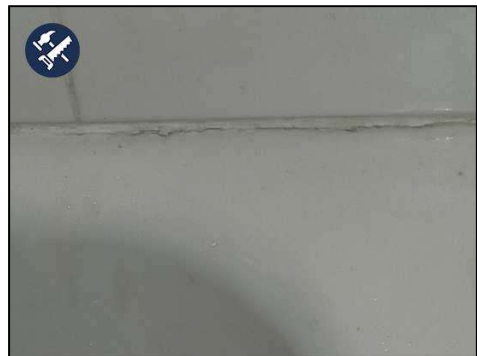
Bathroom#2--Missing/damaged grout observed, suggest regrouting as necessary.

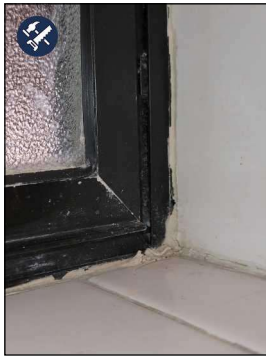
Bathroom#2--Cracked Seal Observed around Window Framing

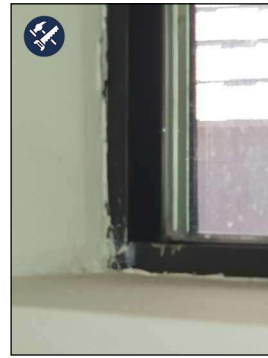
Master Bathroom#1--Cracked Seal Observed around Window Framing

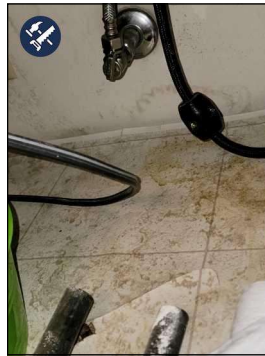
There appears to be water damage under sink. This tested dry at the time of the inspection, but monitor for any further intrusion.

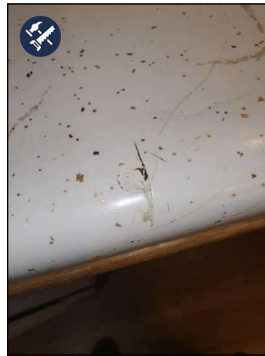
The counter tops are noted as being chipped.

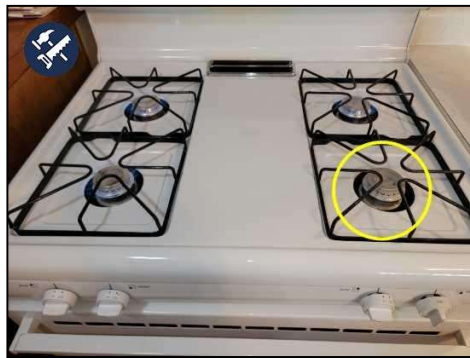
1 burner did not operate properly when tested.

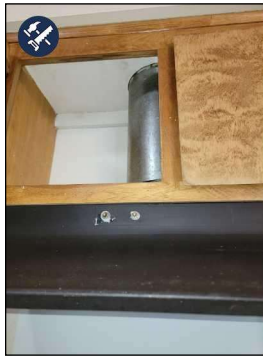
Exhaust fan is noisy.

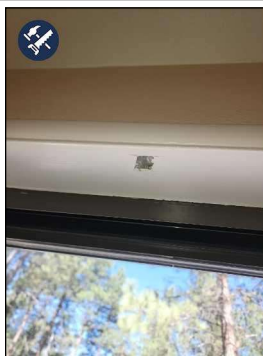
Minor Damage Observed to Window Framing

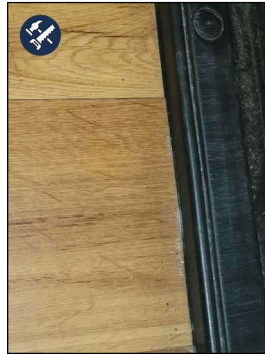
Gap Observed at Threshold, Recommend Sealing to Prevent Moisture Intrusion

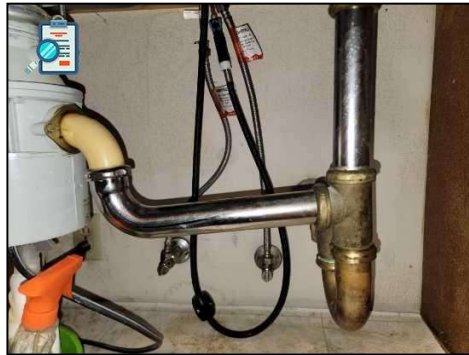
Older style metal traps noted. Buyer is cautioned that these traps can leak at any time due to corrosion.

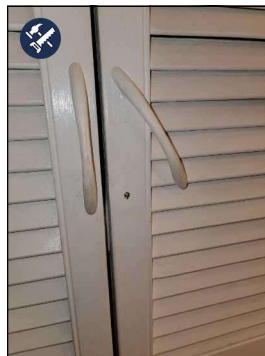
Loose Handle Observed

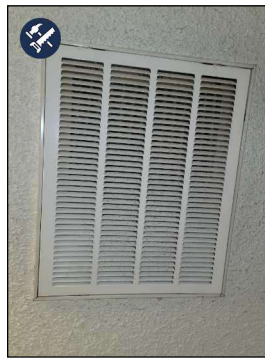
Hallway--The furnace filter is dirty. Filters help clean the house air, making the environment more pleasant. Filters also clean the air before it passes through the blower and heat exchanger. This helps to keep these furnace components working efficiently. It is recommended to change the filter and then regular inspection & maintenance is advised.

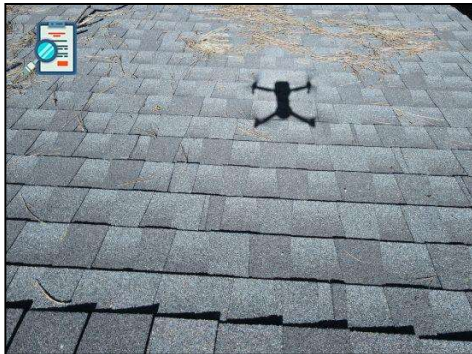
Clear Tree Debris Whenever Possible.

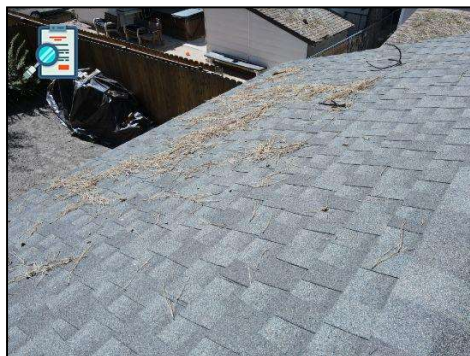
Clear Tree Debris Whenever Possible.

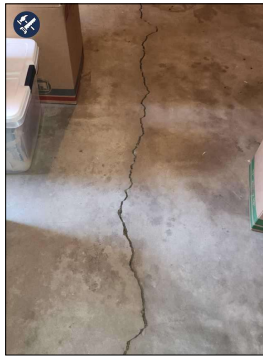
Crack entire Length Down Center Noted.

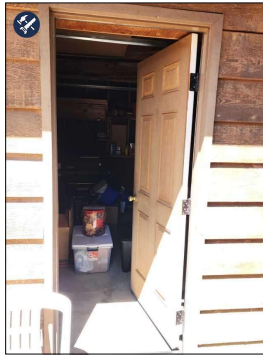
Garage Exterior Door has Peeling Finish and Bare Wood Observed.

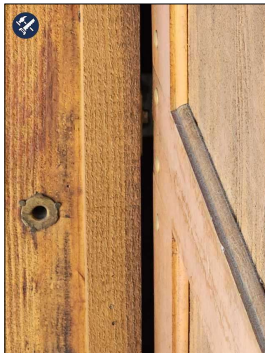
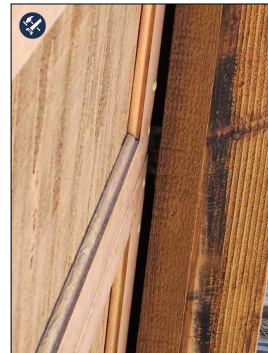
Sides of the Main Garage Door are not Sealed up when Closed.

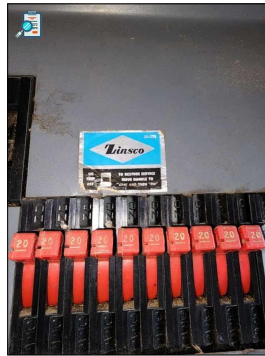
There is a Zinsco service panel present. Zinsco components are prone to problems that can lead to failures, lack of proper protection of circuits and other serious issues, including fire and electrocution. We cannot definitively call this panel defective, but recommend, for your peace of mind, to consult a qualified electrical contractor to get their opinion on this matter. You can learn more about this issue at <http://www.inspect-ny.com/electric/zinsco.htm>

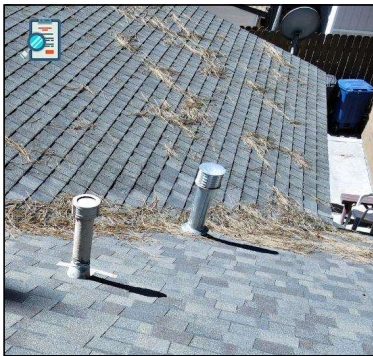
Clean Tree Debris whenever possible.

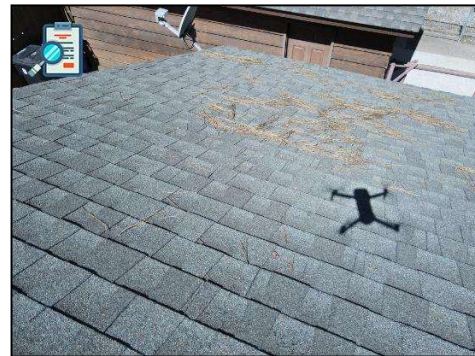
Clean Tree Debris Whenever Possible.

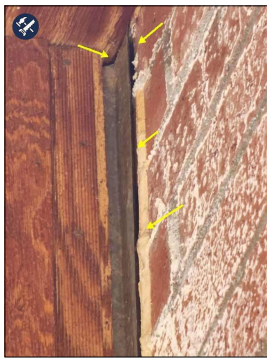
Sealant Between Chimney and the Home is Cracked/Broken or Missing.

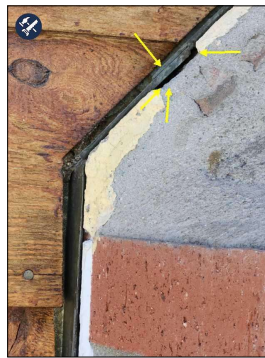
Sealant Between Chimney and the Home is Cracked/Broken or Missing.

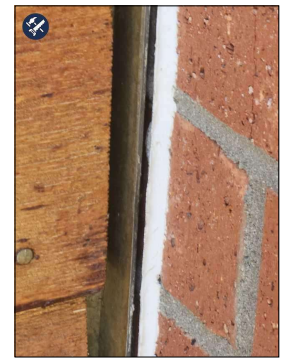
Sealant Between Chimney and the Home is Cracked/Broken or Missing.

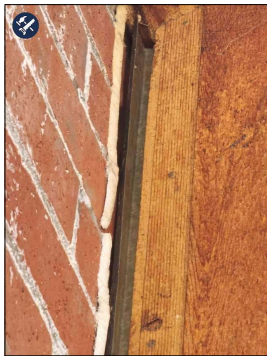
Sealant Between Chimney and the Home is Cracked/Broken or Missing.

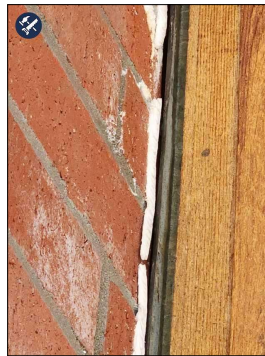
Sealant Between Chimney and the Home is Cracked/Broken or Missing.

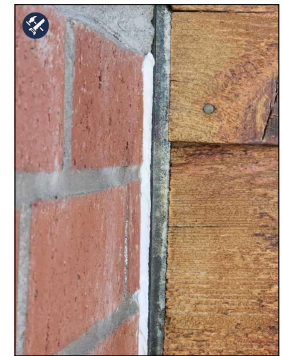
Sealant Between Chimney and the Home is Cracked/Broken or Missing.

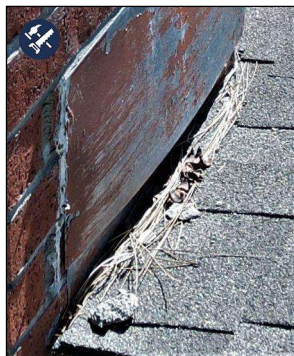
Sealant & Flashing appear compromised Here. Recommend further Evaluation by a Roofing Contractor.

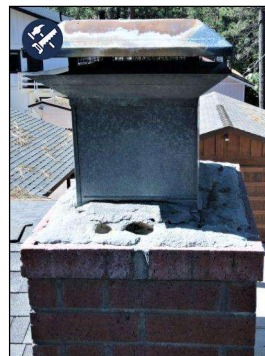
Concrete Crown is Pitted and Cracked.

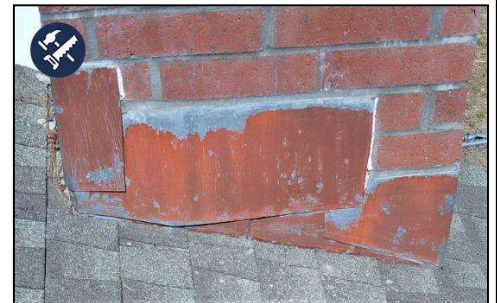
Step Flashing should be completely secured to Chimney.

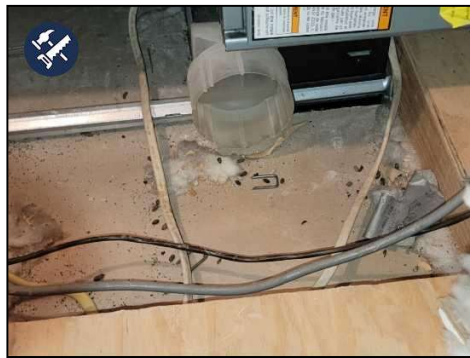
Evidence of Rodent Activity Observed

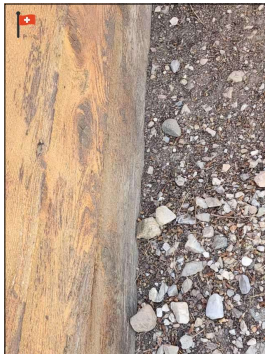
Siding-Soil contact or proximity. This may provide entrance of moisture or insects to siding. Recommend grading soil so there is at least 6" of space (where practical) between the siding and the soil below and checking for any damaged trim and siding materials. West Side of the Garage.

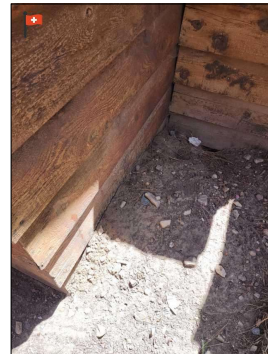
Siding-Soil contact or proximity. This may provide entrance of moisture or insects to siding. Recommend grading soil so there is at least 6" of space (where practical) between the siding and the soil below and checking for any damaged trim and siding materials. South Side of the Garage.

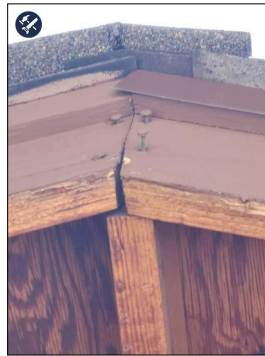
Nail Observed coming out of the Fascia Board. West Side. Another Observation, Drip Edge Flashing is only installed on the Center Sides to South Side Roofing Only!

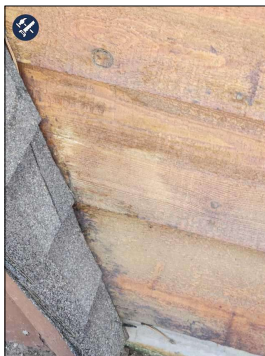
Peeling Finish observed, suggest scraping and Re-Staining as necessary. North Side.

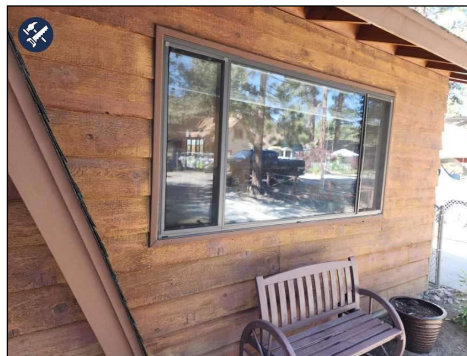
Peeling Finish observed, suggest scraping and Re-Staining as necessary. Most of North Side.

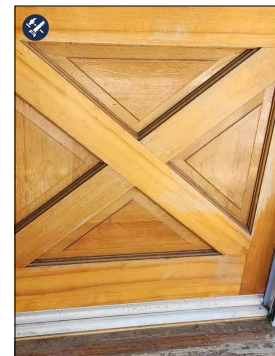
Peeling Finish observed, suggest scraping and Re-Staining as necessary. North Front Entry Door.

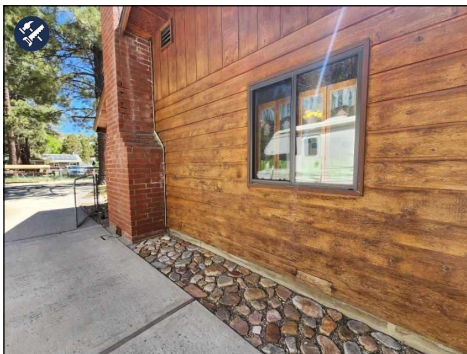
Peeling Finish observed, suggest scraping and Re-Staining as necessary. Most of the West Side.

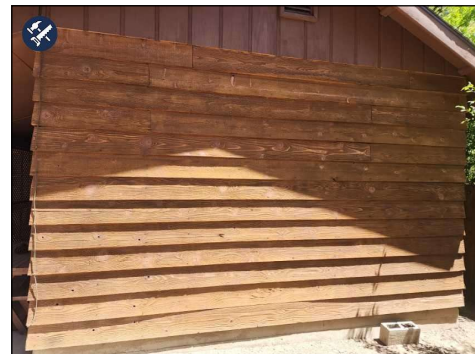
Peeling Finish observed, suggest scraping and Re-Staining as necessary. Most of the South Side.

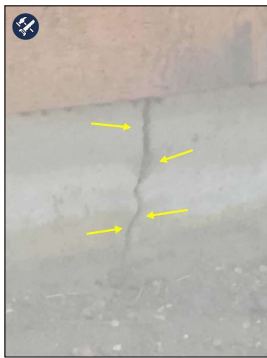
Cracks and deterioration observed. North Side.

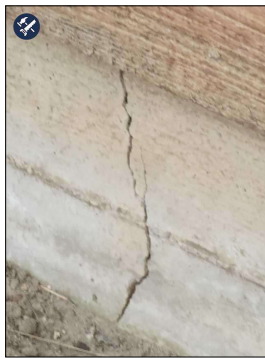
Cracks and deterioration observed. North Side.

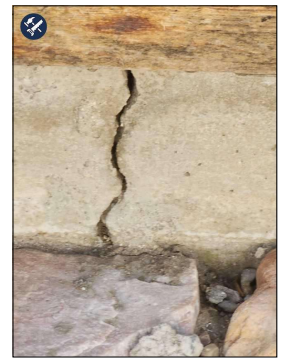
Cracks and deterioration observed. West Side.

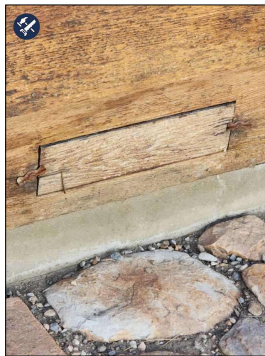
Vent screens noted as blocked. West Side.

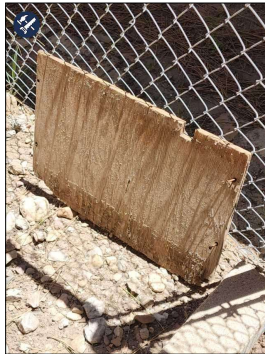
Entry Door is a Riddled piece of Plywood and should be replaced.

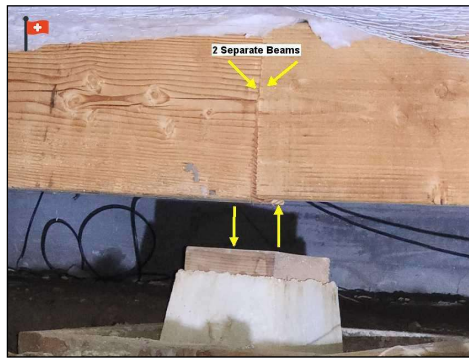
Questionable-Recommend further evaluation by a General Contractor for Answers & Options to this issue if there is one.

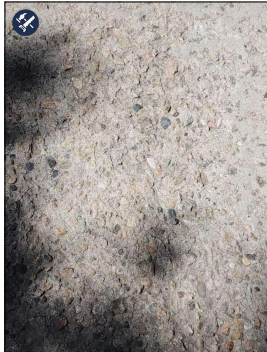
Concrete spalling noted at driveway. This loosening of the top, smooth layer of the cement is a common occurrence, possibly due to an improper curing process, age, or use of snow-melting materials.

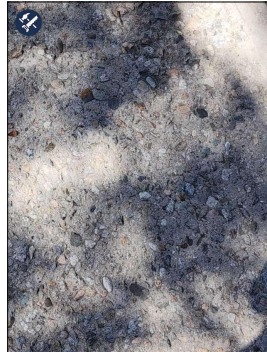
Concrete spalling noted at driveway. This loosening of the top, smooth layer of the cement is a common occurrence, possibly due to an improper curing process, age, or use of snow-melting materials.

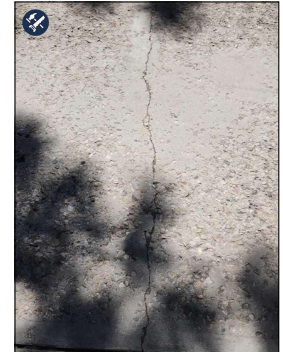
Moderate cracks in driveway. Repair and / or monitor for expansion and development of trip hazards.

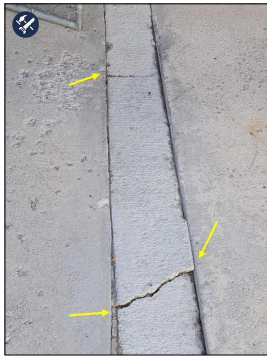
Extensive cracks in driveway. Repair and / or monitor for expansion and development of trip hazards.

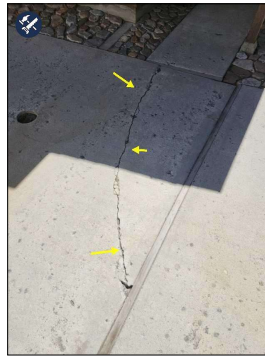
Moderate cracks in driveway. Repair and / or monitor for expansion and development of trip hazards.

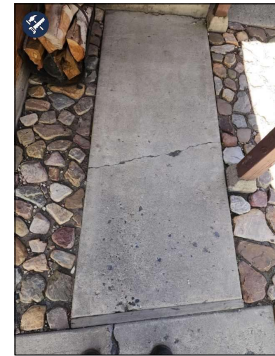
Minor Crack in The Walkway Observed. West Side From Driveway to South Side Back Door.

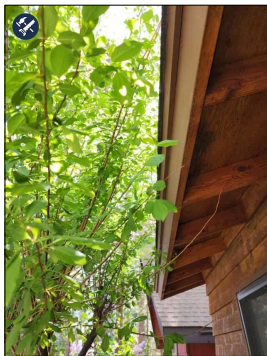
Trim trees that are in contact or proximity to home, as branches can abrade roofing or siding. North Side.

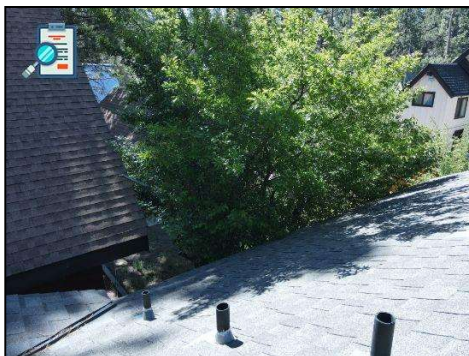
Tree branches overhanging roof and/or against siding. Trim trees that are in contact or proximity to home, as branches can abrade siding and damage roofing.

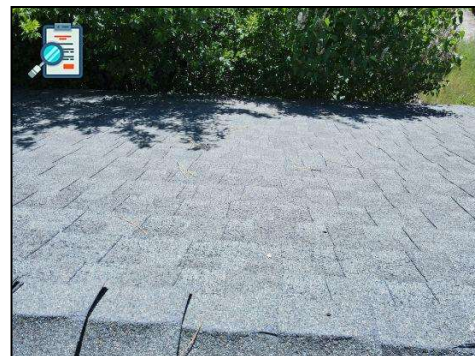
Tree branches overhanging roof and/or against siding. Trim trees that are in contact or proximity to home, as branches can abrade siding and damage roofing.

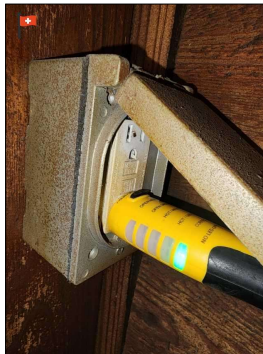
GFCI Receptacle would not Trip When Tested. Made a loud humming sound but no trip. Recommend Replacing Receptacle. South Side Right Side of the Water Heater Closet.

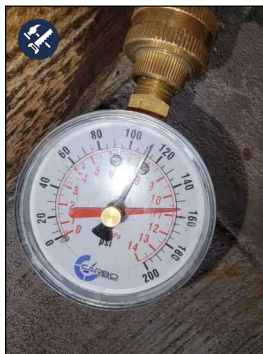
- High pressure.
- 110

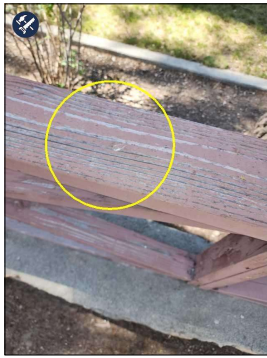
Peeling Paint and Bare Wood Observed. North Side.

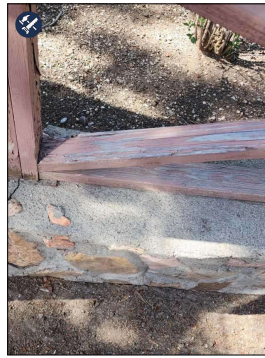
Peeling Paint and Bare Wood Observed. North Side.

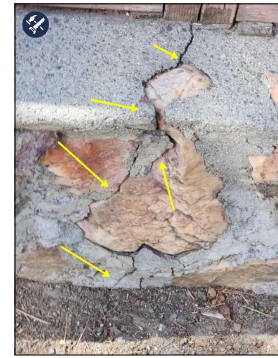
Crack in the Garden Wall Mortar. North Side.

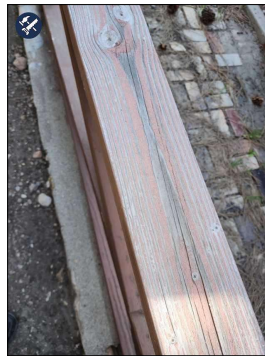
Peeling Paint and Bare Wood Observed. East Side Fencing.

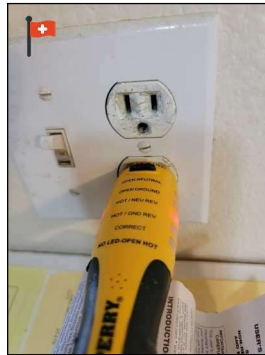
Hot/Neutral Reversed Observed

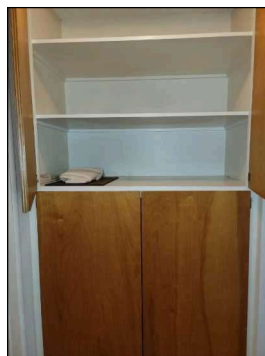
- Appeared functional and in satisfactory condition, at time of inspection.

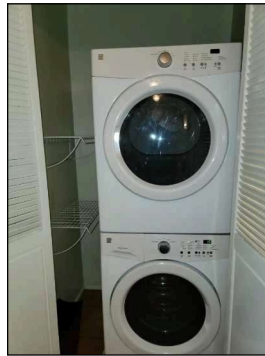
- The closet is in serviceable condition.

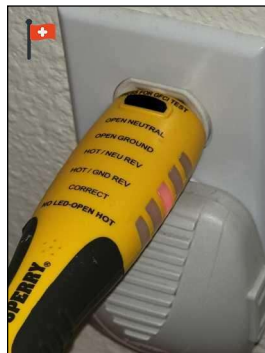
Living Room -Reversed polarity, hot and neutral reversed and other terms used for electric receptacles are usually easily corrected by minor wiring adjustments at the specified item. When these conditions are noted in this report, a licensed electrician should be consulted for repairs/replacement as needed to ensure safety.

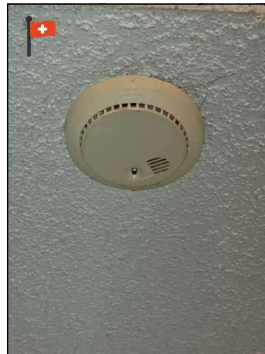
Hallway--Old detectors. Smoke detectors last 6-10 years. Recommend replacing.

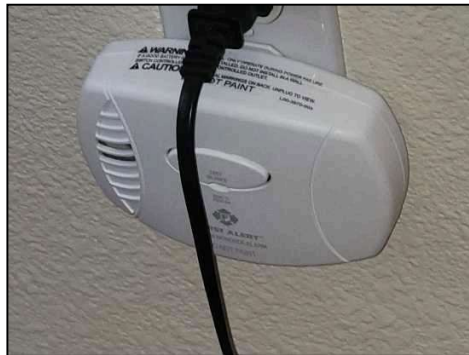
• No Apparent Issues with the Interior CO2 Detector(s)

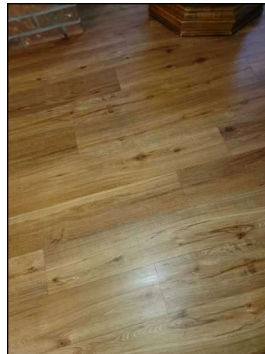
• No Apparent Issues with the Interior Flooring

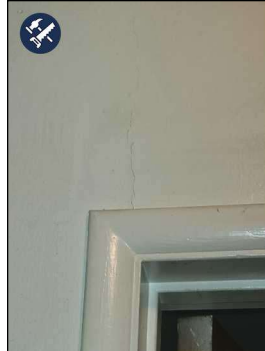
Hallway--Settlement Crack Observed

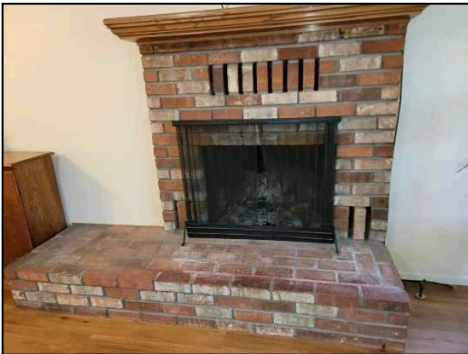
Living Room--Recommend having Fireplace Fully Inspected and Cleaned by a Chimney Specialist Annually

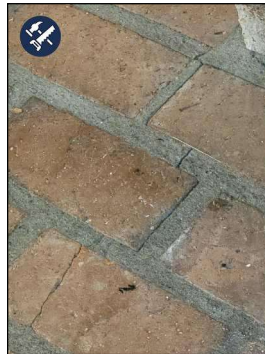
Living Room--Cracked or Deteriorated Mortar Observed in Hearth

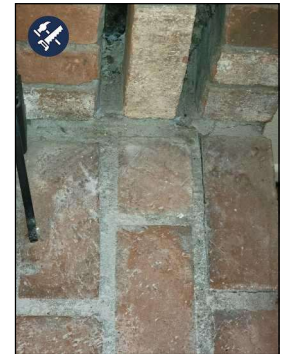
Living Room--Cracked or Deteriorated Mortar Observed in Hearth

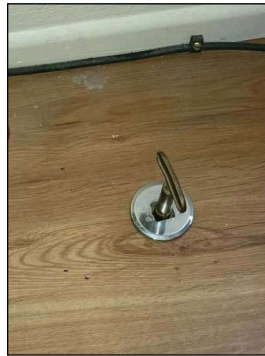
Living Room--Gas Assist Lighting
Noted

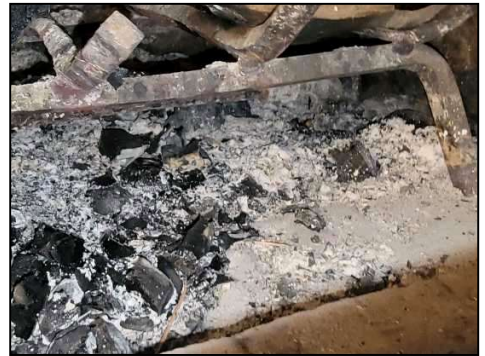
Living Room--Gas Assist Lighting
Noted

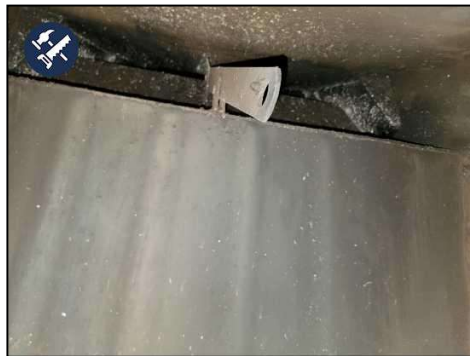
Living Room--Flue Damper is Stuck Open

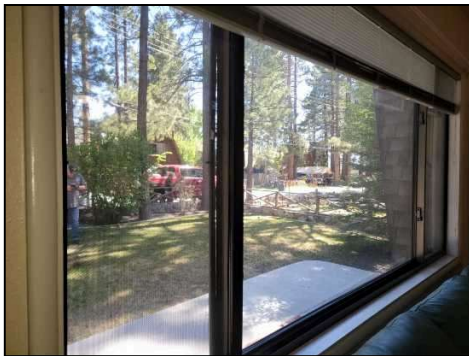
- Cracked Seal Observed around Window Framing

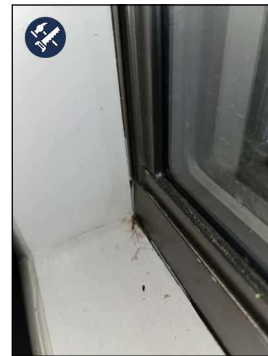
Living Room--Cracked Seal Observed around
Window Framing

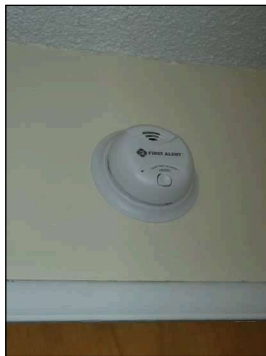
• **Replace all old not functioning smoke/ fire detectors with new hard wired detectors or make sure batteries are good.**

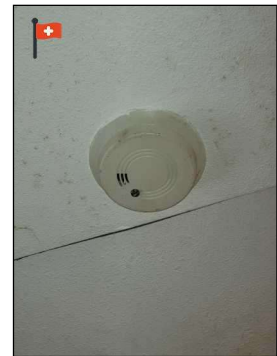
Master Bedroom#1--Replace all old not functioning smoke/ fire detectors with new hard wired detectors or make sure batteries are good.

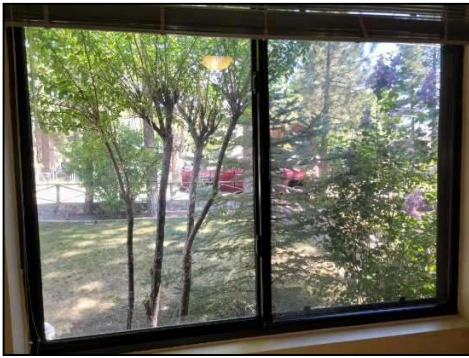
• **Cracked Seal Observed around Window Framing**

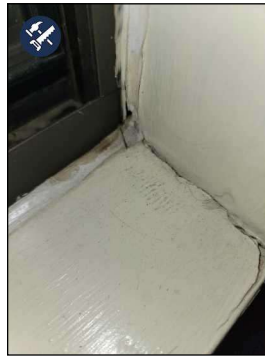
Bedroom#3--Cracked Seal Observed around Window Framing

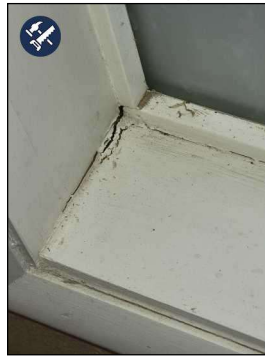
Master Bedroom#1--Deterioration noted due to contact with moisture, repairs needed.

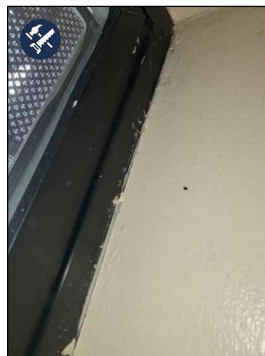
Master Bedroom#1--Cracked Seal Observed around Window Framing

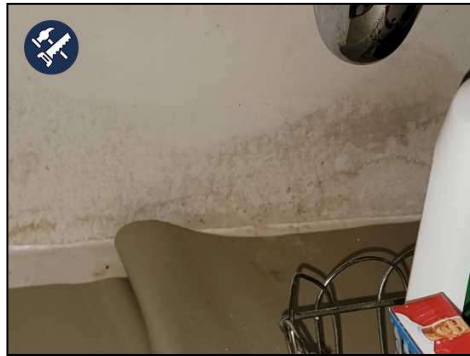
Bathroom#2--There appears to be water damage under sink. This tested dry at the time of the inspection, but monitor for any further intrusion.

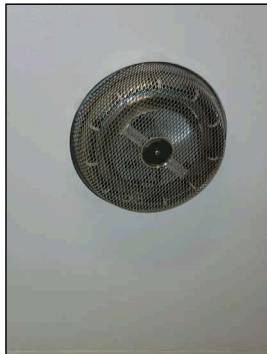
Observations:
• The bath fan was operated and no issues were found.

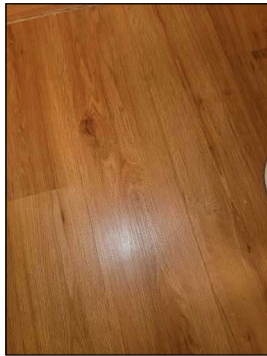
Materials: Sheet vinyl flooring is noted. • Floating laminate type flooring noted.
Observations:
• No Apparent Issues with the Flooring
• Recommend caulking at the tub and shower areas

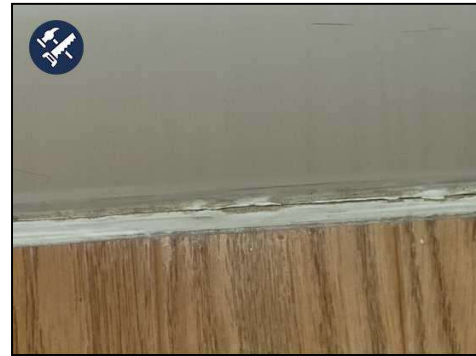
Master Bathroom#1--Recommend caulking at the tub and shower areas

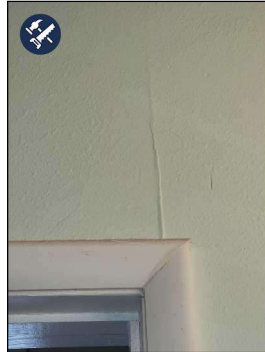
Master Bathroom#1--Small cracking in the wall finish is noted. This is probably caused by the joint compound (spackle) drying too quickly during application.

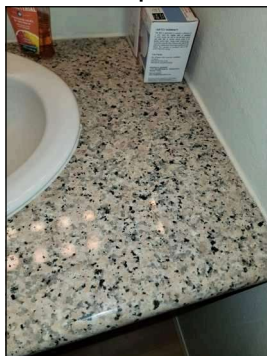
- Solid Surface tops noted.
- Granite tops noted.
- No discrepancies noted.

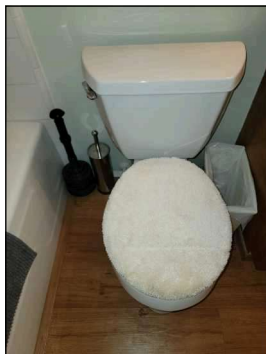
- Observed as functional and in good visual condition.
- Operated when tested. No deficiencies noted.
- Excessive corrosion on water shutoff valve. Valve could leak at any time or may not work properly when used. Recommend further evaluation by licensed plumbing professional.

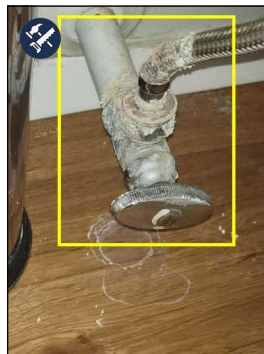
Bathroom#2--Excessive corrosion on water shutoff valve. Valve could leak at any time or may not work properly when used. Recommend further evaluation by licensed plumbing professional.

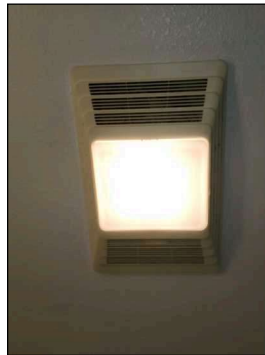
- Electric ceiling mounted heating noted in this room. At the time of the inspection, it appeared to be functioning and in serviceable condition.

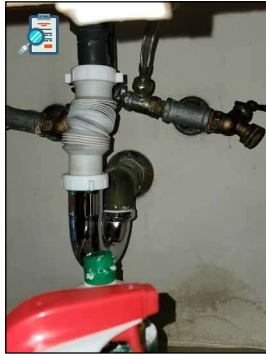
Bathroom#2--Flex drain observed, these are subject to frequent clogging.

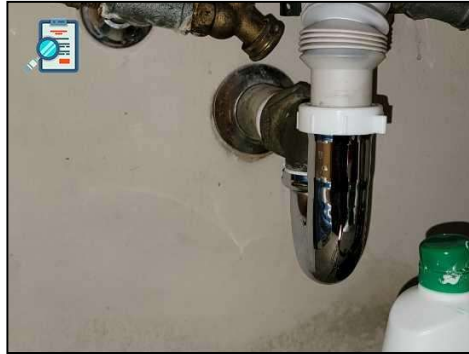
Bathroom#2--Older style metal traps noted. Buyer is cautioned that these traps can leak at any time due to corrosion.

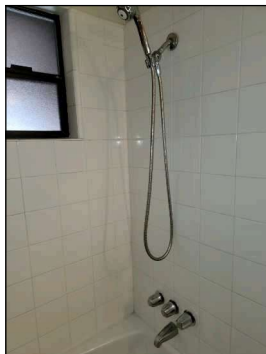
- ****SHOWER BASE****
- functional
- ****SHOWER FAUCET****
- Functional
- Shower diverter does not fully engage.
- Tub Spout leaks while operating

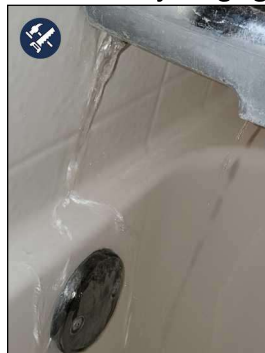
Master Bathroom#1--Tub Spout leaks while operating

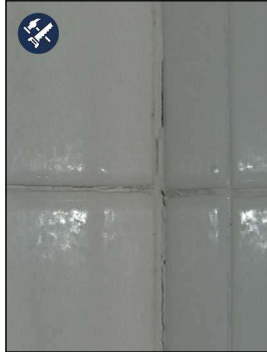
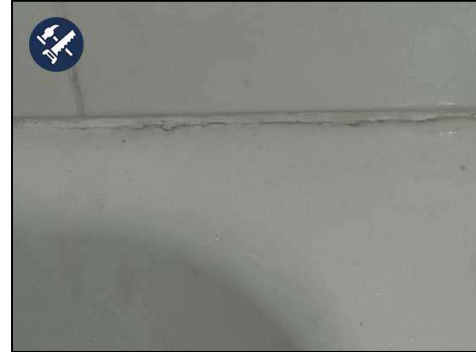
Bathroom#2--Missing/damaged grout observed, suggest regrouting as necessary.

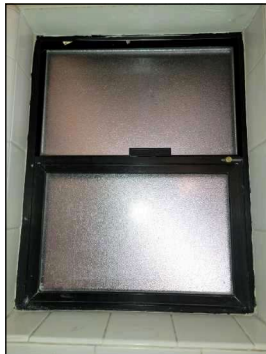
- Cracked Seal Observed around Window Framing

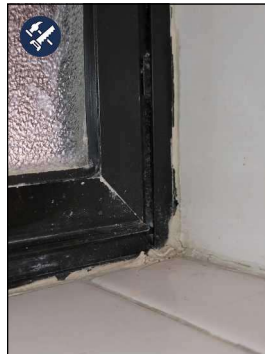
Bathroom#2--Cracked Seal Observed around Window Framing

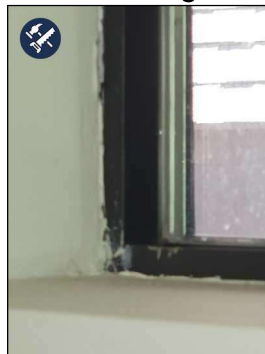
Master Bathroom#1--Cracked Seal Observed around Window Framing

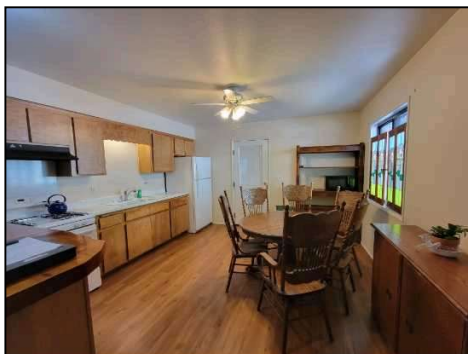
2. Refrigerator Condition

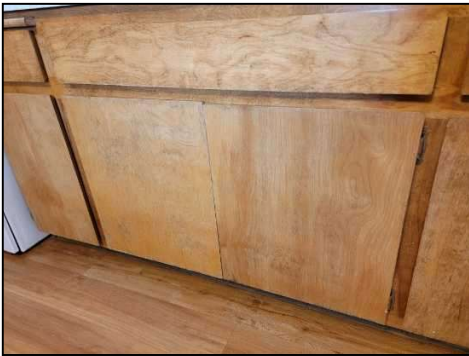
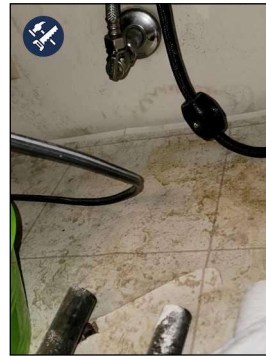
There appears to be water damage under sink. This tested dry at the time of the inspection, but monitor for any further intrusion.

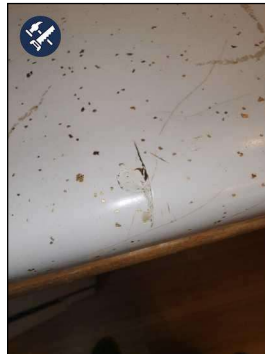
The counter tops are noted as being chipped.

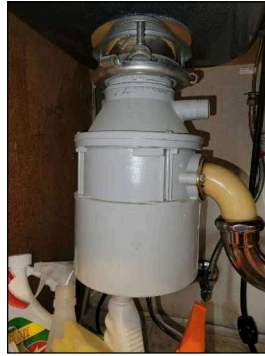
7. Cook top condition

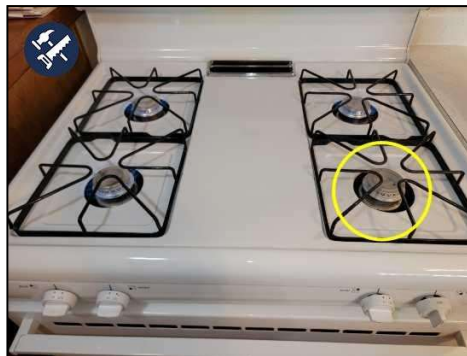
1 burner did not operate properly when tested.

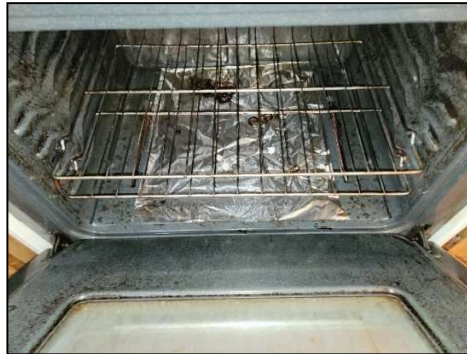
- Oven: gas burners
- All heating elements operated when tested.

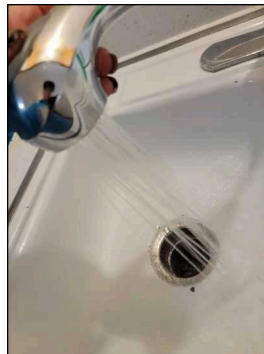
- The spray wand was operated and was functional.

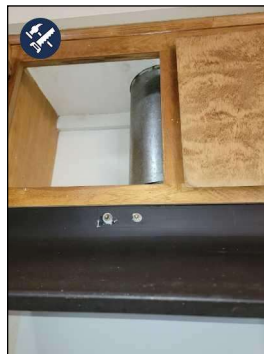
Exhaust fan is noisy.

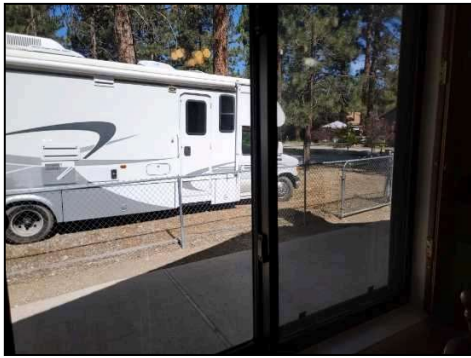
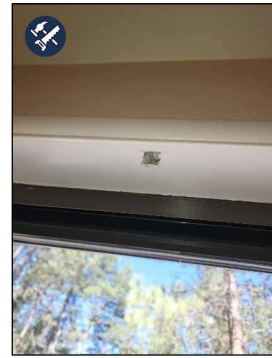
Minor Damage Observed to Window Framing

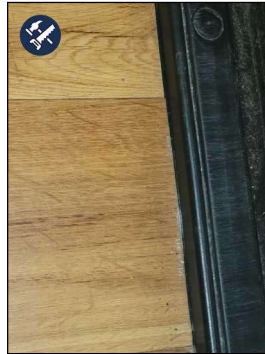
Gap Observed at Threshold, Recommend Sealing to Prevent Moisture Intrusion

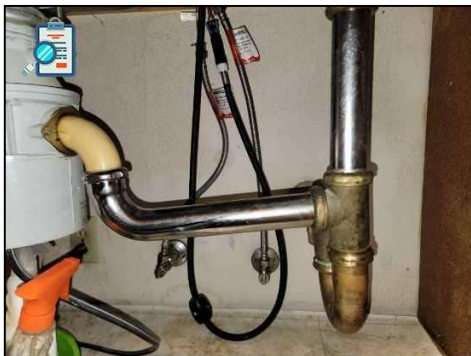
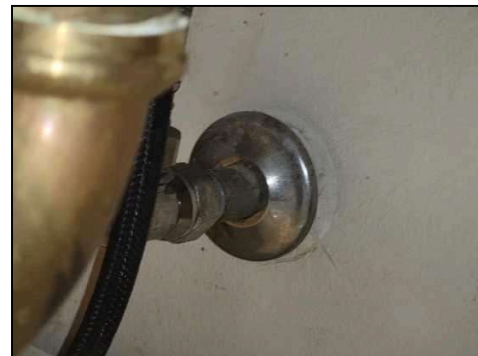
Older style metal traps noted. Buyer is cautioned that these traps can leak at any time due to corrosion.

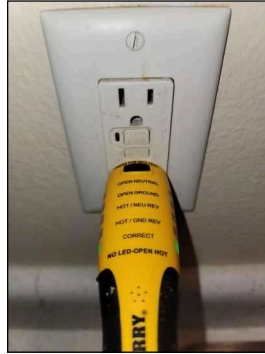
- Observations:
- GFCI in place and operational.

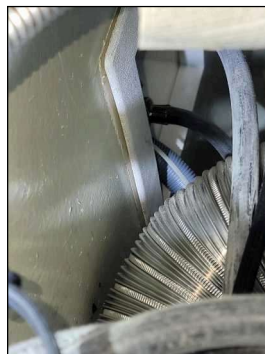
- No Apparent Issues with the Plumbing

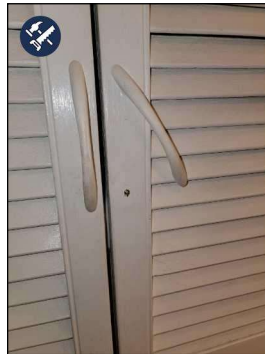
Loose Handle Observed

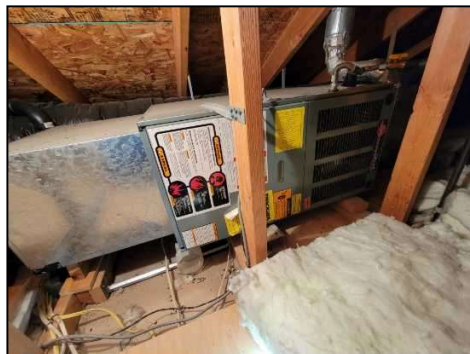
• Fuel Furnace: Last service date is over one year ago, or is unable to be determined. Although this unit appears to be operating properly from controls, there are areas which cannot be seen without specialized equipment and training. One such area is the combustion chamber / heat exchanger where cold air blows across the "fire box", becoming the hot air that circulates throughout your home. During the life span of any furnace, this metal wall may develop a crack or a broken weld, allowing carbon monoxide to circulate throughout the home. This is why furnace specialists recommend a complete inspection annually; consider having unit inspected by certified HVAC technician.

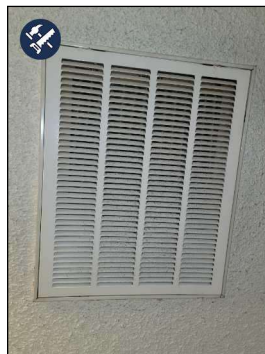
Hallway--The furnace filter is dirty. Filters help clean the house air, making the environment more pleasant. Filters also clean the air before it passes through the blower and heat exchanger. This helps to keep these furnace components working efficiently. It is recommended to change the filter and then regular inspection & maintenance is advised.

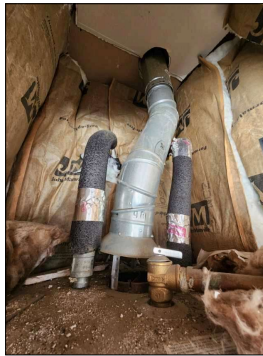
No Apparent Issues with the Venting.

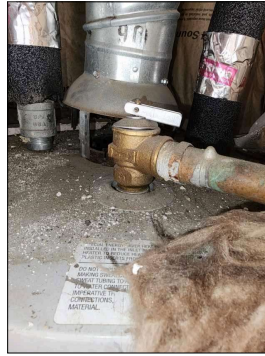
Appears to be in satisfactory condition -- no concerns.

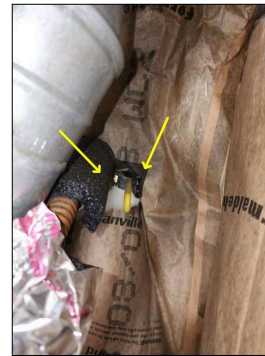
Water Supply Shut Off Valve for the Water Heater.

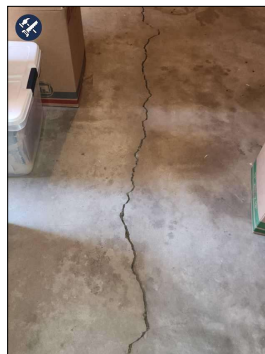
Crack entire Length Down Center Noted.

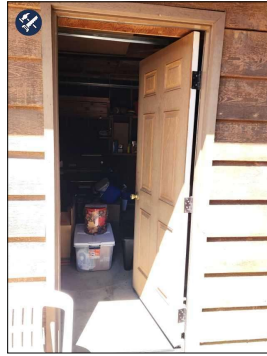
Garage Exterior Door has Peeling Finish and Bare Wood Observed.

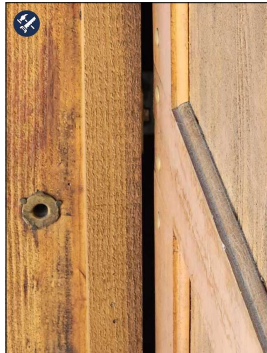
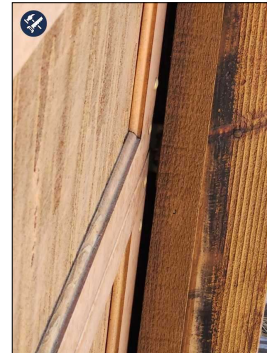
Sides of the Main Garage Door are not Sealed up when Closed. Sides of the Main Garage Door are not Sealed up when Closed.

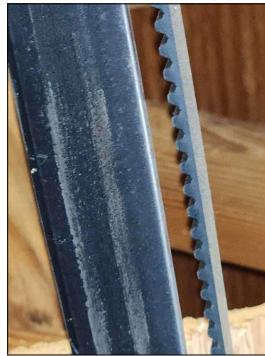
Belt drive opener noted.

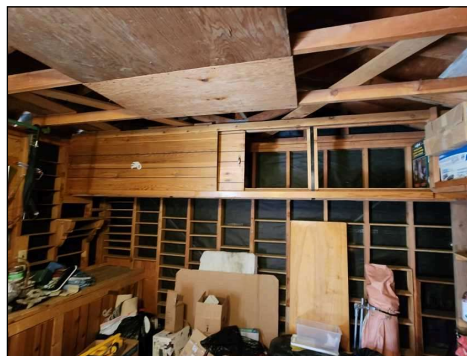
Appeared functional and in satisfactory condition, at time of inspection.

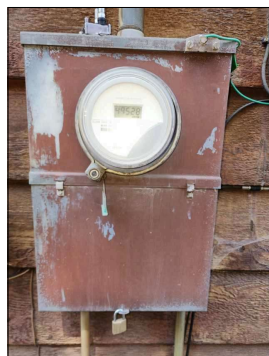
No Apparent Issues with the Electrical Panel. East Side.

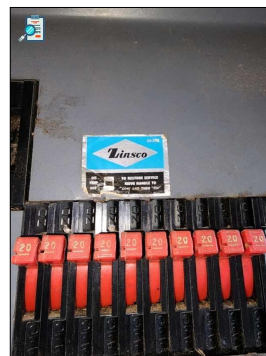
There is a Zinsco service panel present. Zinsco components are prone to problems that can lead to failures, lack of proper protection of circuits and other serious issues, including fire and electrocution. We cannot definitively call this panel defective, but recommend, for your peace of mind, to consult a qualified electrical contractor to get their opinion on this matter. You can learn more about this issue at <http://www.inspect-ny.com/electric/zinsco.htm>

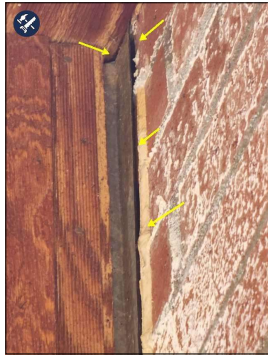
Sealant Between Chimney and the Home is Cracked/Broken or Missing.

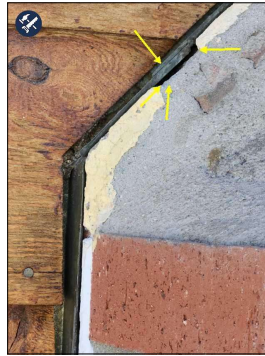
Sealant Between Chimney and the Home is Cracked/Broken or Missing.

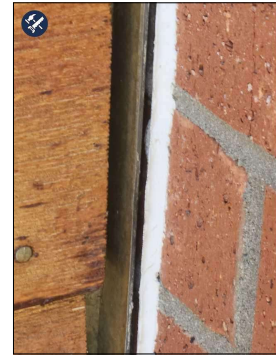
Sealant Between Chimney and the Home is Cracked/Broken or Missing.

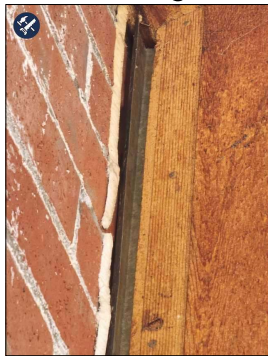
Sealant Between Chimney and the Home is Cracked/Broken or Missing.

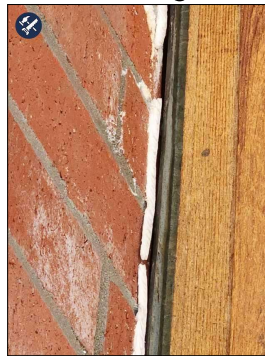
Sealant Between Chimney and the Home is Cracked/Broken or Missing.

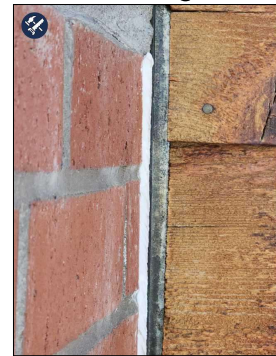
Sealant Between Chimney and the Home is Cracked/Broken or Missing.

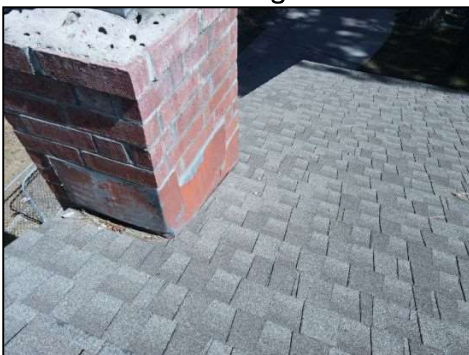
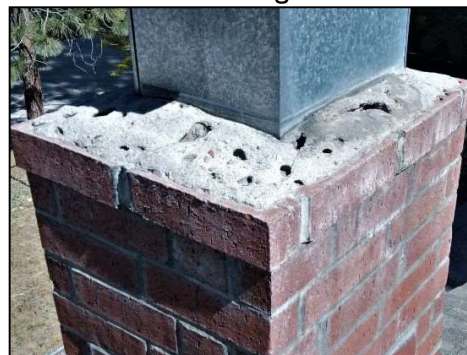
Concrete Crown is all Pitted and Cracked Up. Recommend further evaluation by a Roofing Contractor or Chimney Specialist for Answers & Options to this Issue.

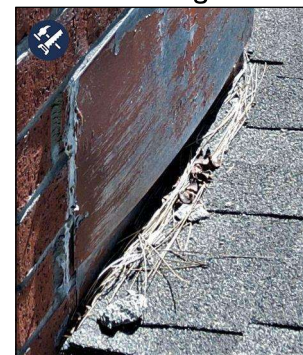
Sealant & Flashing appear compromised Here. Recommend further Evaluation by a Roofing Contractor.

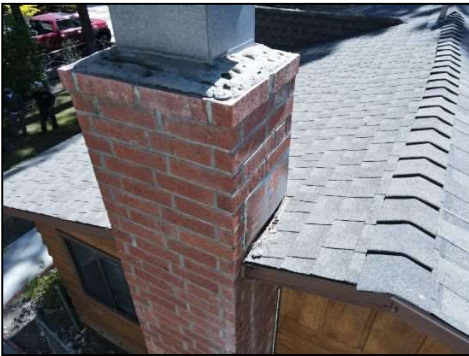
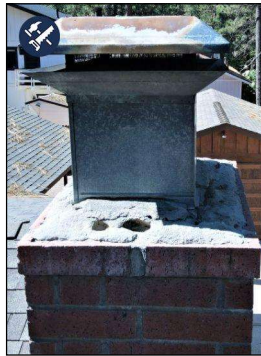
Concrete Crown is Pitted and Cracked.

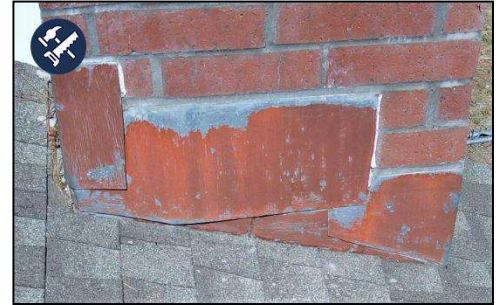
Step Flashing should be completely secured to Chimney.

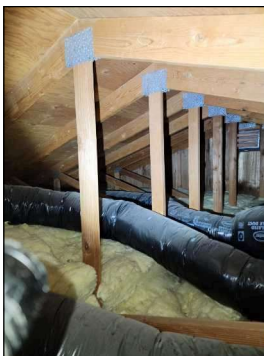
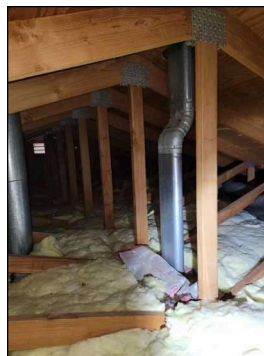
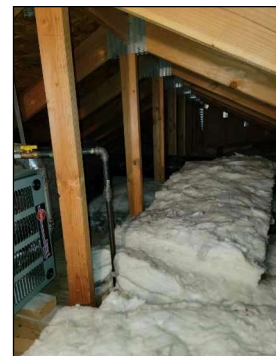
- No Apparent Issues with the Structure
- Evidence of Rodent Activity Observed
