PROPERTY INSPECTION REPORT

**Donald D'Angelo
Big Bear Home Inspectors**

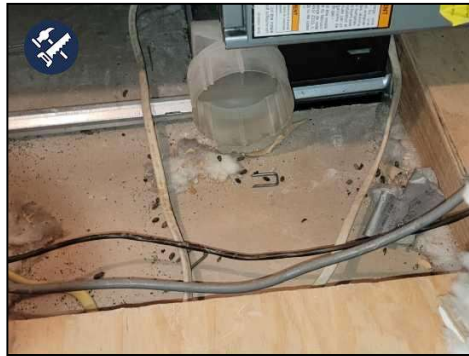
Evidence of Rodent Activity Observed

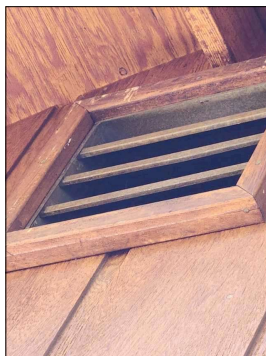
Vent screens noted as functional.
East Side.

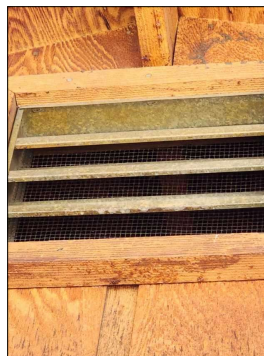
Vent screens noted as functional.
West Side.

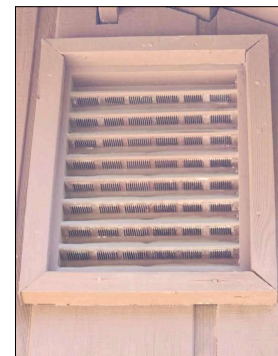
Vent screens noted as functional.
South Side.

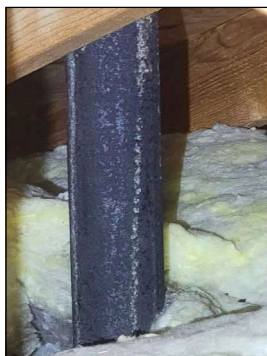
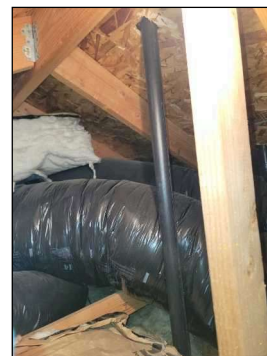
8. Insulation Condition

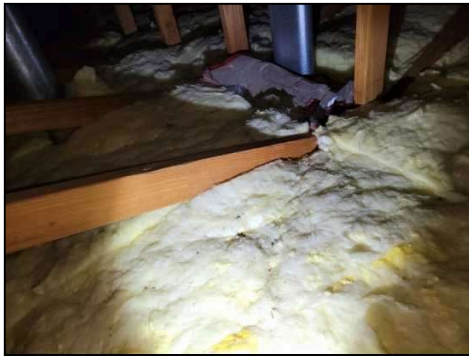
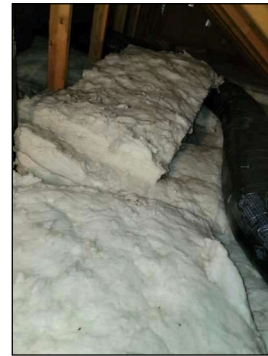
Materials: Encapsulated fiberglass batts noted.
Depth: Insulation averages about 8-10 inches in depth
Observations:
• No Apparent Issues with the Insulation

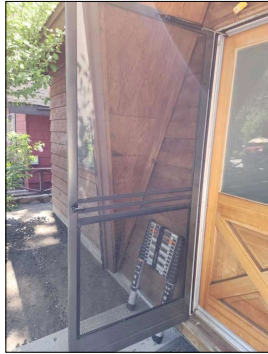
Appeared in functional and in satisfactory condition, at time of inspection. North or Front Side Entry Screen Door.

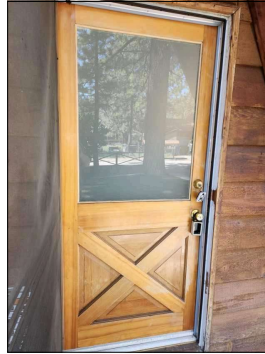
Appeared in functional and in satisfactory condition, at time of inspection. North Side Front Entry Door.

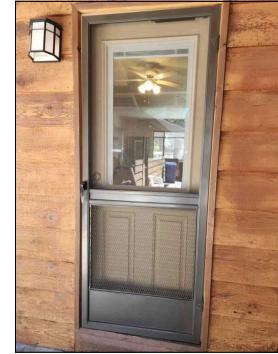
Appeared in functional and in satisfactory condition, at time of inspection. South Side Entry Screen Door.

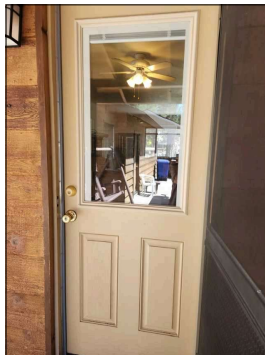
Appeared in functional and in satisfactory condition, at time of inspection. South Side Entry Door.

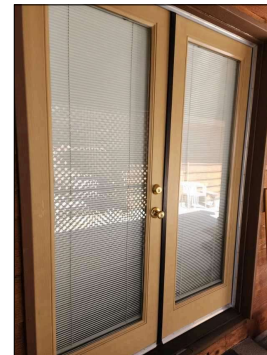
Appeared in functional and in satisfactory condition, at time of inspection. West Side.

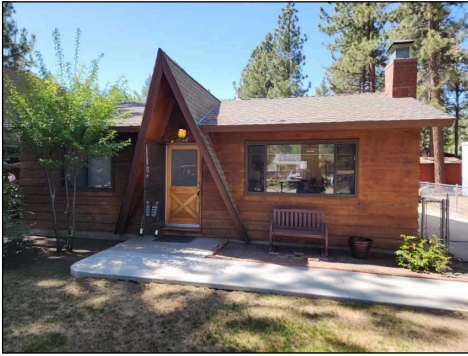
- **Siding-Soil contact or proximity. This may provide entrance of moisture or insects to siding. Recommend grading soil so there is at least 6" of space (where practical) between the siding and the soil below and checking for any damaged trim and siding materials.**

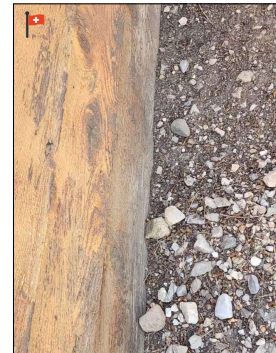
Siding-Soil contact or proximity. This may provide entrance of moisture or insects to siding. Recommend grading soil so there is at least 6" of space (where practical) between the siding and the soil below and checking for any damaged trim and siding materials. West Side of the Garage.

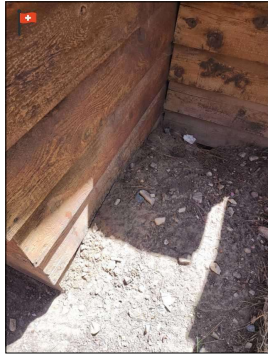
Siding-Soil contact or proximity. This may provide entrance of moisture or insects to siding. Recommend grading soil so there is at least 6" of space (where practical) between the siding and the soil below and checking for any damaged trim and siding materials. South Side of the Garage.

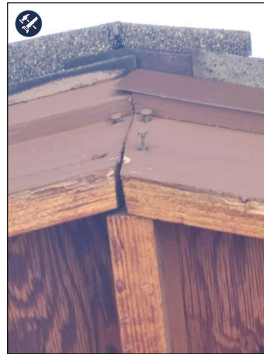
Nail Observed coming out of the Fascia Board. West Side. Another Observation, Drip Edge Flashing is only installed on the Center Sides to South Side Roofing Only!

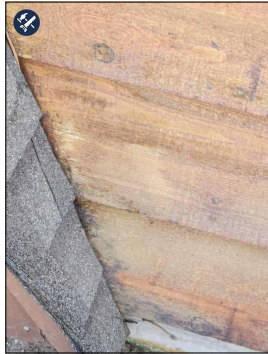
Peeling Finish observed, suggest scraping and Re-Staining as necessary. North Side.

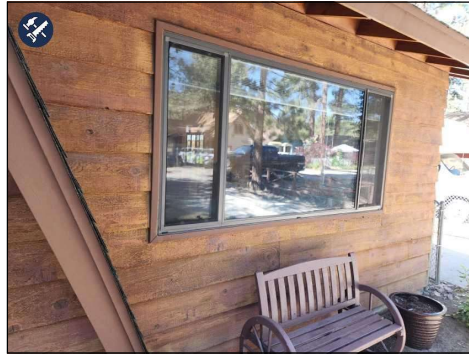
Peeling Finish observed, suggest scraping and Re-Staining as necessary. Most of North Side.

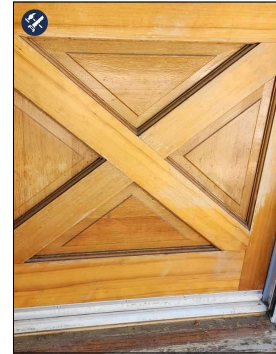
Peeling Finish observed, suggest scraping and Re-Staining as necessary. North Front Entry Door.

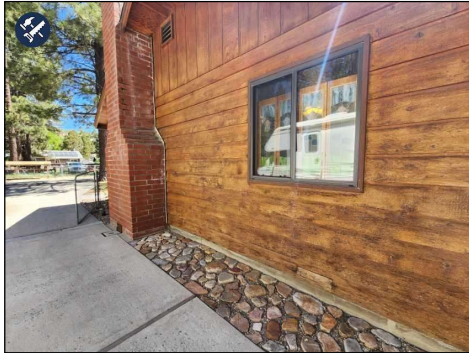
Peeling Finish observed, suggest scraping and Re-Staining as necessary. Most of the West Side.

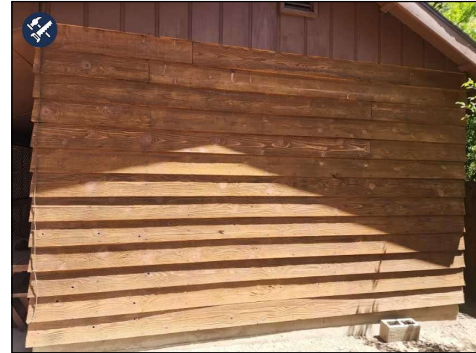
Peeling Finish observed, suggest scraping and Re-Staining as necessary. Most of the South Side.

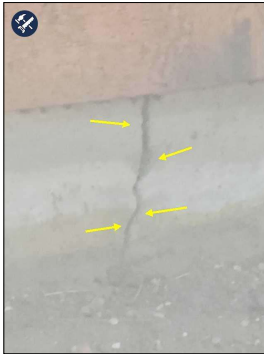
Cracks and deterioration observed. North Side.

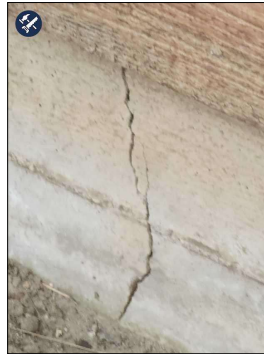
Cracks and deterioration observed. North Side.

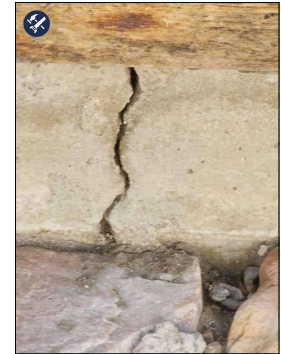
Cracks and deterioration observed. West Side.

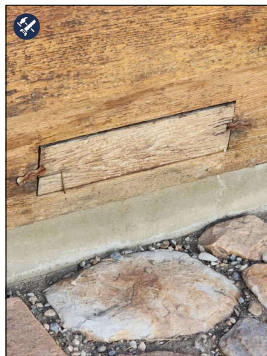
Vent screens noted as blocked. West Side.

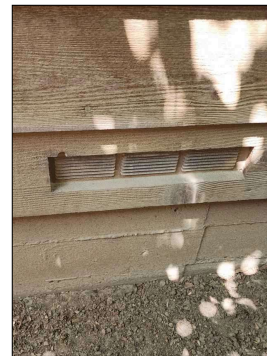
Vent screens noted as functional. East Side.

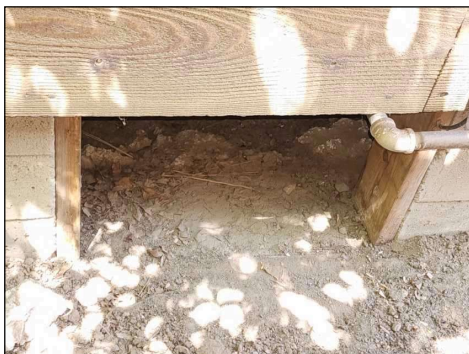
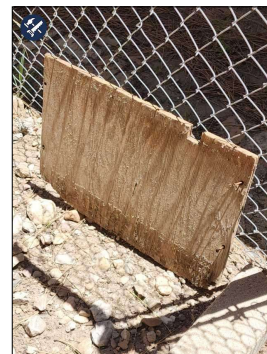
Entry Door is a Riddled piece of Plywood and should be replaced.

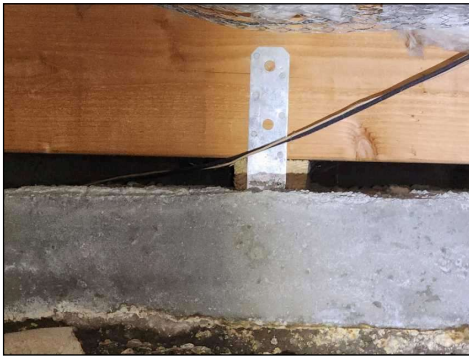
Concrete block/wood piers support floor above.

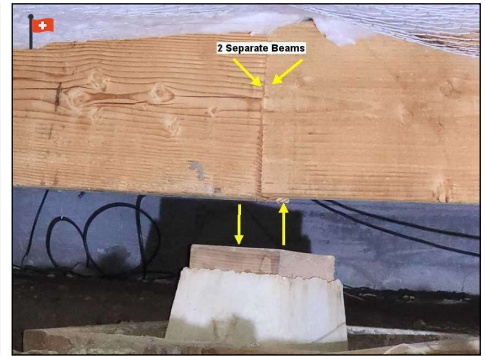
Questionable-Recommend further evaluation by a General Contractor for Answers & Options to this issue if there is one.

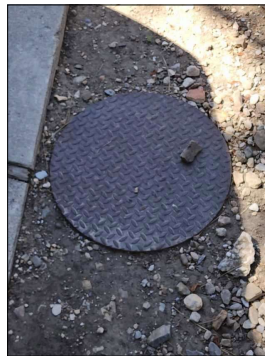
No Apparent Issues with the City Main Water Valve. Northwest Corner of the property Right of the Driveway.

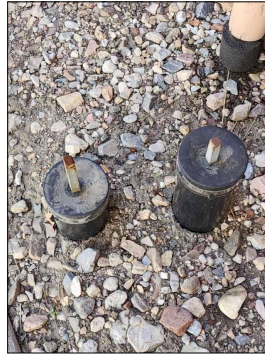
Multiple Stop & Waste Valves all working Correctly.

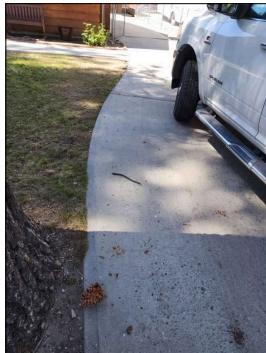
North Side Concrete Driveway.

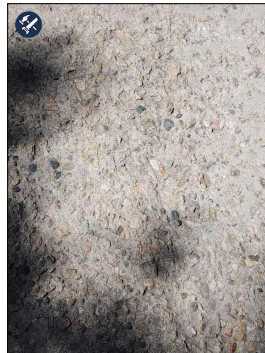
Concrete spalling noted at driveway. This loosening of the top, smooth layer of the cement is a common occurrence, possibly due to an improper curing process, age, or use of snow-melting materials.

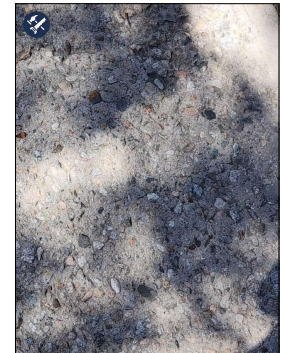
Concrete spalling noted at driveway. This loosening of the top, smooth layer of the cement is a common occurrence, possibly due to an improper curing process, age, or use of snow-melting materials.

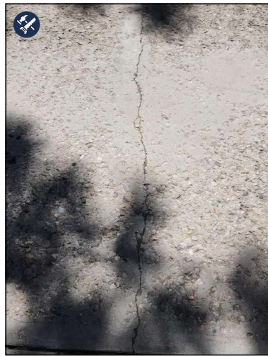
Moderate cracks in driveway. Repair and / or monitor for expansion and development of trip hazards.

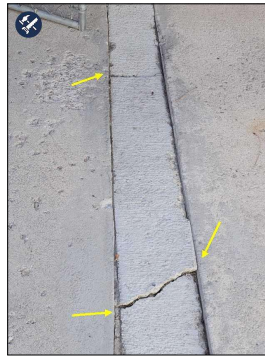
Extensive cracks in driveway. Repair and / or monitor for expansion and development of trip hazards.

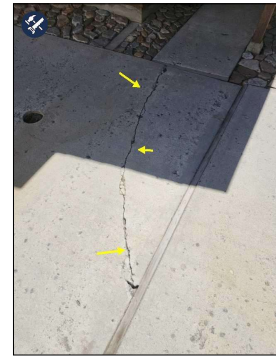
Moderate cracks in driveway. Repair and / or monitor for expansion and development of trip hazards.

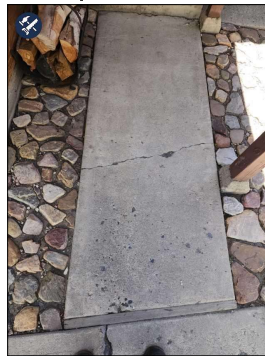
Minor Crack in The Walkway Observed. West Side From Driveway to South Side Back Door.

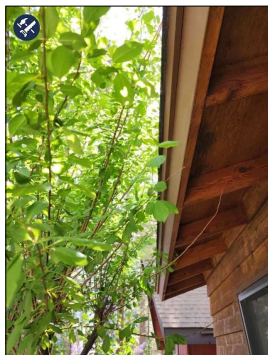
Trim trees that are in contact or proximity to home, as branches can abrade roofing or siding. North Side.

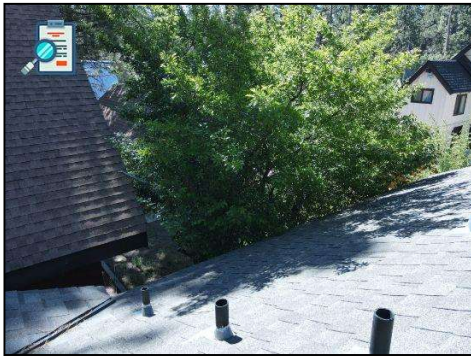
Tree branches overhanging roof and/or against siding. Trim trees that are in contact or proximity to home, as branches can abrade siding and damage roofing.

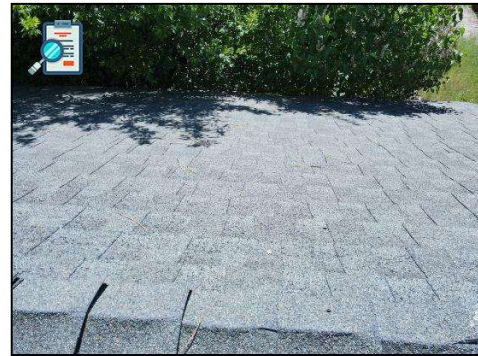
Tree branches overhanging roof and/or against siding. Trim trees that are in contact or proximity to home, as branches can abrade siding and damage roofing.

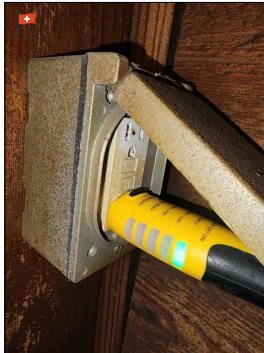
GFCI Receptacle would not Trip When Tested. Made a loud humming sound but no trip. Recommend Replacing Receptacle. South Side Right Side of the Water Heater Closet.

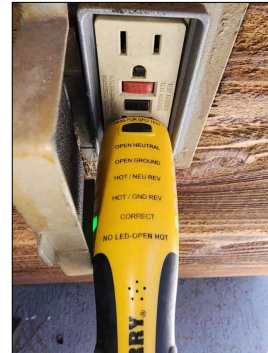
GFCI receptacles are in good condition. Southwest Corner of the Home.

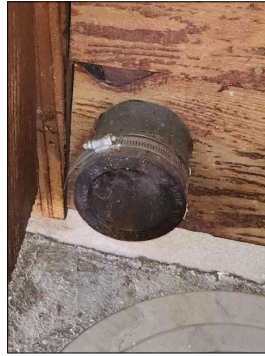
The Clean Out was Observed. South Side Right of Water Heater Closet.

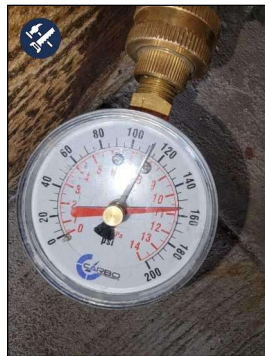
- Observations:
- Recommend 40-60 psi
 - High pressure.
 - 110

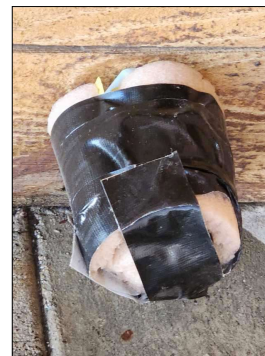
Appears Functional. South Side.

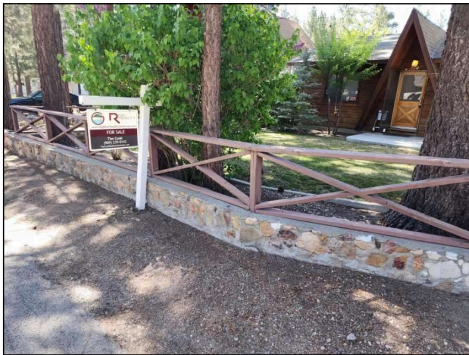
No Apparent Issues with the Fencing. North Side.

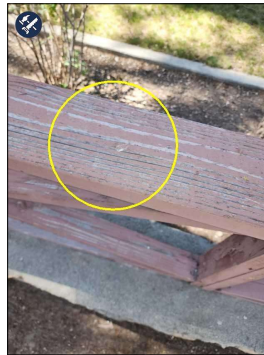
Peeling Paint and Bare Wood Observed. North Side.

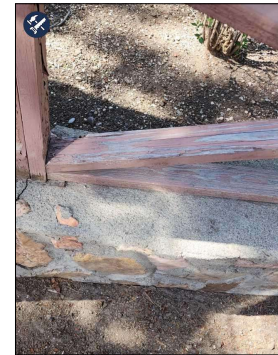
Peeling Paint and Bare Wood Observed. North Side.

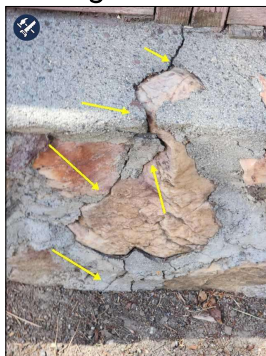
Crack in the Garden Wall Mortar. North Side.

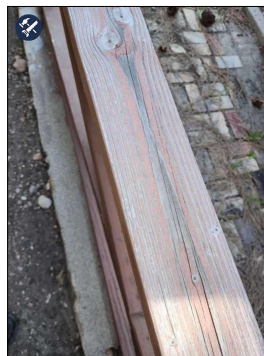
Peeling Paint and Bare Wood Observed. East Side Fencing.

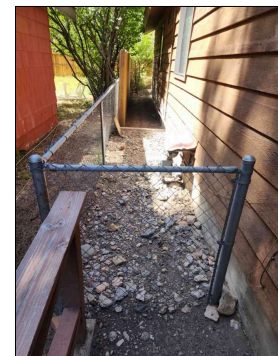
Beginning of Chain Link Fencing. No Gate on East Side.

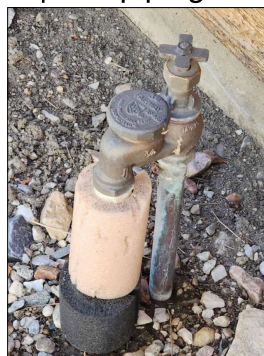
Home is equipped with an underground sprinkler system. The inspector recommends client consult with home owner for operation instructions and proper winterizing information. Sprinkler systems are beyond the scope of a Home Inspection, due to most of its parts/piping not visible for inspection.
West Side.

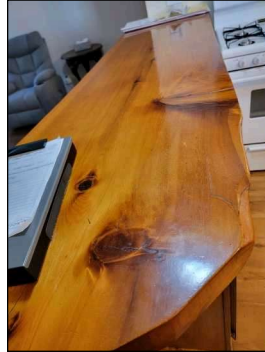
2. Breakfast Bar Electrical Condition

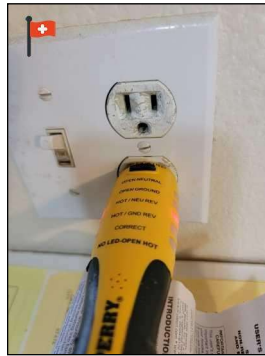
Hot/Neutral Reversed Observed
