Kennedy Watershed Restoration Project

Staghorn, Kootowis, Sandhill, Twin Rivers and Lost Shoe Creeks

Summer Completion Report

For the Central Westcoast Forest Society

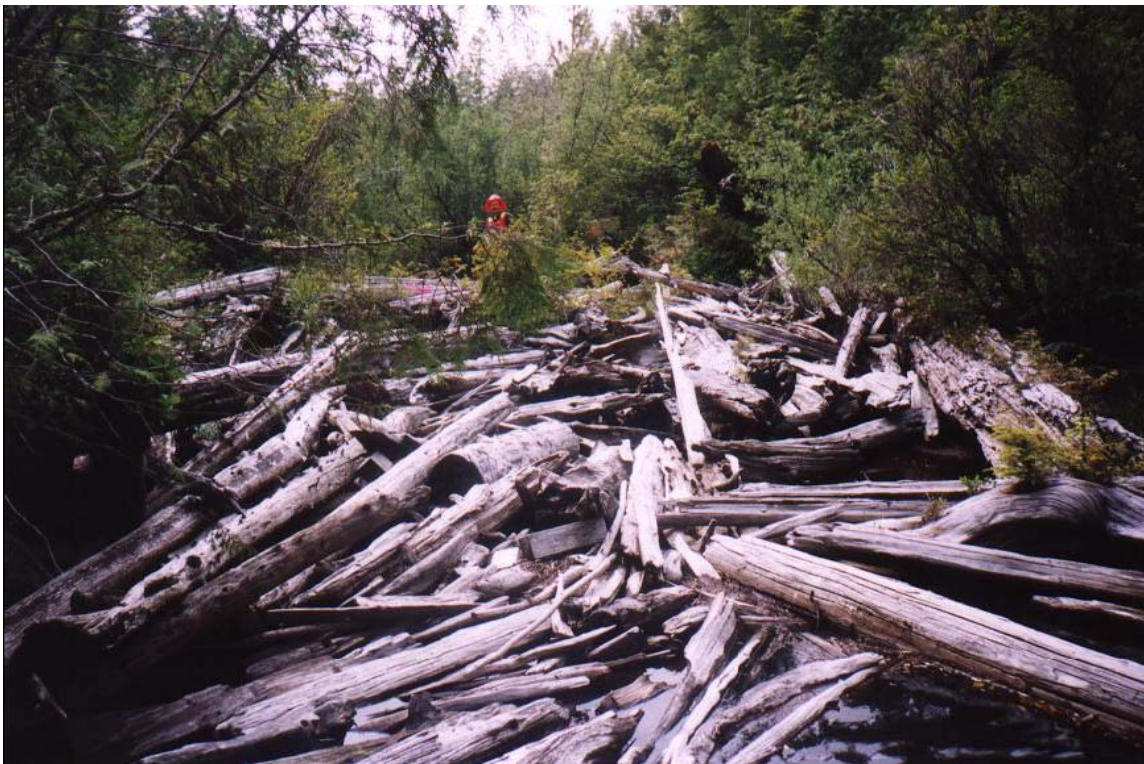
Figure 4.) Debris Jam in Lost Shoe Creek.

In many cases the debris jams also blocked or impaired adult and juvenile salmon movement. These artificially created jams have resisted natural restoration processes (decay, blow outs) as the creeks are generally very low energy and the debris consists mainly of western red cedar (*Thuja plicata* Donn.), which is very decay resistant. A comparison of current conditions with air photos taken in the 1980's clearly shows individual logs within un-restored jams that have not moved since that time. The severity and frequency of jams, along with the slow natural recovery, has made LWD and SWD restoration necessary in many reaches. The addition of spawning gravel may also be necessary. In many of the KWRP streams, gravel was removed and used for road construction, leading to gravel deficiency (R. Redhead, pers. comm.).

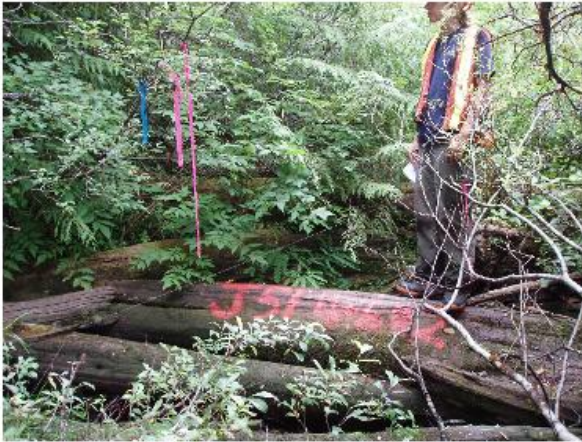
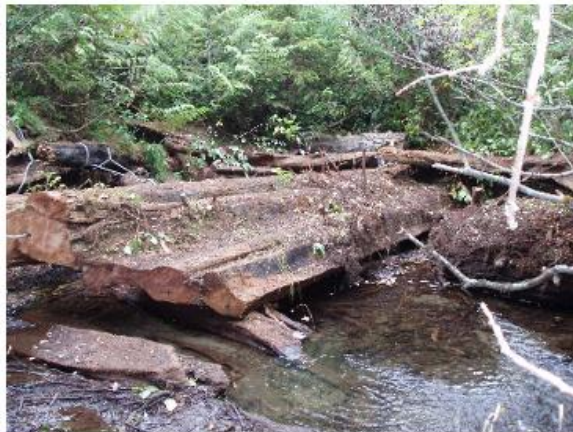
braided and wide, with low banks and a series of significant debris jams. The jams were causing back eddies and segmented pools; at higher flows the jams were causing stream diversion into the flood plain resulting in drying summer pools during low flow periods, trapping fish.

1.) Jam 51- 4+635m before.

2.) Jam 51 - 4+635m after.

In accordance with the Standard Operation Procedures for in-stream work (see Appendix I) non-embedded SWD was removed first. Since the banks are especially low in this area, all SWD was relocated well beyond the extent of the stream flood plain. An estimated 238.5 m³ of SWD was removed from this 230 m stretch of LS4. Following the SWD removal phase, the crew worked to reposition and anchor 208 pieces of LWD into functional in-stream structures. At several jams, such as station 4+662m, LWD was removed from the centre of the creek and anchored along the banks so as to delineate the thalweg, directing the flow of the stream and preventing further flooding of the surrounding riparian area. At station 4+707m the crew hand excavated a 200 m long channel and removed approximately 1.5 m³ of soil to connect a significant river right bank side channel. This work should reduce flooding of the West Main Road and improve fish passage at lower flows. Where LWD was not present (i.e. station 4+857m and station 4+865m) logs from a deactivated bridge were brought in; and from these logs in-stream A-frame structures were constructed. The crew also helped with the removal and proper disposal of 15 creosote logs that were found at the edge of the stream bank.

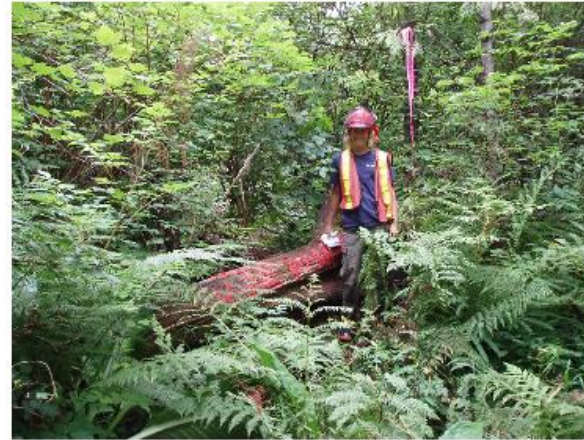
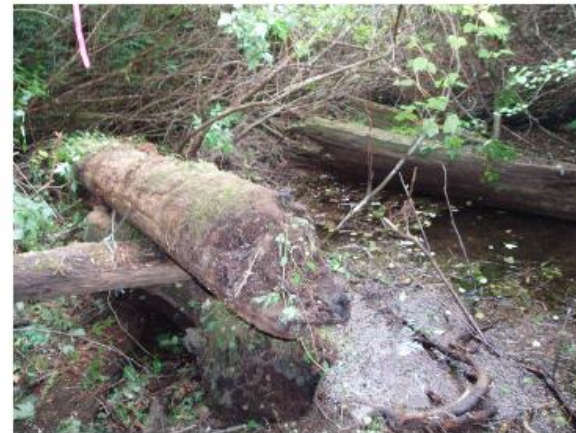
3.) Jam 52 - 4+682m before.

4.) Jam 52 - 4+682m after.

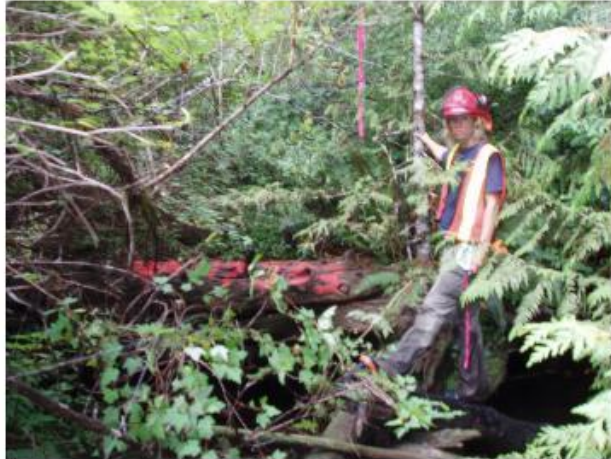
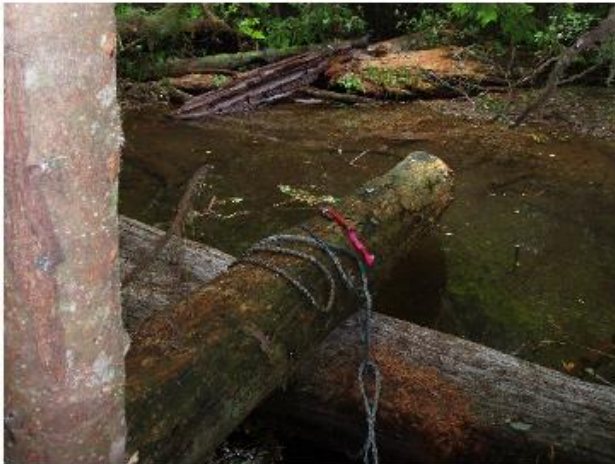
5.) Jam 53 - 4+717m before.

6.) Jam 53 - 4+717m after.

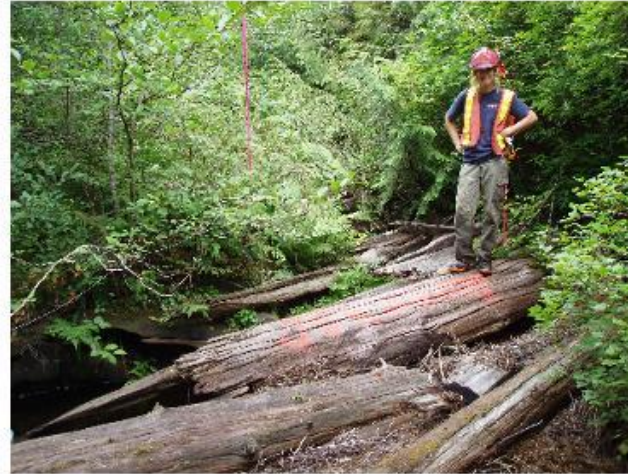
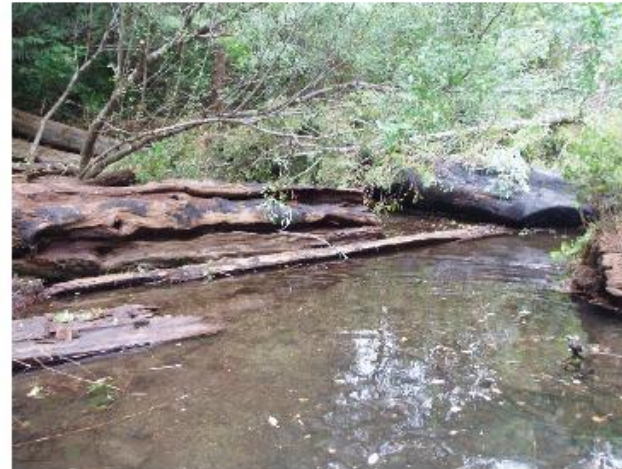
7.) Jam 54 - 4+722m before.

8.) Jam 54- 4+722 m after.

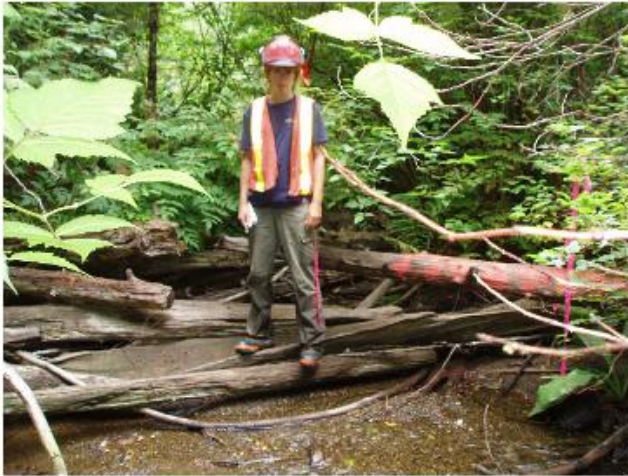
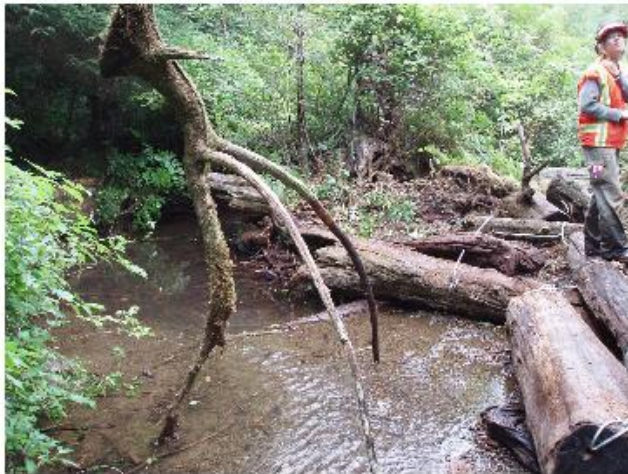
9.) Jam 55 - 4+795m before.

10.) Jam 55 - 4+795m after.

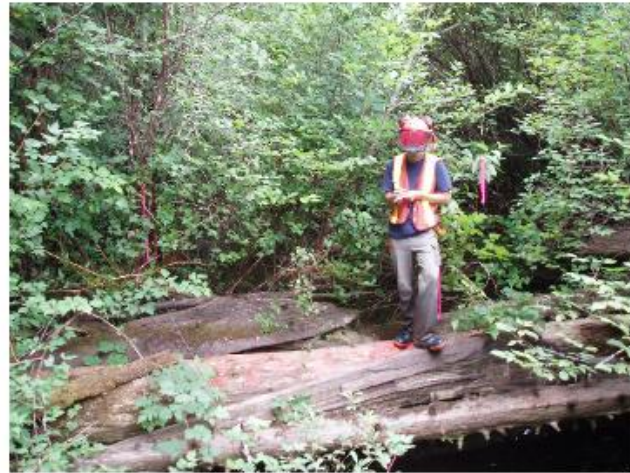
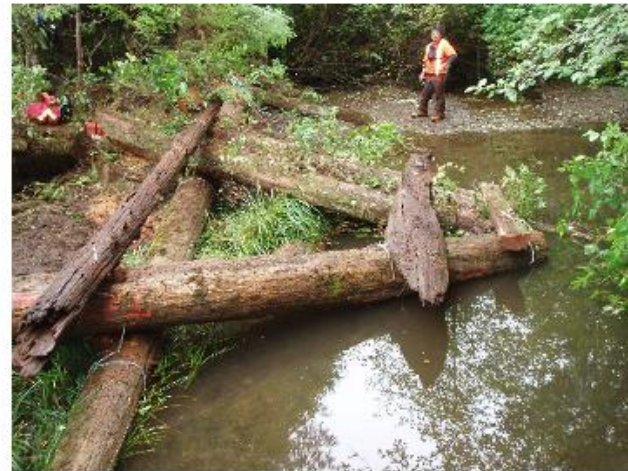
11.) Jam 56 - 4+813m before.

12.) Jam 56 - 4+813m after.

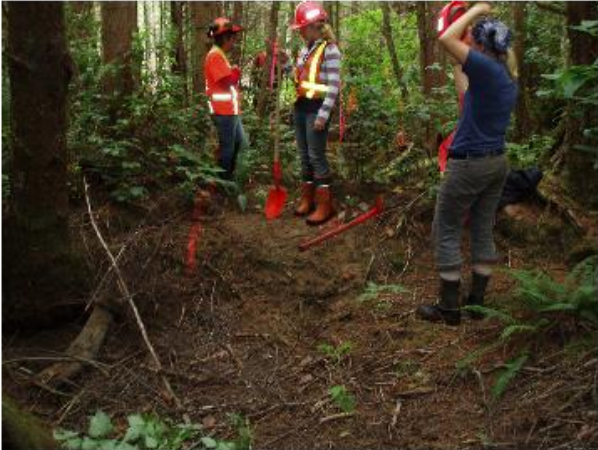
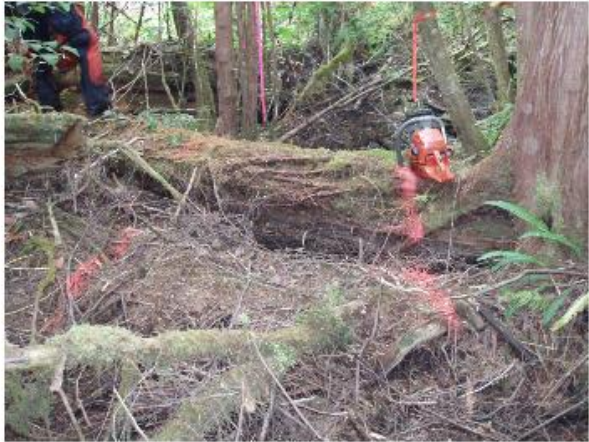
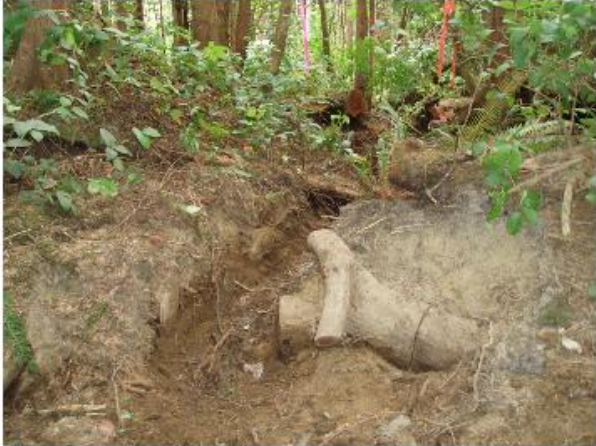
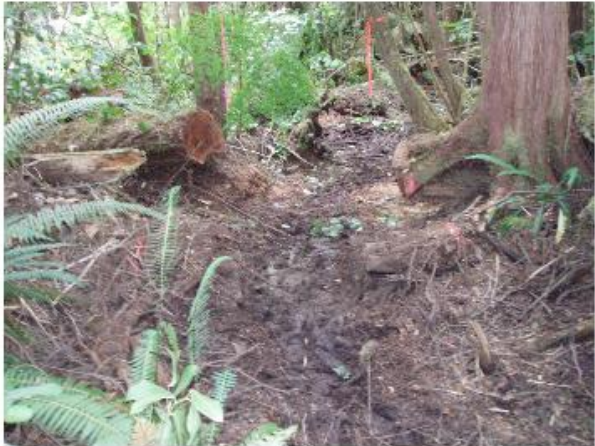
13.) Sidechannel - before.

15.) Sidechannel - before.

14.) Sidechannel - after.

16.) Sidechannel - after.
