FINAL FUNCTIONAL ASSESSMENT OF THE UPPER WABASH RIVER

Upper Wabash River Basin Commission

February 2019

Christopher B. Burke Engineering, LLC 115 West Washington Street, Suite 1368 South Indianapolis, Indiana 46204

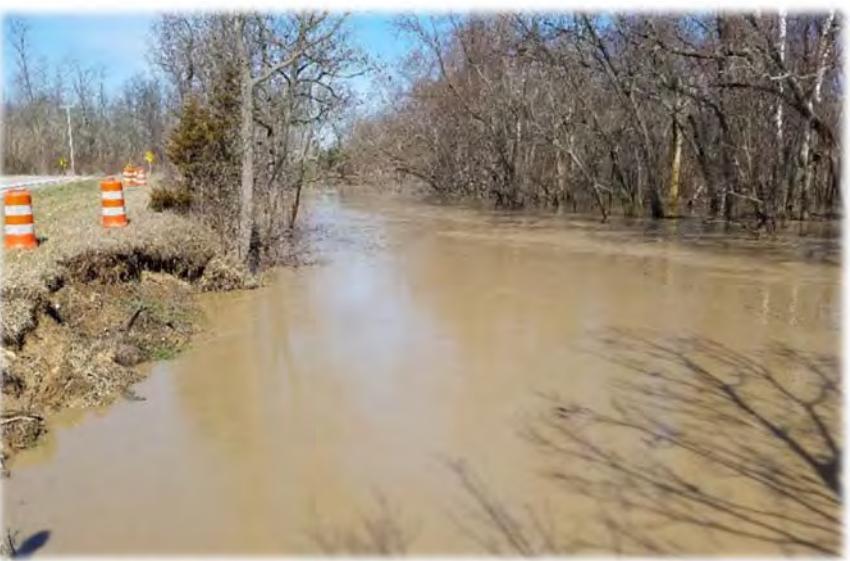
Figure 1: Stream Bank near State Road 116

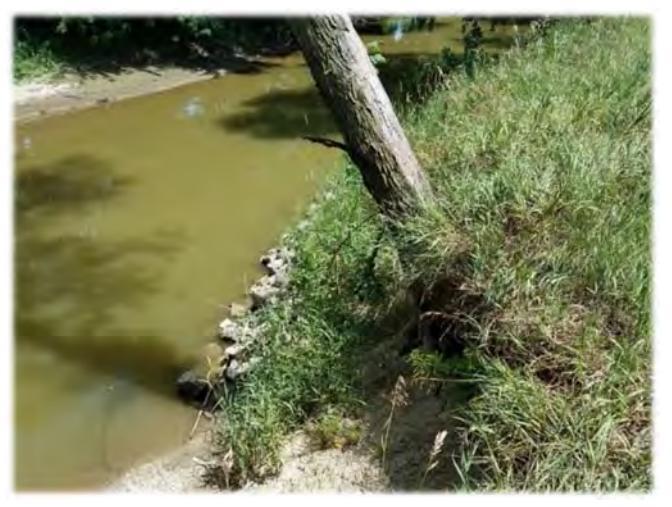
The upstream-most problem area identified is located at 4100 East County Road 1200 South east of County Road 400 East in Adams County. The problem area instability includes slope failure along the left bank of the channel (along the road) for approximately 800 feet (Barr, 2018). The instability is caused by its location on the outside of a meander bend and more frequent saturation of soils due to increased flow rates and highflow frequency. Emergency repairs have been made and consist of riprap placed in the channel but not along the upper portion of the slope, as shown in Figure 9.

Figure 9: Emergency Riprap Repair at 4100 E CR 1200 S

Failed, over-steepened, and undermined banks are unstable due to an inability to support the weight of the soil forming the bank. Where banks suffer from this type of geotechnical instability, a simple and cost-effective means of correcting the issue is to reduce the slope to a more stable angle, typically in the range of 3-feet horizontal to 1-foot vertical (3H:1V), or flatter.

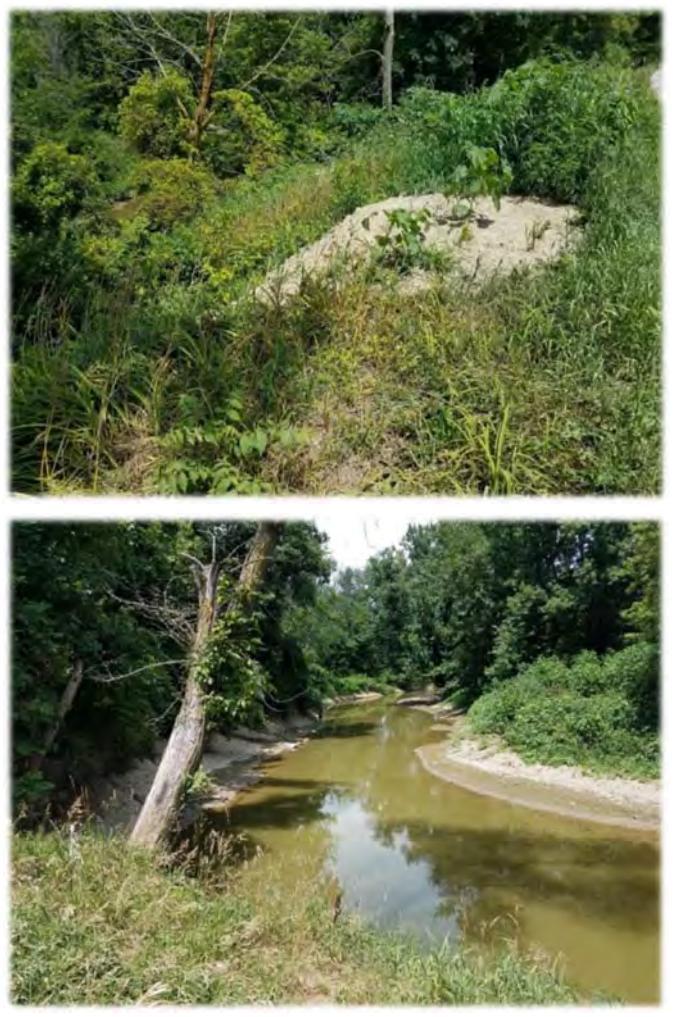
The next problem area is located at 3343 East County Road 1200 South approximately 2 miles east of State Road 27, which is approximately 3,900 feet west of the first problem area. The problem area instabilities include tension cracking and slab failure along the upper left bank and slope failure along approximately 500 feet of the upper left bank. (Barr, 2018). Emergency repairs have been made and consist of riprap placed loosely along the slope, as shown in Figure 10.

Failed, over-steepened, and undermined banks are unstable due to an inability to support the weight of the soil forming the bank. The bank is high, over-steepened, and exhibits the same type of geotechnical instability present at the 4100 E CR 1200 S problem area.

Figure 10: Bank Instability and Emergency Riprap Repair (top) and Toe of Slope (bottom) at 3343 E CR 1200 S

The proposed improvements consist of installing vegetated gabion baskets along the left bank, excavating a shelf along the right bank, and regrading the slope above/behind the baskets to a 3H:1V slope using the excavated material from the shelf. The height of the bank and close proximity of the roadway make it difficult to reliably utilize softer, bioengineered stabilization methods due

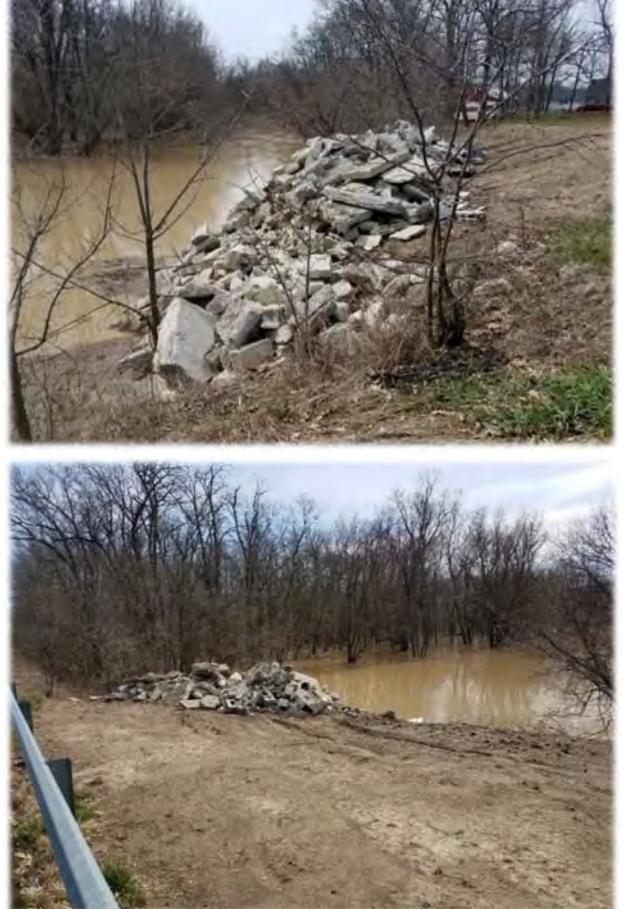
The problem area located at 270 East County Road 1100 South near Geneva, Indiana shows instability in the form of tension cracking, slab failure, and slope failure along the right bank. The slope failure extends for approximately 350 feet. The instability appears to be caused by more frequent saturation of the soils and its location on the outside of a very tight meander bend (Barr, 2018). Riprap has been placed in the channel and along the slope in an attempt to protect the roadway, as shown Figure 11.

Figure 11: Bank Instability and Riprap Repair at 270 E CR 1100 S

The proposed improvements consist of regrading the right slope to the more stable angle of 3H:1V using soil lifts with live stakes, installing riprap toe protection below the filled portion of the stabilized slope, and

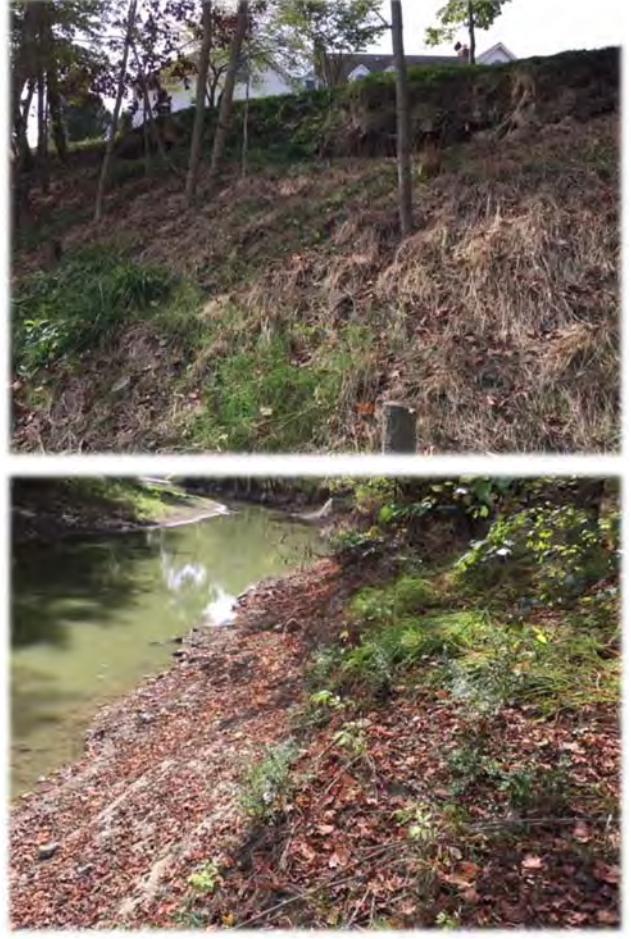
The problem area at 305 Old Hickory Lane in Adams County, Indiana, as shown in Figure 12 exhibits tension cracking and slab failure for approximately 100 feet along the left bank. The cause of the instabilities is more frequent saturation of the soils, a tall bank height, and the over-steepened nature of the bank.

Figure 12: Bank Failure (top) and Toe of Slope (bottom) at 305 Old Hickory Lane

The proposed improvements consist of installing vegetated gabion baskets along the left bank and regrading the slope above the gabion wall to a stable slope of 3H:1V using locally sourced material. Similar to the situation at 3343 E CR 1200 S, the

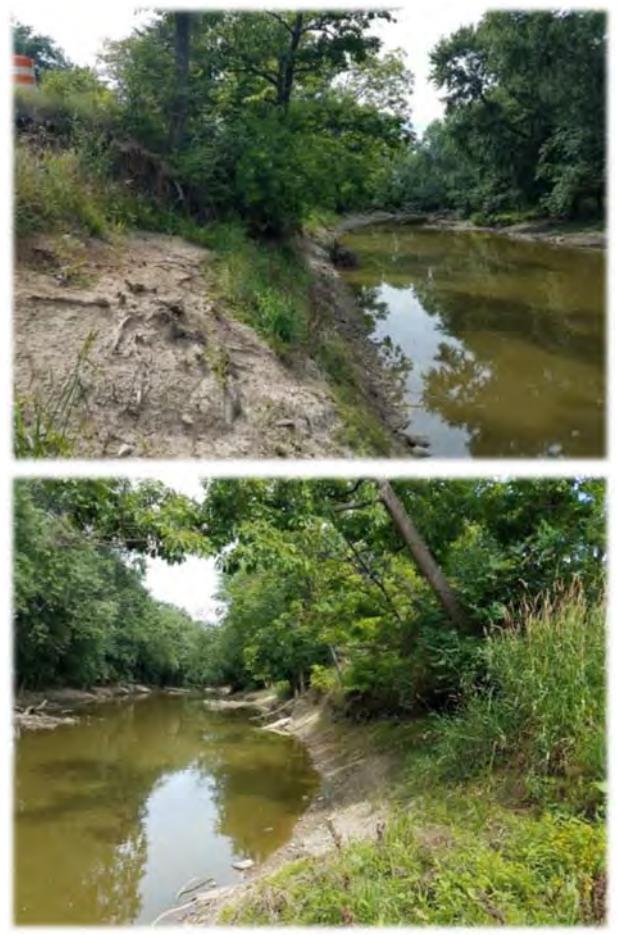
The problem area located at 6500 State Road 116 south of Vera Cruz, Indiana in Wells County has experienced tension cracking and slab failures along the left bank, as shown in Figure 13. Slope failure has extended approximately 700 feet along the bank and appears to be expanding (Barr 2018). The primary causes of the instabilities are more frequent saturation of the soils and the location along a meander bend.

Figure 13: Bank failure (top) and Toe of Slope (bottom) at 6500 State Road 116

The proposed improvements consist of regrading the upper slope to the more stable angle of 4H:1V and installing two levels of soil lifts. The lower level will be 4 lifts high and the upper level will be 3 lifts high. The upper level will be set back from the lower lift to create a shelf along the slope. The purpose of incorporating a shelf rather than a single set of 7 soil lifts is to avoid reducing the channel area and to reduce the potential of cars entering the river at this location. Additionally. guardrail should а be incorporated at the top of the slope to prevent vehicles from damaging the improvements and to reduce the potential for vehicles to enter the stream at this location. A free-draining sand and gravel drainage layer will be installed behind and below both

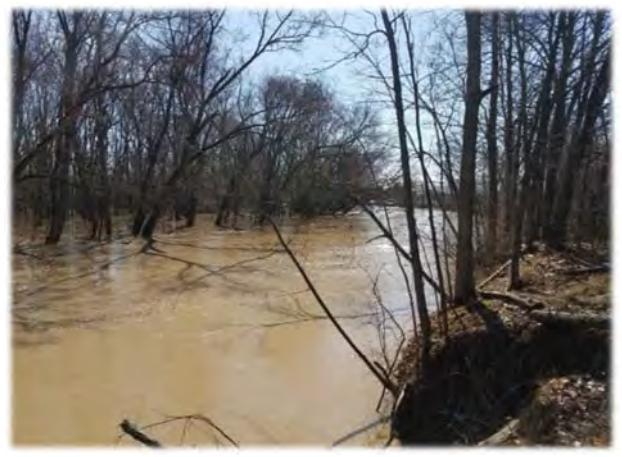
The problem area located at 6595 State Road 116, south of Vera Cruz, Indiana exhibits tension cracking and slab failure along the left bank, as shown in Figure 14. This problem area is approximately 1,000 feet west of the problem area at 6500 SR 116. Slope failure has occurred along the left bank extending approximately 500 feet and expanding in both the upstream and downstream direction. The causes of the instabilities are more frequent saturation of the soils, the location of the site along a meander bend, and the tall and oversteepened nature of the bank.

Figure 14: Bank Failure at 6596 State Road 116

No improvements are recommended at 305 Old Hickory Lane (Exhibit 8) and 6596 State Road 116 (Exhibit 10). No immediate action appears to be necessary at these locations. The bank instabilities at these locations should be monitored. Should the conditions change, and a proactive approach by the homeowner(s) is desired, the homeowner(s) can implement the improvements discussed in Chapter 4 for these problem areas. To help avoid matters from getting worse, it is recommended that the homeowners avoid saturating the slopes with water from storm drainage or watering the lawns (Barr 2018).

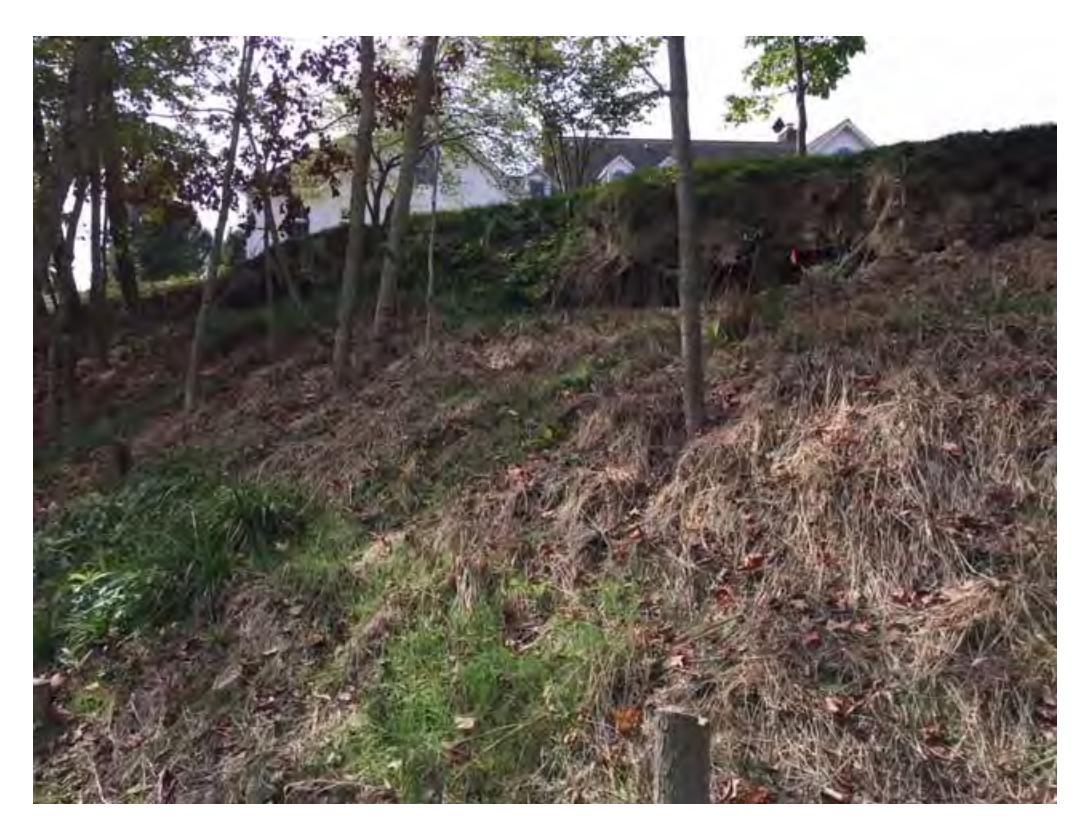
This site has approximately 100-feet of the upper valley wall showing tension cracks and slab failure. No additional movement has been observed in the last 6 months. Slope failure is occurring above the left bank primarily in Blount silt loam soil. Note that the site is on the downstream portion of a meander (red arrow).

Figure 9: Upper slope at UWR 1

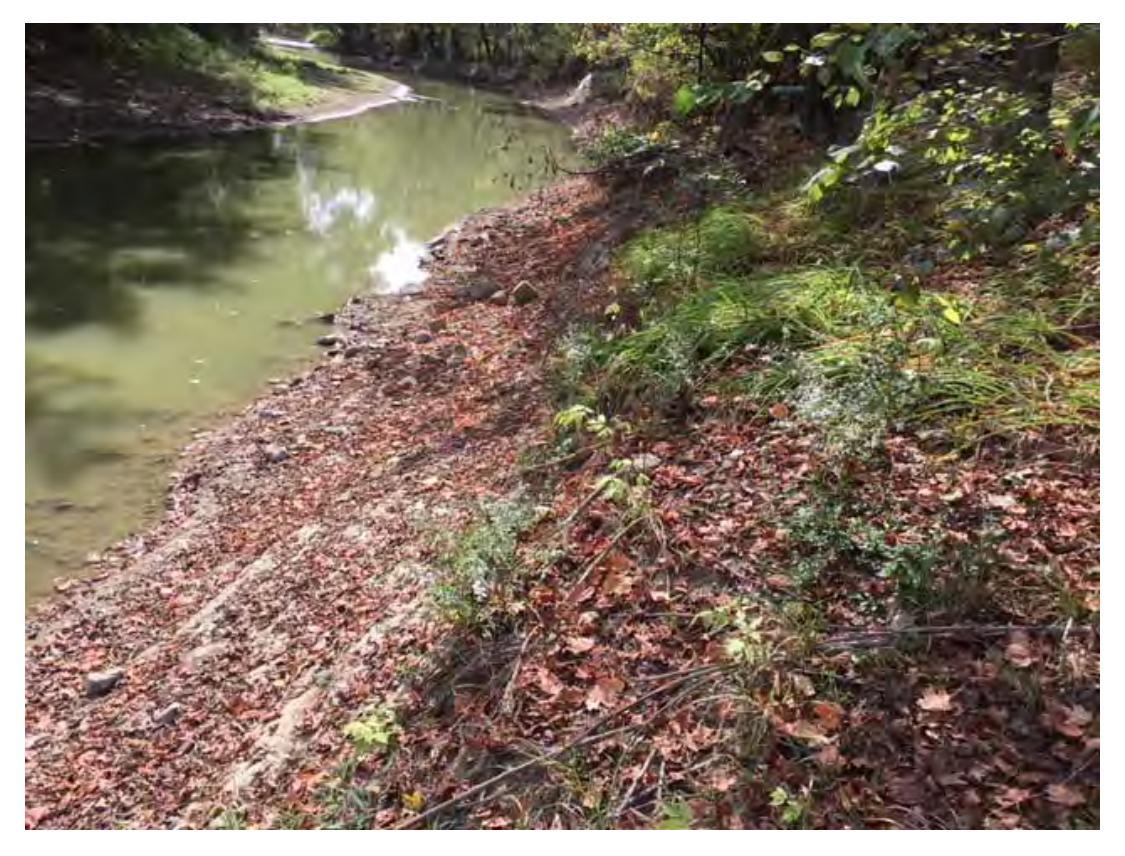
Figure 10: Lower slope at UWR 1

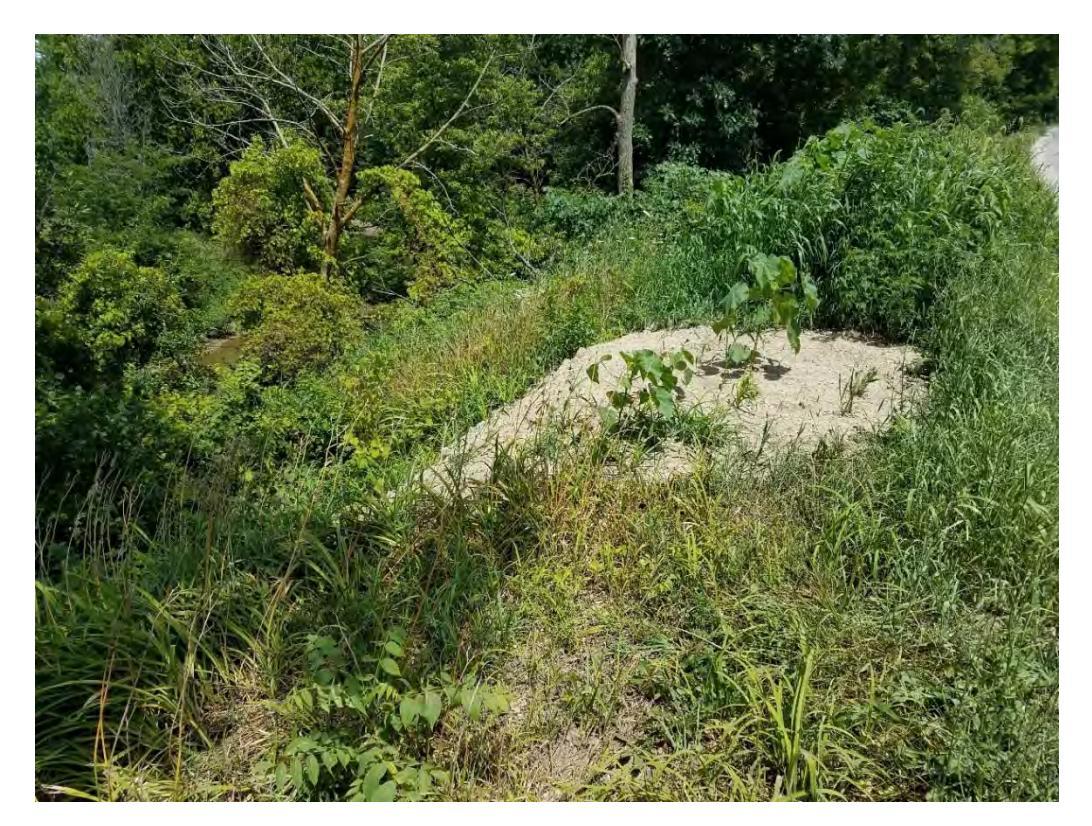
Tension cracking and slab failure along the left upper valley wall are threatening E CR 1200 S approximately 2 miles east of SR 27. Slope failure has occurred along 500-feet of the upper valley wall (red arrow). Soil in that portion of the left bank is Glynwood-Mississinewa clay loam. Emergency repairs have been made at the site, but slope instability continues.

Figure 12: Initial slope repair at UWR 2

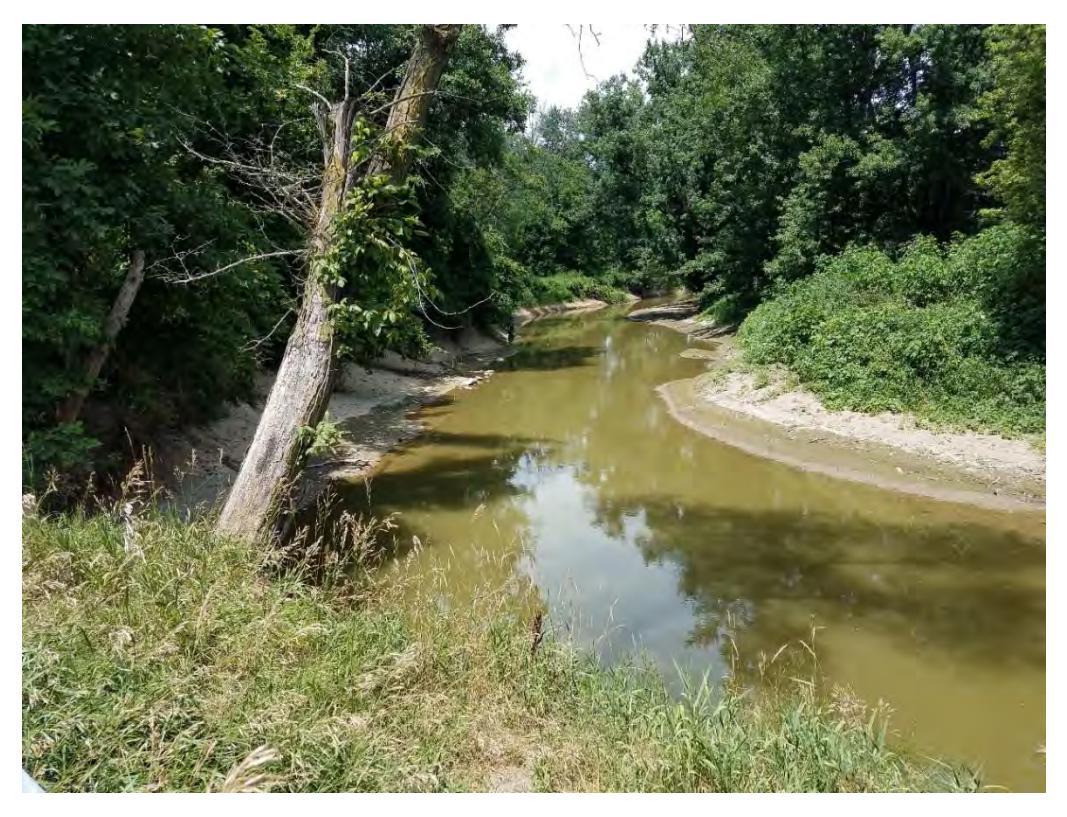
Figure 13: Slope location of UWR 2. Note slumping tree and stable toe of slope and channel.

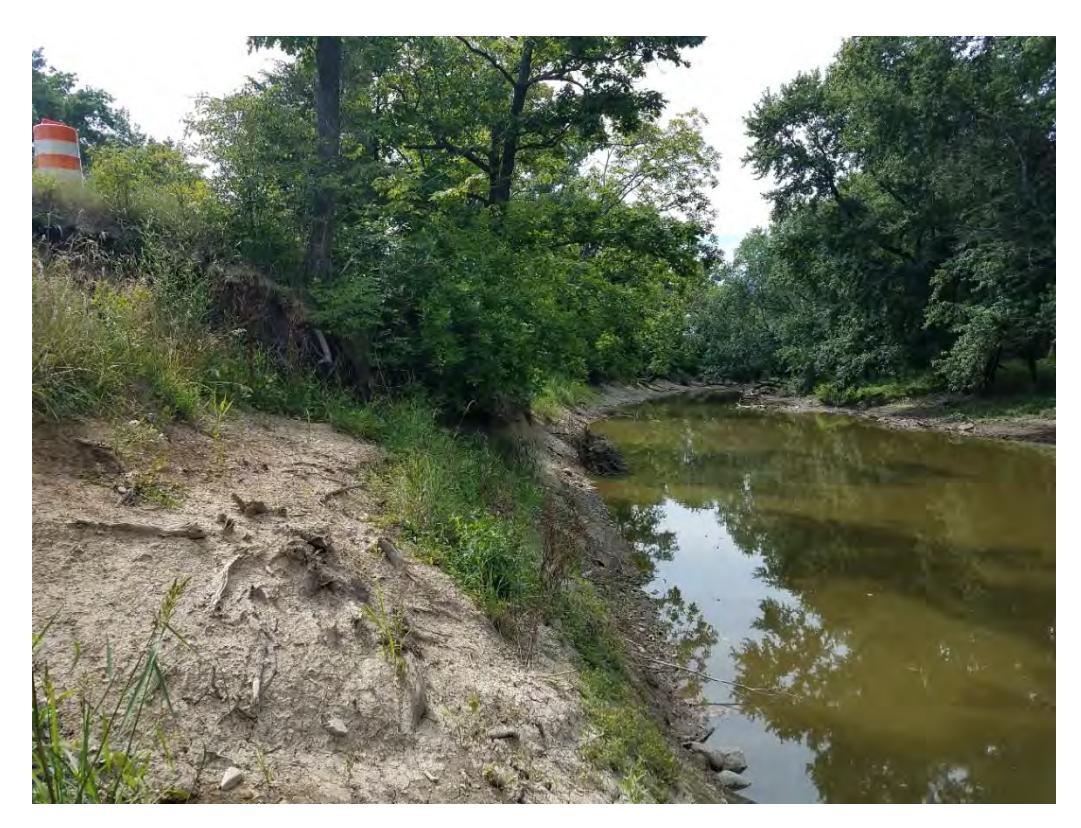
Tension cracking and slab failure of the slope above the left bank. Slope failure is occurring in Blount and Del Rey silt and silty clay loam soils above the left bank. The visible slope failure extends for approximately 700 feet, but tree angle suggests that the failure area is expanding.

Figure 15: Stable toe at UWR 3

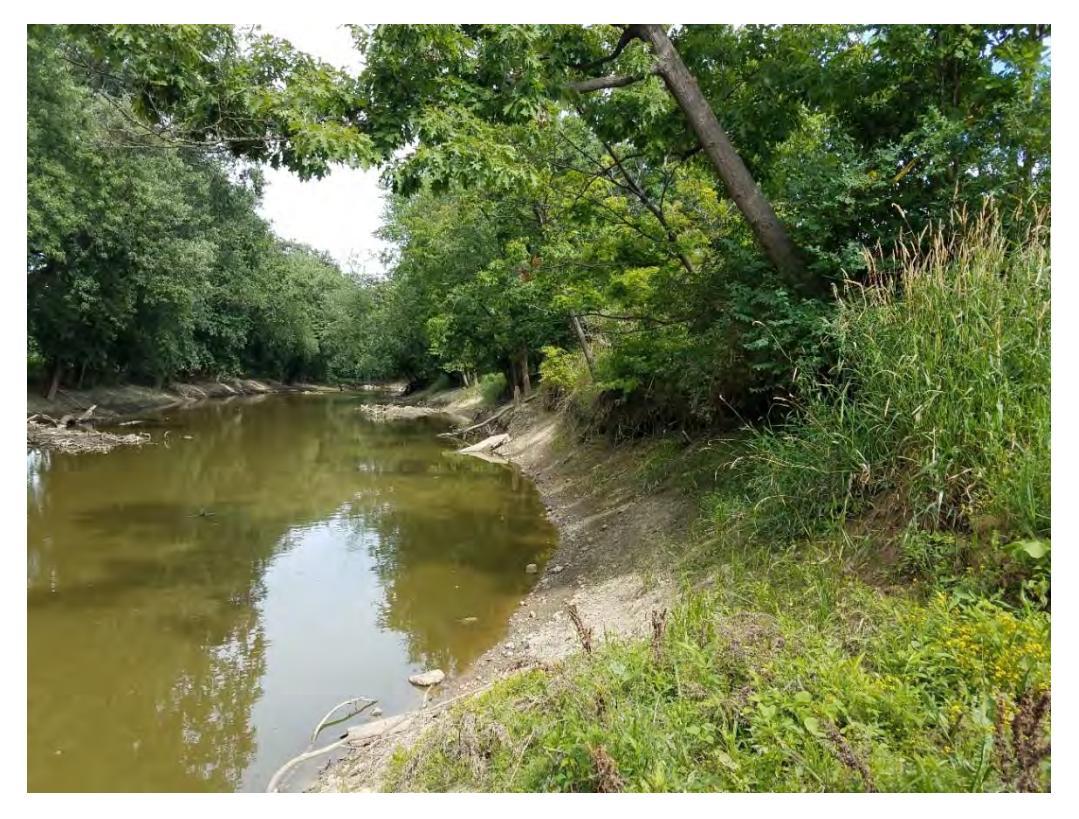
Figure 16: Stable toe at UWR 3 but note tree angle on upper slope looking upstream.

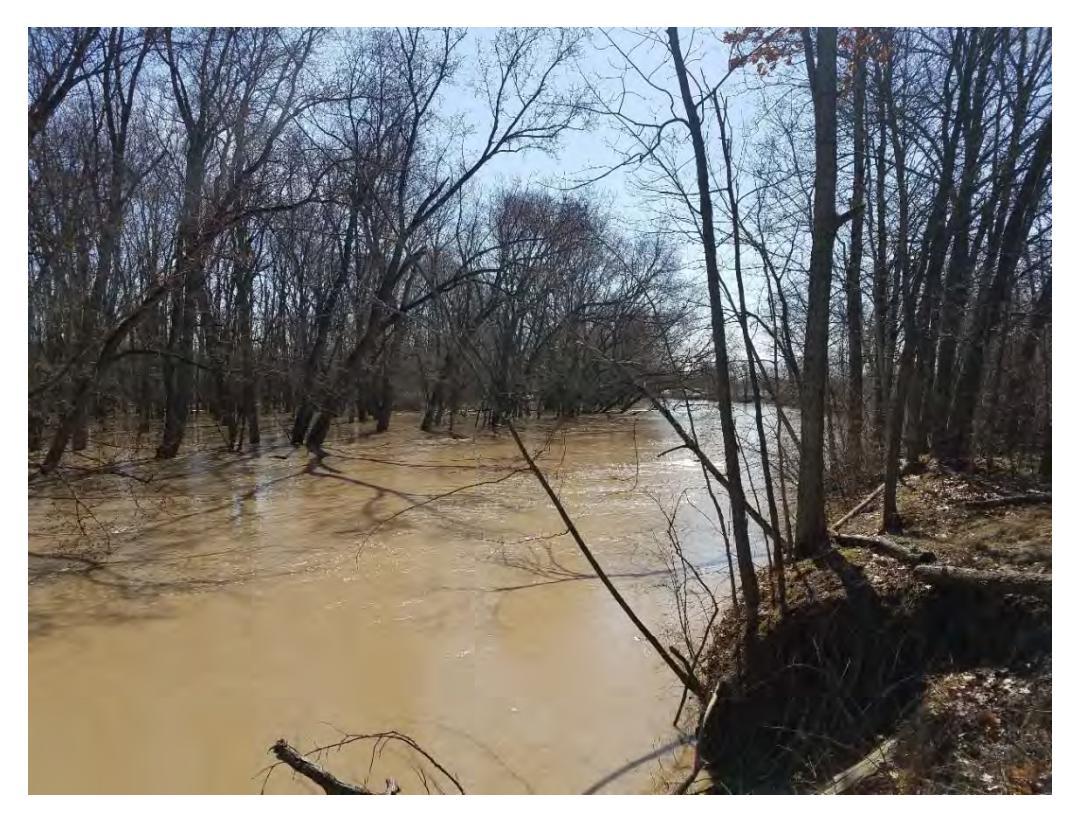
Tension cracking and slab failure of upper valley wall above left bank of the Wabash River. Slope failure is occurring in the Glynwood silt loam soil above the left bank (red arrow). Note the dashed slope symbol on the soil map. The slope failure currently extends for about 500 feet, but it is expanding in both the upstream and downstream directions.

Figure 18: Slope failure along upper slope above left bank at UWR 4. Note the elevation difference between the top of slope and the floodplain on the right bank.

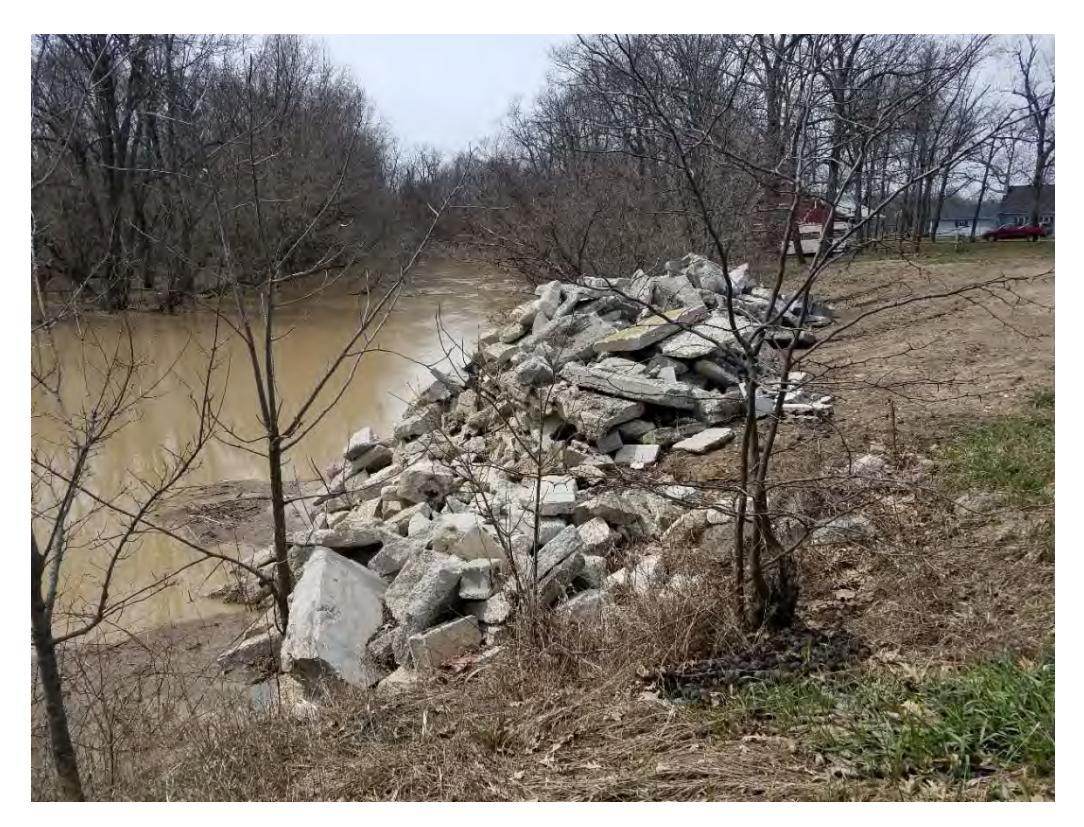
Tension cracking and slab failure along the upper valley wall above the right bank of the Wabash River (red arrow). Slope failure is occurring in Glynwood silt loam. Slope failure extends for about 350 feet in the crest of a very tight meander

Figure 20: Emergency stabilization at UWR 6

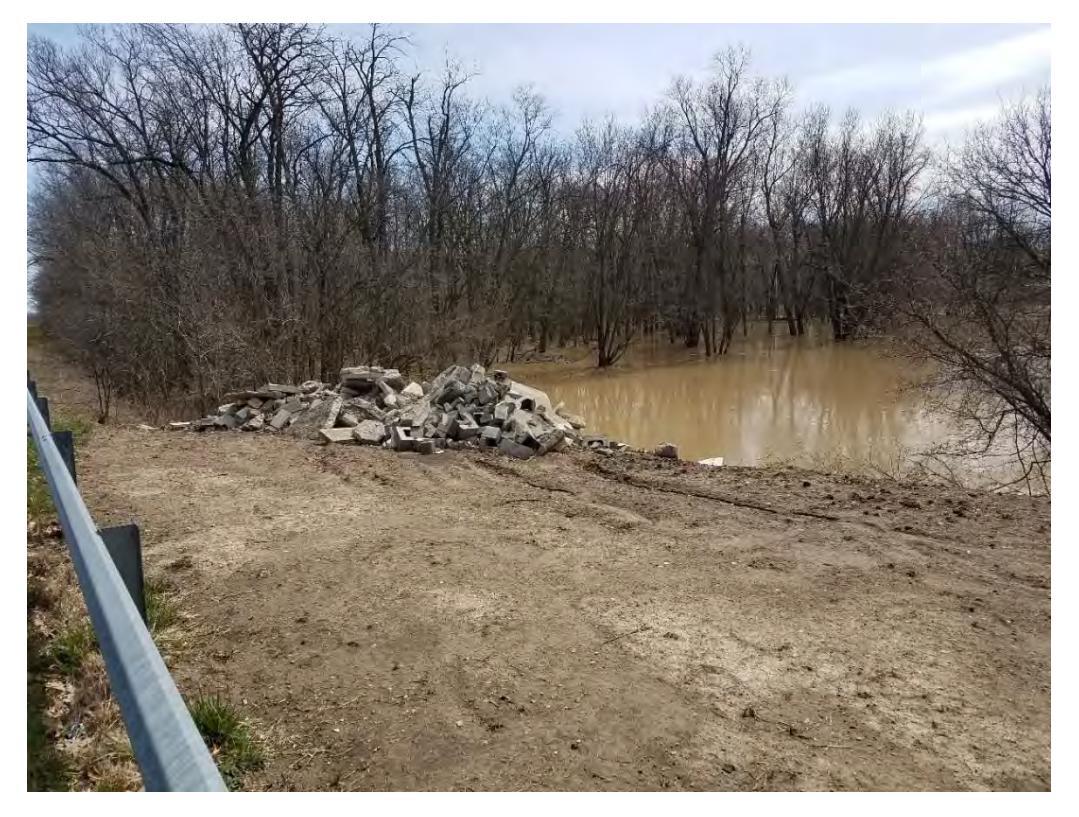
Figure 21: New and old stabilization at UWR 6. Note the elevation of the slope relative to the floodplain visible in the background.

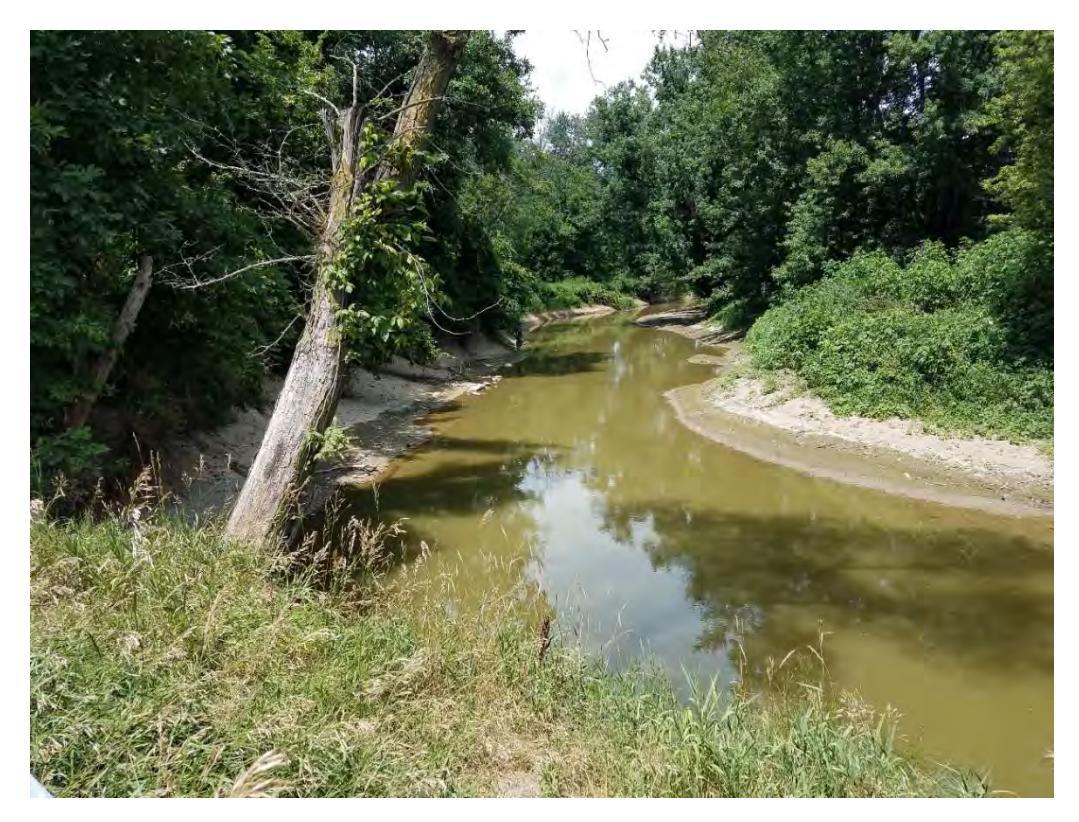
Slope failure along the valley wall above the left bank. Failure is occurring in Pewamo silty clay loam soil. Failure is threatening the county road for approximately 800 feet.

Figure 23: Looking downstream at UWR 7. Note angle of tree.

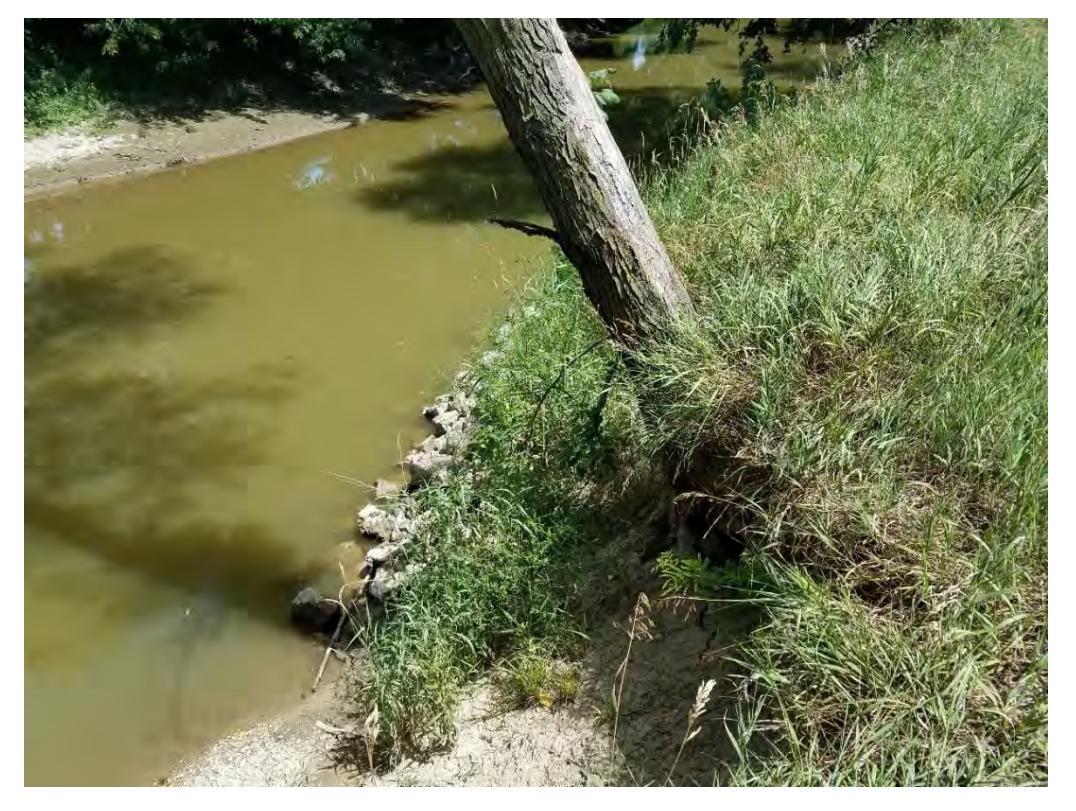
Figure 24: UWR 7, same tree as in Figure 22. Note rock repair is in channel, not on slope. New slope failure in downstream direction.
